Site Assessment and Remediation Work Plan

Murchison Oil & Gas, LLC

Ogden State #4

NMOCD Incident # nAPP2424335058

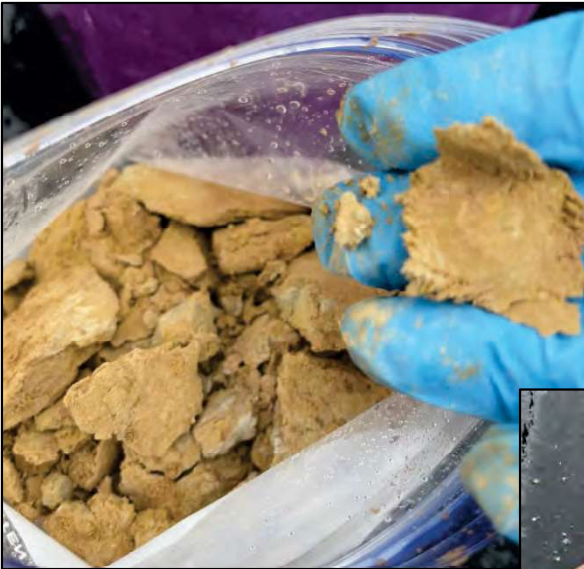
3-ft sample: demonstration of plasticity

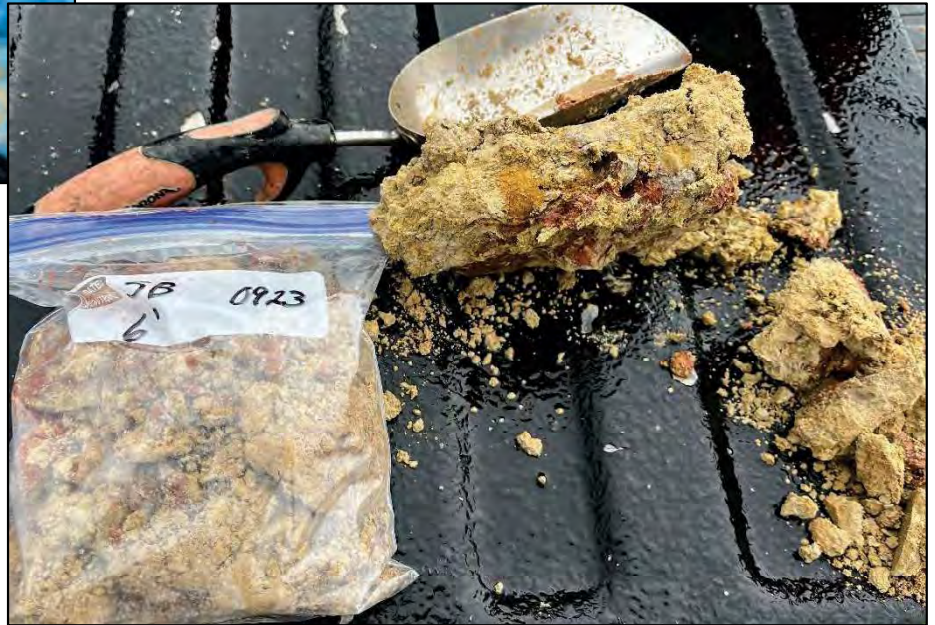
6-ft sample: appearance of red clay at
bottom of auger

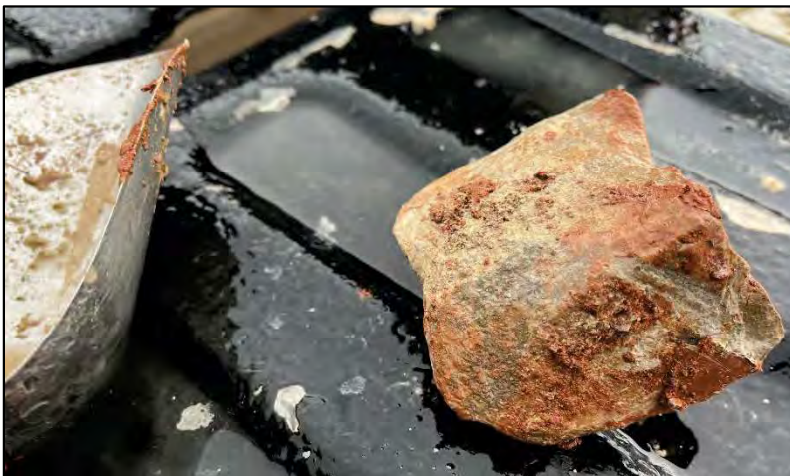
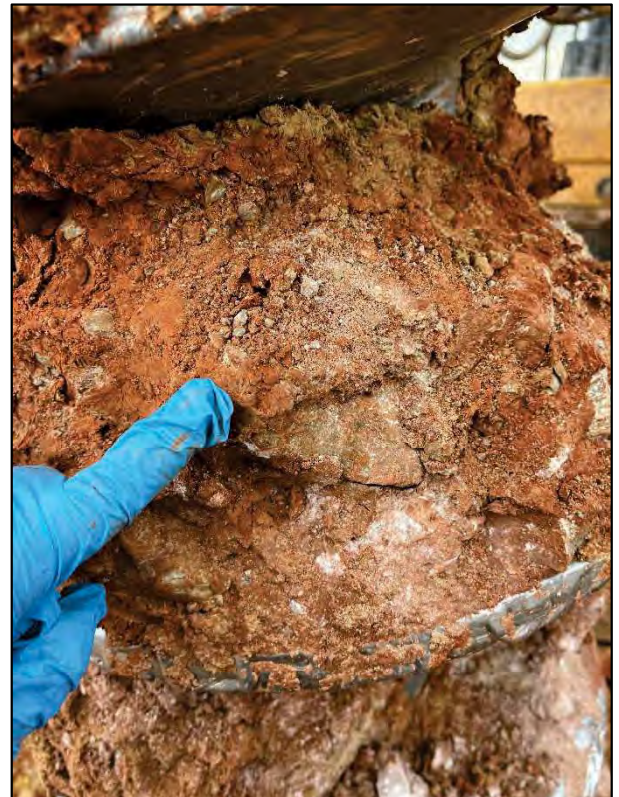
10-ft sample: auger (right), dolomite (bottom)

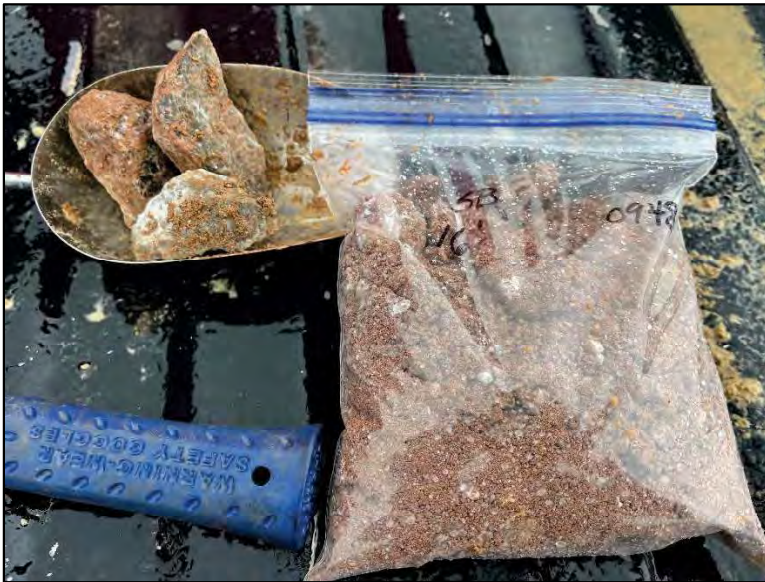
16-ft sample: Silt with gypsum or dolomite

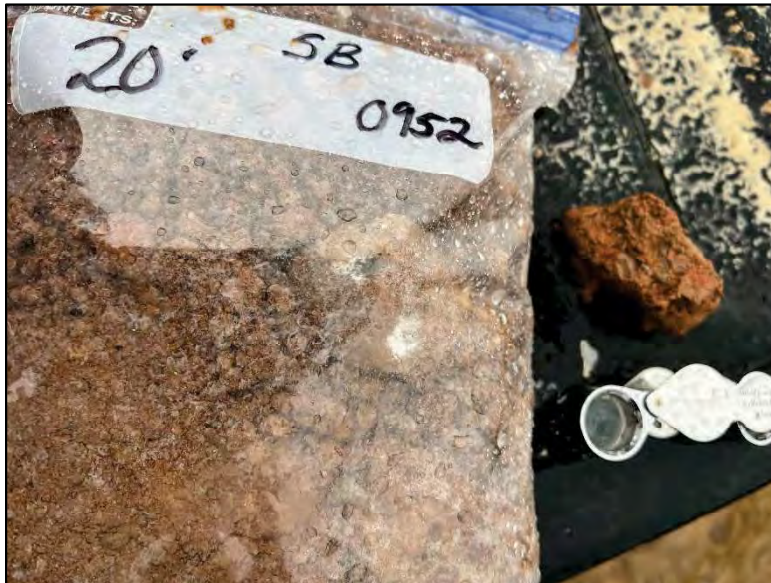
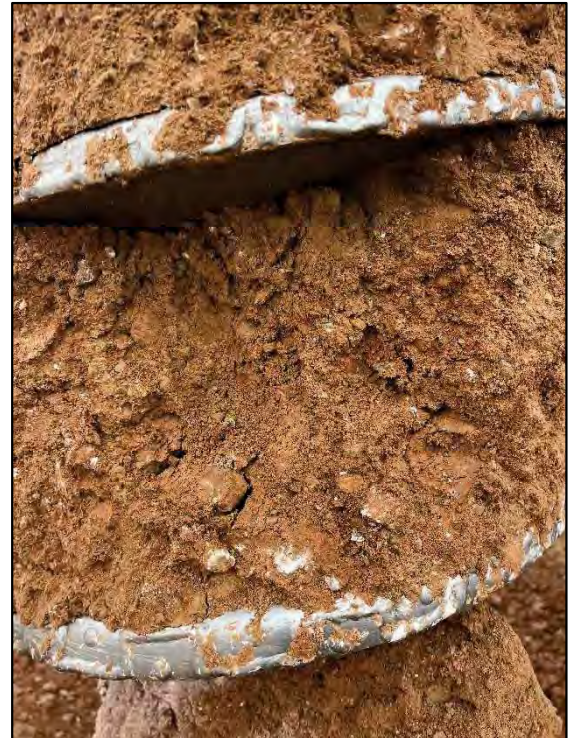
20-ft sample: Auger (left) and vitreous gypsum shown (bottom)

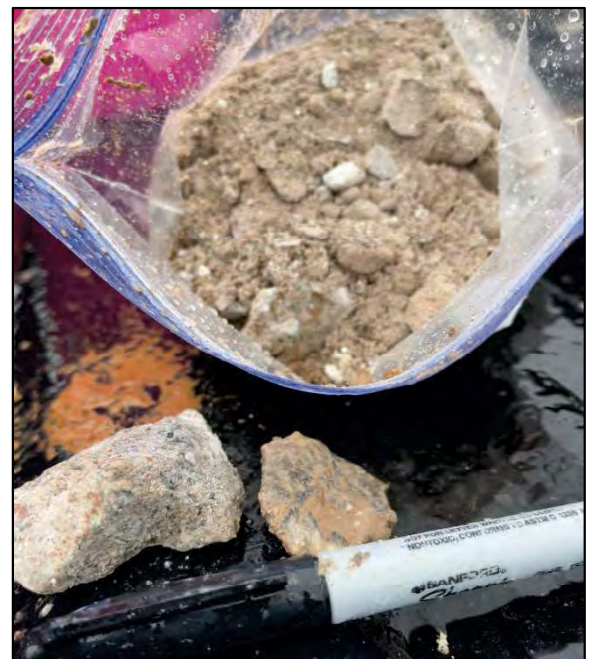
30-ft sample: Dolomite or gypsum with silt

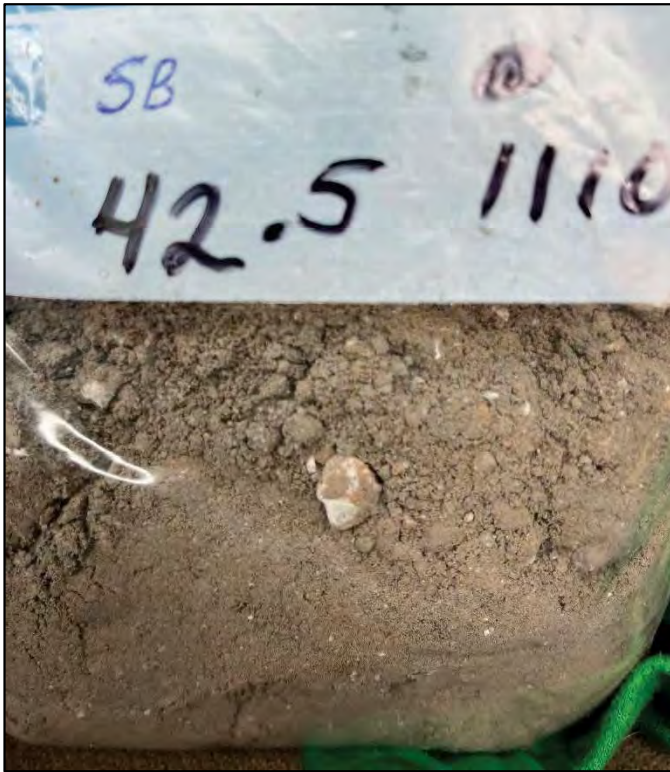
42.5 ft-sample: Silt with dolomite

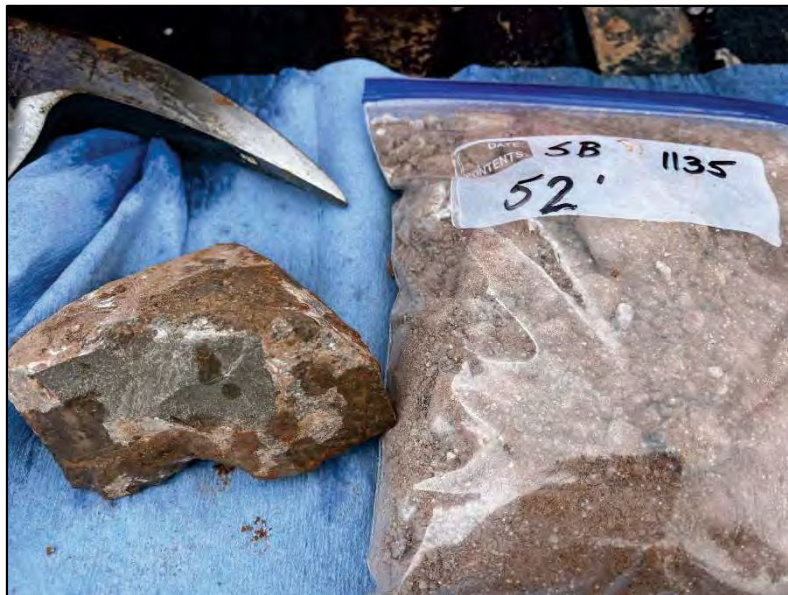
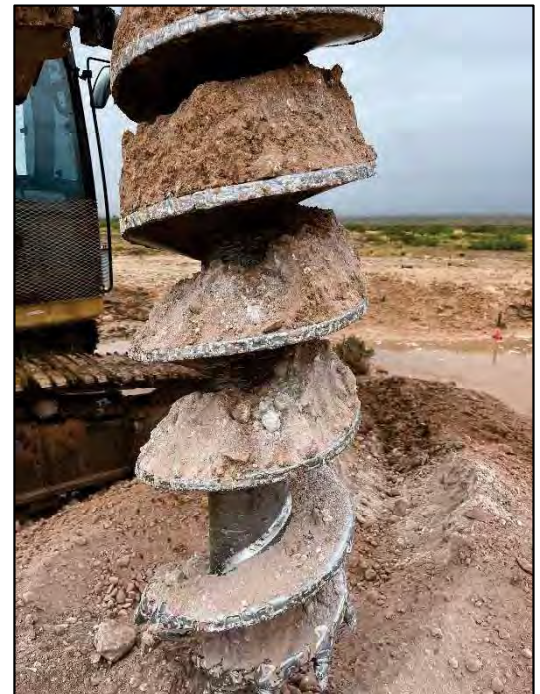
52-ft sample: hard limestone or dolomite in silt (left),
auger(right)

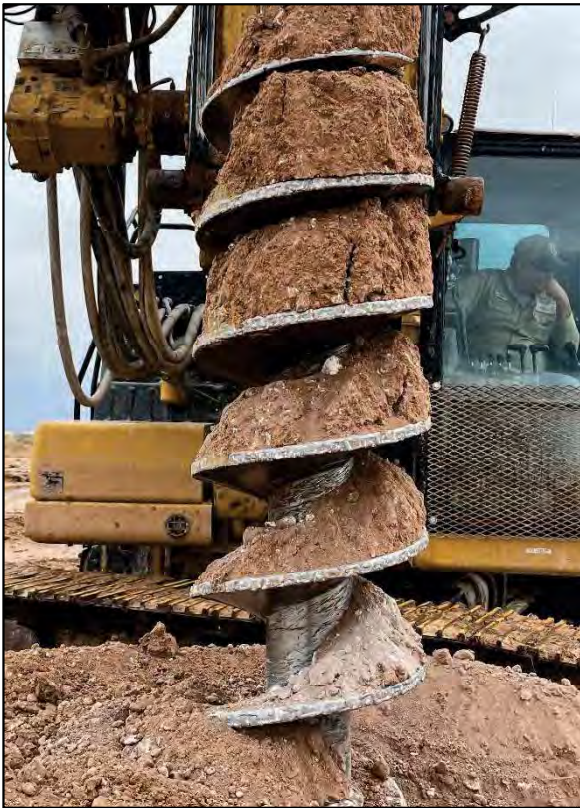
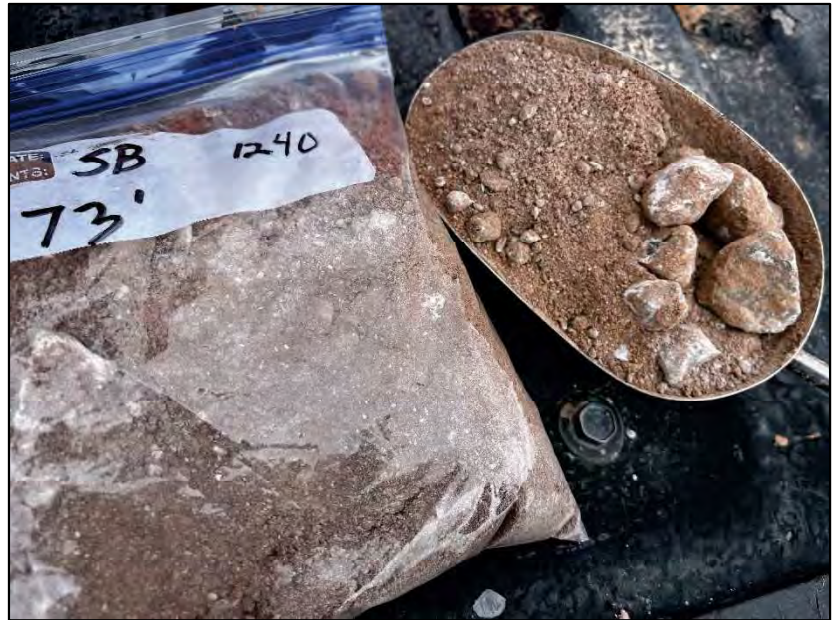
73-ft sample: auger (left), silt with limestone or dolomite (above)

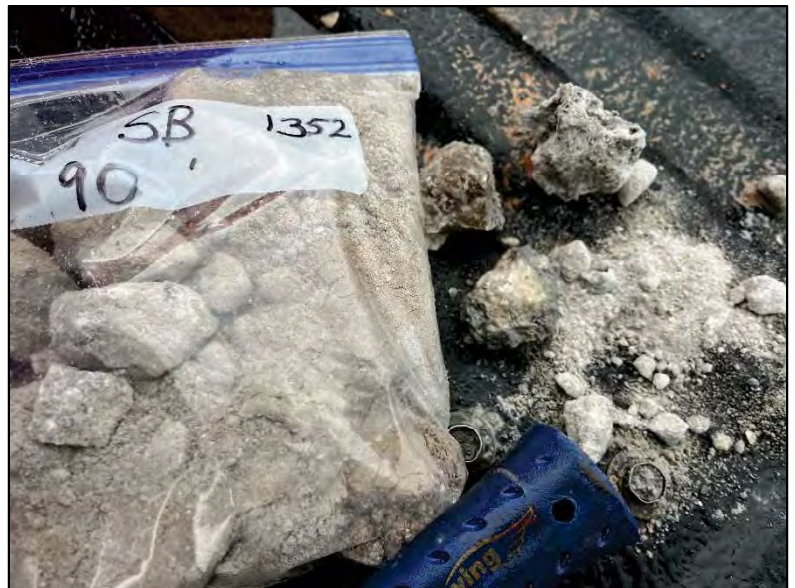
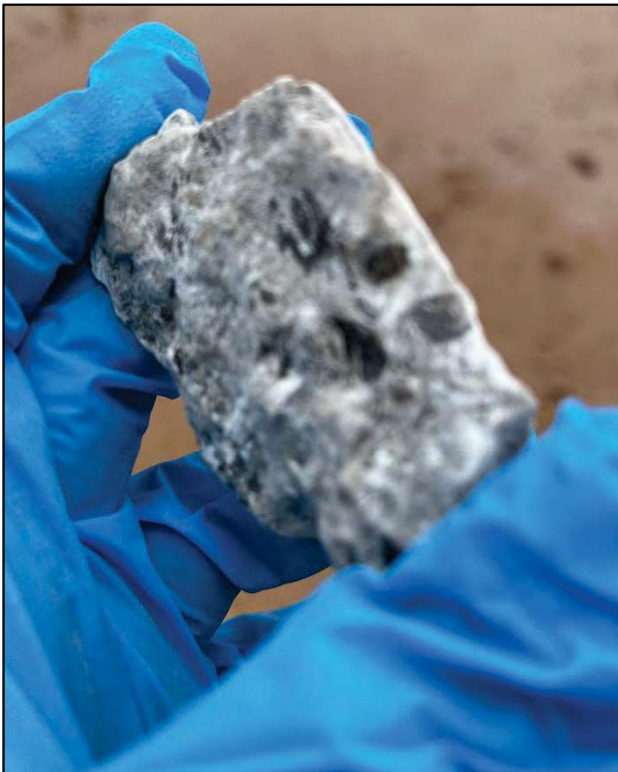
90-ft sample: returns have become dusty

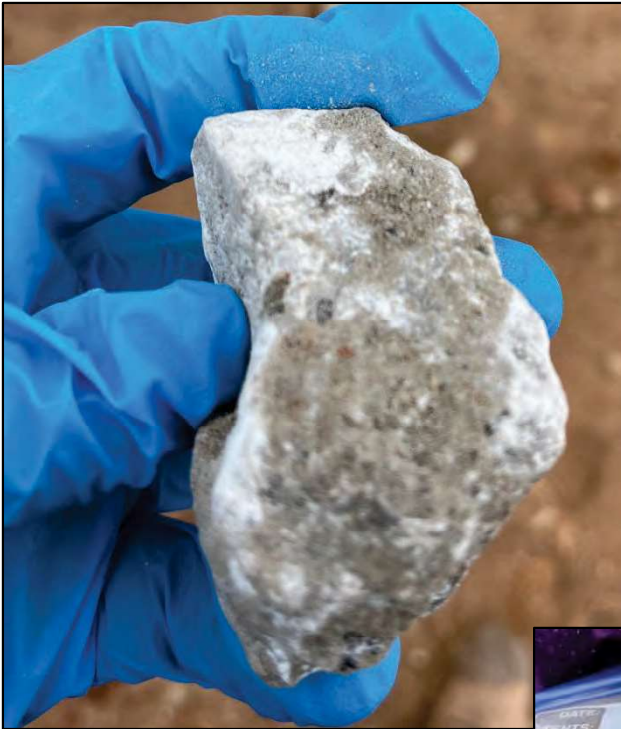
Hard dolomite or limestone at 95 ft

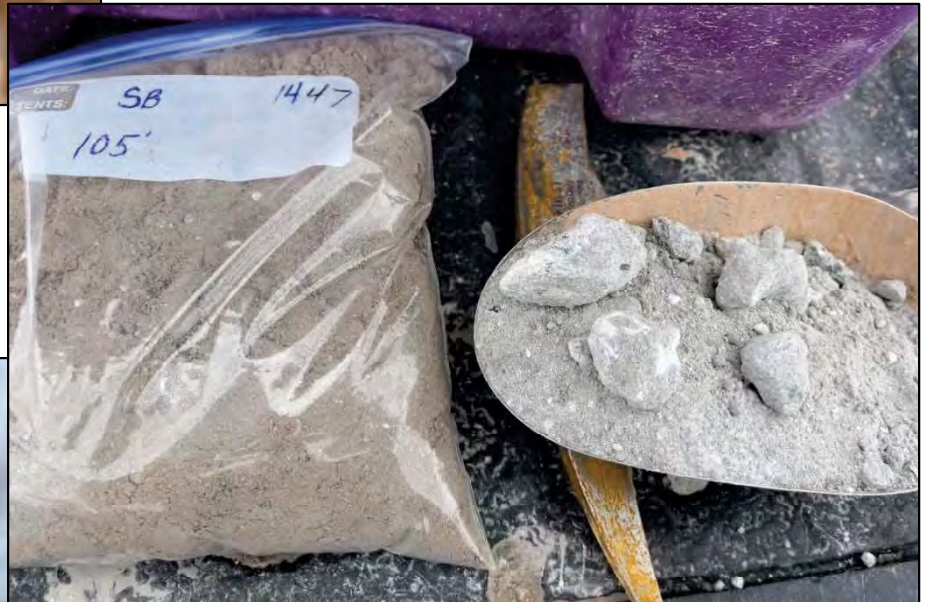
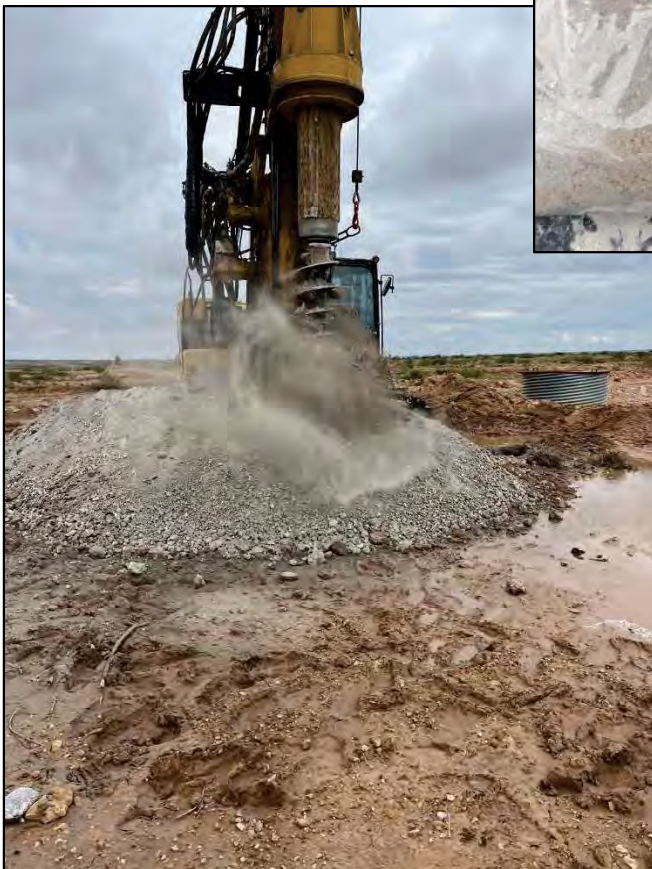
105-ft sample from TD (above); spin of final TOOH (left)
