DTW LINE LEAKRemediation Action Plan

NMOCD Incident No. nAPP2408932632 UL "A", Sec. 01, T23S, R31E 32.339851, -103.723865 Eddy County, New Mexico

Re: Remediation Action Plan

Tasman Project No. 7131

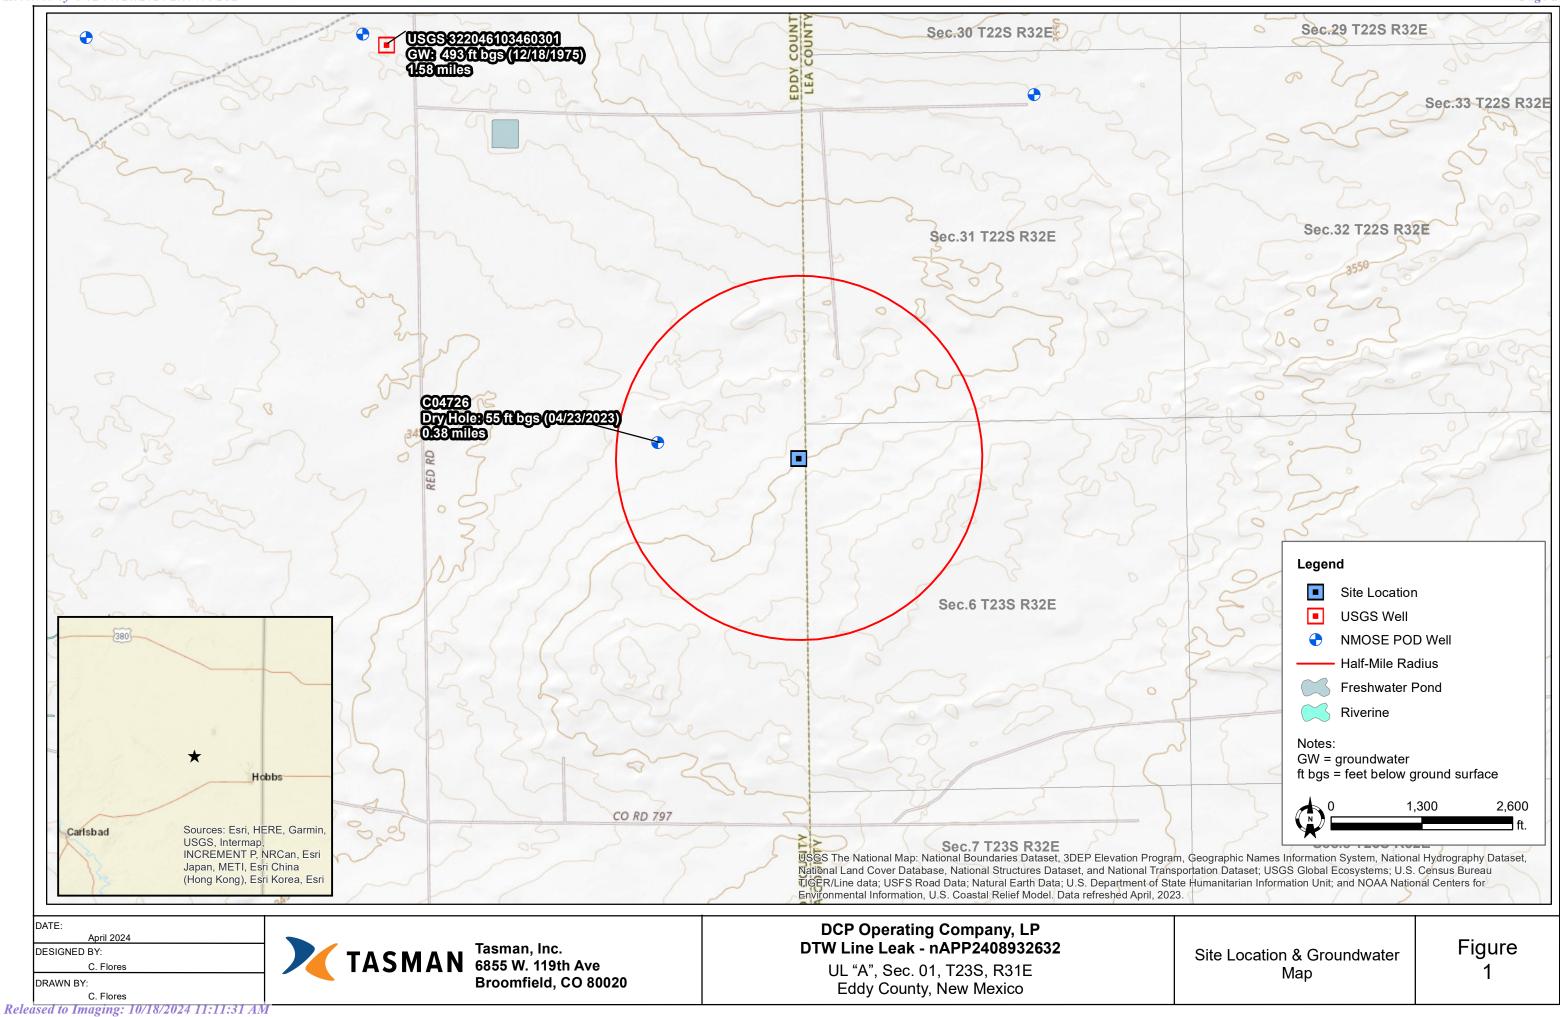
Figure 1 – Site Location & Groundwater Map

The Site Location & Groundwater Map included as Figure 1 illustrates the location of the registered water wells within the vicinity of the site, and a summary of depth to groundwater information is provided as Appendix B.

The nearest potable water well is USGS 322046103460301. The well is located 1.58 miles from the site. The location of USGS 322046103460301 is shown on the attached Figure 1.

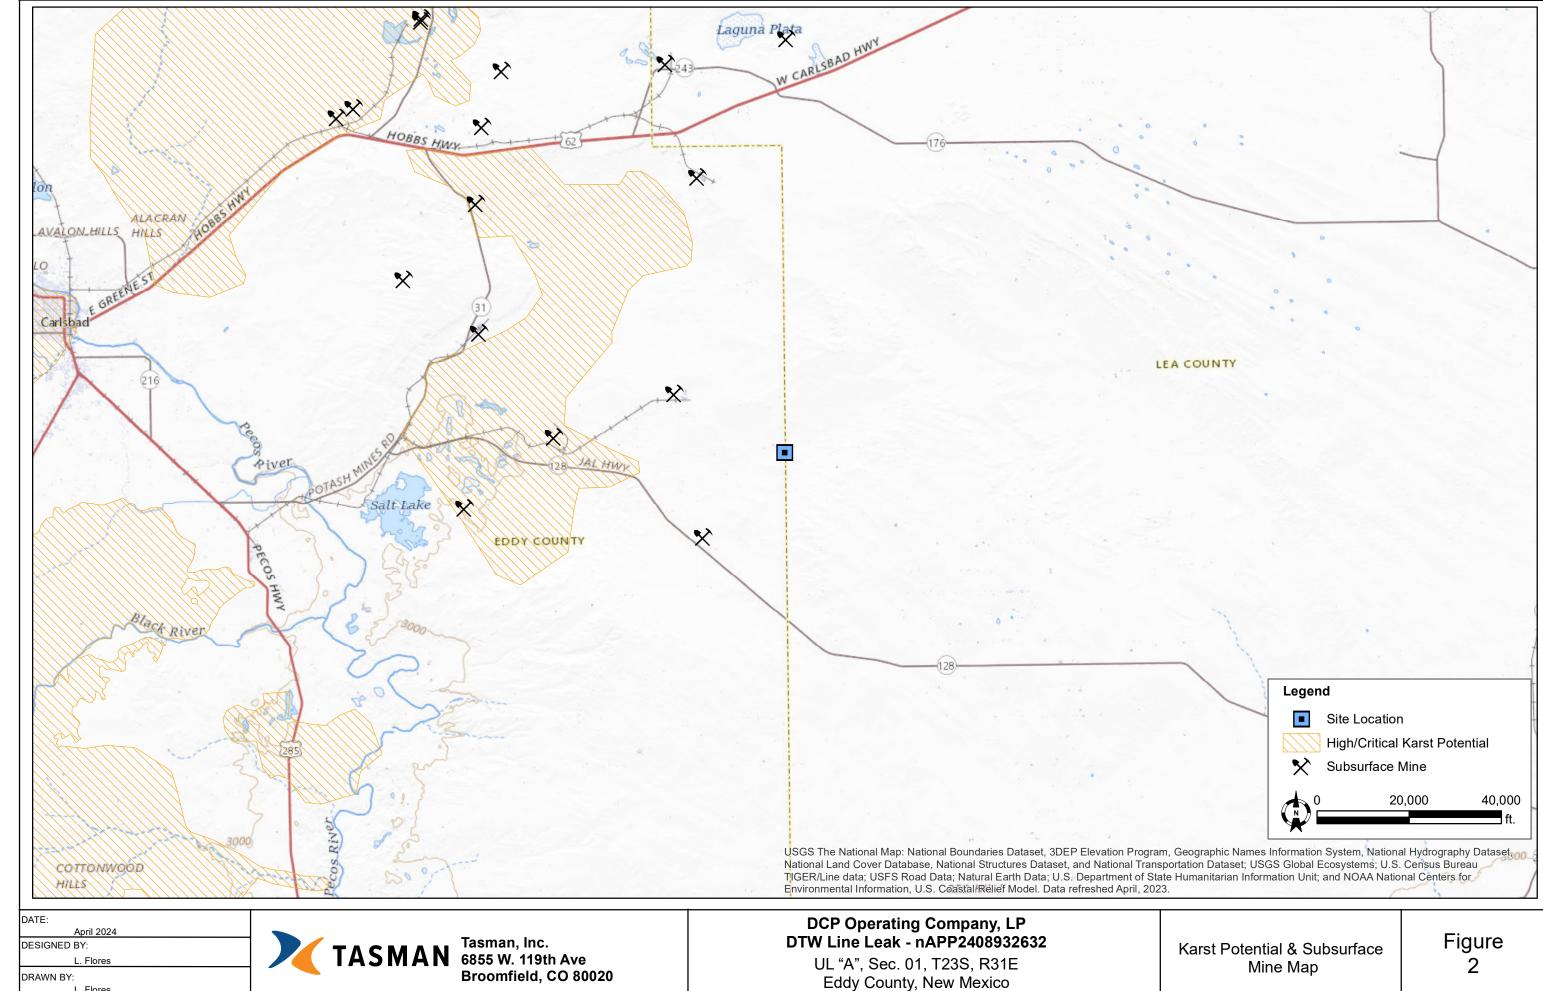
Figure 2 – Karst Potential & Subsurface Mine Map

Areas of high/critical karst and subsurface mine locations are illustrated on Figure 2.

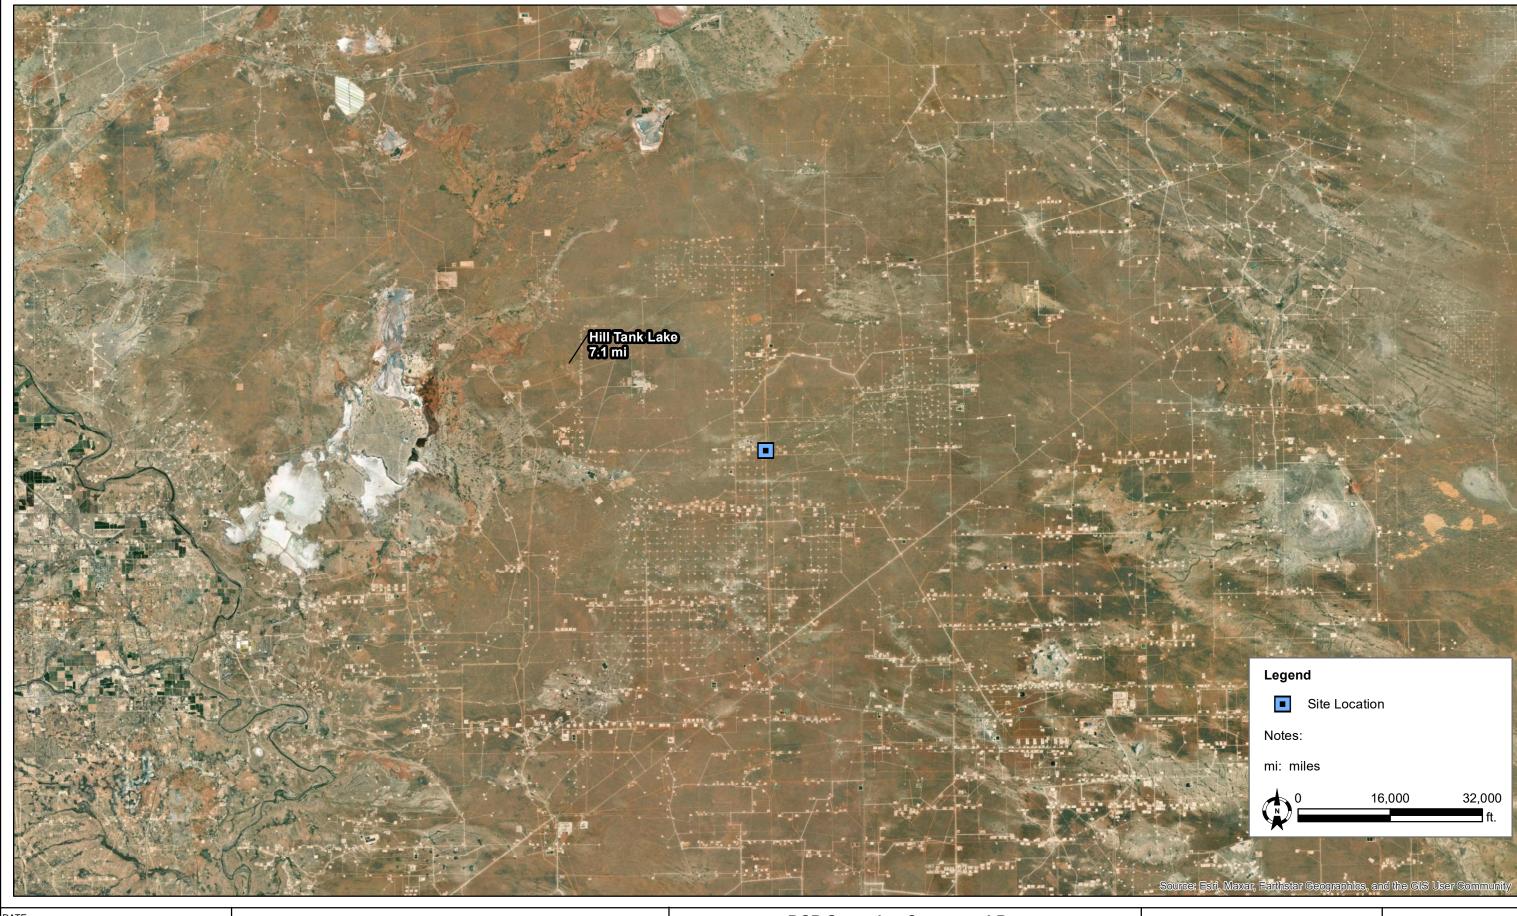
Figure 3 – Surface Water Map

Tasman reviewed aerial imagery and the National Wetland Inventory Map, published by the U.S. Fish and Wildlife Service, for wetlands and surface water in the vicinity of the site. The nearest wetland, freshwater pond, is located approximately 1.07 miles from the site. The nearest significant surface water was identified as Hill Tank Lake, located 7.1 miles from the site. The location of the nearest surface water body can be seen on Figures 1 and 3.

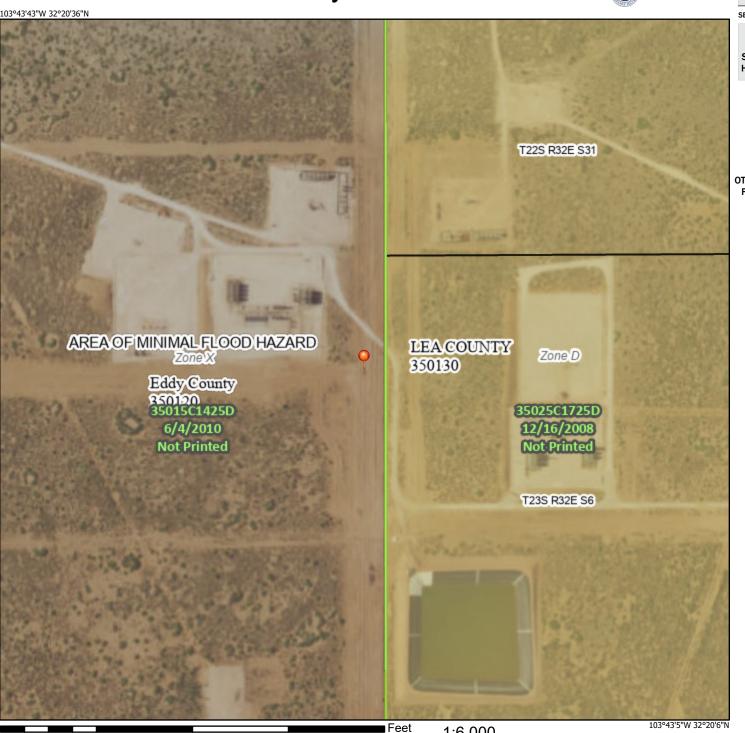
Figure 4

Review of flood map data published by the Federal Emergency Management Agency (FEMA) indicates the site is not located within a 100-year floodplain. A copy of the FEMA FIRMete Map can be found attached as Figure 4.

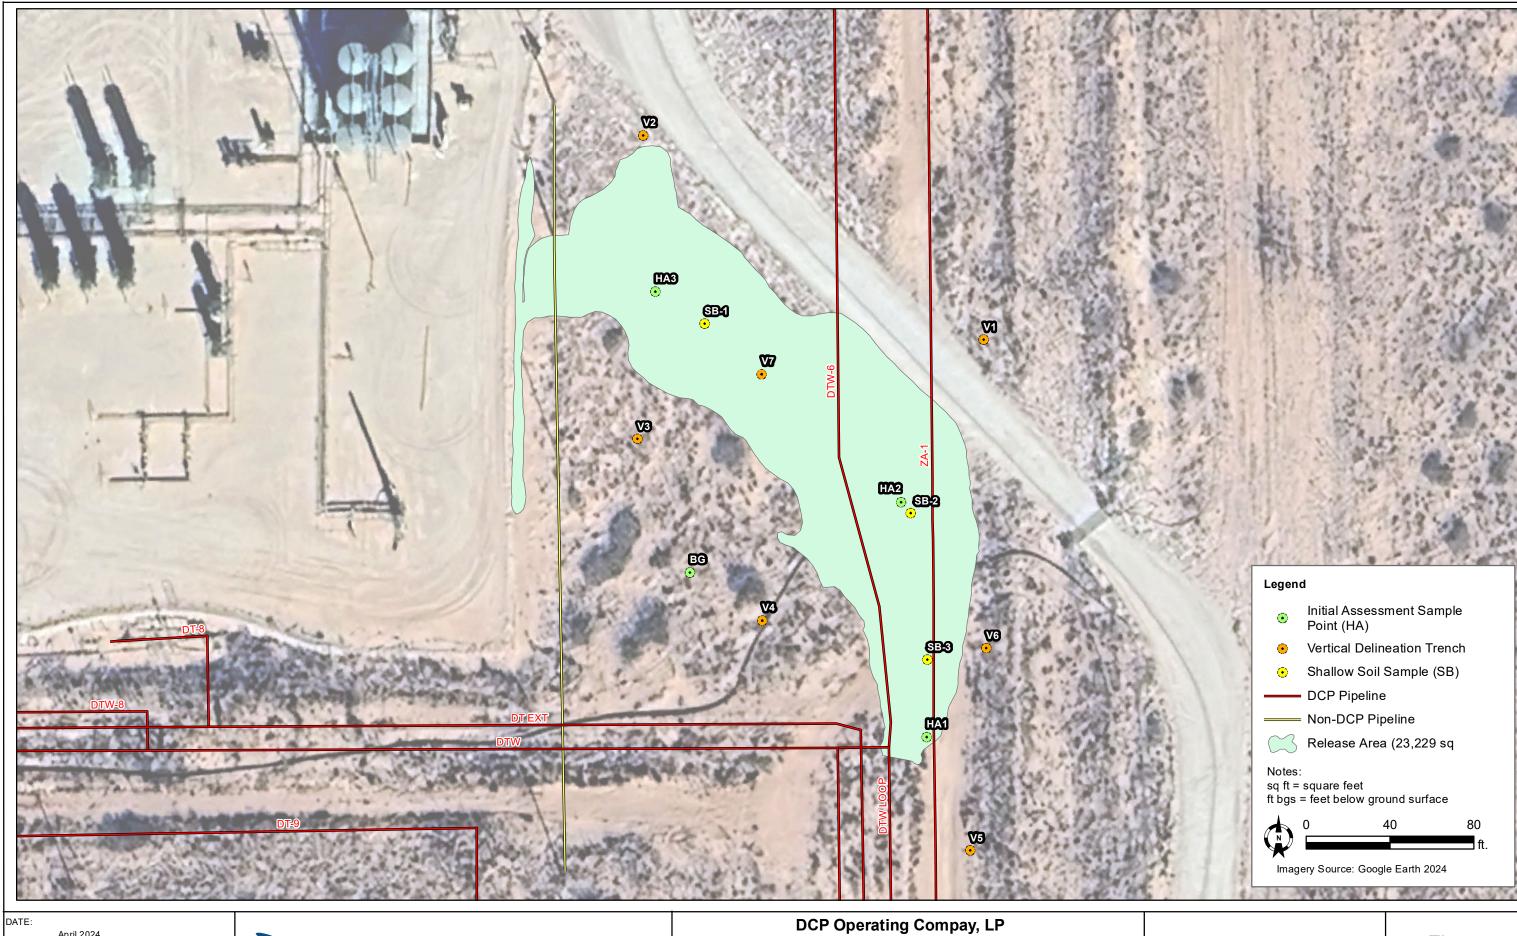
Figure 5 – Delineation Overview Map

On April 17, 2024, Tasman advanced seven delineation trenches using machinal equipment, referred to as verticals (V-1 through V-7), to delineate the release area. Verticals were advanced to depths ranging from 6 ft bgs to 12 ft bgs.

On May 14, 2024, Tasman personnel returned to the advance three soil borings (SB-1 through SB-3) via hand auger within the release area to a depth of 0.5 ft bgs.

The attached Figure 5 illustrates the observed release and location of soil sample locations.
