**RE: Request for Closure
XTO Energy Inc. – Poker Lake Unit #430H
UL/B sec. 21 T24S R30E
API No. 30-015-42374
2RP-4583**

XTO Energy Inc. (XTO) has retained Basin Environmental Service Technologies (Basin) to address potential environmental concerns at the above-referenced site.

XTO Energy – Poker Lake Unit #430H

Unit Letter B of Section 21, T24S, R30E

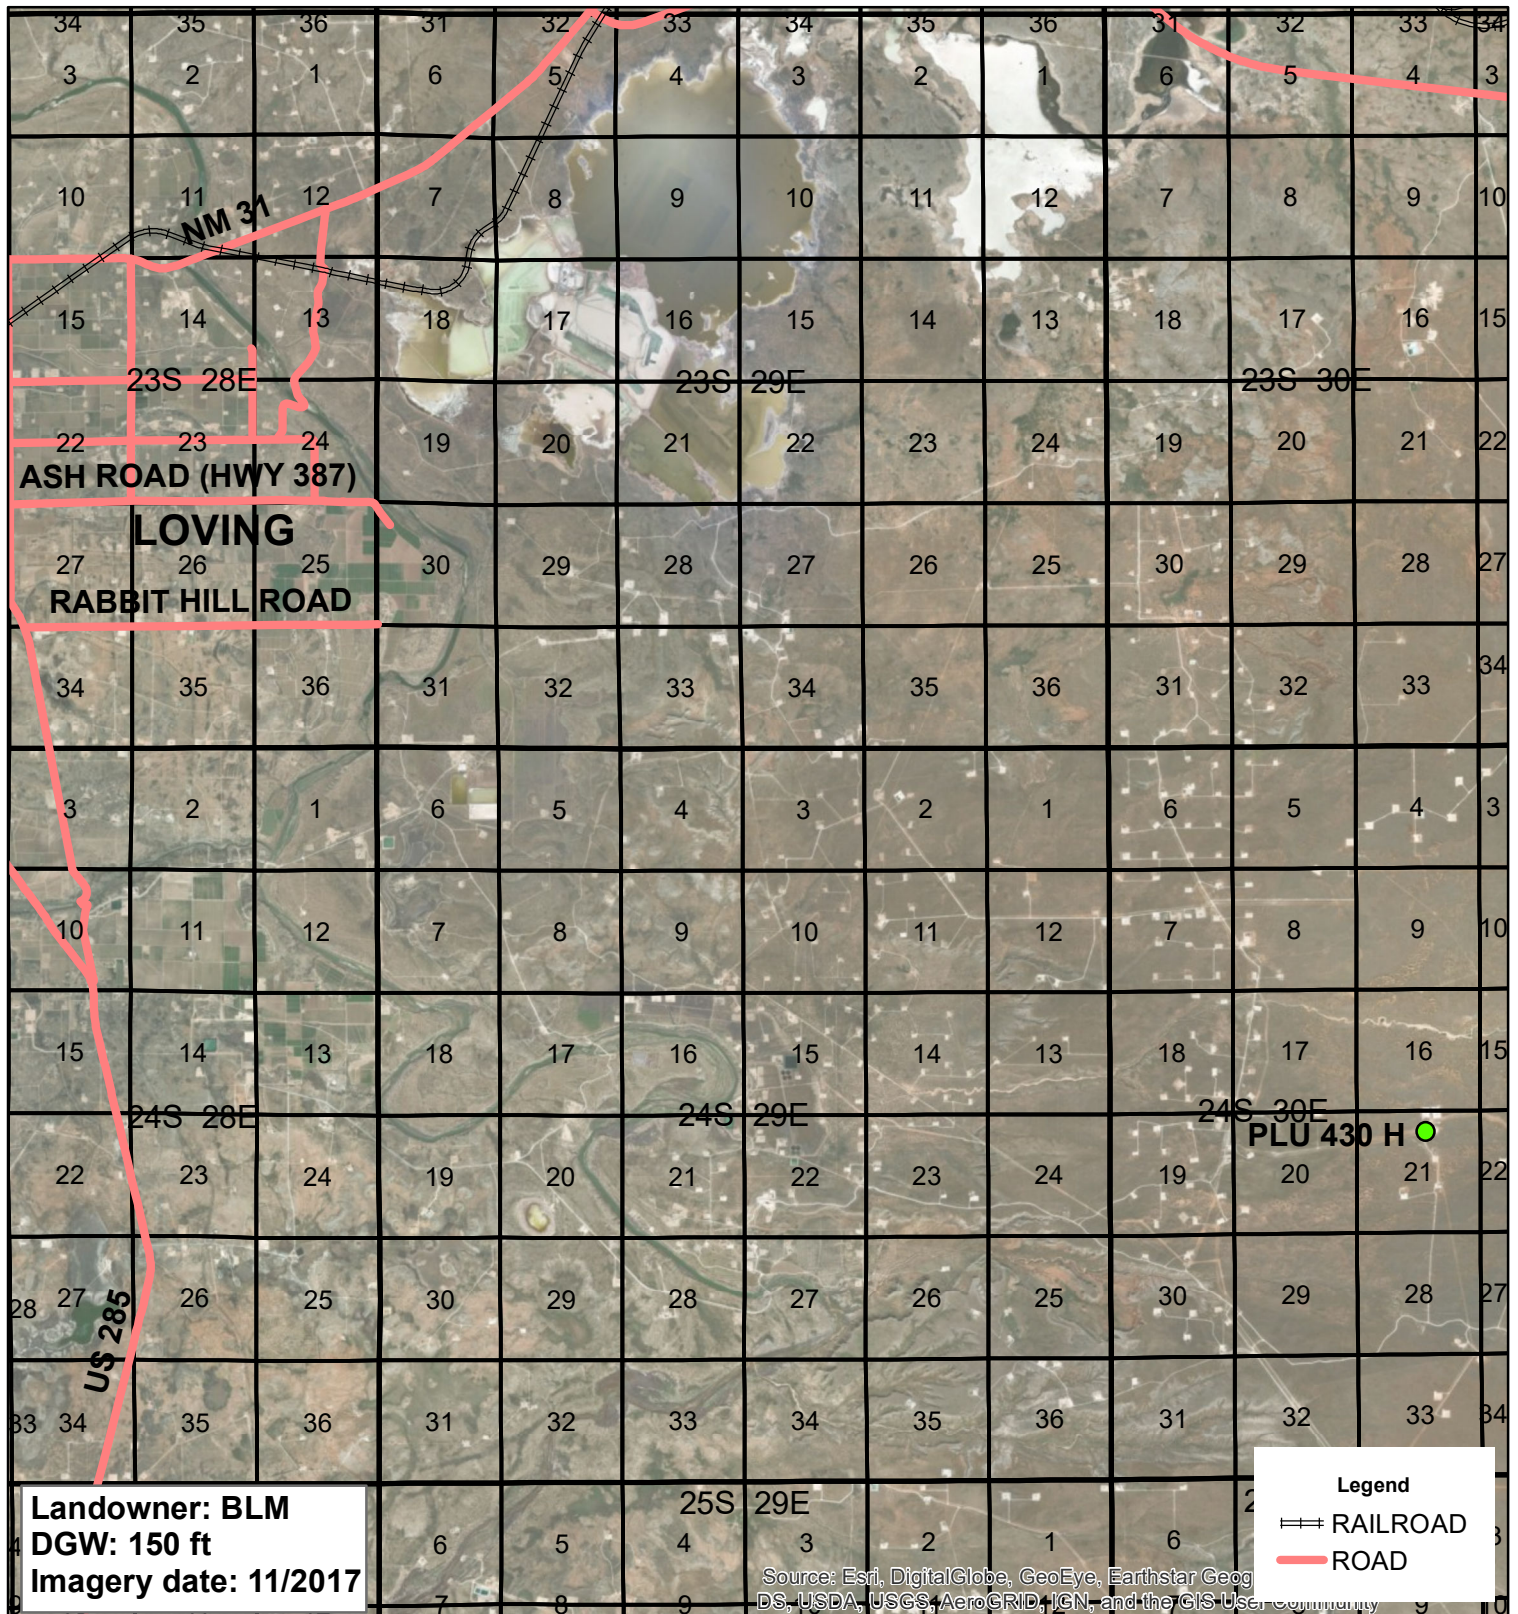
***XTO
PLU 430 H***

**UL B SECTION 21
T-24-S R-30-E
EDDY COUNTY, NM**

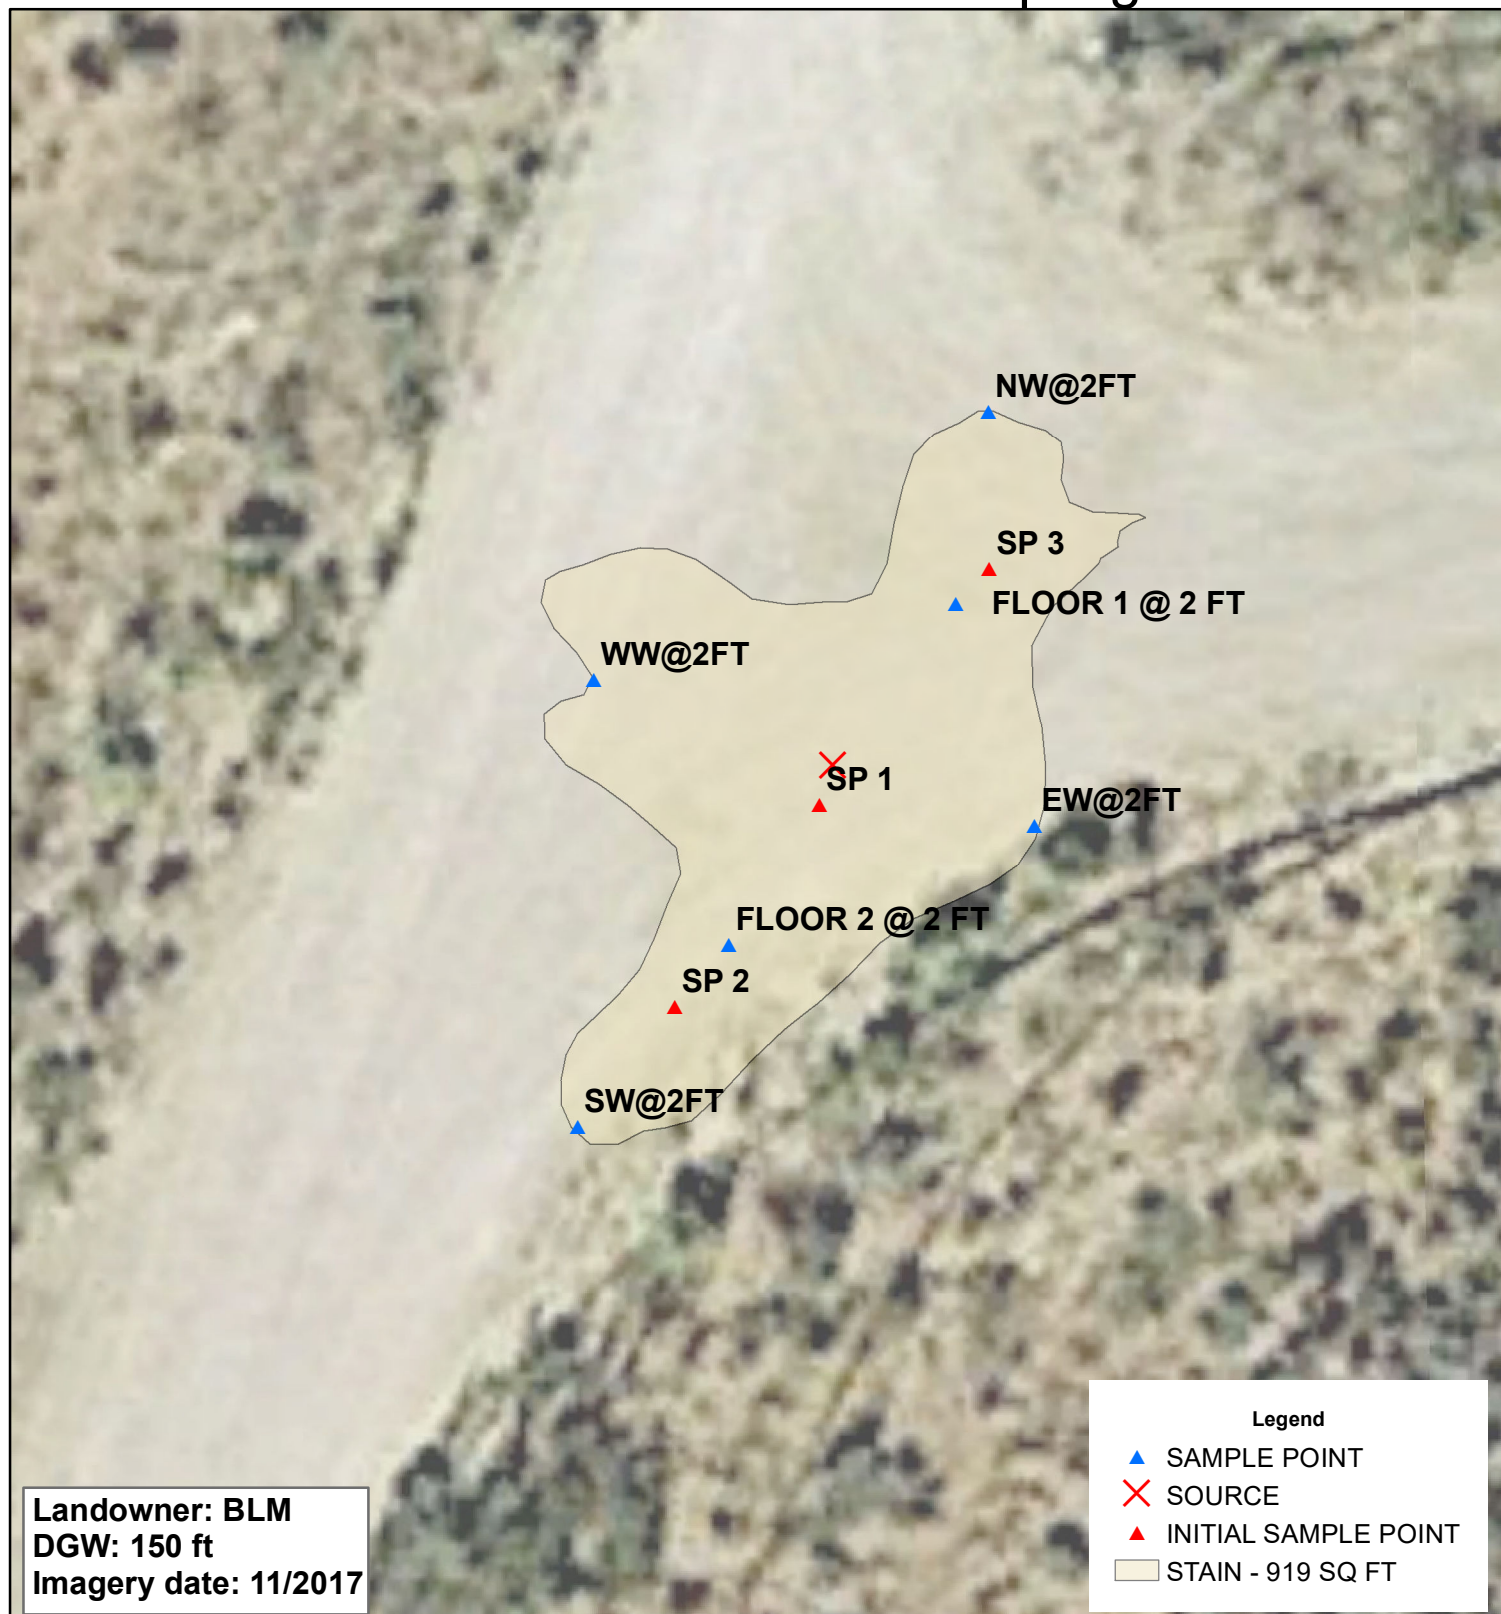
XTO
PLU 430 H

UL B SECTION 21
T-24-S R-30-E
EDDY COUNTY, NM

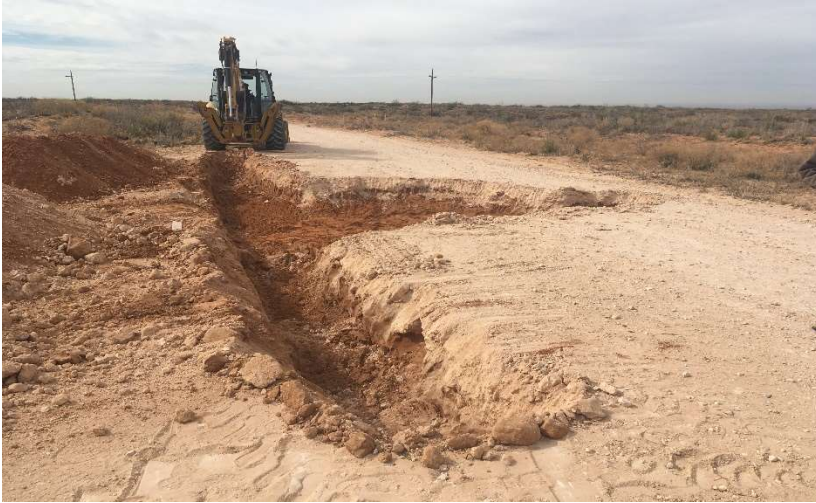
On January 12th, 2018, XTO discovered a release of approximately ten and one-half (10.5) barrels (bbls) of produced water and crude oil when a buried steel flow-line developed a hole due to corrosion. The line was exposed and clamped then later repaired. An estimated ten (10) bbls of produced water mixed with crude oil were recovered. The release impacted an approximate eight-hundred sixty-five (865) square feet (ft²) of lease road. The New Mexico Oil Conservation Division (NMOCD) was notified of the release on January 12th, 2018, and an initial Release Notification and Corrective Action form (C-141) was submitted to NMOCD January 23rd, 2018, for approval (Appendix A). The C-141 was approved on the same day.

Release area

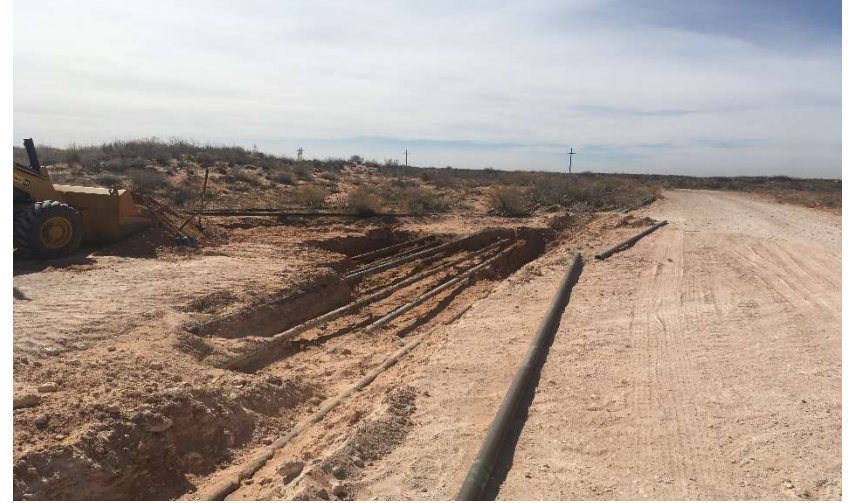
Release area

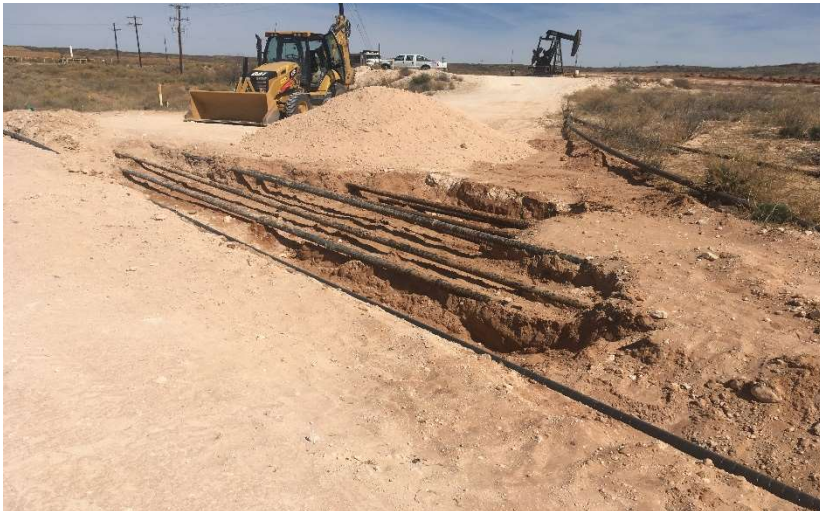
Backfilling area

The leak affected approximately 865 square feet of lease road and all free-standing fluids were recovered. The impacted area was remediated to below recommended remediation action levels for chloride, TPH, and BTEX. Location was backfilled and compacted with clean, non-impacted soils and contoured to the surrounding area.

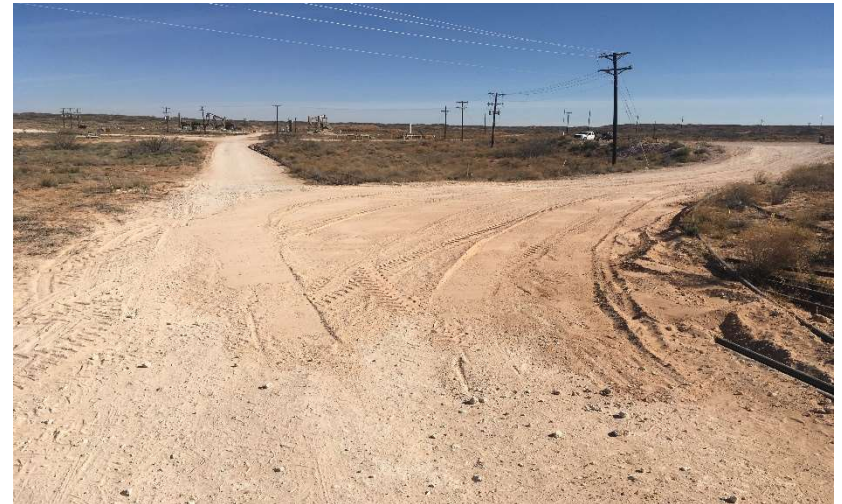
Remediation complete

Basin began remediation activities on February 27th, 2018. The impacted area was excavated to a total depth of 2' bgs and confirmatory samples were retrieved along with excavation wall soil samples to ensure the impacted area was remediated horizontally as well as vertically. The discrete soil samples were submitted to Cardinal for chloride, TPH and Benzene, Toluene, ethyl-benzene, xylenes (BTEX) concentrations. Analytical results confirmed that the impacted soil was removed vertically and horizontally to below the recommended remediation action levels (RRAL) of 5,000 mg/kg for TPH, 10 mg/kg for Benzene, and 50 mg/kg for BTEX. While there is no set guideline level for chloride concentration in the RRAL, it is assumed to be 600 mg/kg. Chloride concentration levels for all submitted samples were below the assumed action level.
