September 13, 2024

**Re: Reclamation Closure Report
ConocoPhillips
Super Cobra State Com #001H Flowline Release
Unit Letter P, Section 13, Township 19 South, Range 34 East
Lea County, New Mexico
Incident ID: nAPP2310336759**

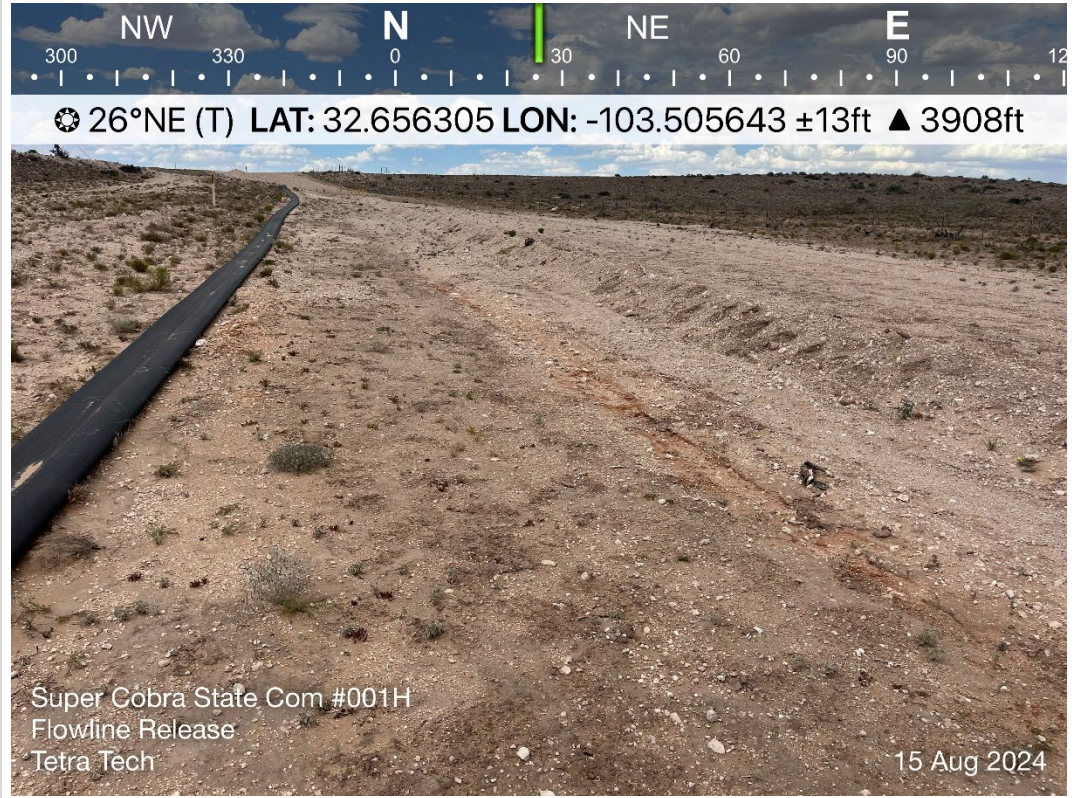
TETRA TECH, INC. PROJECT NO. 212C-MD-03092	DESCRIPTION	View northeast. Vegetation observed.	2
	SITE NAME	Super Cobra State Com #0011H Flowline Release	8/15/2024

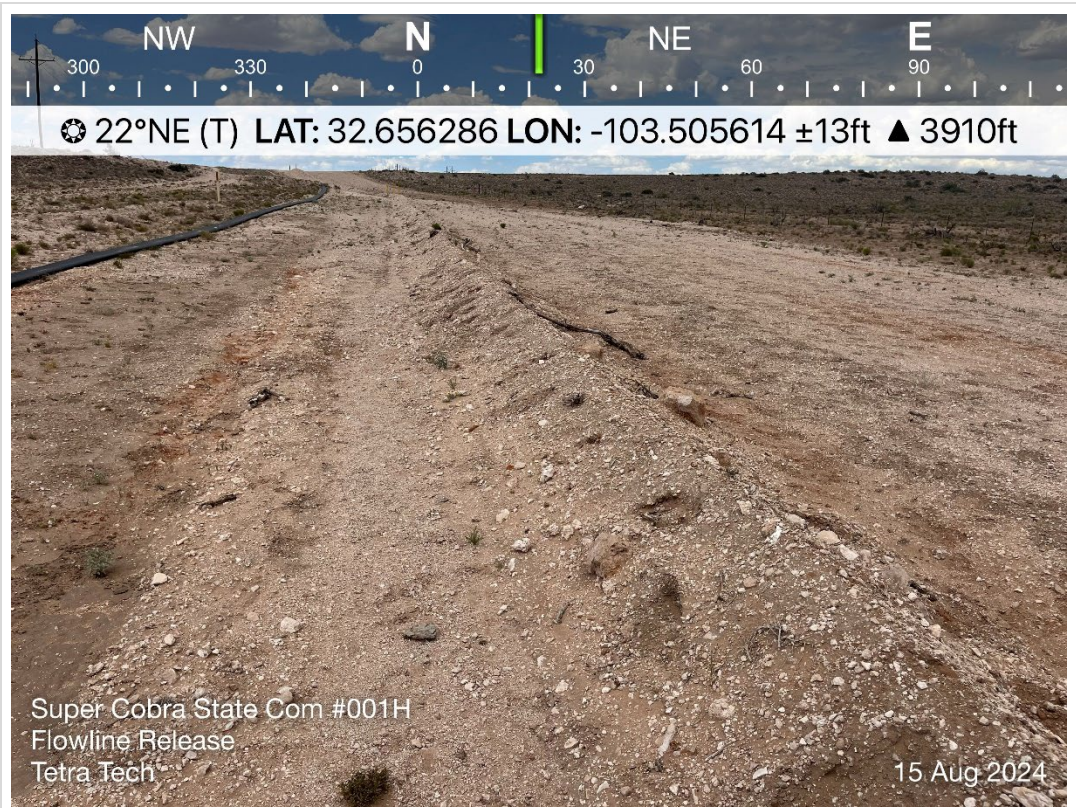
TETRA TECH, INC. PROJECT NO. 212C-MD-03092	DESCRIPTION	View north. View of remediated area.	3
	SITE NAME	Super Cobra State Com #0011H Flowline Release	8/15/2024

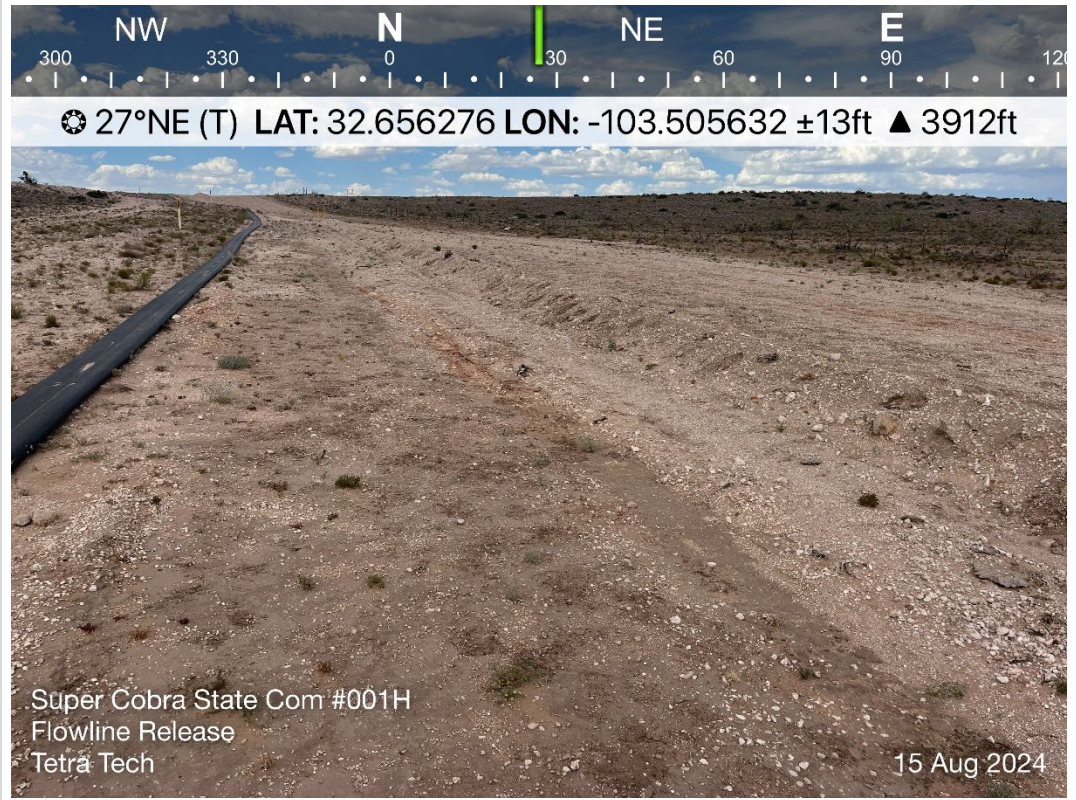
TETRA TECH, INC. PROJECT NO. 212C-MD-03092	DESCRIPTION	View north. Vegetation observed.	4
	SITE NAME	Super Cobra State Com #0011H Flowline Release	8/15/2024

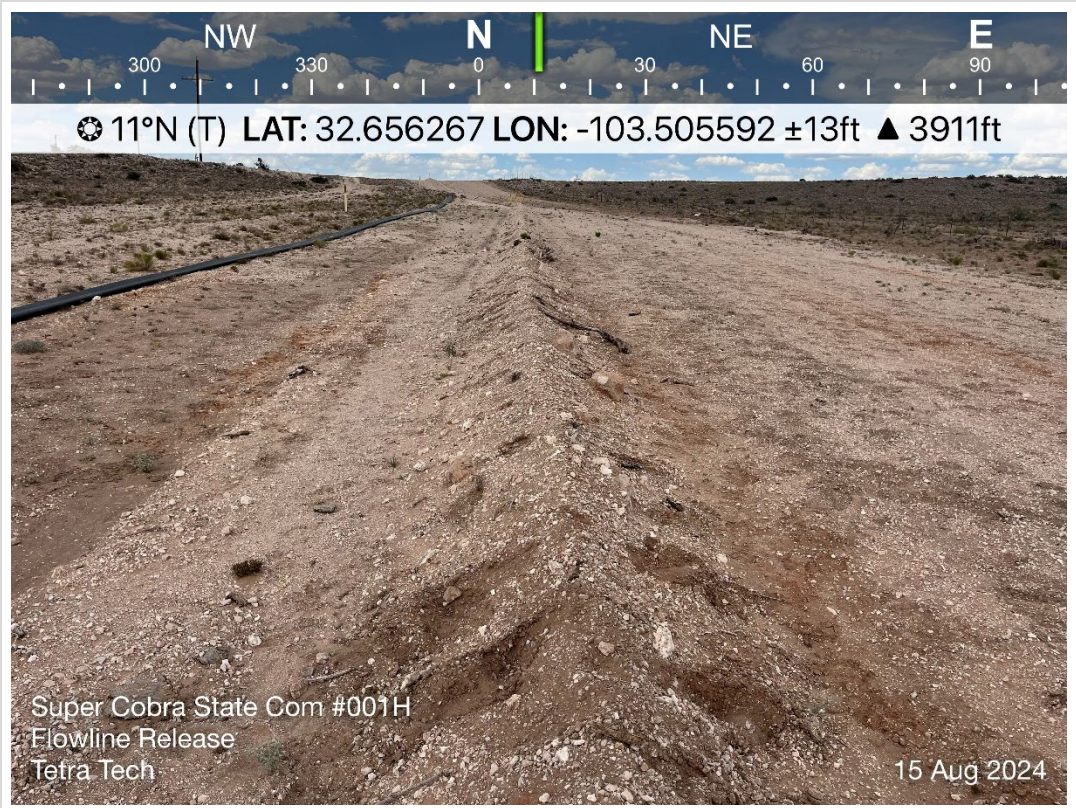
TETRA TECH, INC. PROJECT NO. 212C-MD-03092	DESCRIPTION	View north. View of remediated area.	5
	SITE NAME	Super Cobra State Com #0011H Flowline Release	8/15/2024

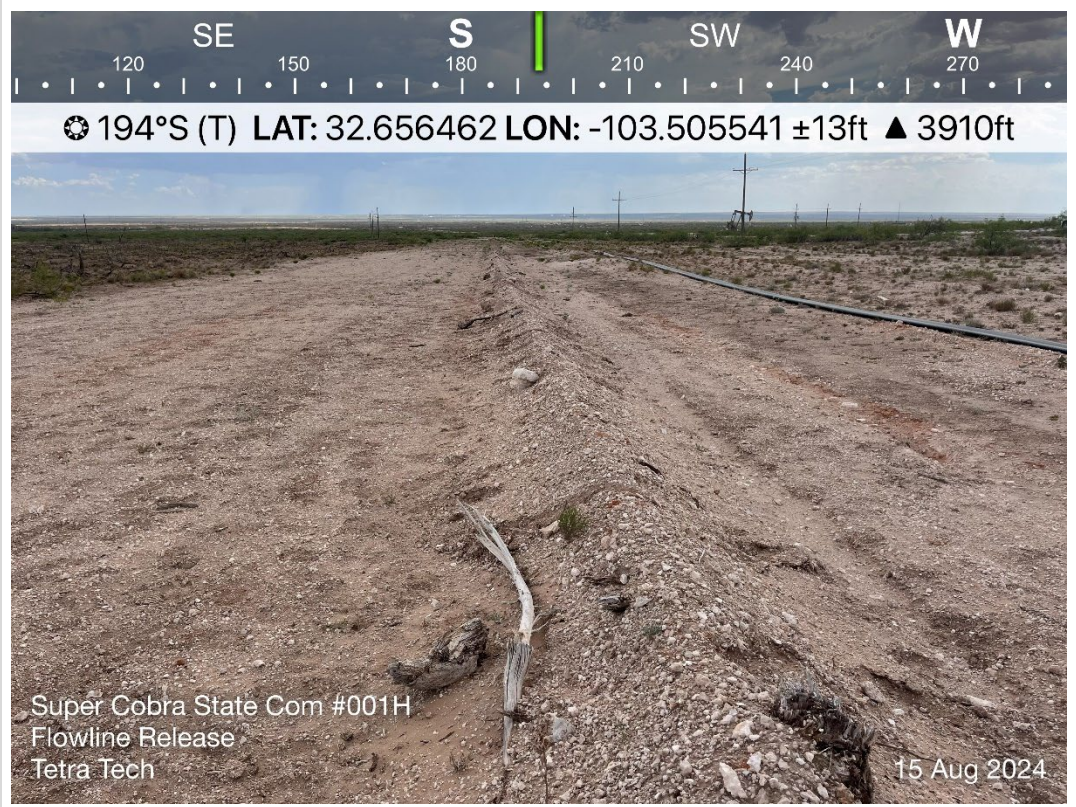
TETRA TECH, INC. PROJECT NO. 212C-MD-03092	DESCRIPTION	View south. View of remediated area.	6
	SITE NAME	Super Cobra State Com #0011H Flowline Release	8/15/2024
