Re: Status Report – 3rd Quarter 2024
Fifield 5 No. 1 (SE ¼, SW ¼, Sec. 5, T29N, R11W)
Hilcorp Energy Company
San Juan County, New Mexico
OCD Incident No. NVF1718155324

On behalf of Hilcorp Energy Company (Hilcorp), Timberwolf Environmental, LLC (Timberwolf) presents this report to document activities conducted during the 3rd quarter of 2024 (3Q24) at the Fifield 5 No. 1 (Site). The Site is a plugged well site in northeast San Juan County, New Mexico (Figures 1 through 3).

Status Report - 3rd Quarter 2024

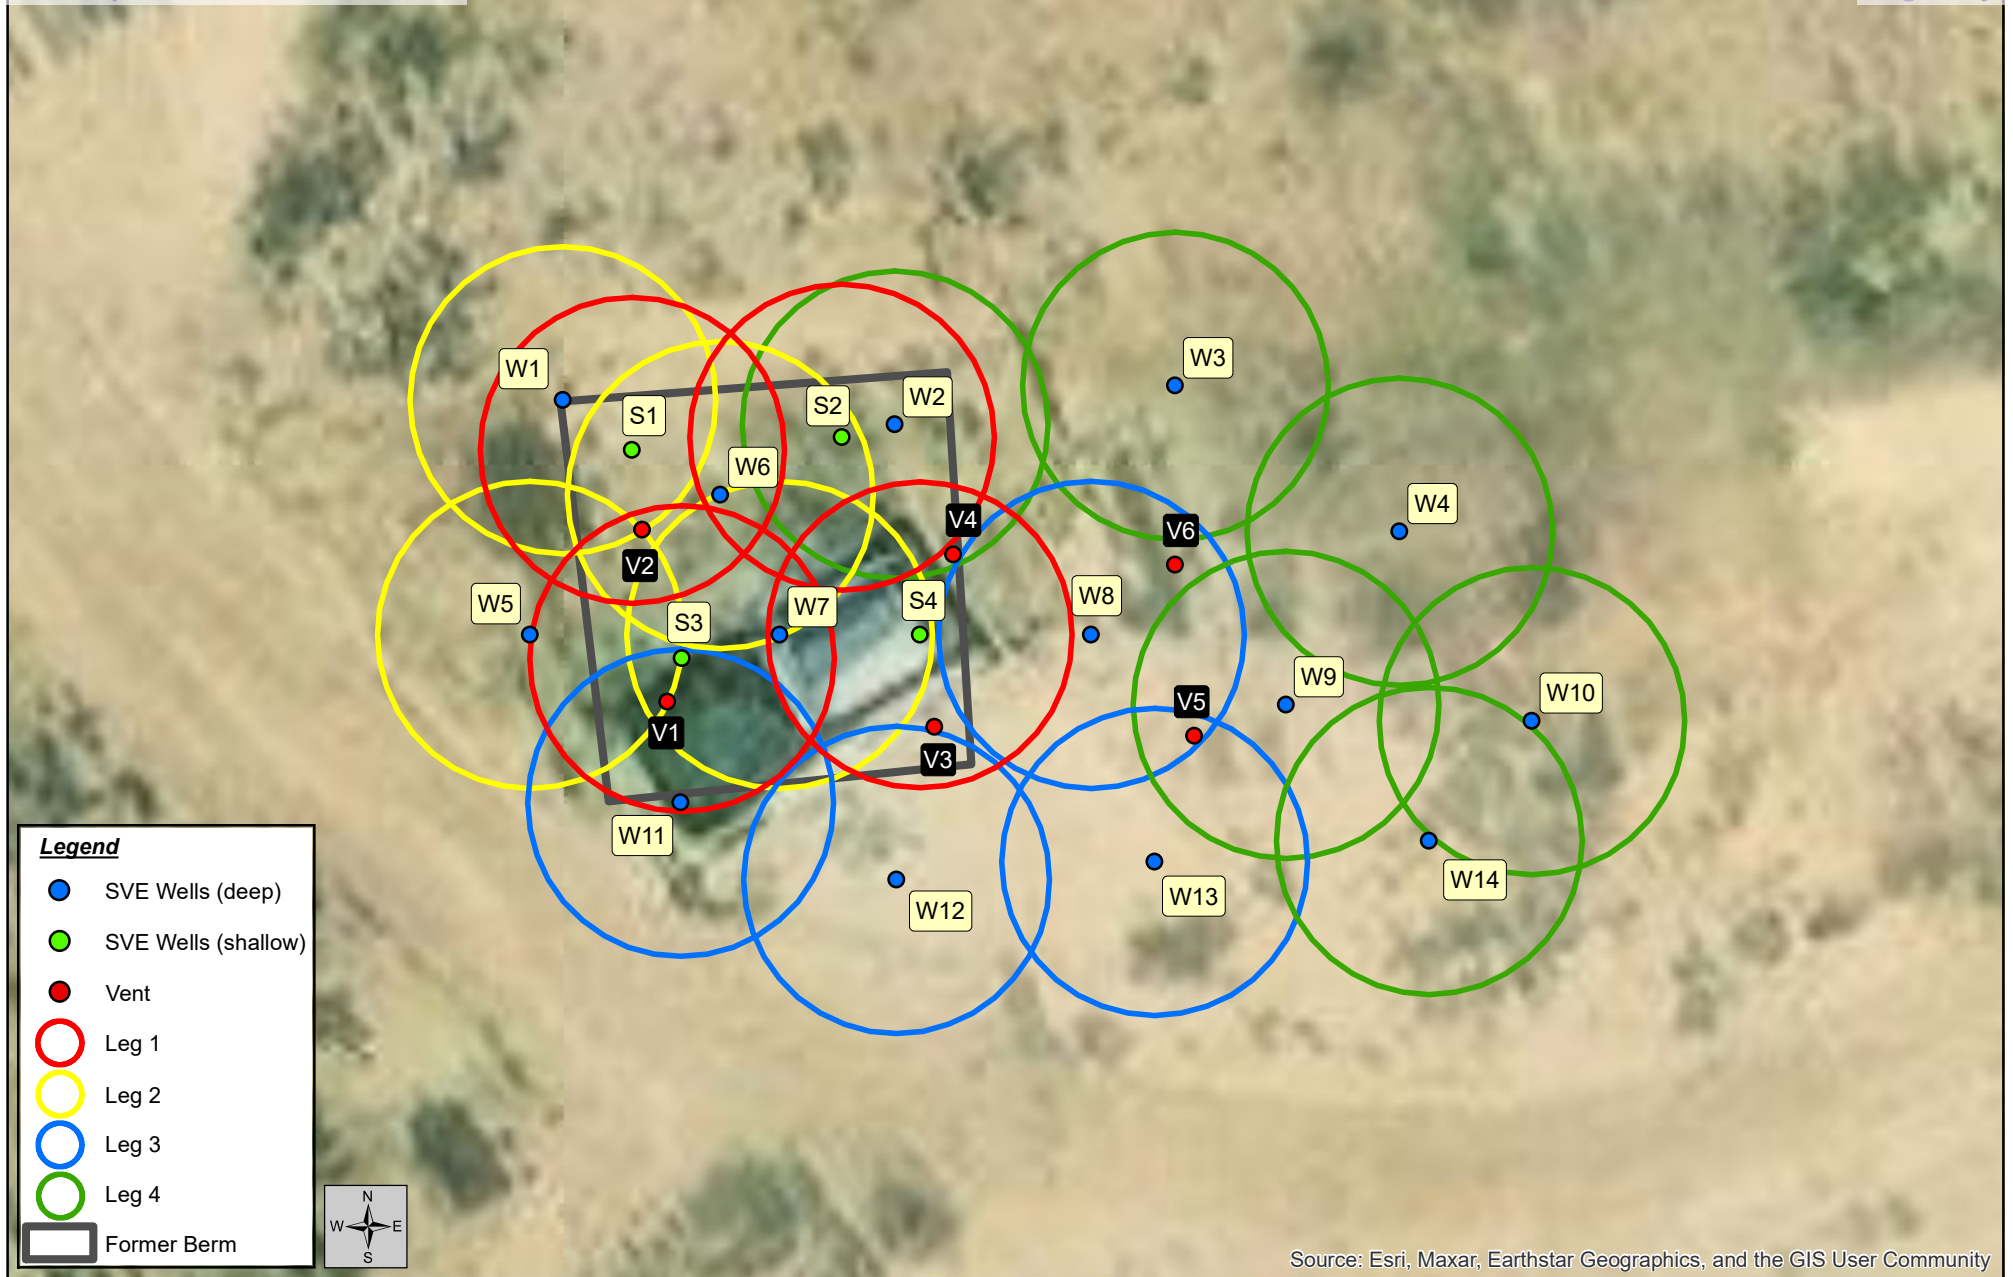
Figure 4
SVE Well
Location Map

The SVE system is equipped with four independent legs (i.e., Leg 1, Leg 2, Leg 3, and Leg 4). Leg 1 provides vacuum to the shallow wells and Legs 2, 3, and 4 provide vacuum extraction to the deep SVE wells. System automation was incorporated in April 2024; automation was activated on 04/19/24 and programmed to oscillate between Legs 1, 2, 3, and 4 every 6 hours for continuous 24-hr operations. The SVE wells were configured as shown in Figure 4. Programmed runtimes are presented in Table 1 below.

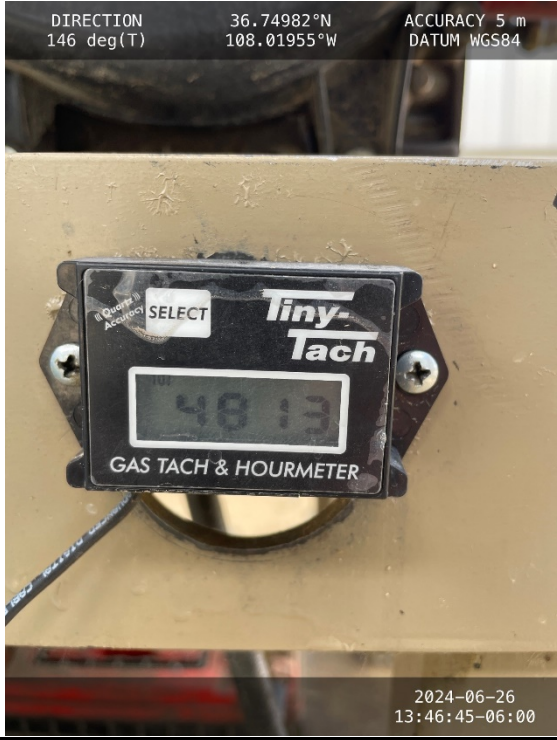
Direction: N/A			
Comments: View of hour meter on 06/26/24.			
Photo No.: 2

System runtime between the last 2Q24 reading (06/26/24) and the latest 3Q24 reading (09/24/24) was 2,120 hours. The total hours available during this period was 2208 hours; therefore, yielding a runtime percentage (%) of 98.1 for 3Q24. A vacuum pump motor failure occurred on 8/17/24; the motor was replaced by Hilcorp on 8/19/24. Cygnet telemetry data showed continuous operation throughout the quarter, except for the SVE pump failure. Photographs of relevant meter readings are documented in the attached Photographic Log.

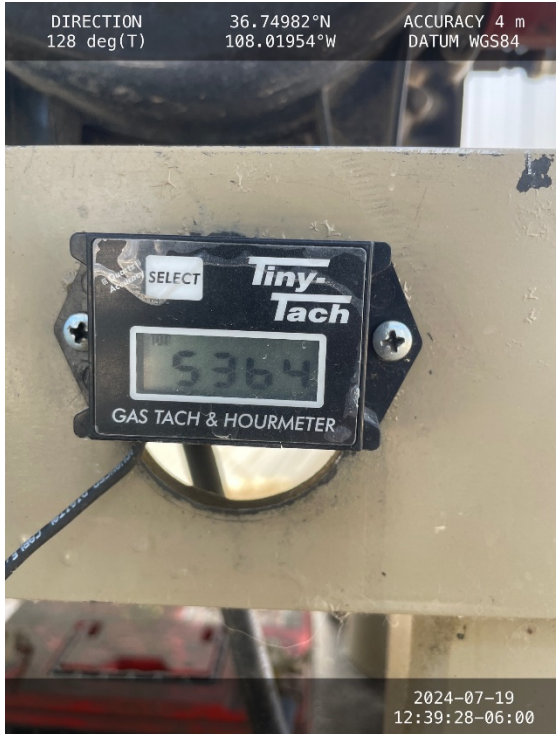
Direction: N/A			
Comments: View of hour meter on 07/19/24.

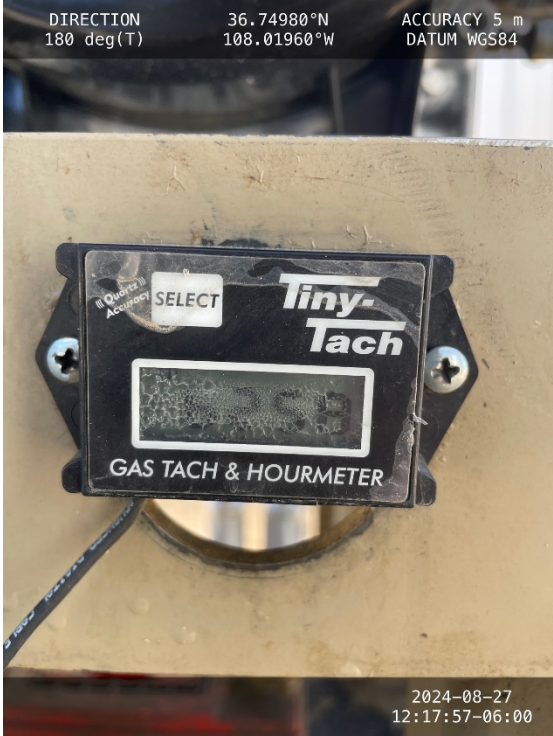
DIRECTION 180 deg(T) 36.74980°N 108.01960°W ACCURACY 5 m DATUM WGS84	
Direction: N/A			
Comments: View of hour meter on 08/27/2024.		2024-08-27 12:17:57-06:00	
Photo No.: 6

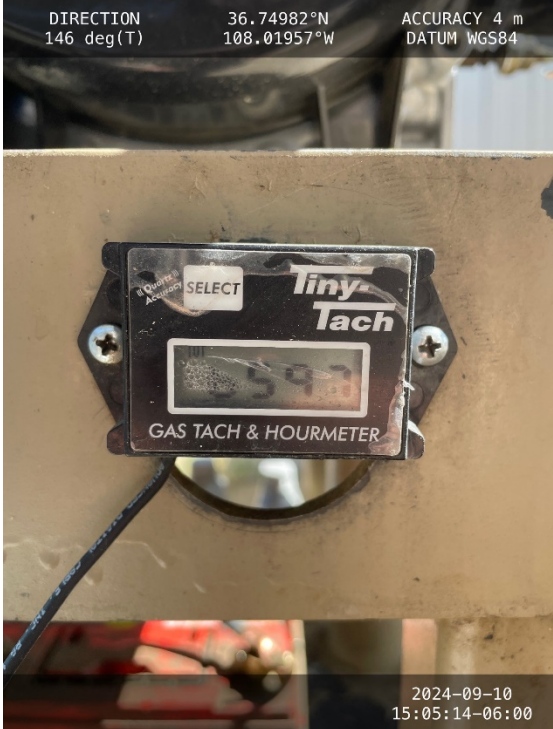
DIRECTION 146 deg(T) 36.74982°N 108.01957°W ACCURACY 4 m DATUM WGS84	
Direction: N/A			
Comments: View of hour meter on 09/10/24.		2024-09-10 15:05:14-06:00

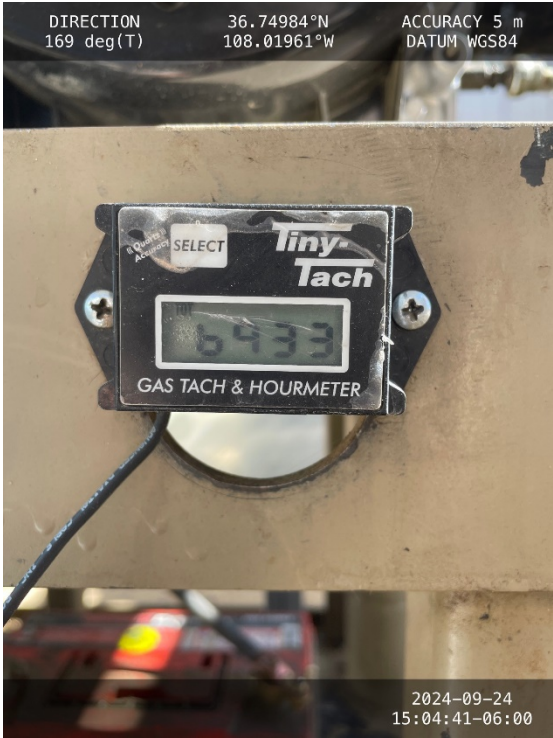
Direction: N/A			
Comments: View of hour meter on 09/24/24.			
Photo No.:			
Direction: N/A			
Comments:
