Remediation Summary and Closure Request

Ridge Runner Resources Operating, LLC

Bear Draw State Com #1

NMOCD Incident # NMLB1215347504

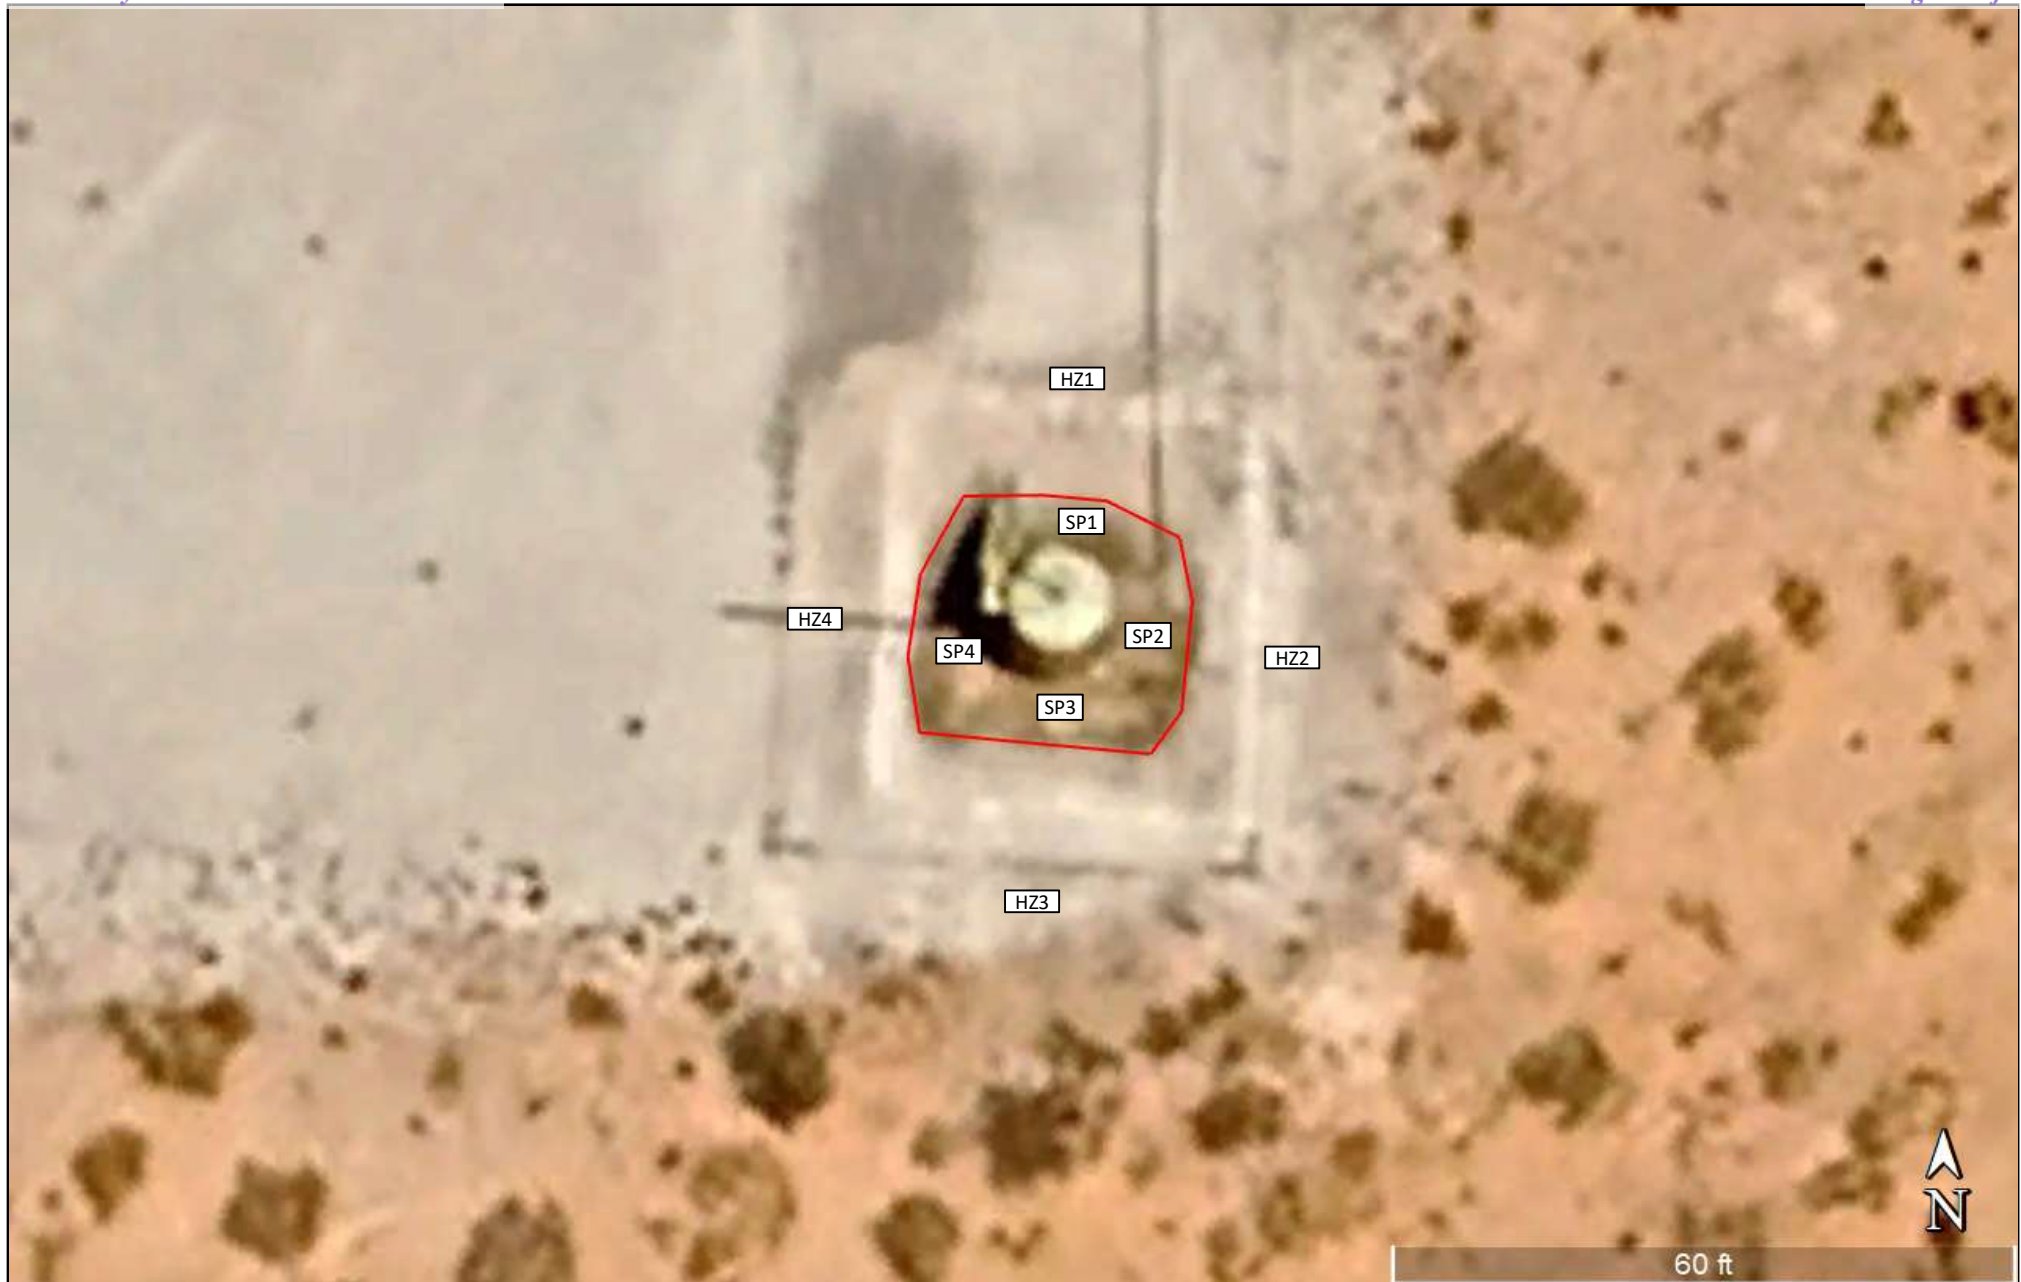
**Figure 4**

Based on field observations and field test data noted above and provided in Attachment V, thirty-two representative soil samples were selected for laboratory analysis. Delineation soil samples SP1 through SP4, and HZ1 through HZ4, were submitted to the laboratory for analysis of BTEX, TPH, and chloride. Laboratory analytical results indicated contaminant concentrations were below the NMOCD Closure Criteria in each of the submitted samples, with the exception of SP2 at Surface, which exhibited TPH concentrations in excess of NMOCD Closure Criteria.

Delineation Sample Map
Ridge Runner Resources Operating, LLC
Bear Draw State Com #1
GPS: 32.868718, -104.060104
Eddy County

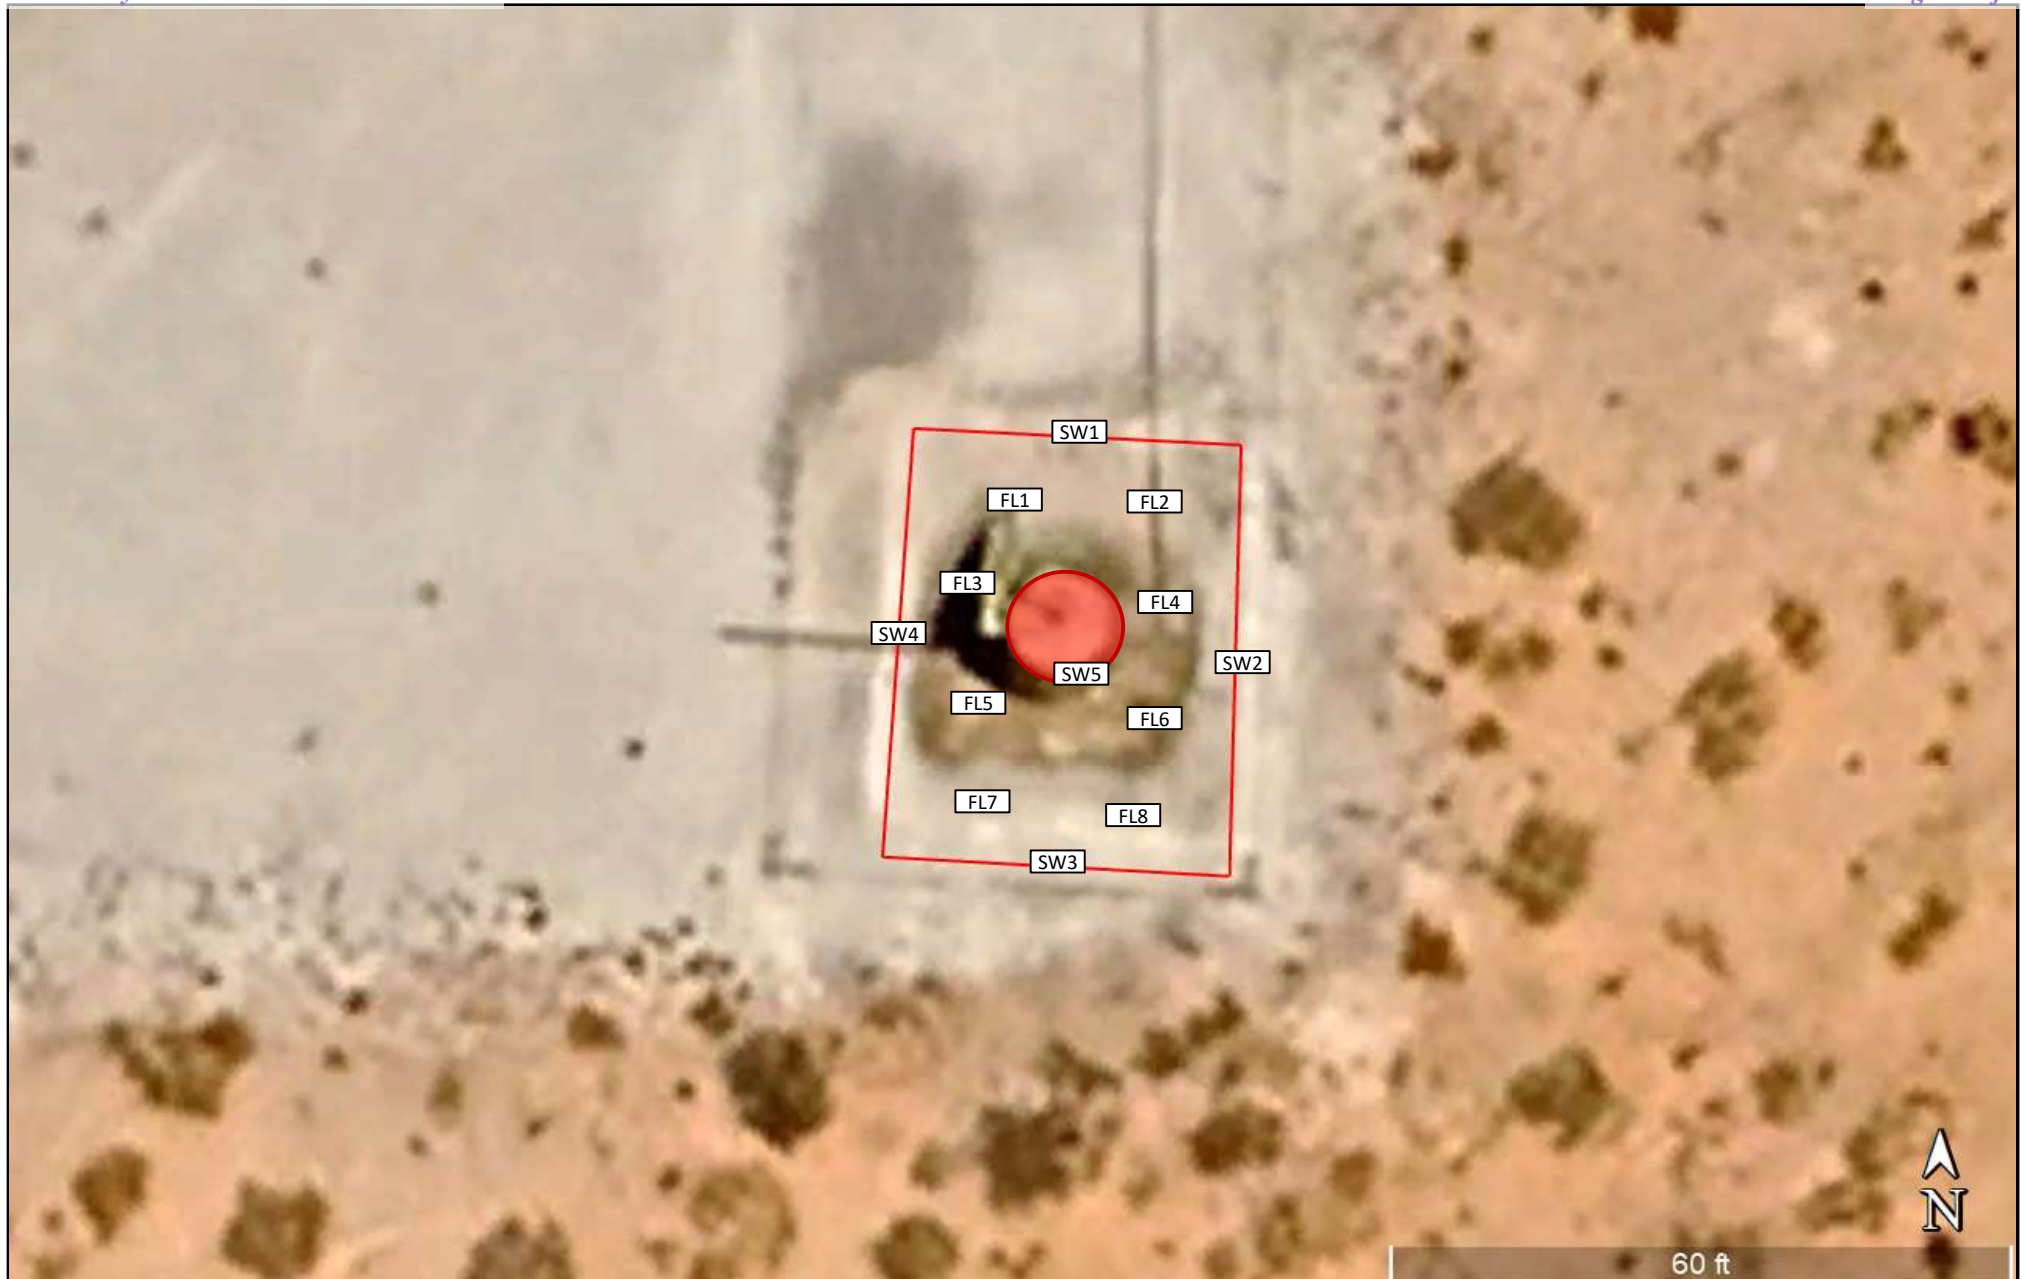
**Figure 5**

Excavation Sample Map
 Ridge Runner Resources Operating, LLC
 Bear Draw State Com #1
 GPS: 32.868718, -104.060104
 Eddy County
