Remediation Summary & Variance Request

Mewbourne Oil Company Apollo Chile Verde Water Transfer Line

Eddy County, New Mexico
Unit Letter "J", Section 15, Township 21 South, Range 27 East
Latitude 32.4780968 North, Longitude 104.1706733 West
NMOCD Reference No. nAPP2315849467

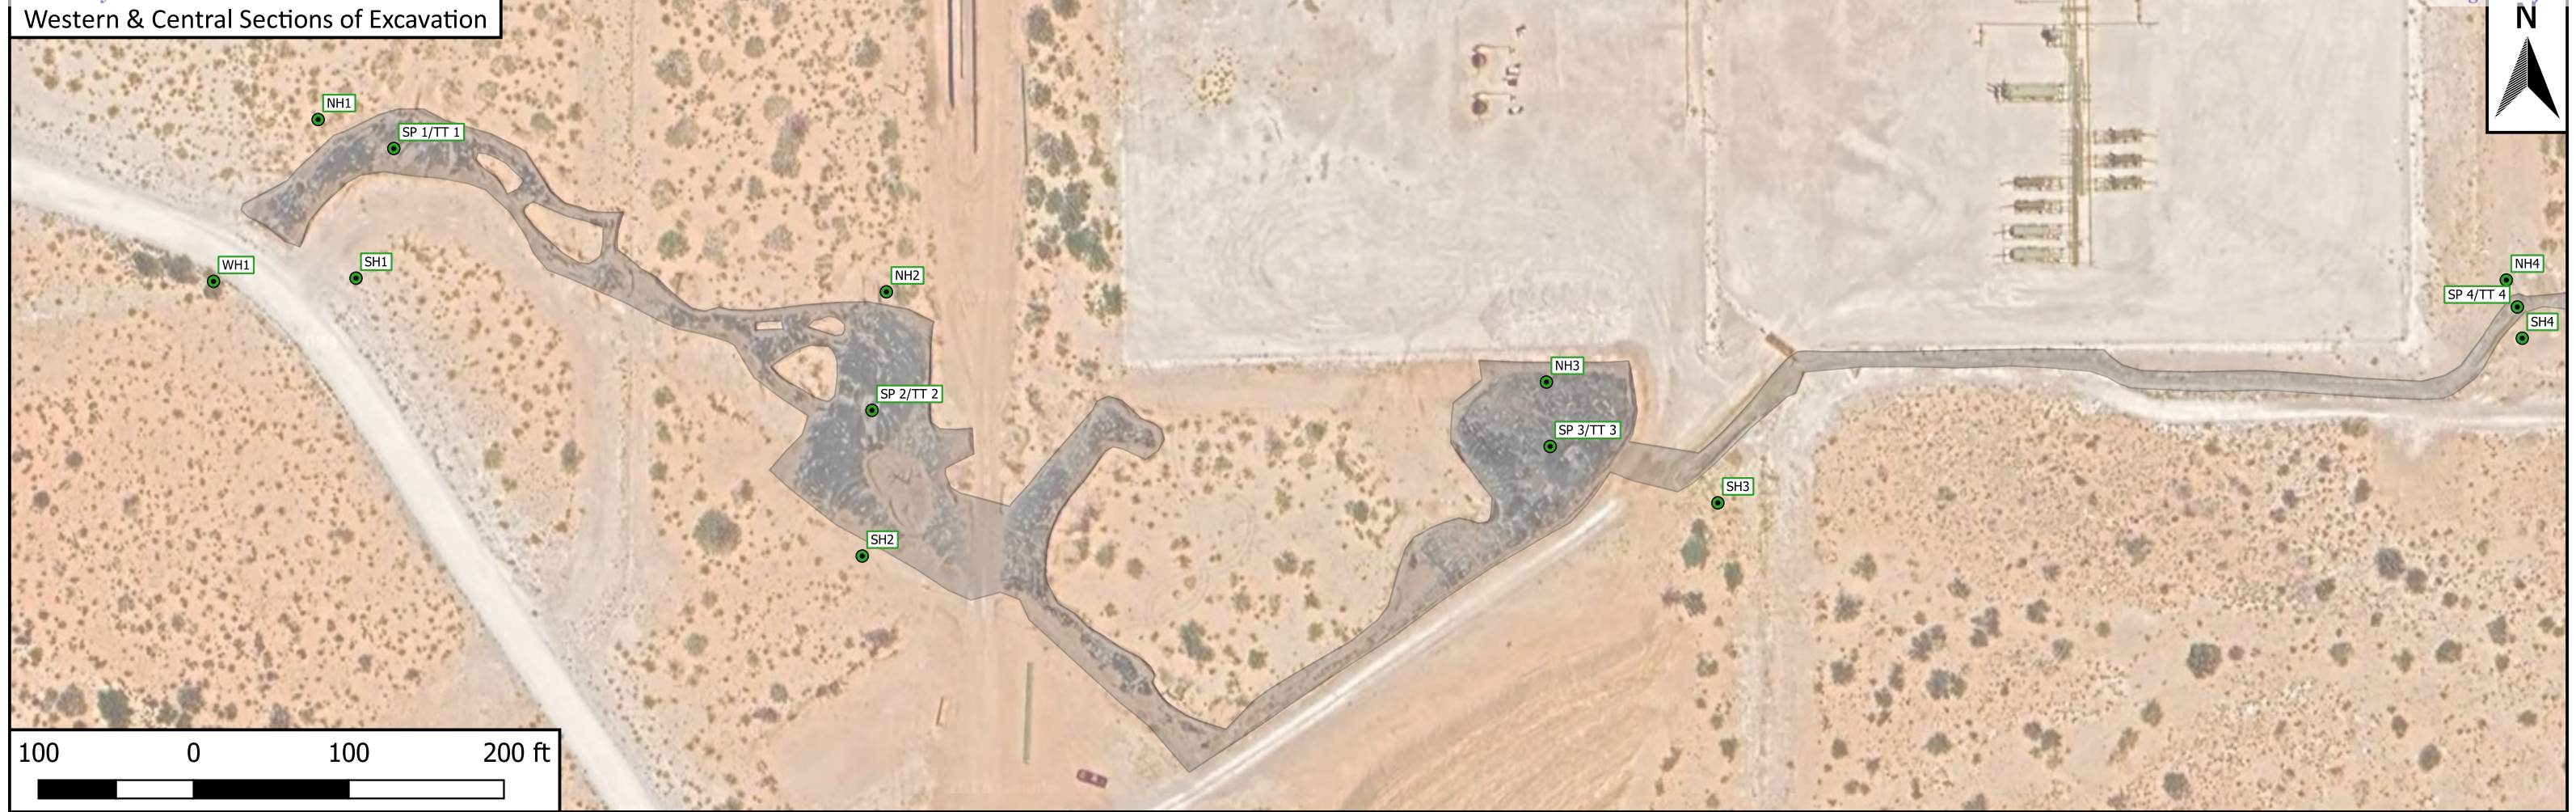
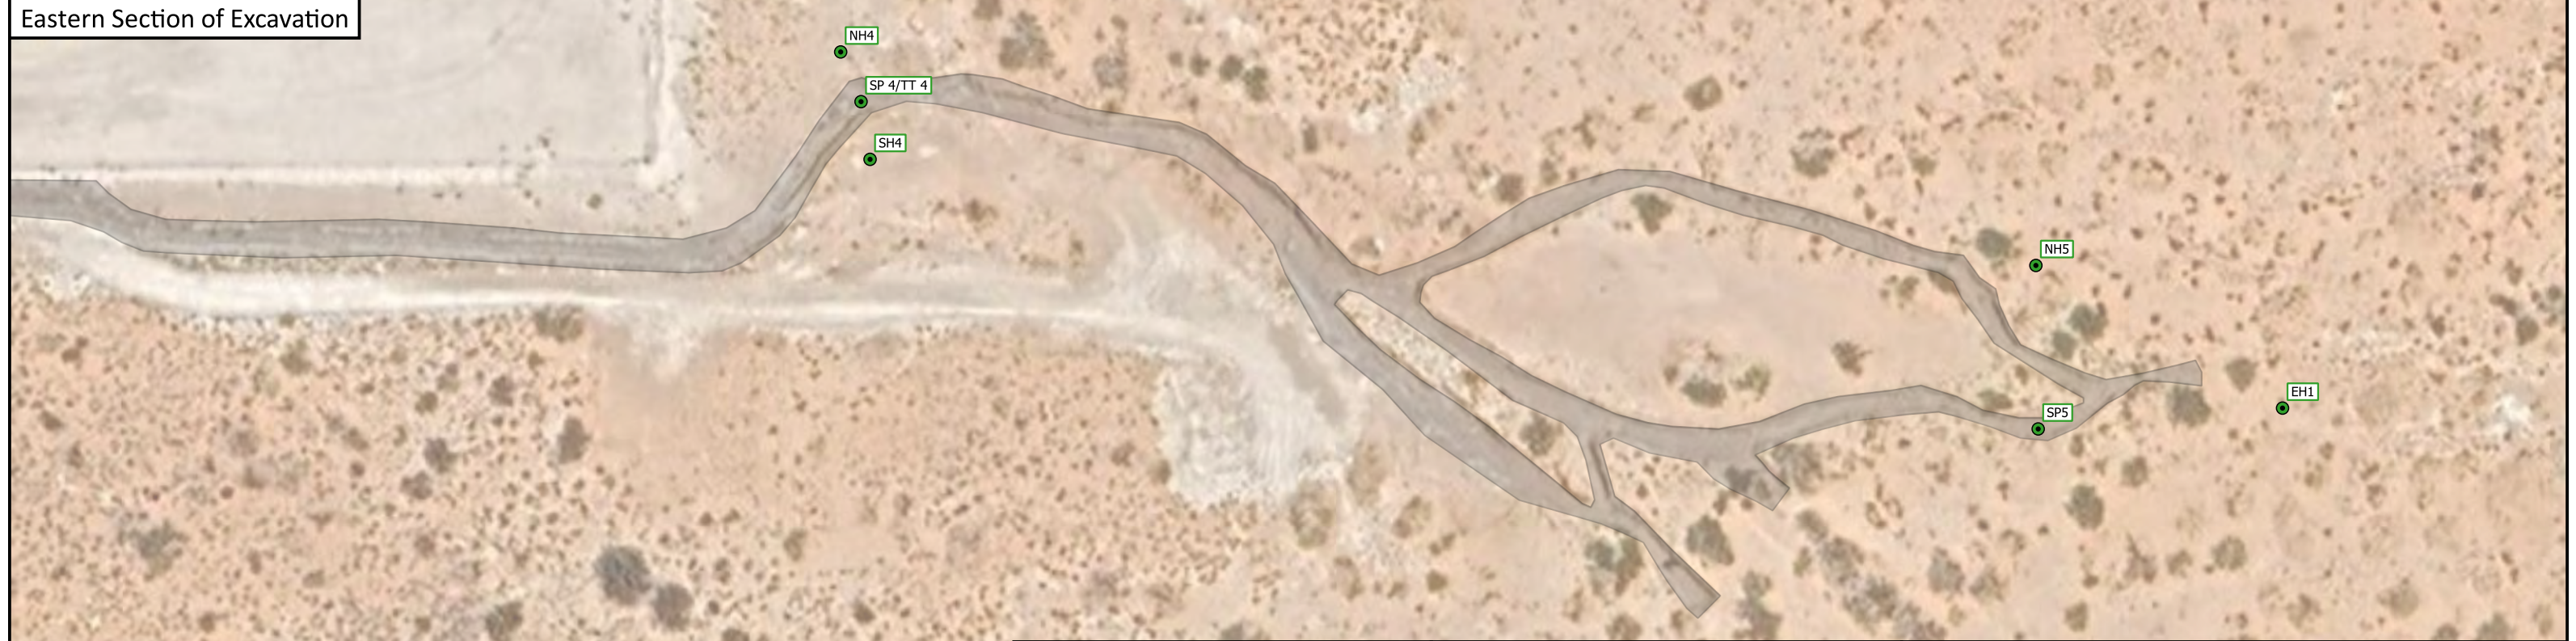
Figure 3

Delineation Sample Location Map

Western & Central Sections of Excavation

Eastern Section of Excavation

- Legend**
- Excavation Extent (68,806 ft²)
 - Delineation Sample Location

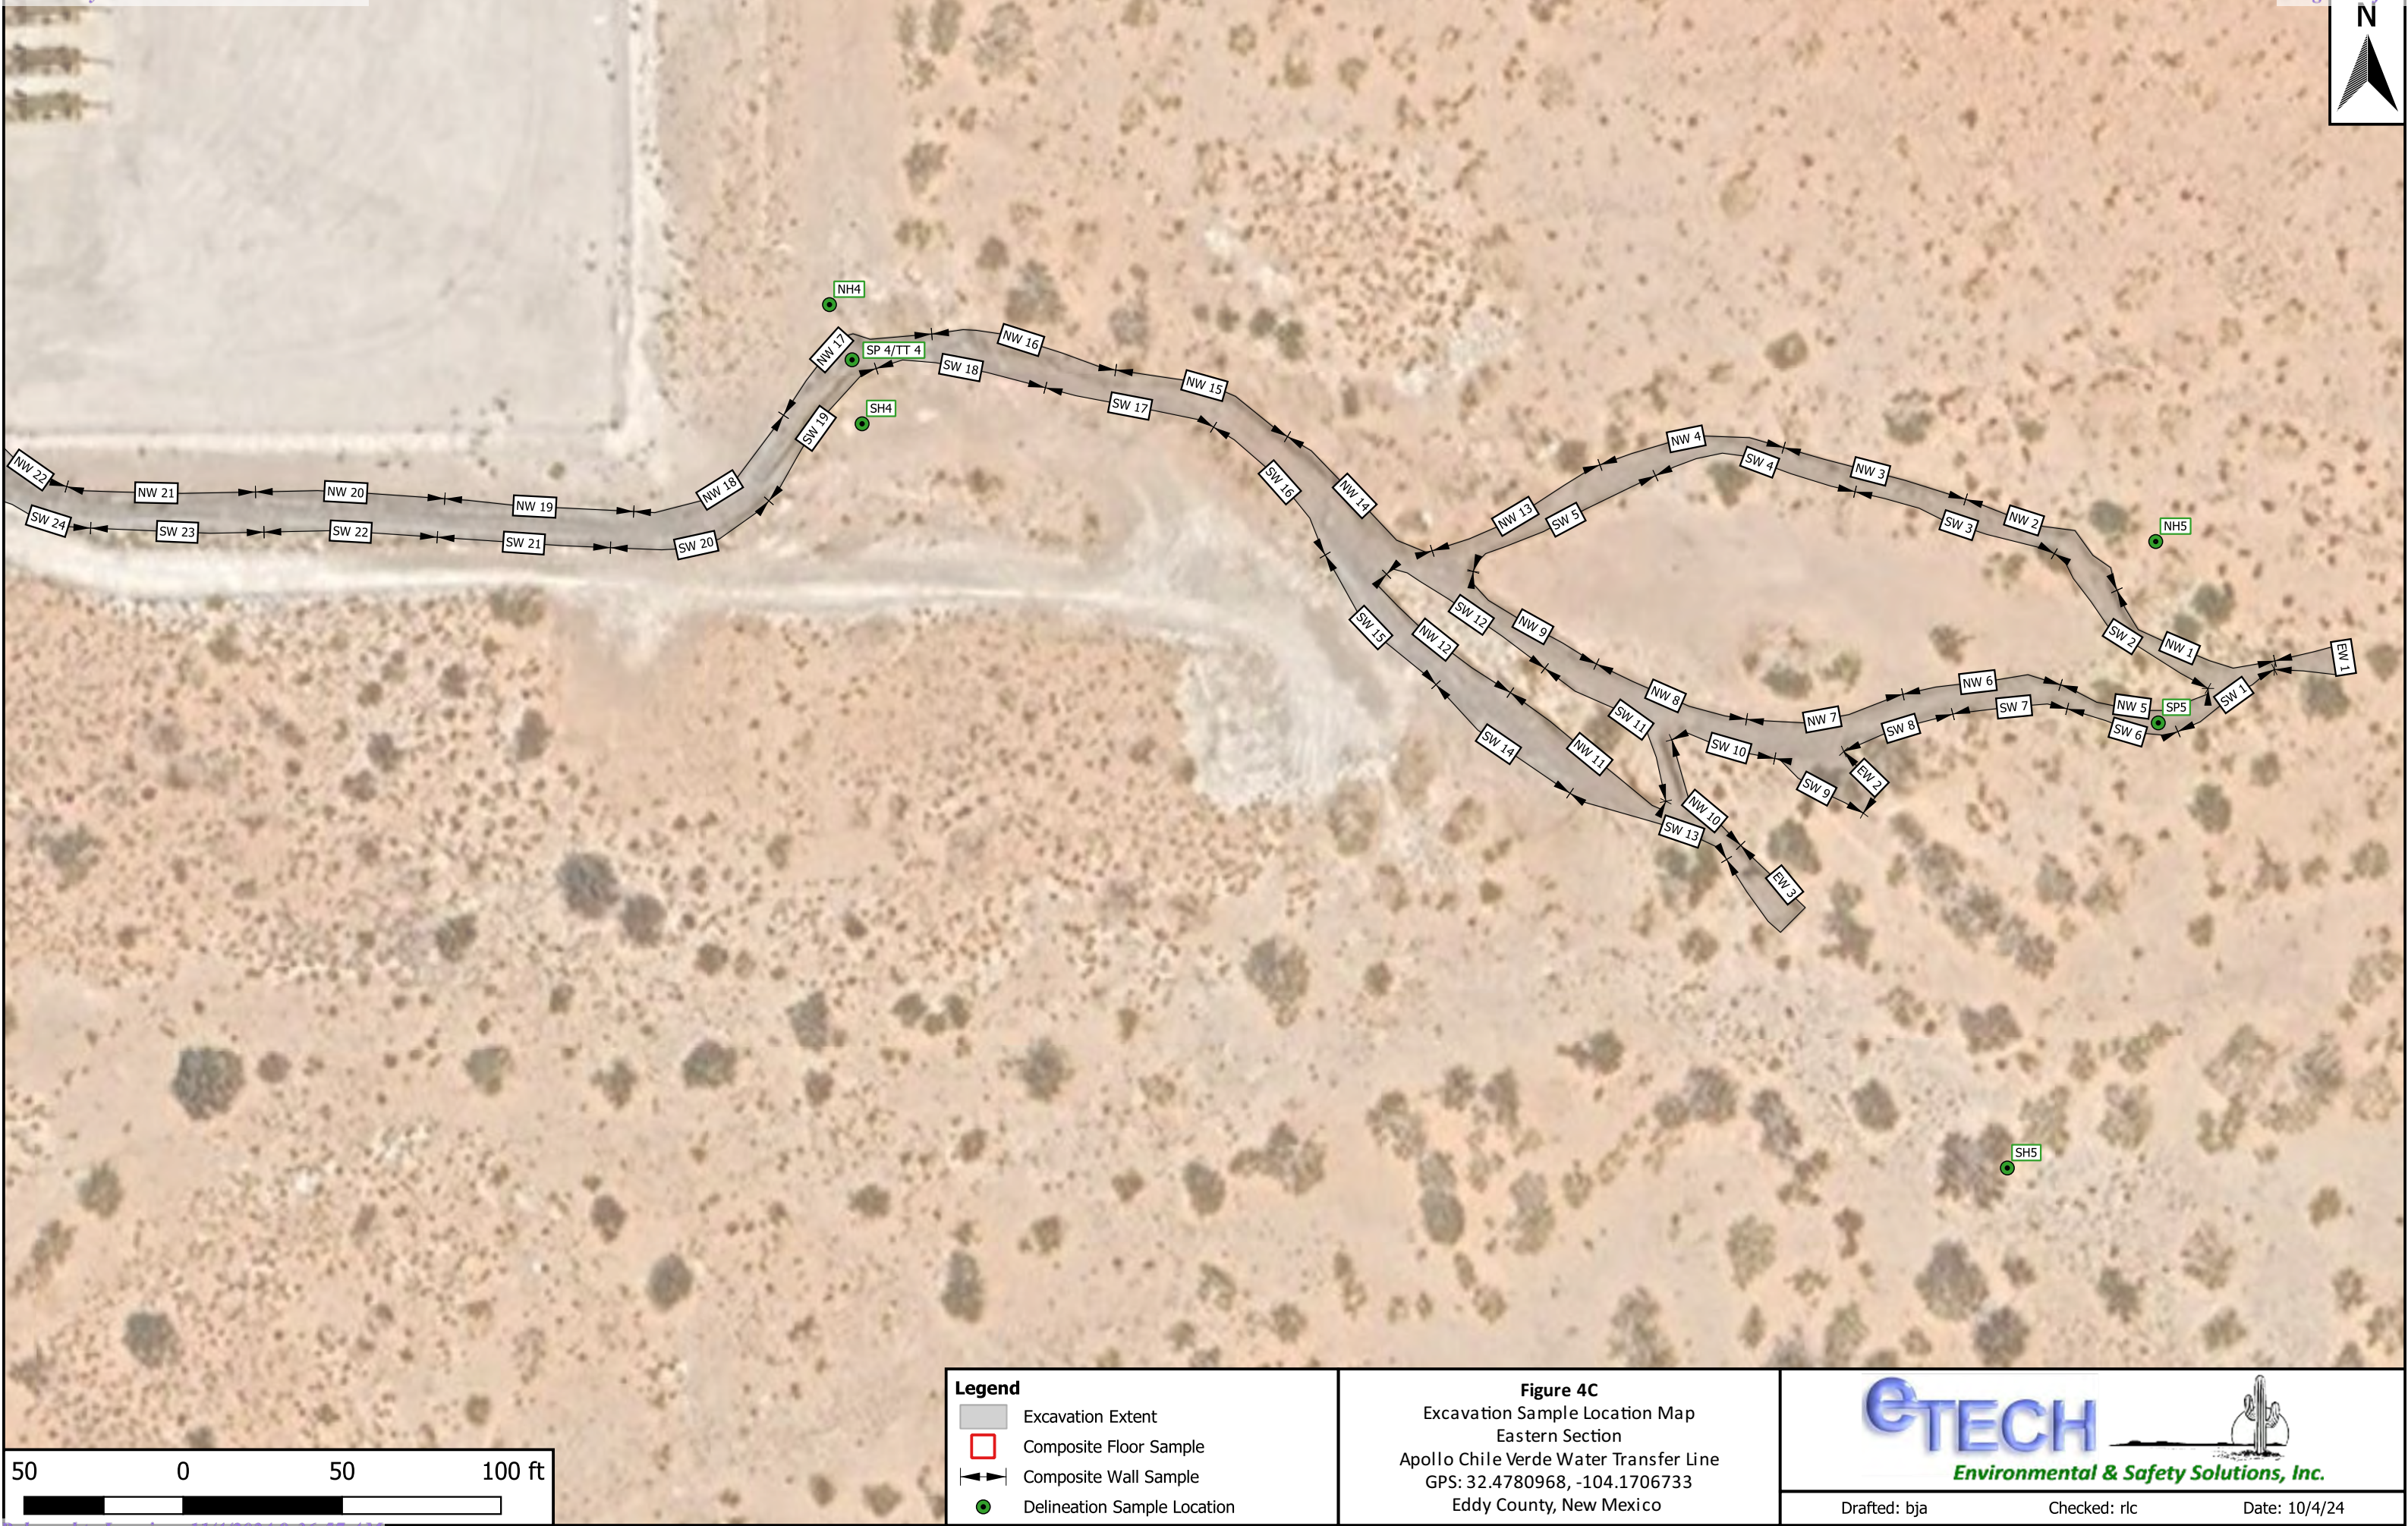
Figures 4A – 4C

Excavation soil sample locations are depicted in Figures 4A – 4C. Soil chemistry data is summarized in Table 1. Field data and a soil profile log are provided in Appendix B. General photographs of the release site are provided in Appendix C. Laboratory analytical reports are provided in Appendix D. Copies of all regulatory correspondence are provided in Appendix F.

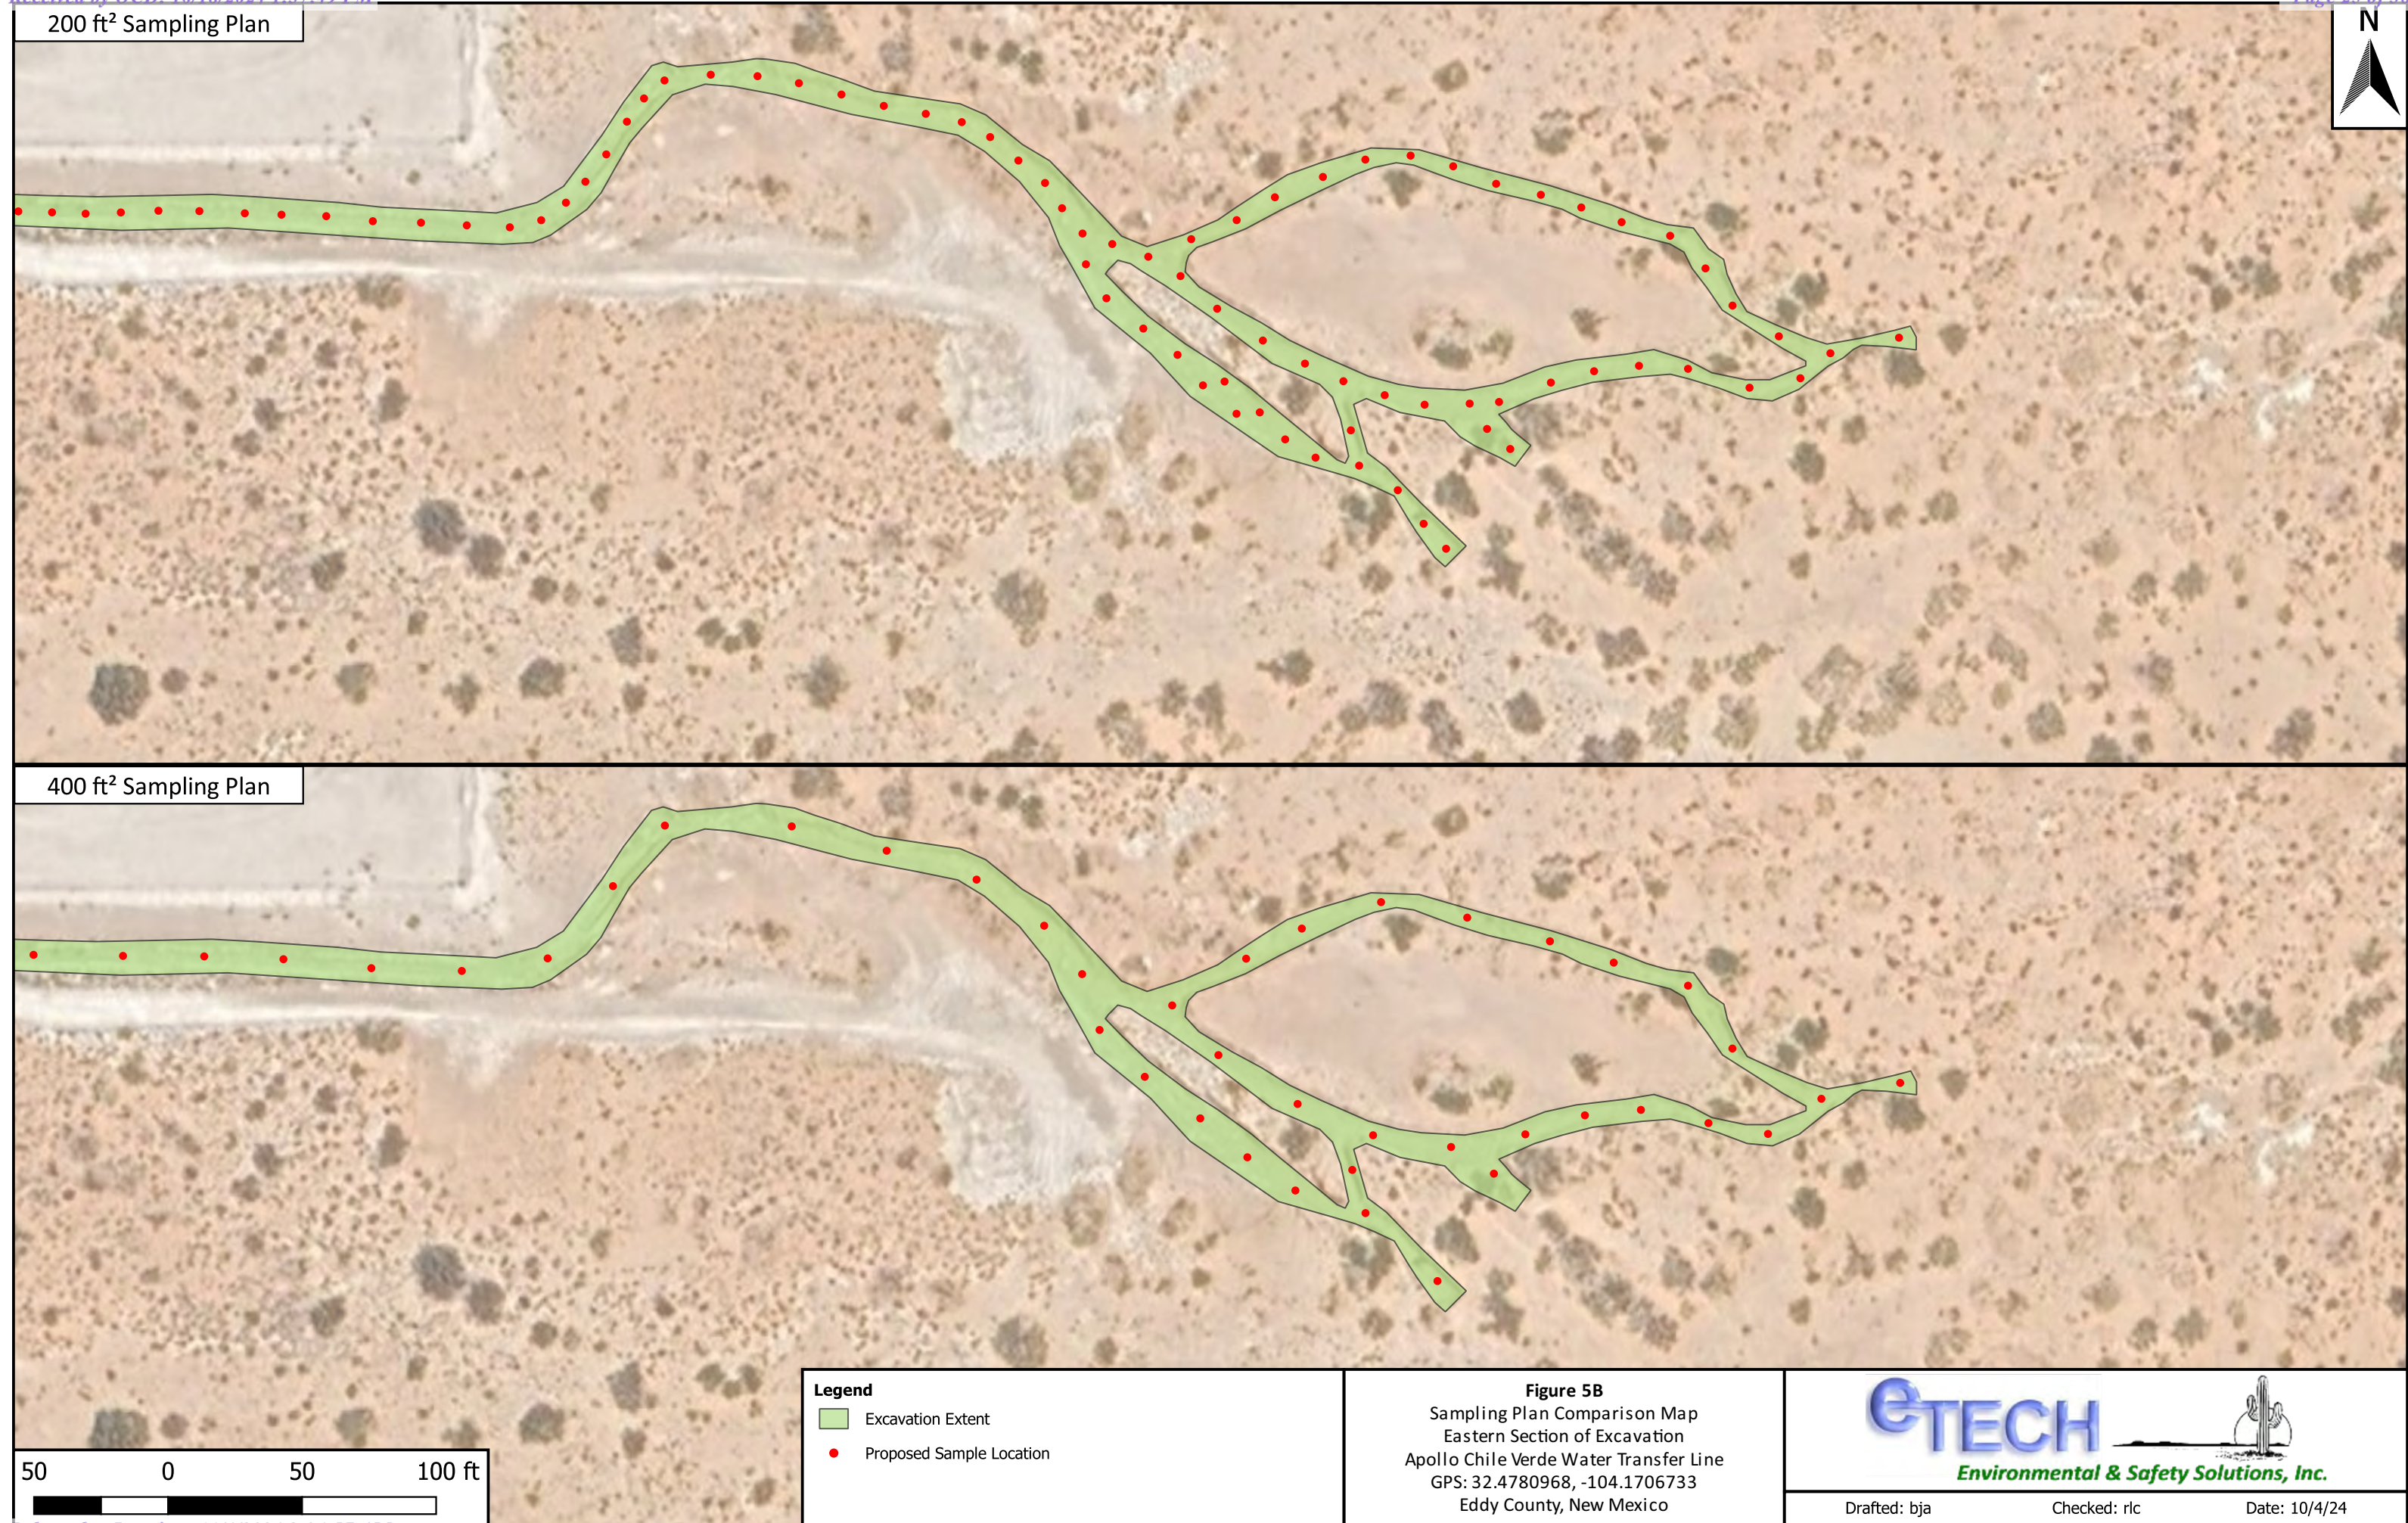
Figures 5A & 5B

Sampling Plan Comparison Maps

Based on the size of the affected area (approximately 68,806 square feet), a total of approximately 172 composite soil samples will be collected from the floor of the excavated area under the proposed alternative sampling plan, as opposed to approximately 344 samples under a standard 200-square-foot plan. Figures 5A and 5B provide a side-by-side comparison of the 200-square-foot and 400-square-foot sampling plans. The maps illustrate that, while there are fewer total composite samples in the 400-square-foot plan, there is a nominal difference between the spatial coverage of the plans, and both plans are equally representative of the affected area, with minimal gaps between each sampling section/zone. Since each individual composite sample will incorporate soil from five (5) spots within a 400-square-foot zone, this effectively equates to a total of approximately 860 sample points, which decreases the likelihood that any hotspots will be missed. Furthermore, the composite samples will include wet and/or visibly stained areas, from which additional discrete samples will also be collected, as necessary.

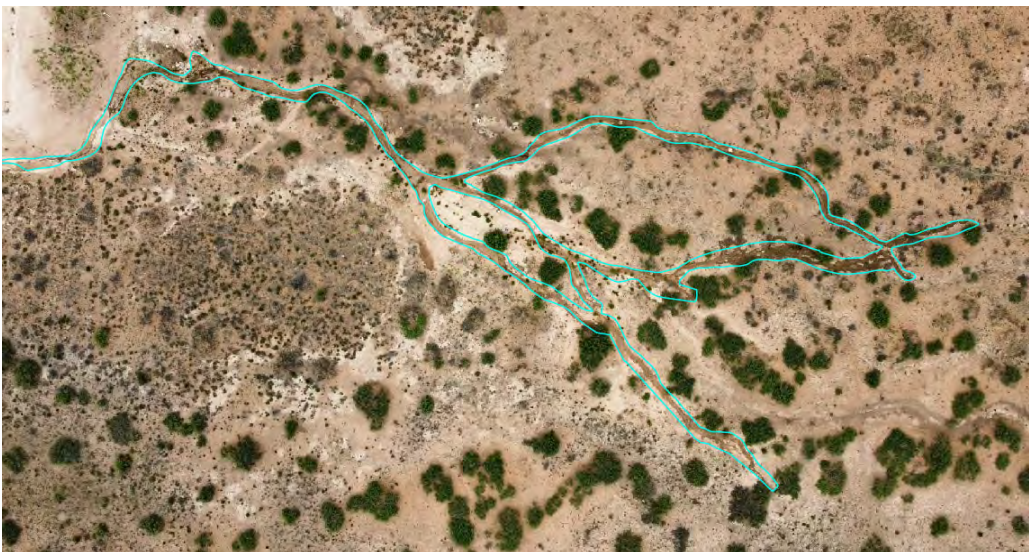
Photo Number: 1

Photo Direction: Overhead/Bird's Eye	
Coordinates: 32.477686,-104.165391	
Date/Time: 5/20/23, Time Unknown	
Photo Description: Aerial view of the eastern portion of the affected area (outlined in cyan).

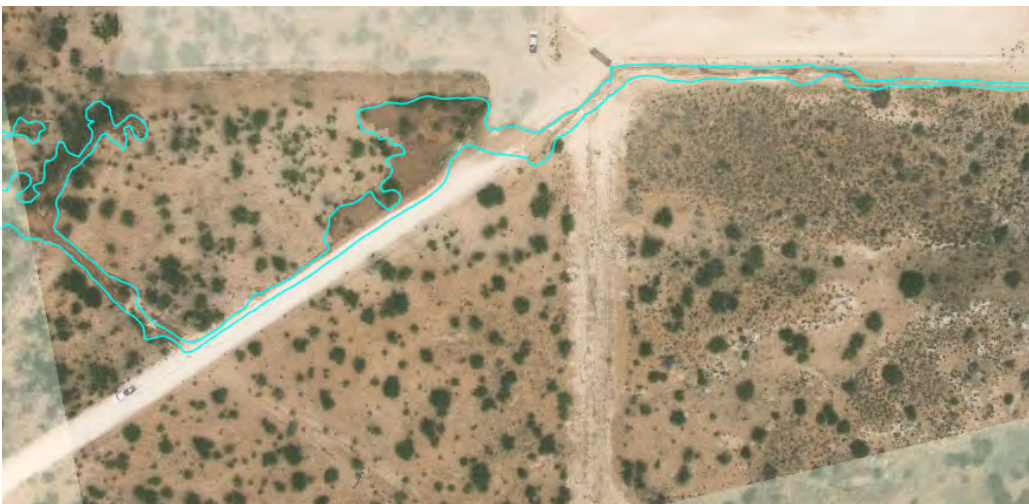
Photo Number: 2

Photo Direction: Overhead/Bird's Eye	
Coordinates: 32.477570,-104.167615	
Date/Time: 5/20/23, Time Unknown	
Photo Description: Aerial view of the central portion of the affected area (outlined in cyan).

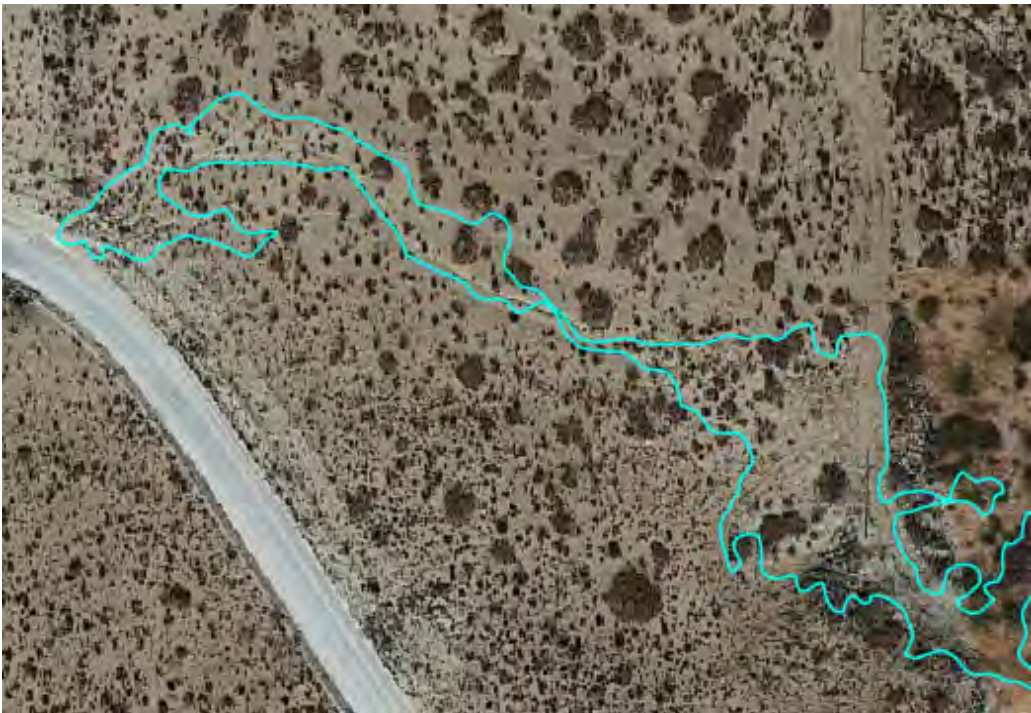
Photo Number: 3

Photo Direction: Overhead/Bird's Eye	
Coordinates: 32.477948,-104.169893	
Date/Time: GPS: 5/20/23, ≈14:00.	
Photo Description: Aerial view of the western portion of the affected area (outlined in cyan).

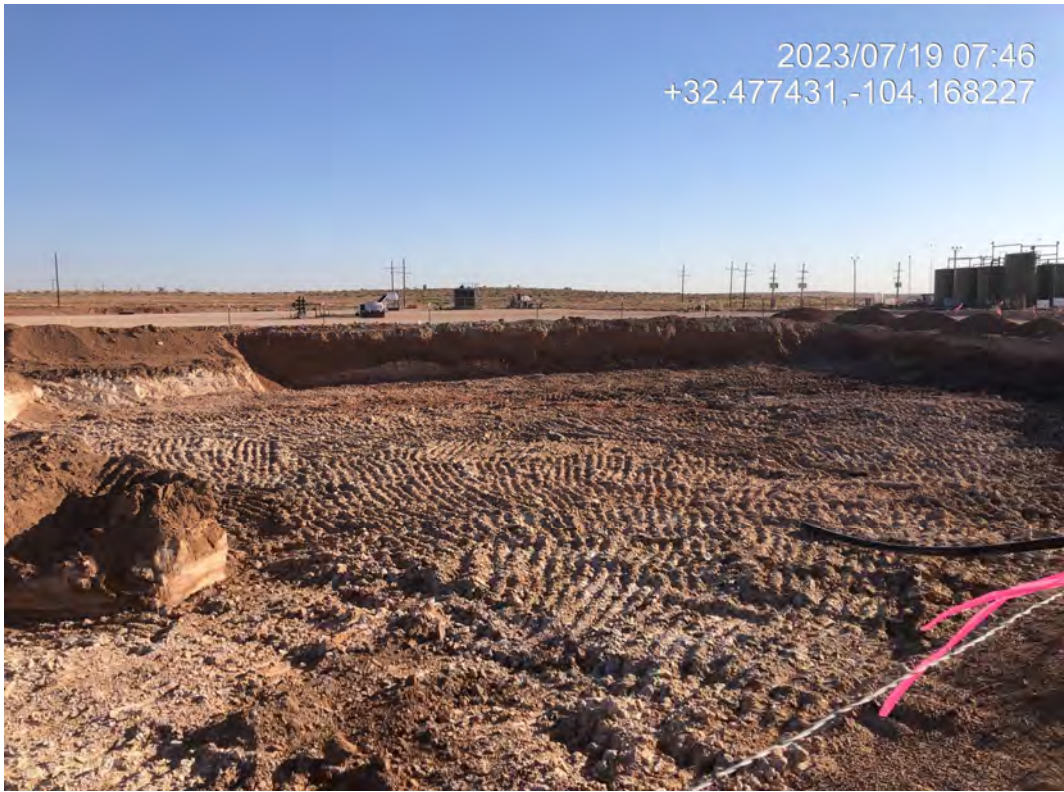
Photo Number: 6

Photo Direction: North	
Photo Description: View of the excavated area.

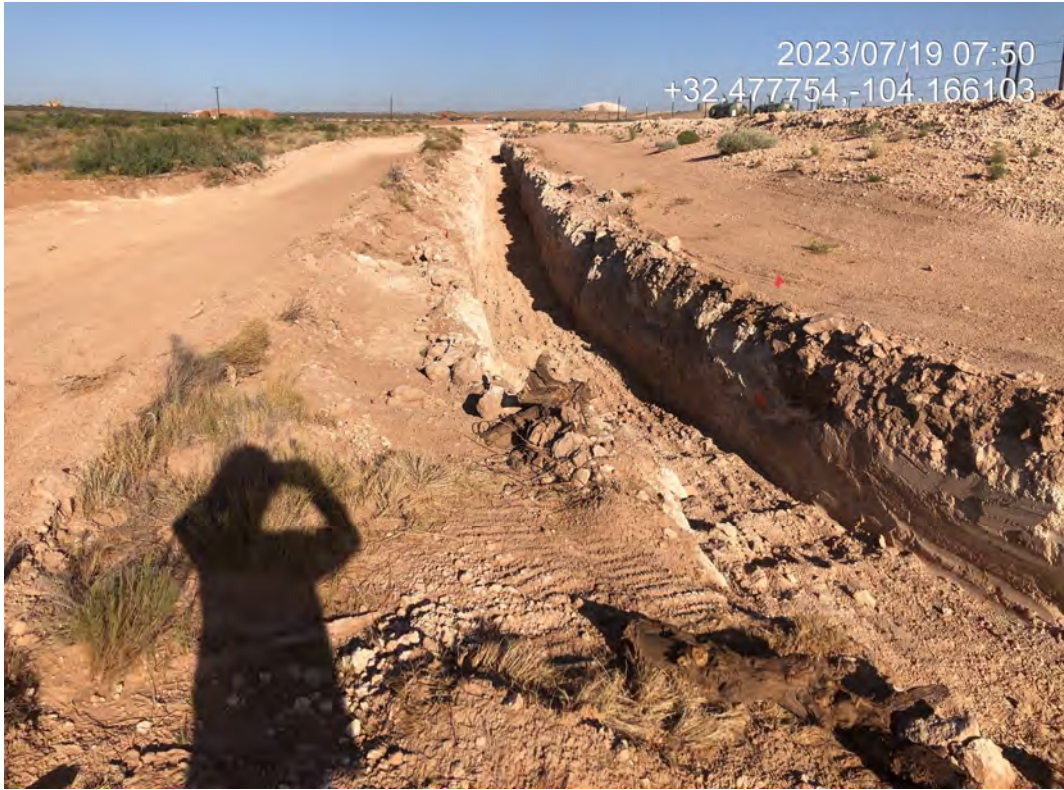
Photo Number: 8

Photo Direction: West	
Photo Description: View of the excavated area.

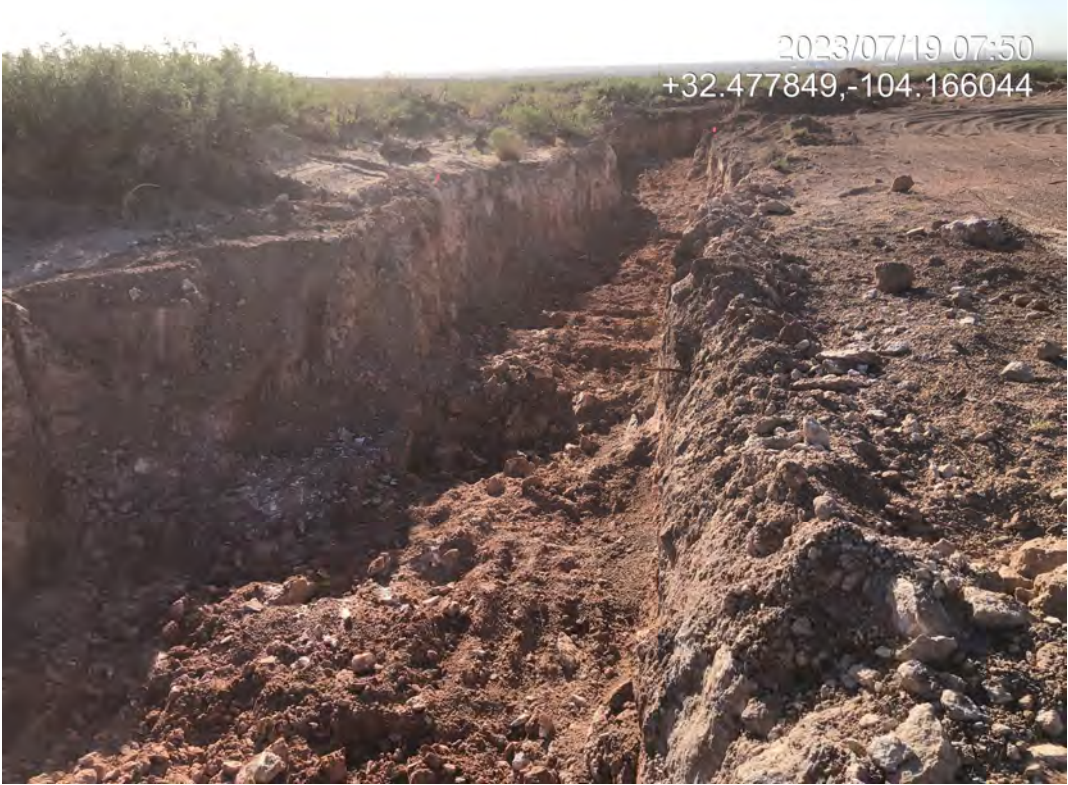
Photo Number: 9

<p>2023/07/19 07:50 +32.477849,-104.166044</p>
Photo Direction: Northeast	
Photo Description: View of the excavated area.

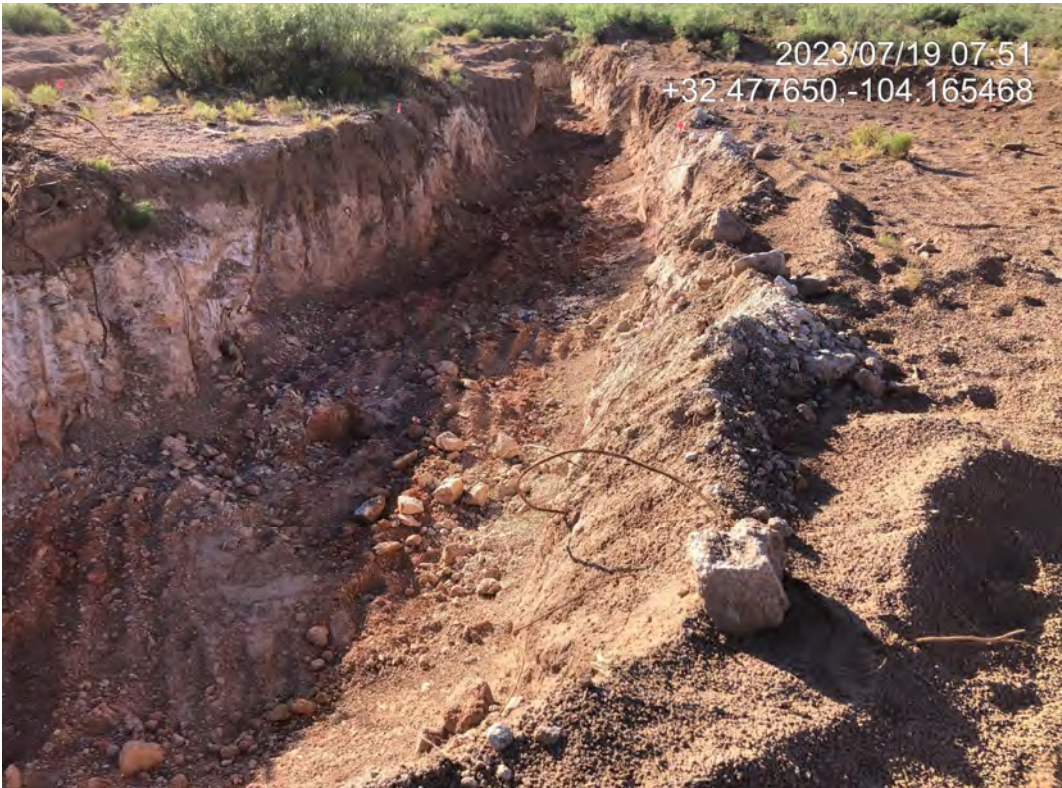
Photo Number: 11

Photo Direction: Southeast	
Photo Description: View of the excavated area.

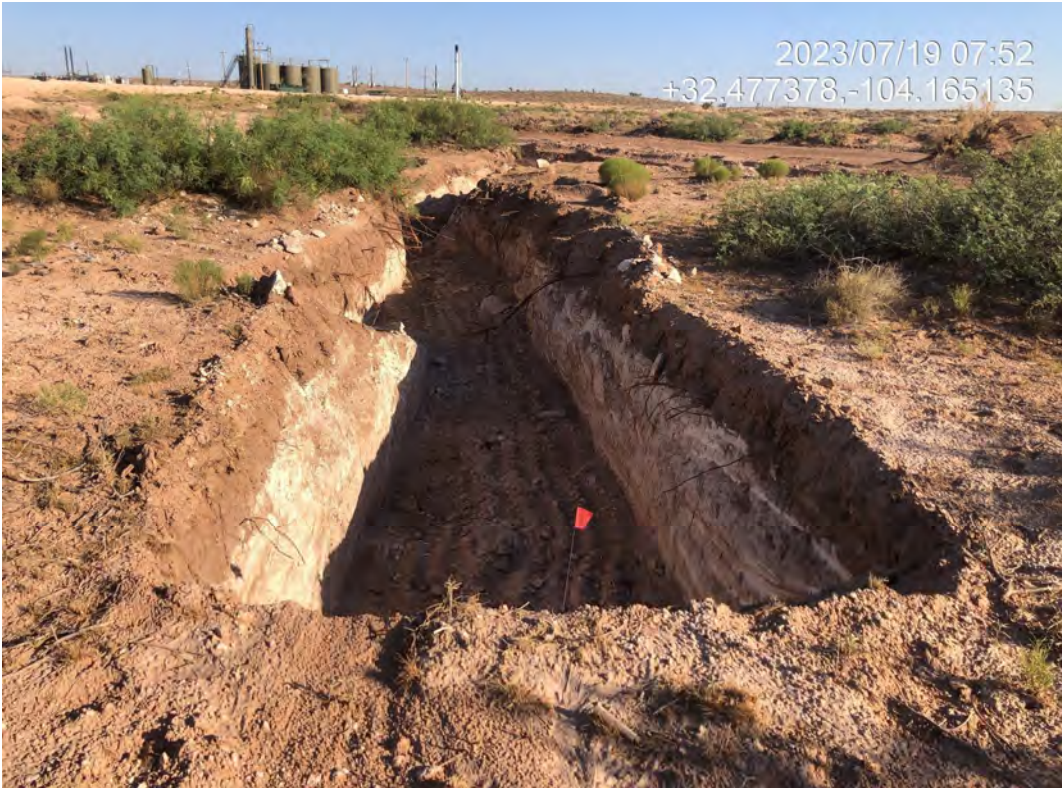
Photo Number: 12

Photo Direction: Northwest	
Photo Description: View of the excavated area.

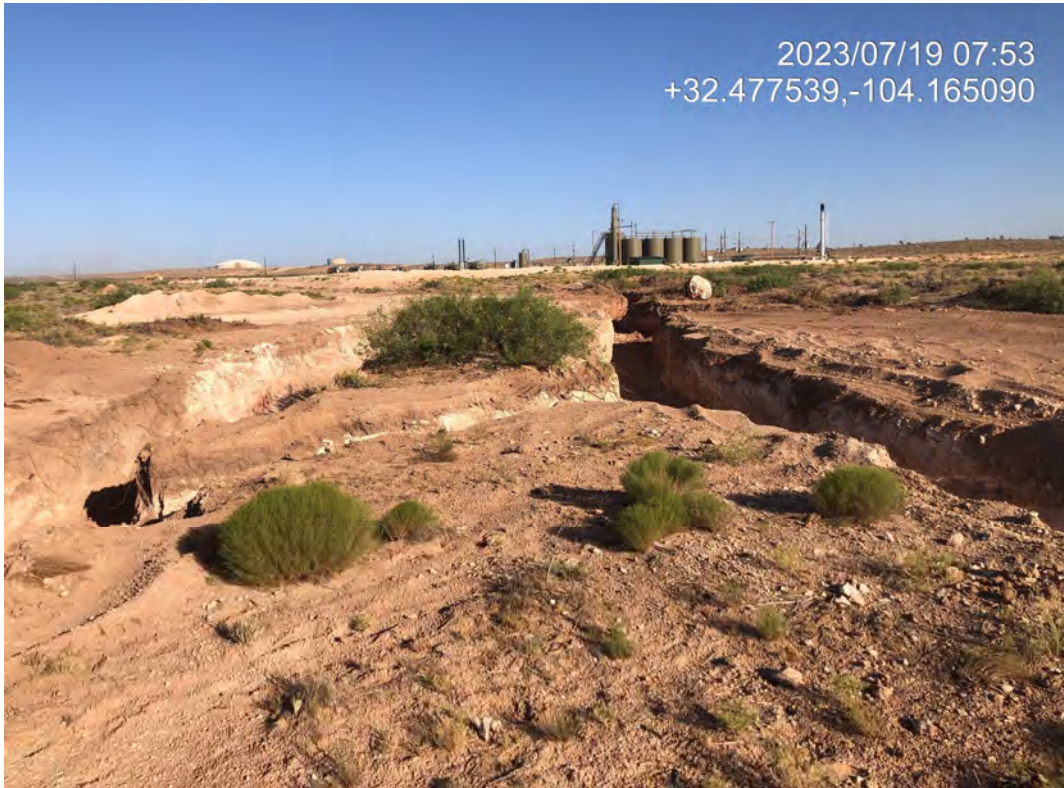
Photo Number: 13

Photo Direction: West-Northwest	
Photo Description: View of the excavated area.

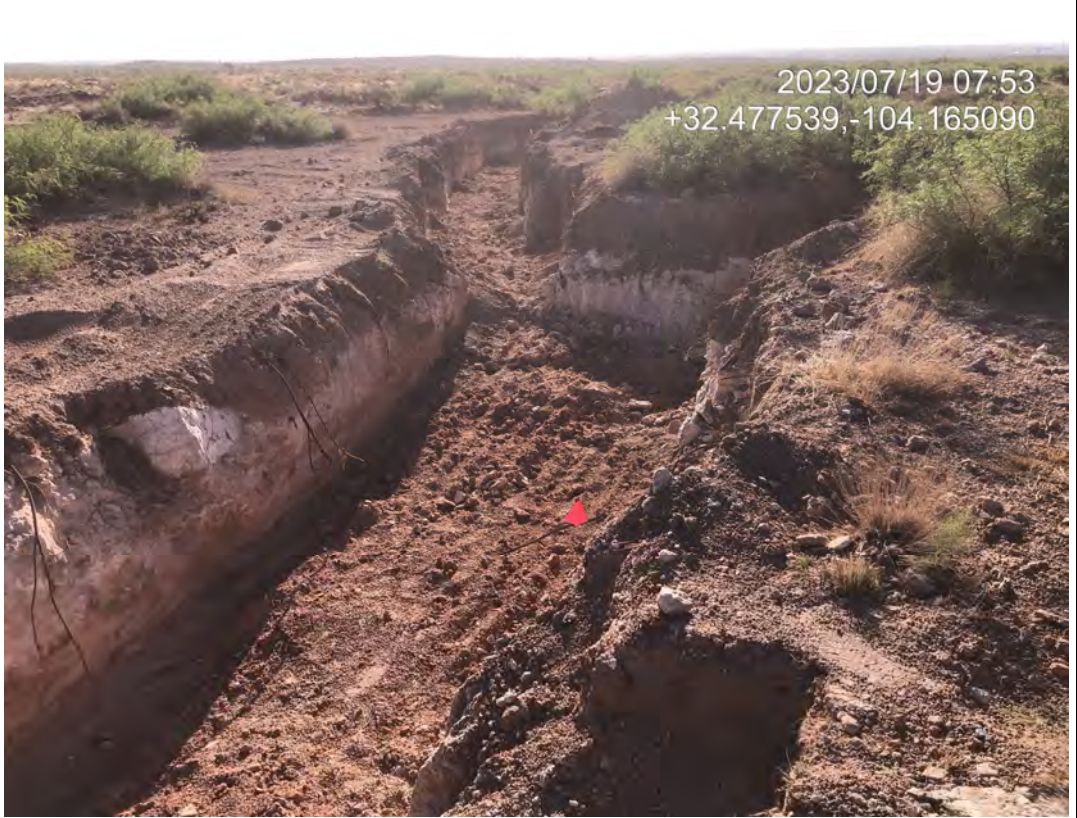
Photo Number: 15

Photo Direction: East	
Photo Description: View of the excavated area.

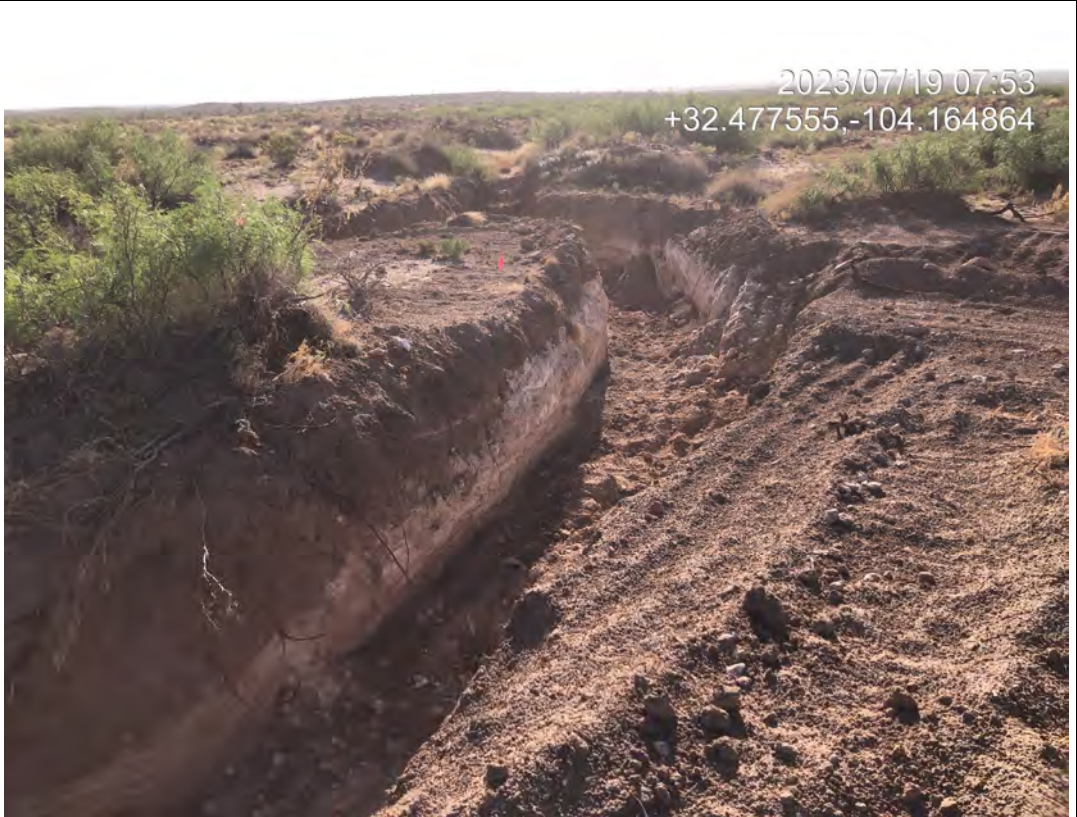
Photo Number: 16

Photo Direction: East	
Photo Description: View of the excavated area.

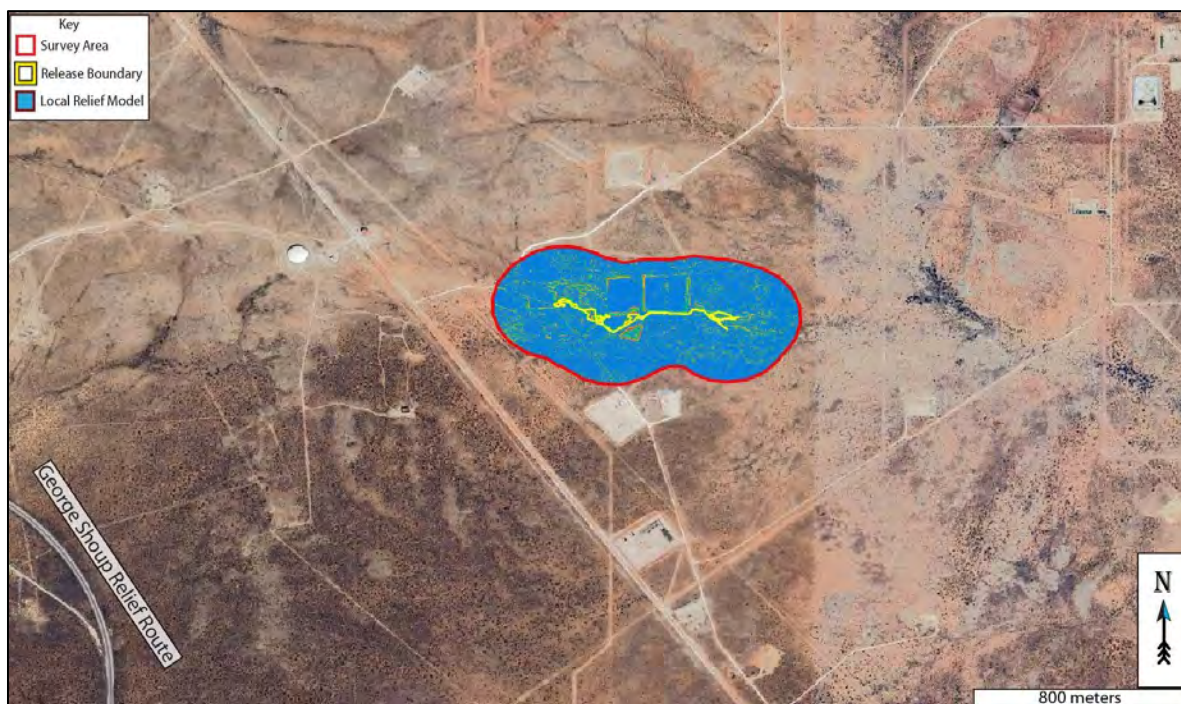
Figure 4: Survey overview. Background image credit: Google Earth. Image date: December 21, 2019. Datum: WGS-84.

Aerial karst surveys are conducted at low elevation following a preplanned raster pattern flightpath designed for the purpose of generating at least 75% imagery overlap. The collected high-resolution, georeferenced imagery is stitched together to develop orthomosaic imagery which is further developed into a digital elevation model (DEM); the DEM is then processed into a local relief model (LRM) (**Figure 4**). This LRM is color coded to enhance differences in elevation of as little as five centimeters. The orthoimagery, DEM, and LRM are uploaded to a server where they are analyzed by a highly qualified karst geologist. Finally, the data is reviewed by a senior karst geologist for quality assurance and downloaded into a table for inclusion in a written report^[14].

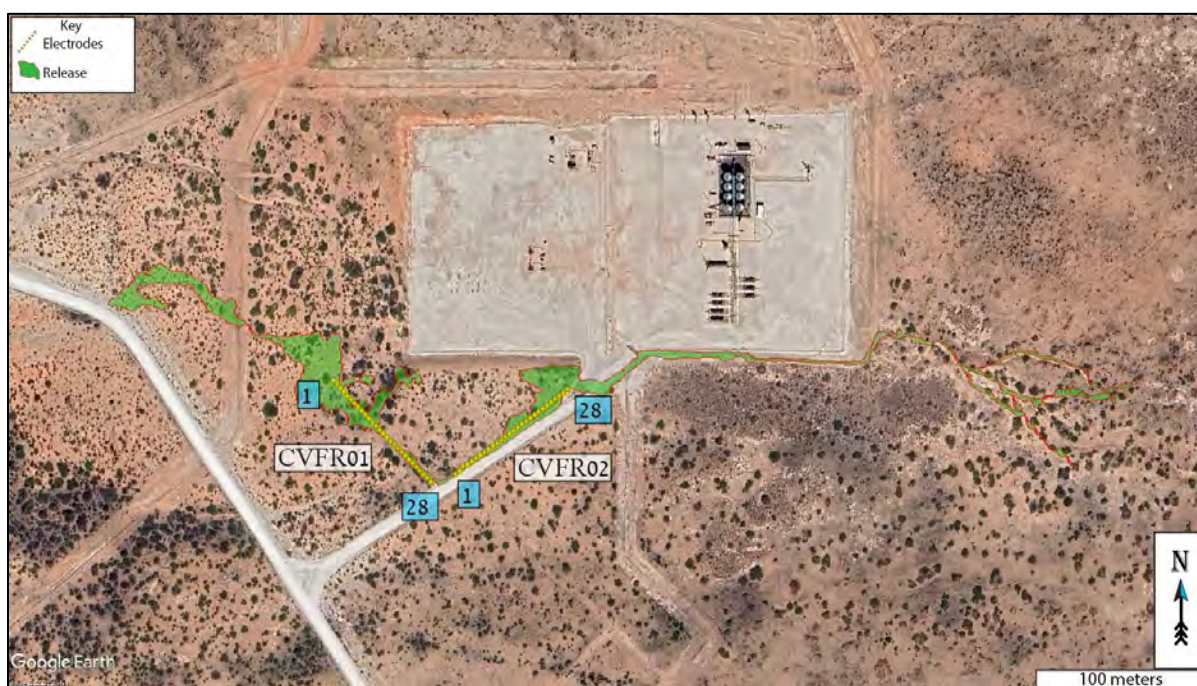
For this survey, an Advanced Geosciences Inc. (AGI) SuperSting™ Wifi R8 with a multi-electrode switchbox, a 28-electrode array of 40-centimeter-long electrodes, and a tablet controller were used to image the subsurface. This survey consisted of two resistivity lines in a dipole-dipole strong gradient configuration; CVFR01 is laid out northwest to southeast and CVFR02 is laid out southwest to northeast. Both lines consisted of 28 electrodes at 3-meter spacing, resulting in 81-meter-long arrays. (**Figure 5**, **Table 1**, and **APPENDIX 7.2**). A preconfigured command file was used to run the data collection (DDSG28). This electrode configuration provided a depth of investigation of 16 meters (53 feet) and a resolution of 1.5 to 2 meters (4.9 to 6.6 feet) within the first 5 to 8 meters (16 to 26 feet) from the surface. A Leica GS18 GPS was used to record electrode locations and elevations.

Figure 5: Survey overview. Two survey lines (denoted with white numbers) were conducted with 28 electrodes each at 3-meter spacing (yellow dots denoted with blue numbers). Background image credit: Google Earth. Image date: April 15, 2023. Image datum: WGS-84.
