Remediation Summary & Variance Request

Mewbourne Oil Company Apollo Chile Verde Water Transfer Line

Eddy County, New Mexico
Unit Letter "J", Section 15, Township 21 South, Range 27 East
Latitude 32.4780968 North, Longitude 104.1706733 West
NMOCD Reference No. nAPP2315849467

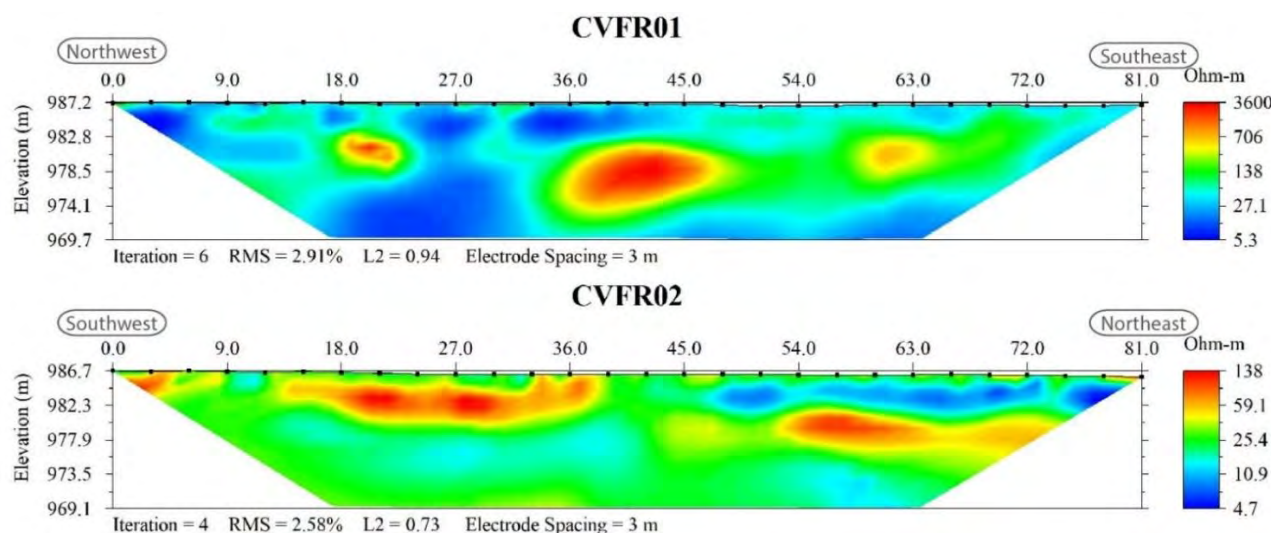
The results of this study indicate a well-layered geologic system with resistivities between 5 and 150 Ohm-m with occasional areas of up to 700 Ohm-m (**Figure 6**). Please keep in mind when viewing the 2D inverted resistivity sections that color maps can be widely different for each view. Always check the color map located on the right side of the image when viewing the 2D images to ensure you understand the range of resistivities presented. Distances along the top and depths along the left side are in meters. The color map along the right side is in Ohm-m. Due to the nature of the survey, shallower zones have higher resolution between electrodes than deeper zones; therefore, small features at depth will not be visible.

One area of higher-than-average resistivity exists under line CVFR01. Areas of lower-than-average resistivity (4.5 to 5.5 Ohm-m) exist both at the surface and at depth within the survey area (**Figure 6**).

Figure 6: 2D inverted resistivity section. Reds and oranges indicate higher resistivity values. Yellows and greens are medium resistivity values. Blues are low resistivity values. Please note that the color scale is relative, and that even the highest values in these sections are lower than what is typically seen in the region.

Low resistivity areas between 5 – 15 Ohm-m may either represent fluid from the brine release, moist to saturated subsurface remnants of the Salado Formation, or a layer of either clays and halite lenses or moist or saturated layers within the Artesia Group.
