RE: **Amended Closure Report**
Cochise 2 State #004
Unit G, Section 02, Township 19 South, Range 32 East
32.692152°, -103.7347785°
Lea County, New Mexico
NMOCD Incident No. NOY1728952379
Terracon Project No. KH247026

Closure Documentation
Cochise 2 State #004 | Lea County, New Mexico
June 18, 2024 | Terracon Report No. KH247026

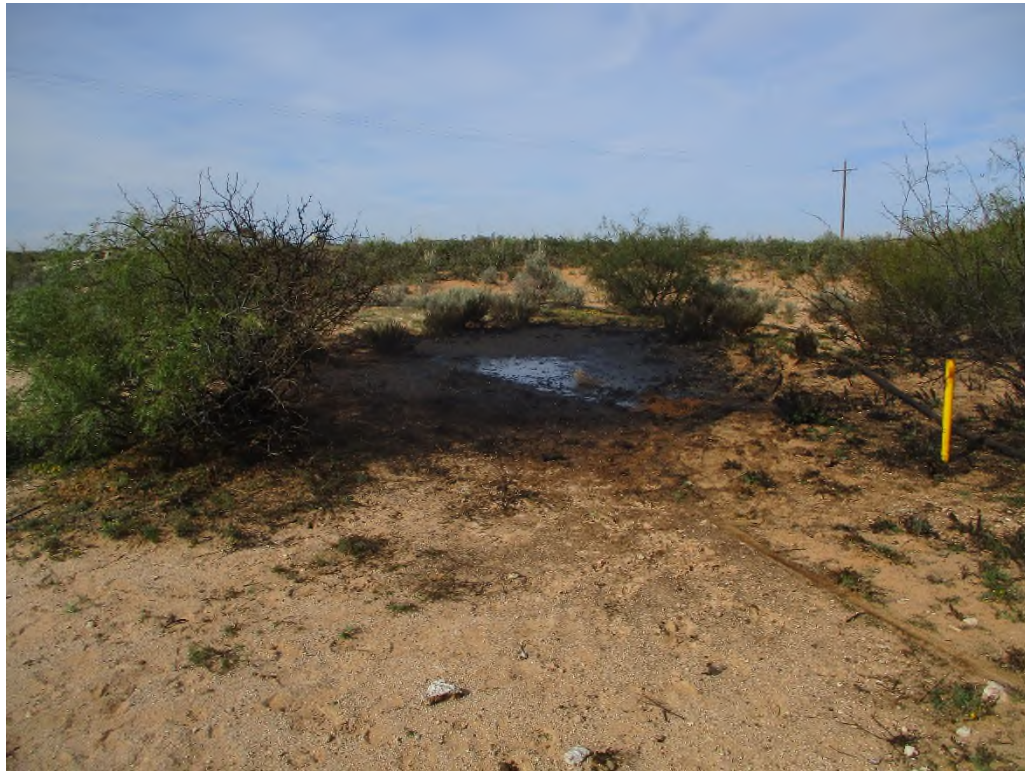
View Northwest – Release Area

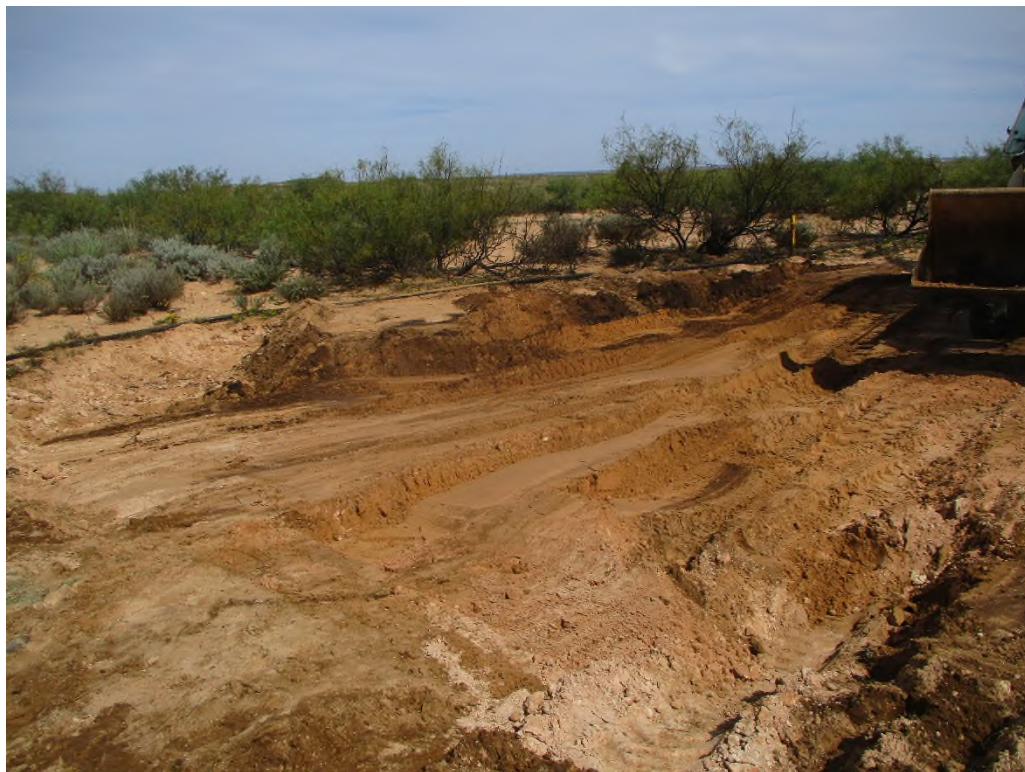
View Northeast – Excavated Release Area

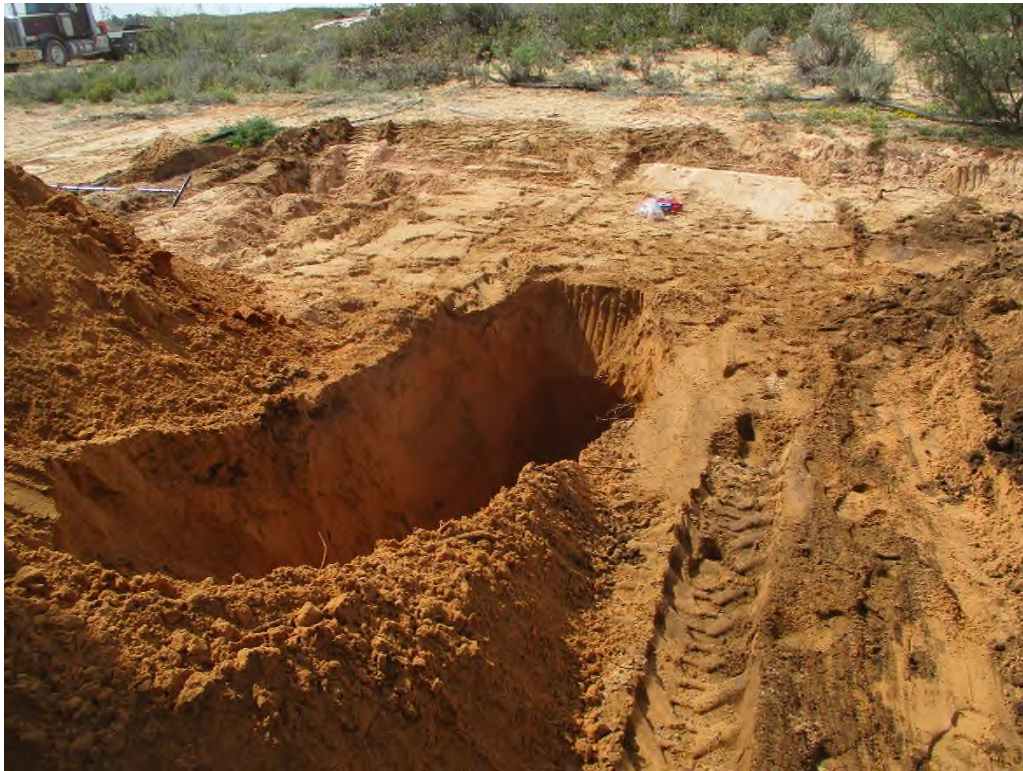
View West – Area of T-1

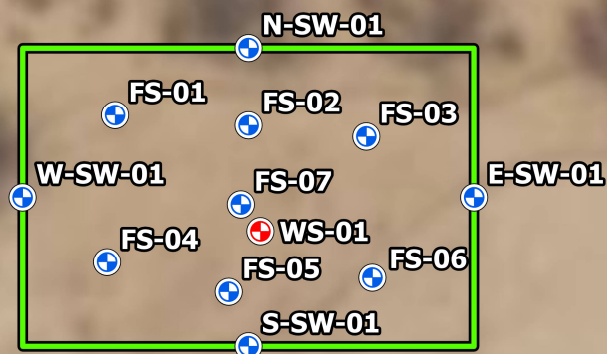
NMOCD RAL $\leq 4'$ BGS
 600 mg/kg for Chloride
 100 mg/kg for Total TPH
 10 mg/kg for BTEX

NMOCD RAL $> 4'$ BGS
 10,000 mg/kg for Chloride
 2,500 mg/kg for Total TPH
 10mg/kg for BTEX

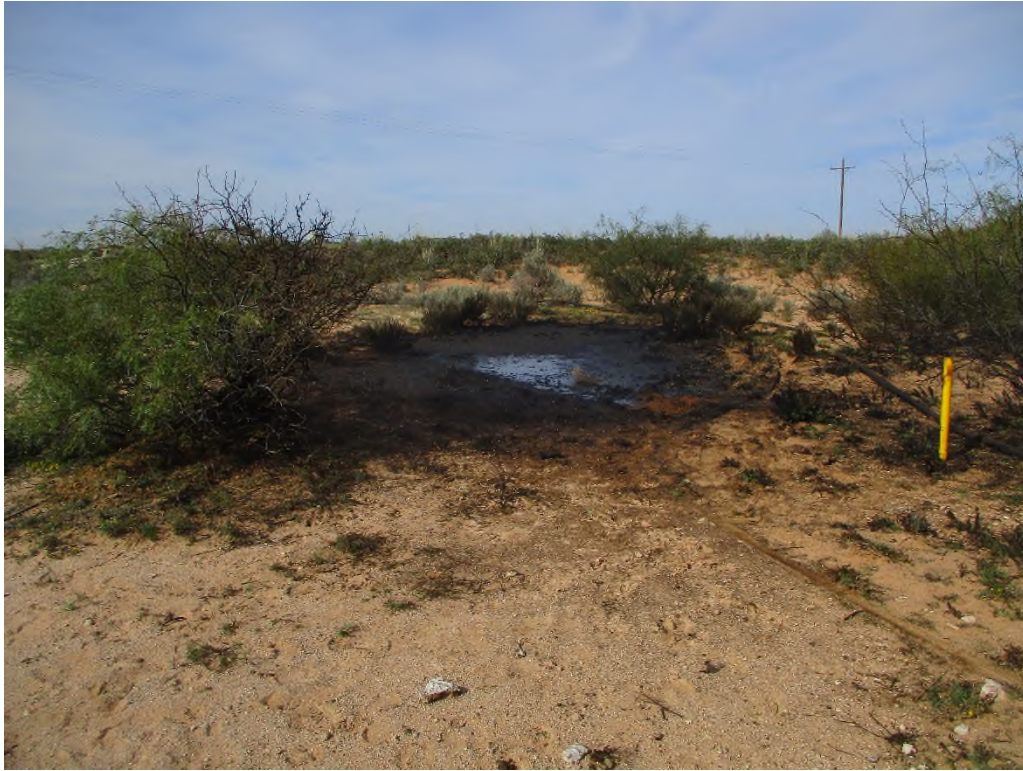
View Northwest – Release Area

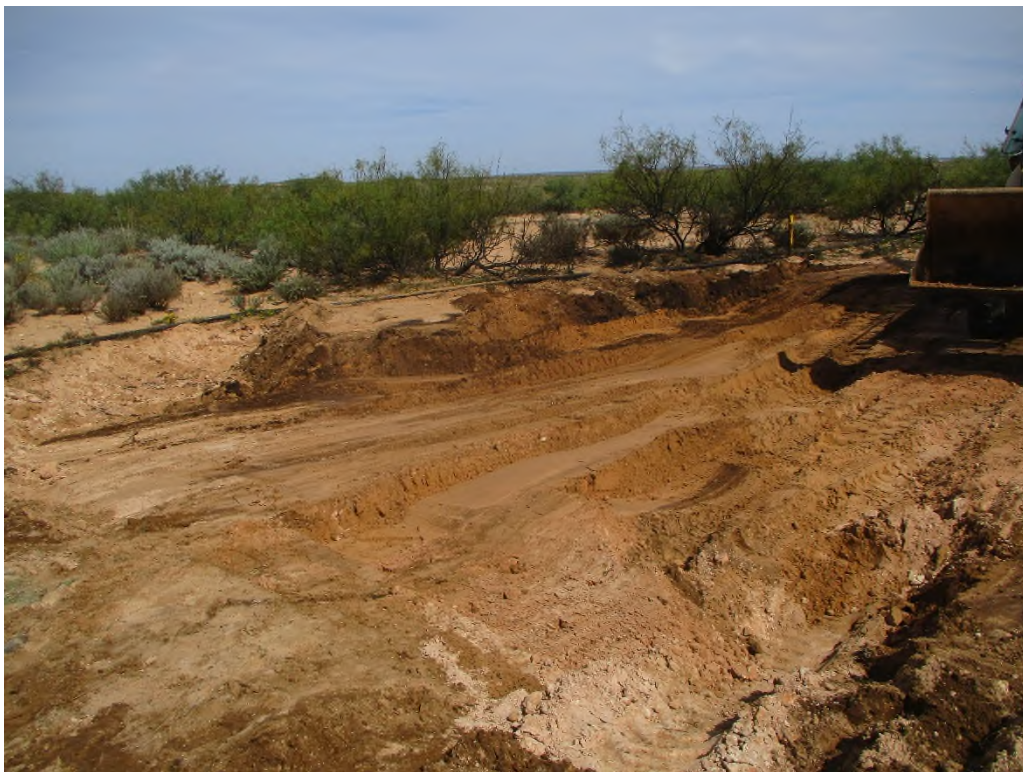
View Northeast – Excavated Release Area

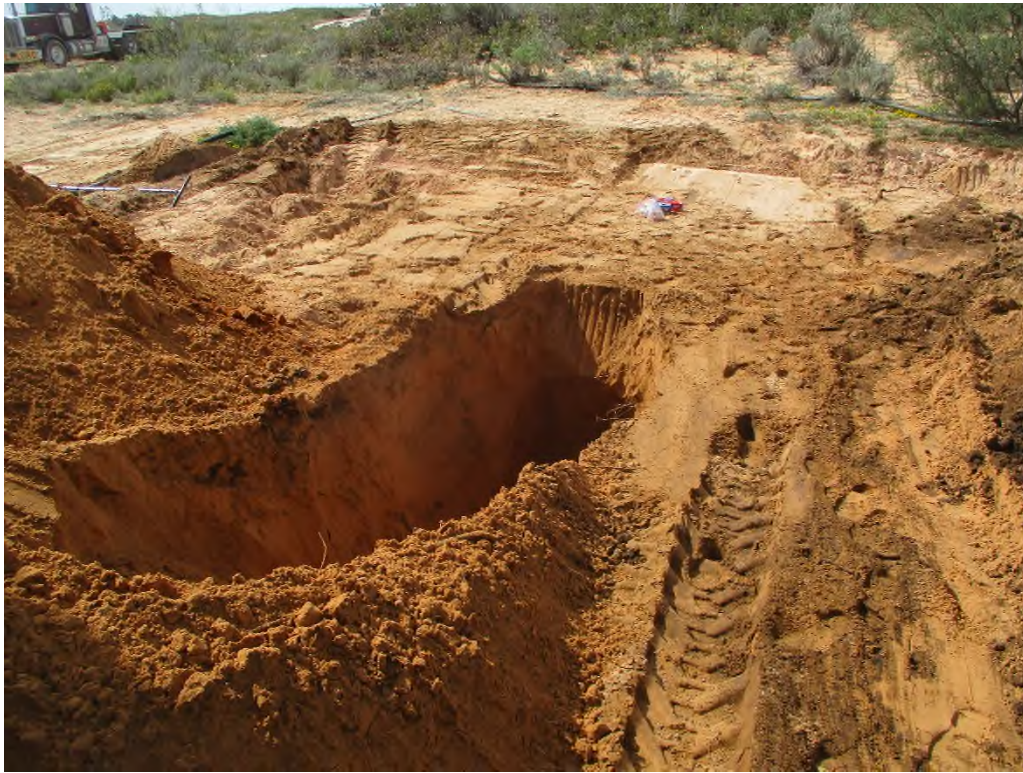
View West – Area of T-1
