Re: Site Characterization and Remediation Work Plan  
Devon Energy Production Company  
Red Bull 29 Federal #001H  
Unit D, Section 29, Township 23S, Range 35E  
Site Coordinates: 32.2818451, -103.3969345  
Lea County, New Mexico  
Incident ID: nAPP2424054089

**SITE LOCATION MAP**  
**SITE CHARACTERIZATION AND REMEDIATION WORK PLAN**  
RED BULL 29 FEDERAL #001H  
DEVON ENERGY PRODUCTION COMPANY  
LEA COUNTY, NEW MEXICO

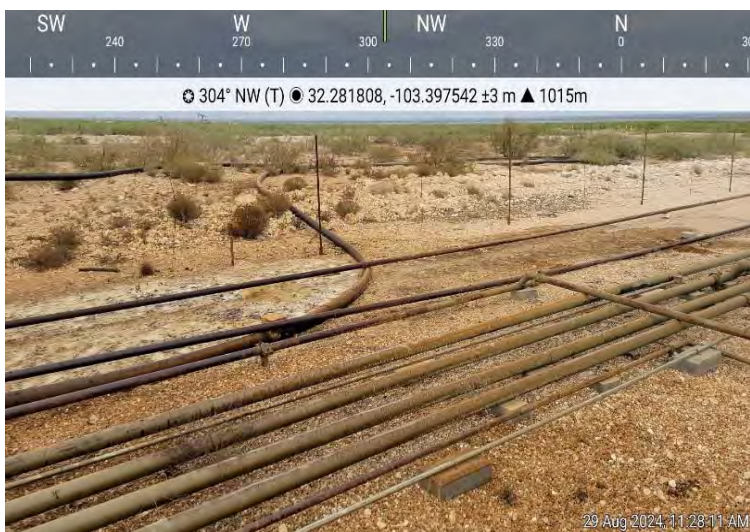
**Photograph No. 2**

**Description:**  
Area of Concern.

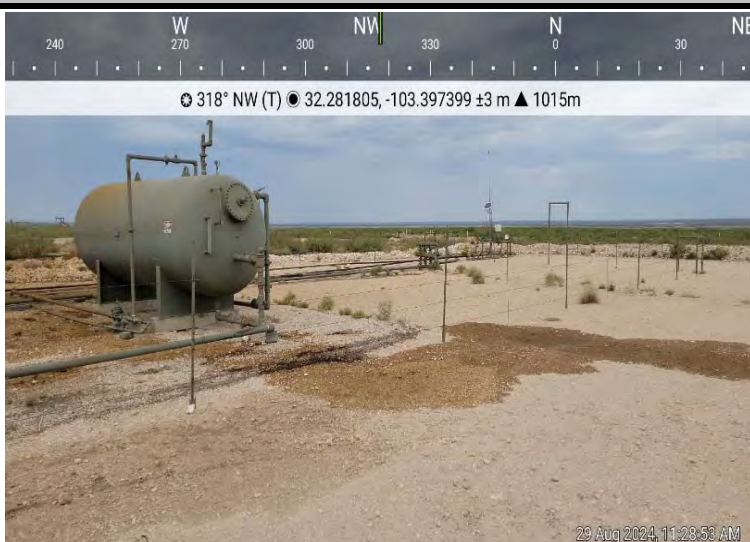
**Photograph No. 3**

**Description:**  
Area of Concern.
