## Remediation Summary and Closure Request

**FAE II Operating, LLC**

**Farnsworth 4 #7**

**NMOCD Incident # nAPP2225654053**

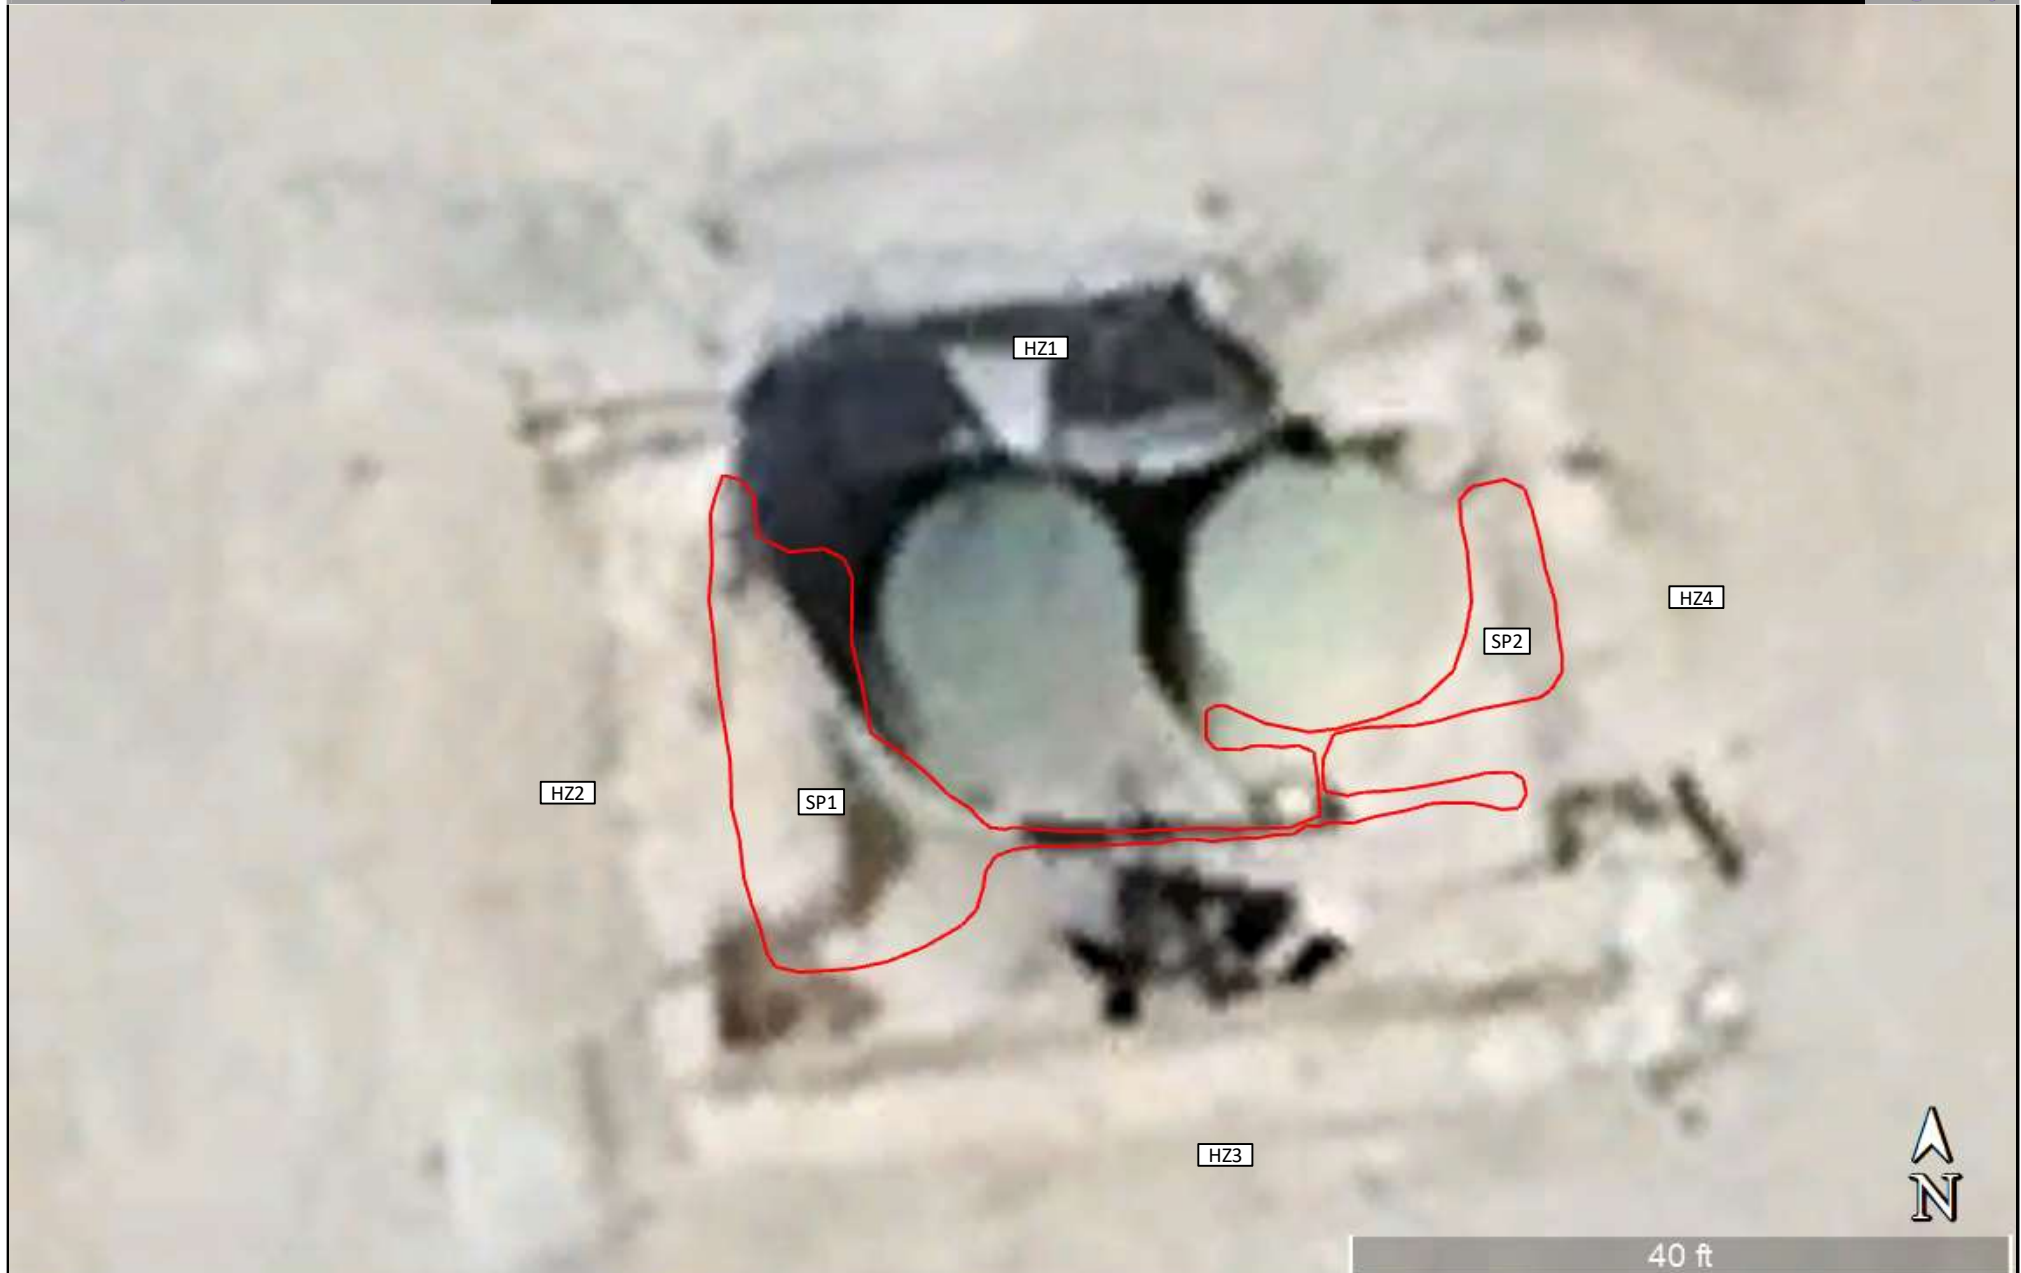
**Figure 4**

Based on field observations and field test data noted above and provided in Attachment IV, ten representative soil samples were selected for laboratory analysis. Delineation soil samples SP1 and SP2, and HZ1 through HZ4, were submitted to the laboratory for analysis of BTEX, TPH, and chloride. Laboratory analytical results indicated contaminant concentrations were below the NMOCD Closure Criteria in each of the submitted samples, with the exception of SP1 and SP2 at Surface, which exhibited TPH and chloride concentrations in excess of NMOCD Closure Criteria.

Delineation Sample Map  
FAE II Operating, LLC  
Farnsworth 4 #7  
GPS: 32.074211, -103.169078  
Lea County

A Delineation Sample Map and Excavation Sample Map are provided as Figure 4 and Figure 5, respectively. A Summary of Soil Sample Laboratory Analytical Results is provided as Table 1 and Laboratory Analytical Reports are provided as Attachment VI.

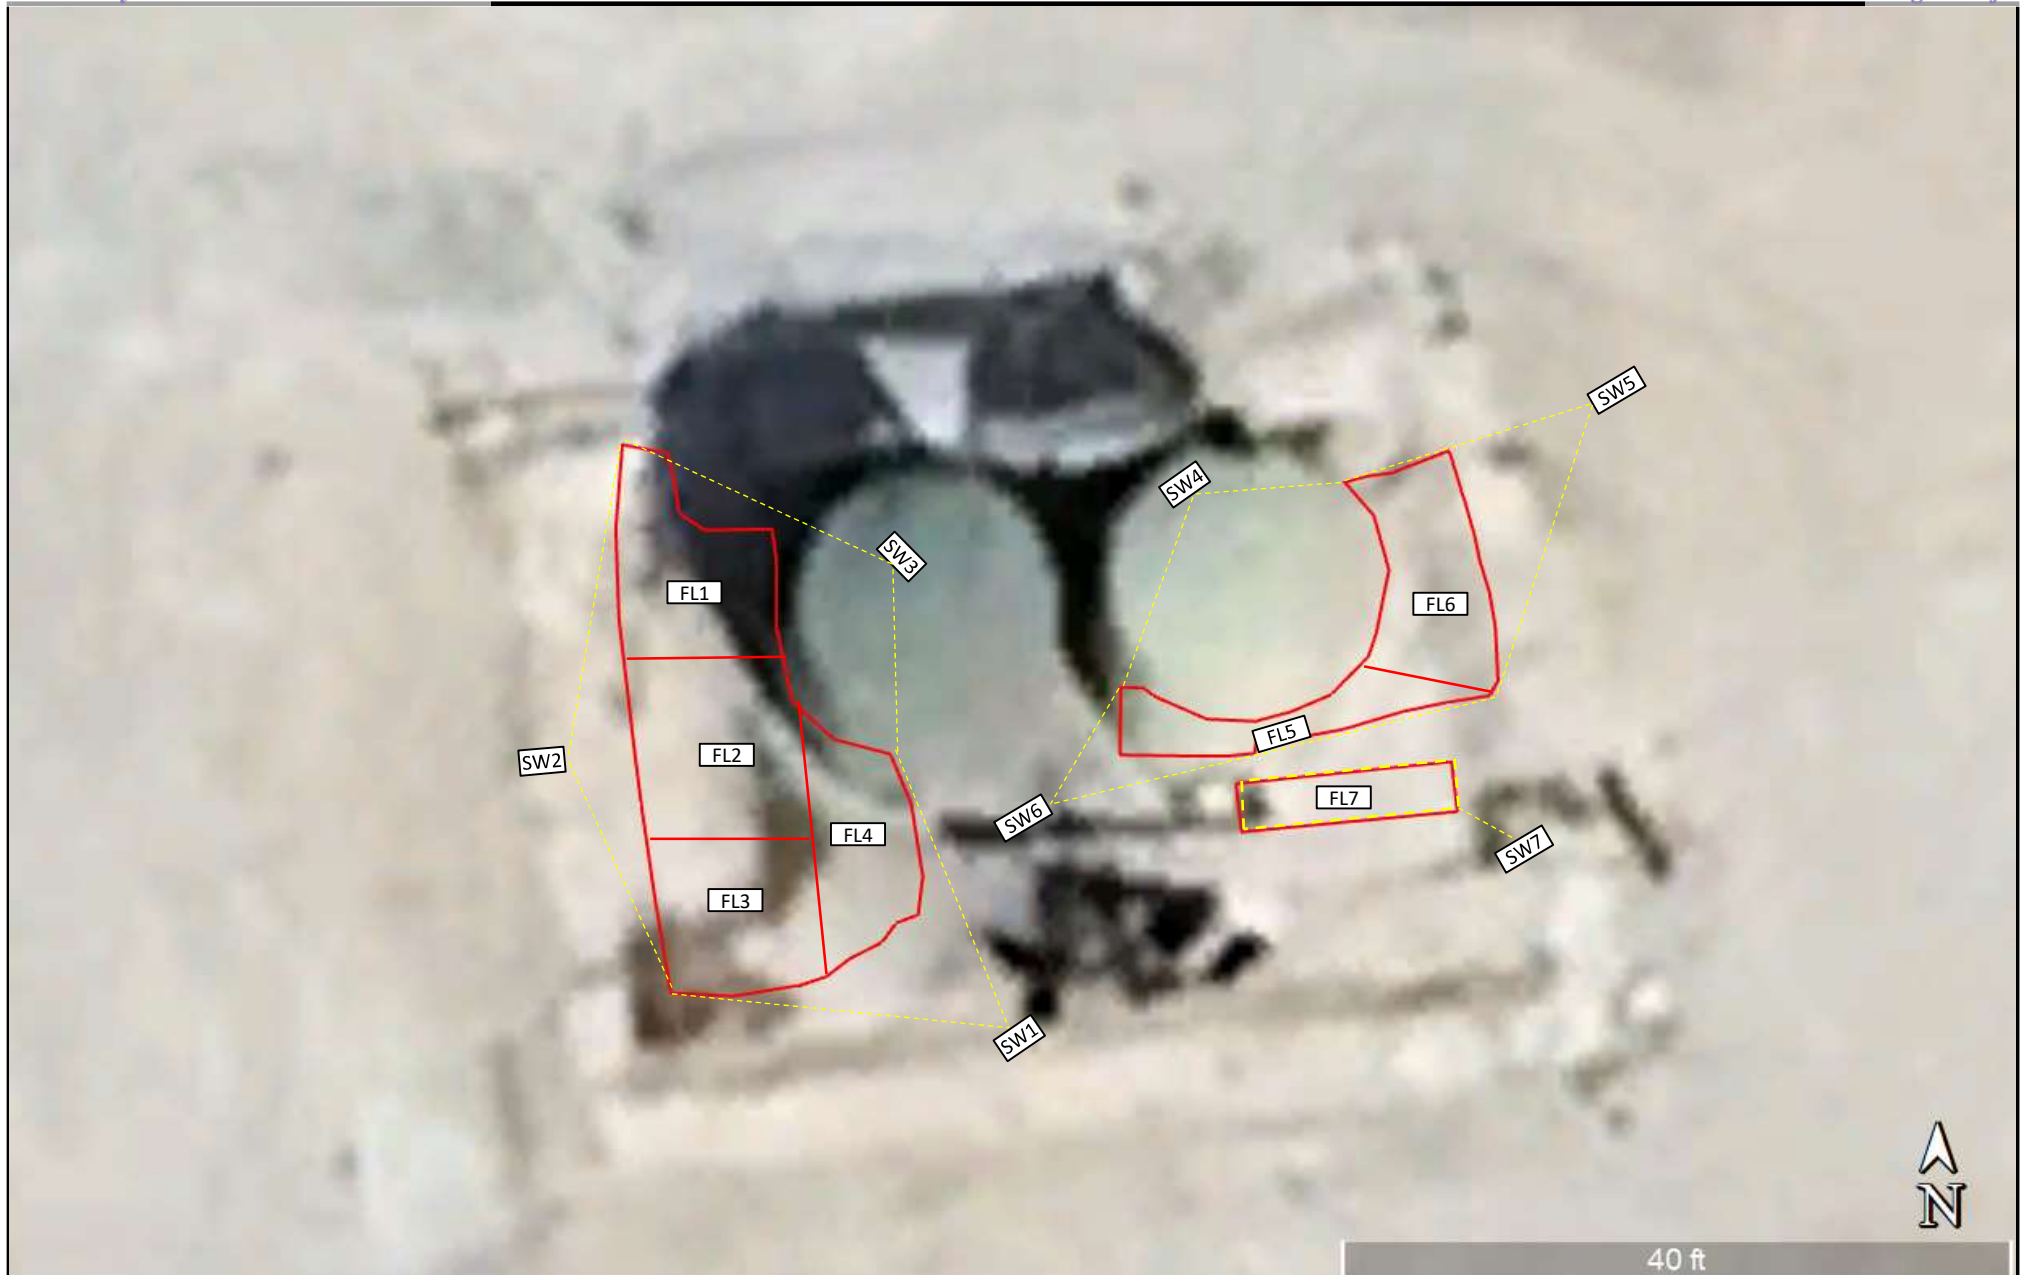
**Figure 5**

On July 29, 2024, fifteen five-point composite confirmation soil samples were collected from the excavation floor and sidewalls, with each sample representing no more than 200 square feet. Soil samples FL1 through FL7, and SW1 through SW8, were submitted to the laboratory for analysis of BTEX, TPH, and chloride. Laboratory analytical results indicated contaminant concentrations were below the NMOCD Closure Criteria in each of the submitted samples.

Excavation sidewall samples SW1 through SW8 were collected as five-point composite samples collected from the sidewalls of the excavation, from the excavation surface to the excavation floor. Excavation Sample Map, provided as Figure 5, depicts sidewall sample boundaries.

Excavation Sample Map

From June 28 – July 3, 2024, the release area was excavated to an approximate depth of five feet bgs. A hydro-excavator was initially utilized to excavate around process equipment. When the lines had been exposed, a backhoe finished the excavation. Excavated contaminated soil was temporarily stockpiled onsite, within the excavation, before transport to an NMOCD approved disposal facility. Hydro-excavated material was immediately transported to a disposal facility.

The excavated area measured approximately five hundred sixty square feet. During remediation activities approximately 120 cubic yards of impacted soil were excavated and hauled to an NMOCD approved disposal facility.
