## REMEDIATION CLOSURE REPORT

**Ragin Cajun 12 CTB 3**

Prepared For:  
Devon Energy Production, LP

**Re: Site Assessment, Remediation, and Closure Report**  
**Ragin Cajun 12 CTB 3**  
**Facility ID: fAPP2423338309**  
**GPS: Latitude 32.0614366 Longitude -103.419365**  
**UL - H, Section 12, T26S, R34E**  
**Lea County, NM**  
**NMOCD Ref. No. NAPP2423962613**

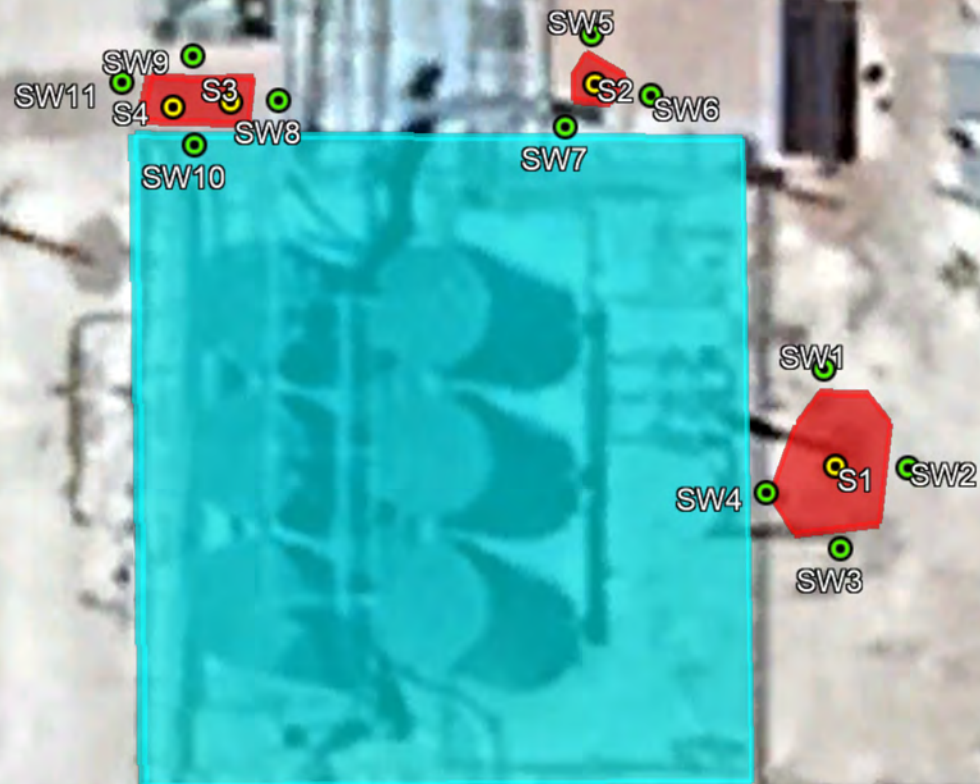
Figure 4- Site Map & Liner Map

On August 29, 2024, Pima mobilized personnel to the site to collect soil samples from the spill area using a hand auger. The laboratory results of these sampling events are provided in the following data table. A Site Map is available in Figure 4.

Devon Energy  
Incident ID: NAPP2423962613  
Lea County, NM  
Site Map

On October 28, 2024, the Devon Construction Department mobilized personnel and equipment to initiate immediate remediation activities. They began excavating to a depth of 1 foot below ground surface (BGS). A total of 7 cubic yards of contaminated soil was hauled to R360 Antelope draw an approved, lined disposal facility.

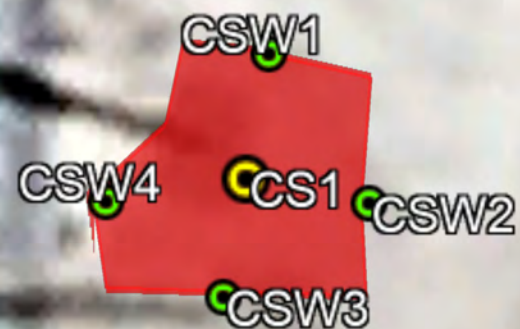
Figure 5- Confirmation Sample Map

On October 31, 2024, after sending a 48-hour notification (application ID: 396945, Appendix C), Pima returned to the site to collect 5-point confirmation samples from the excavation. The 5-point composite samples were taken from the exposed excavation sidewalls and bottom sample was collected at 1 foot deep. The samples were Immediately put on ice, jarred, and delivered to Envirotech Inc. for official testing. All samples were analyzed for all constituents listed on Table 1 19.15.29.12 NMAC. The results of this sampling event are provided in the following data table, and a Confirmation Sample Map can be found in Figure 5.

Devon Energy  
Incident ID: NAPP2423962613  
Lea County, NM  
Confirmation Sample Map

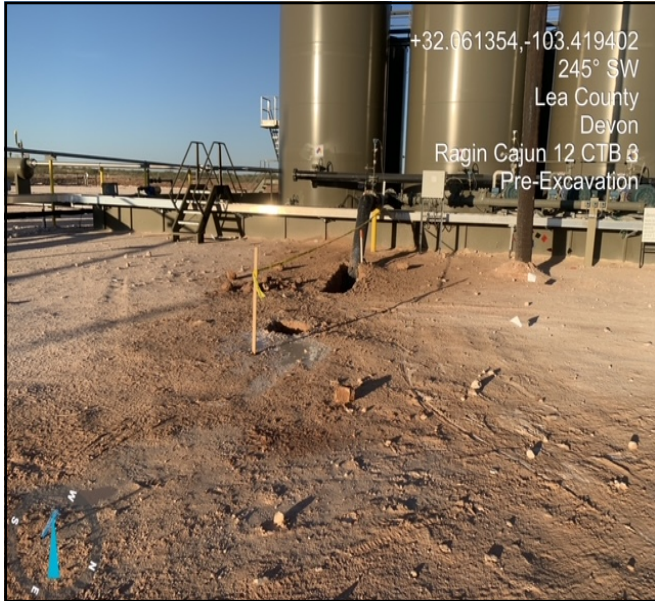
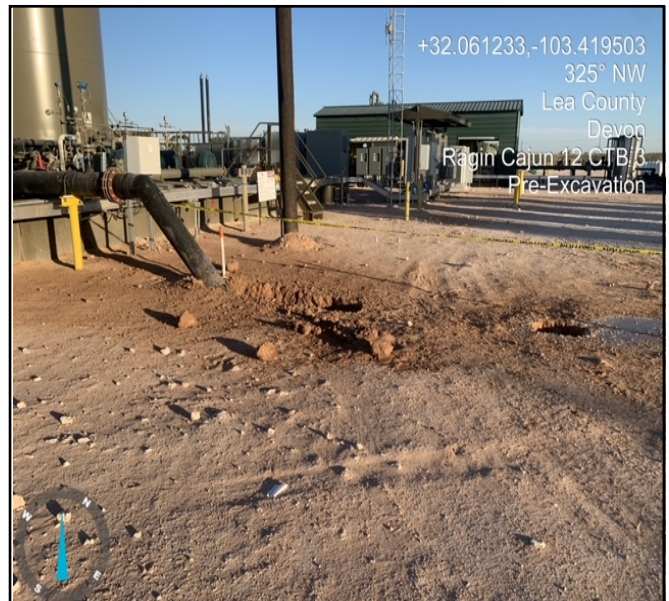
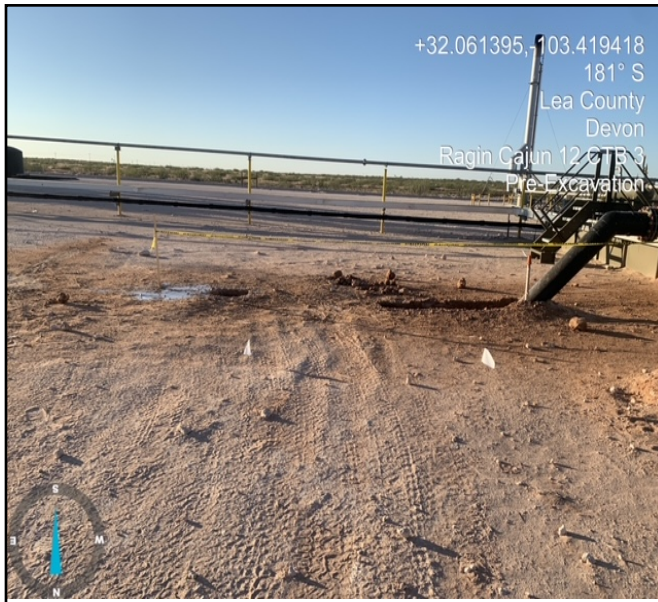
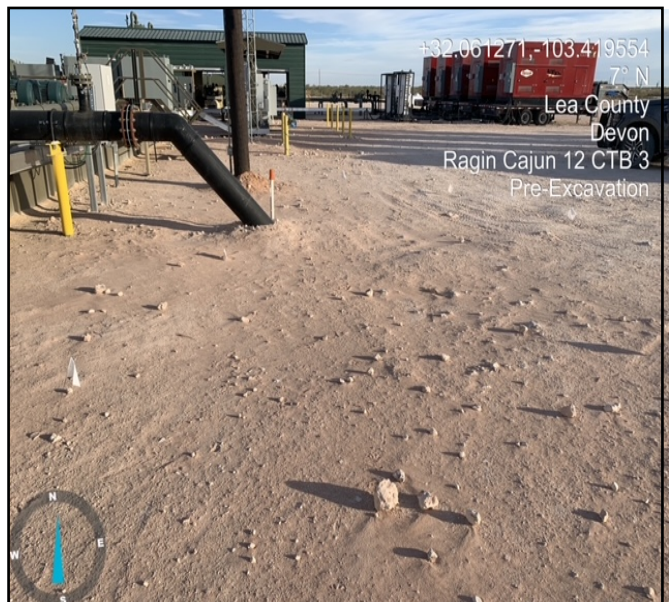
### Pre-Excavation:

Photo taken prior to excavation, taken facing Southwest.

Photo taken prior to excavation, taken facing Northwest.

Photo taken prior to excavation, taken facing South

Photo taken prior to excavation, taken facing North.

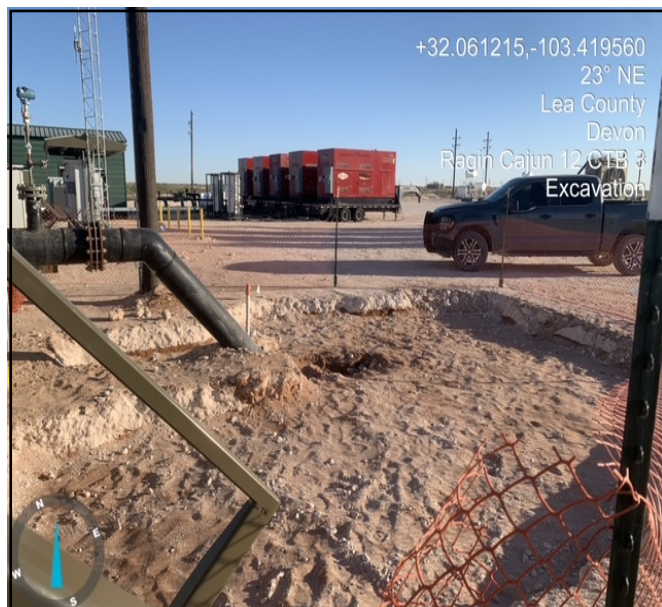
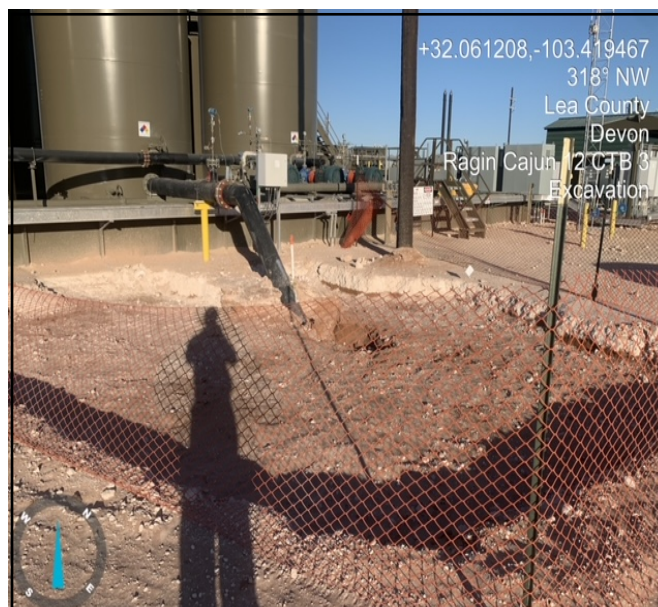
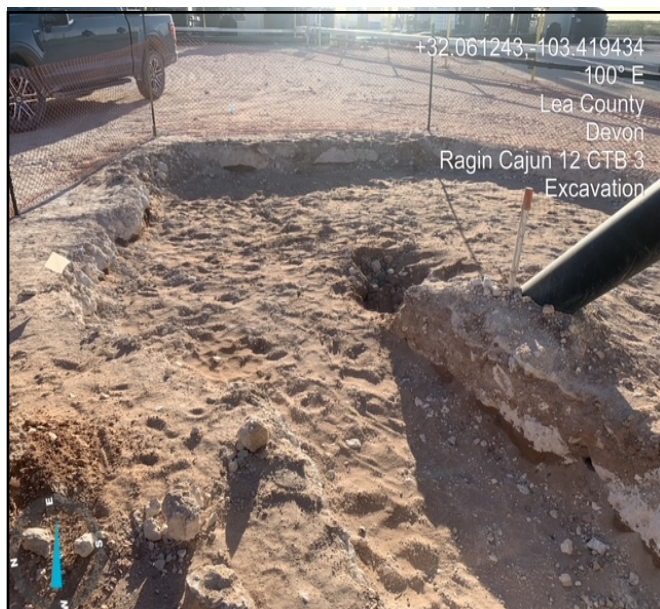
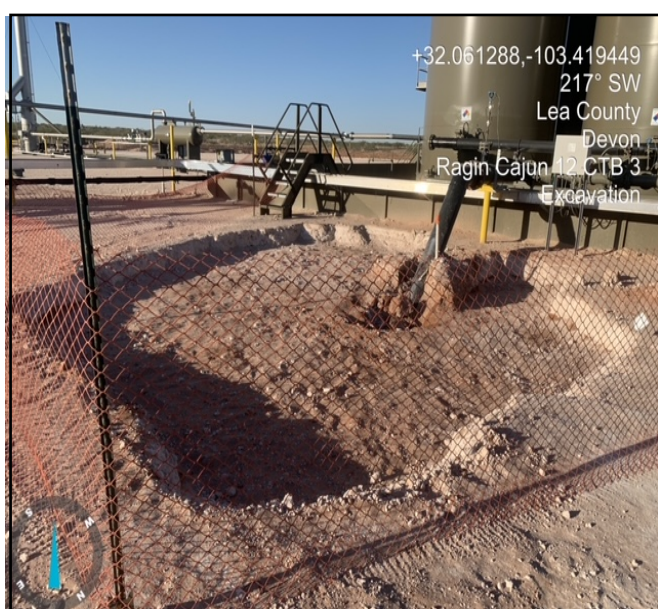
### Excavation:

Pictures taken during excavation, Facing Northeast.

Pictures taken during excavation, Facing Northwest.

Pictures taken during excavation, Facing East.

Pictures taken during excavation, Facing Southwest.

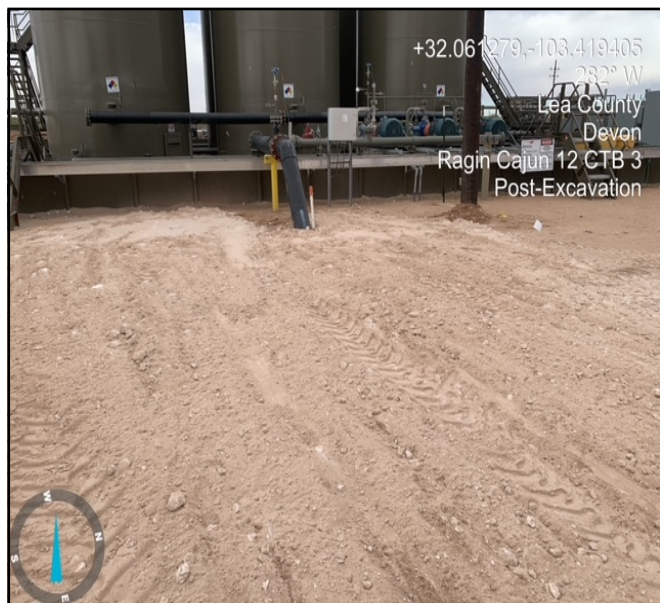
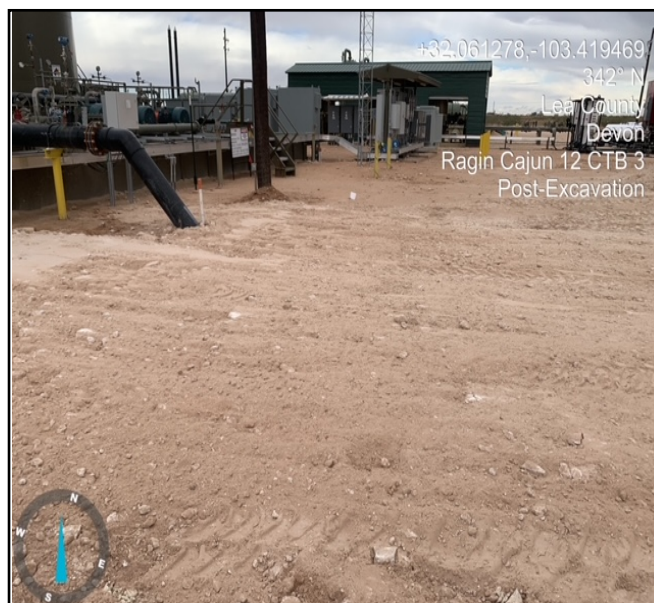
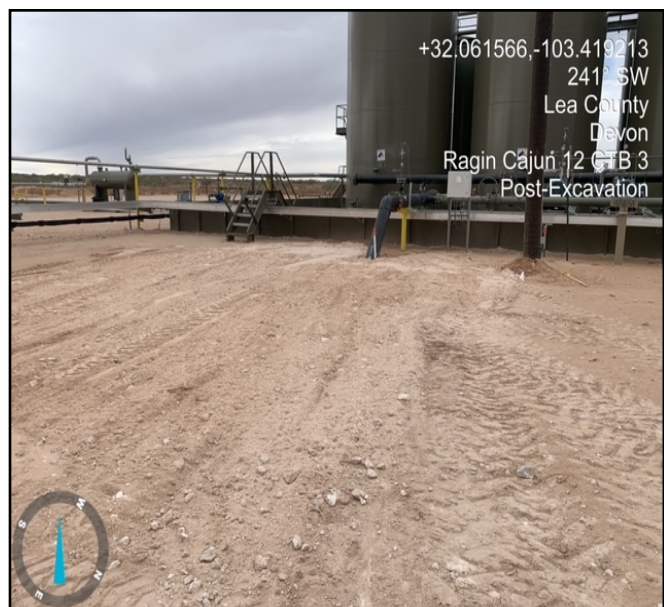
### Post- Excavation:

Photo taken pursuant to excavation, taken facing West.

Photo taken pursuant to excavation, taken facing North

Photo taken pursuant to excavation, taken facing Southwest.

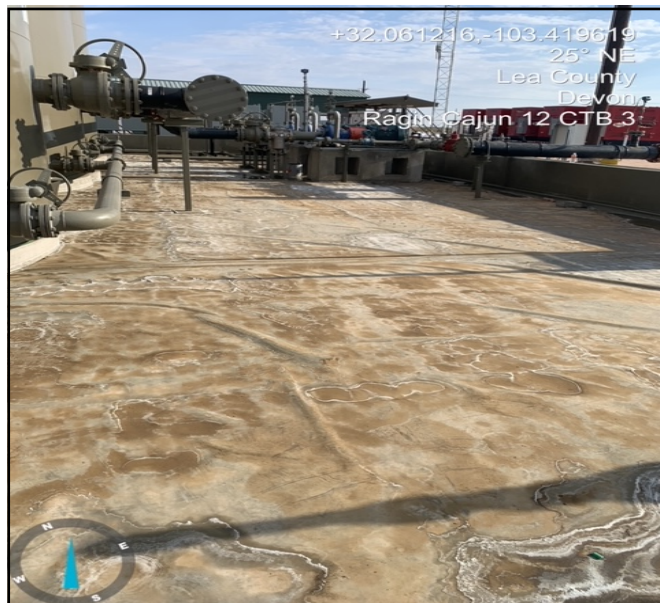
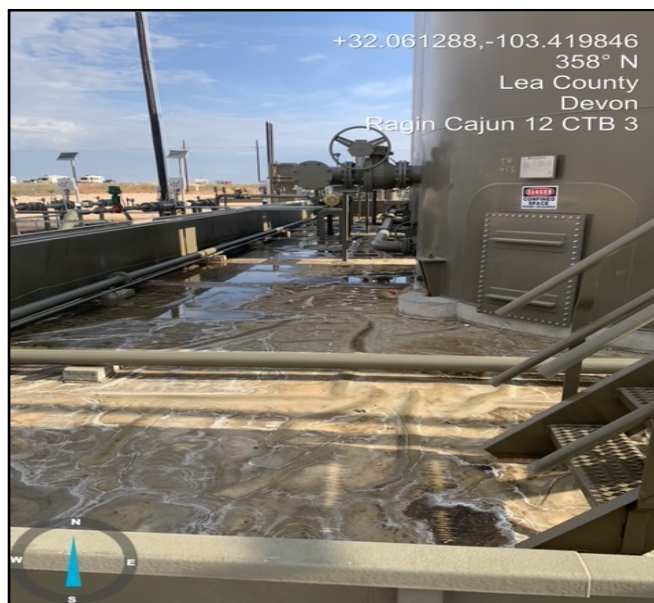
### Intial Liner Inspection:

Photo of liner taken prior to power washing.  
Facing Northeast.

Photo of liner taken prior to power washing.  
Facing North.

**NAPP2423962613:** On September 6, 2024, Pima personnel mobilized equipment to the site to perform power washing of the liner and containment. A vacuum truck accompanied the crew to recover the power washing fluids.

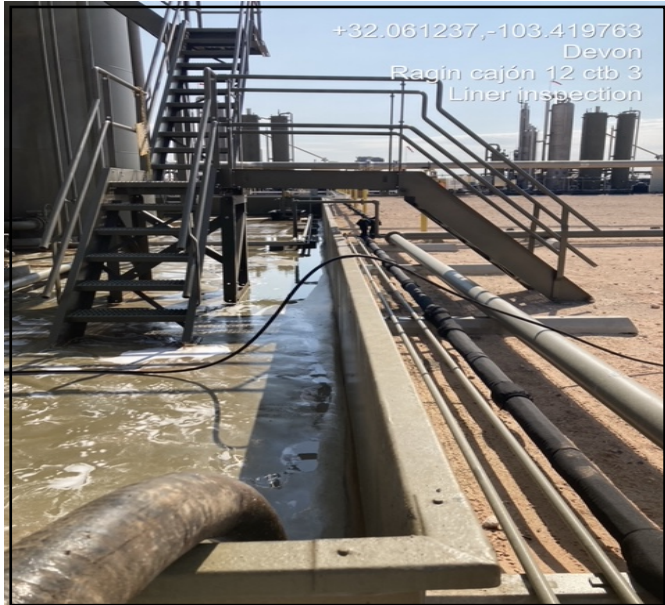
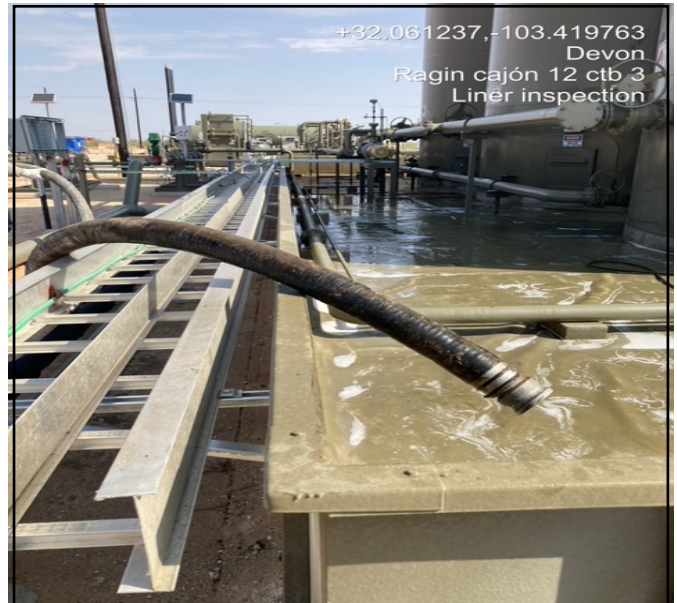
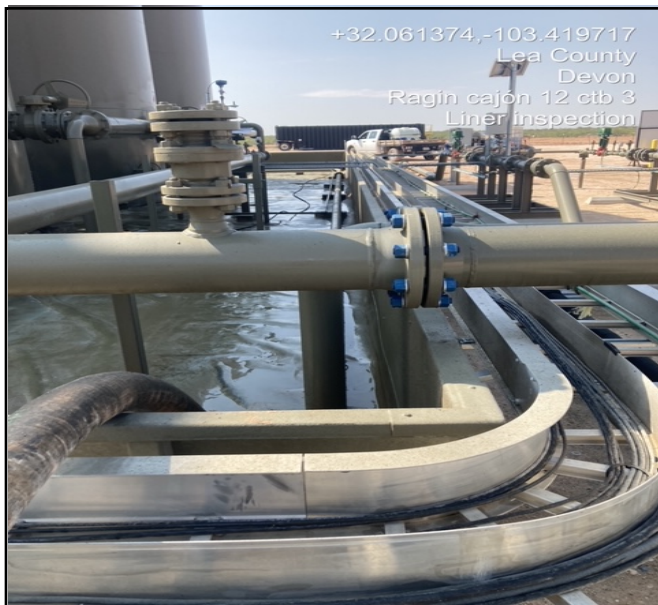
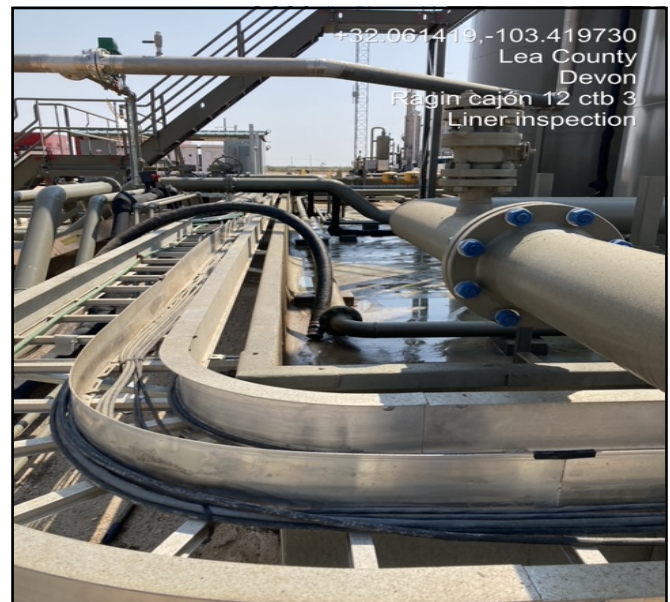
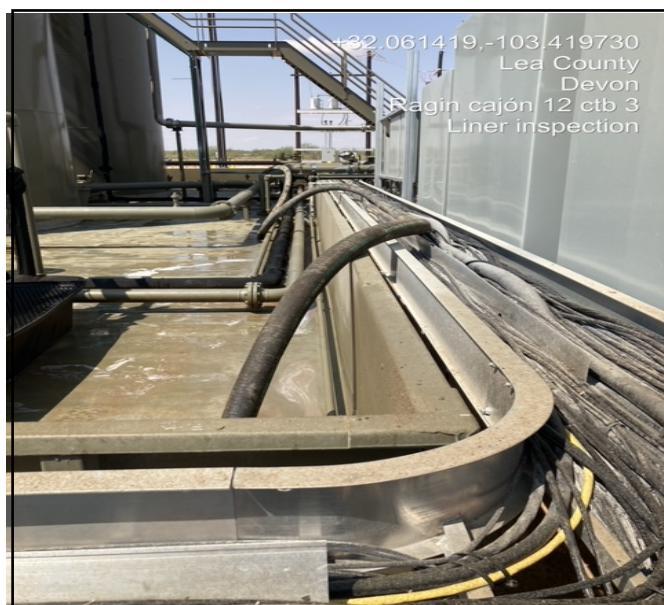
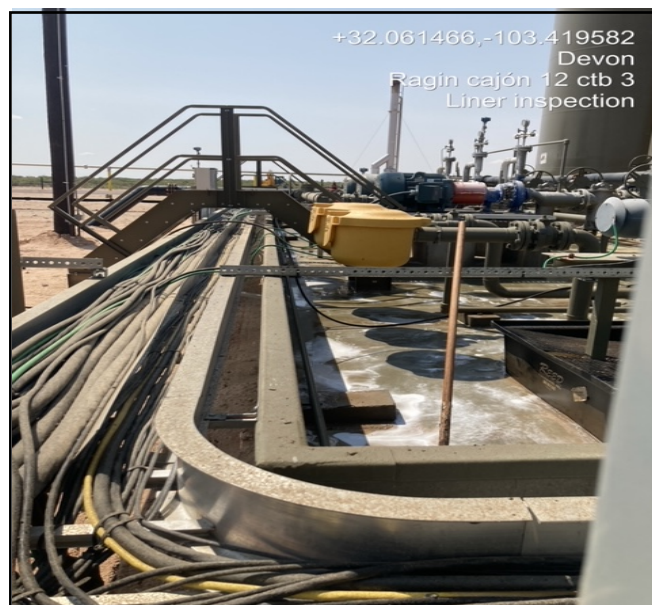
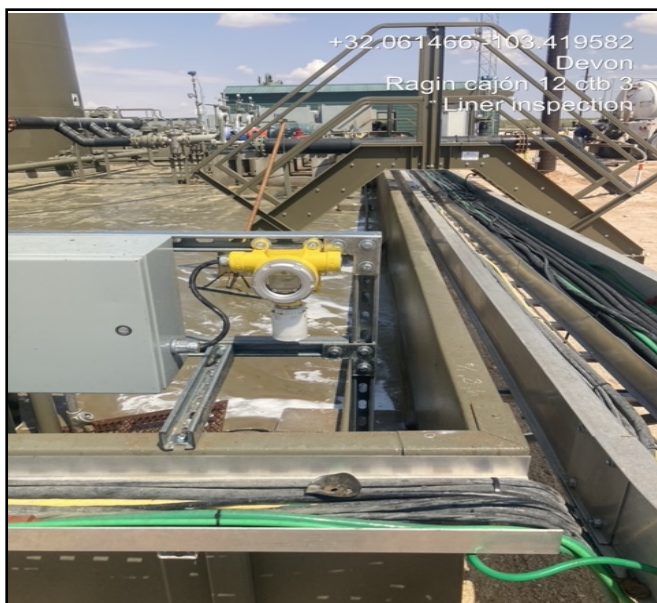
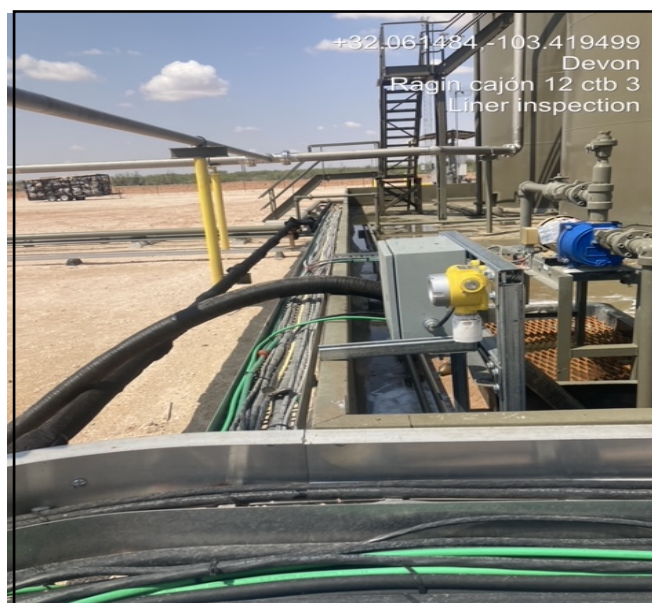
### Liner Inspection:

On September 11, 2024, after submitting the 48-hour notification application ID: 381653 to the OCD, Pima Environmental conducted a liner inspection at this location. Pima concluded that the liner and containment maintained their integrity and successfully retained the fluids. The Liner Inspection Form and Photographic Documentation can be found in Appendix C.

Photo taken pursuant to power washing.

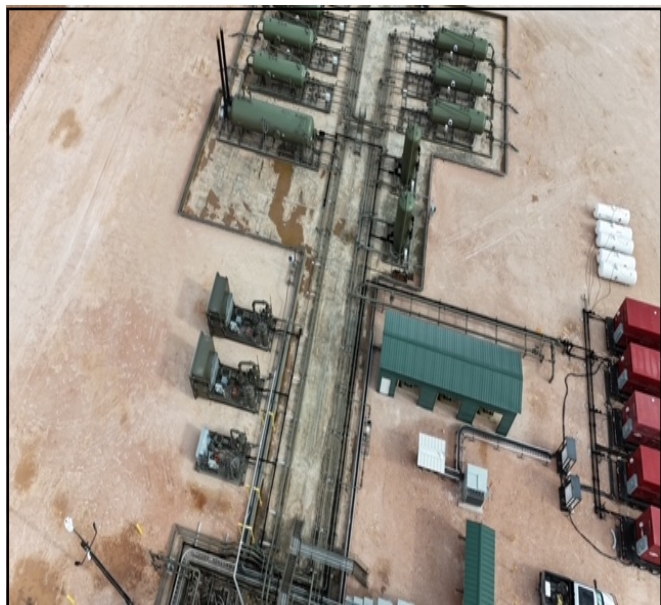
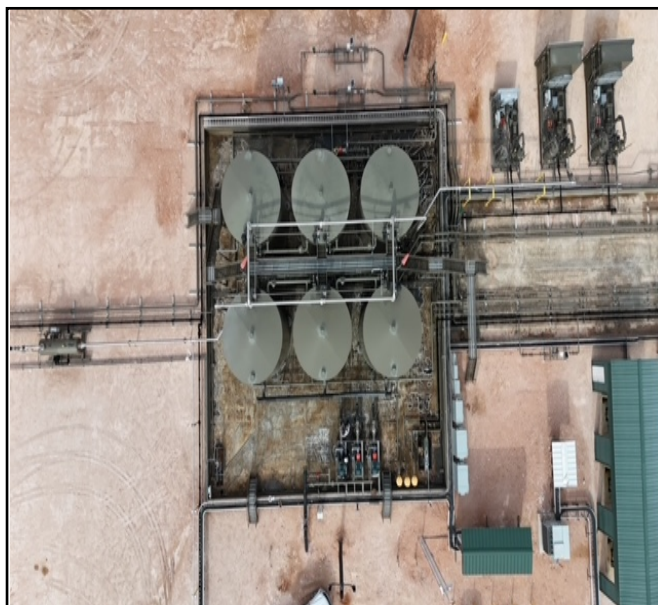
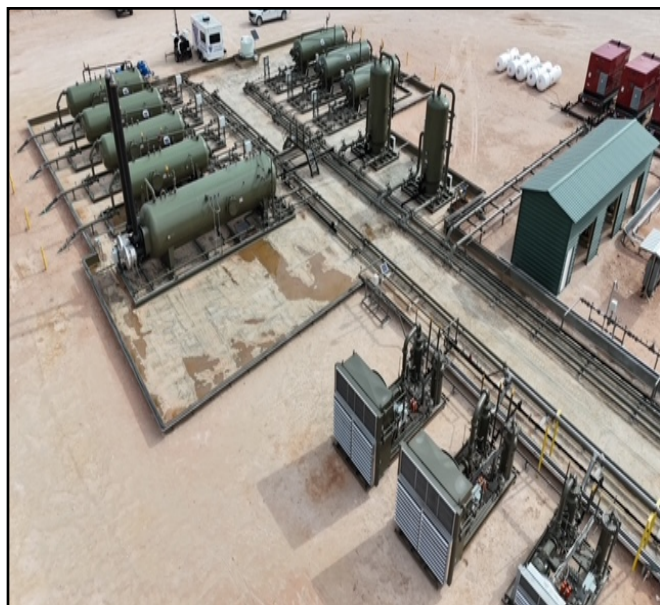
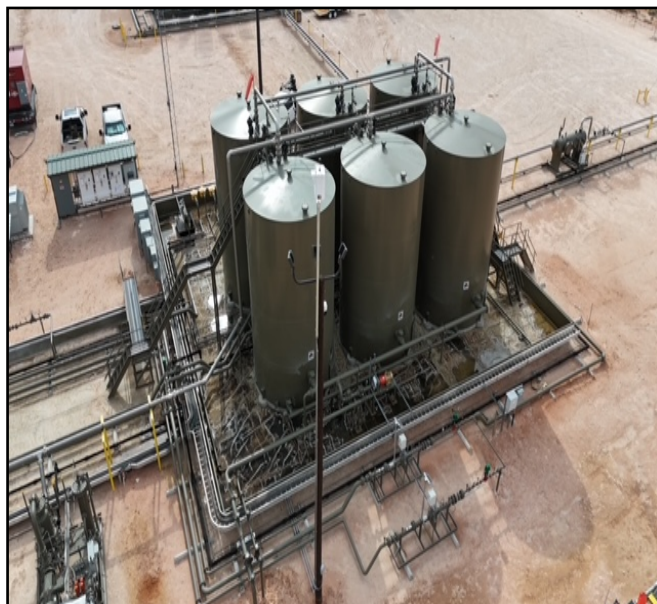
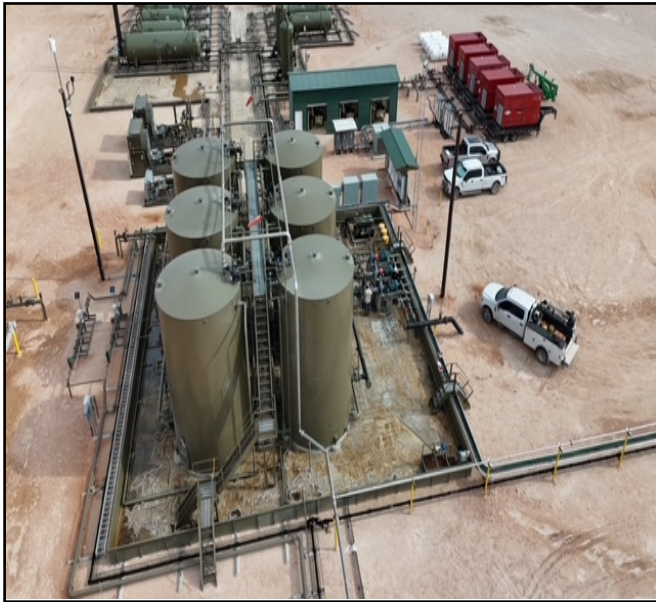
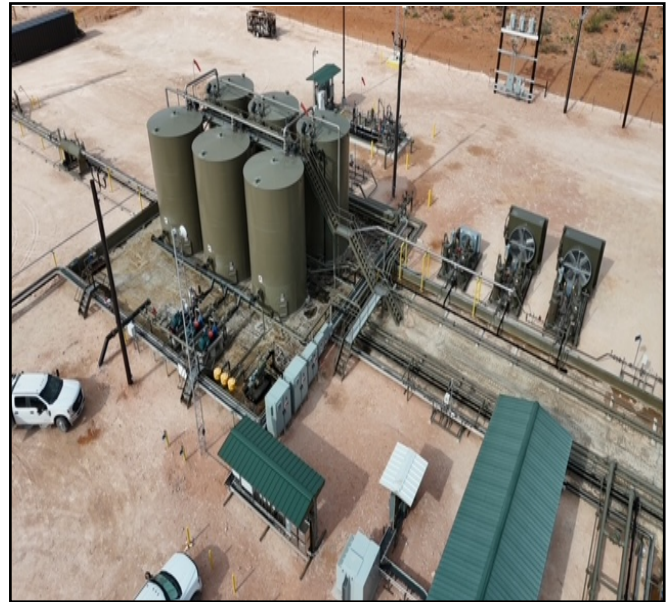
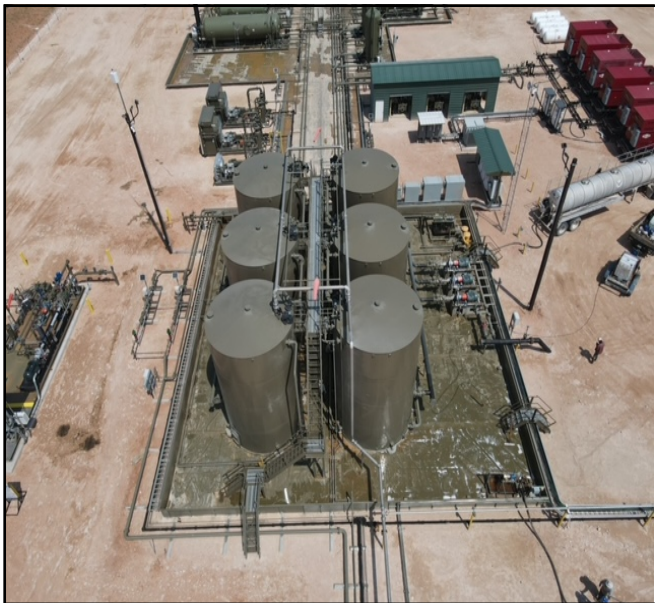
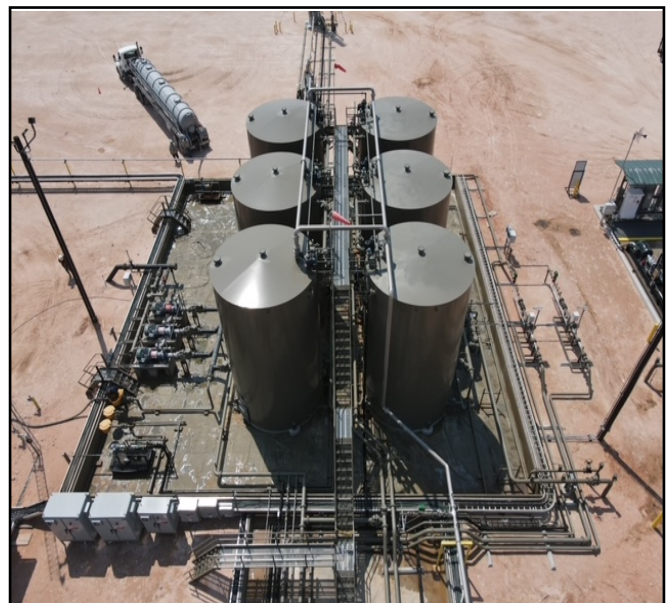
### Aerial Photos:

Aerial photo of liner.
