# GRUMPY CAT 15 CTB 2

## Remediation Summary & Closure Report

NMOCD Incident No. nAPP2113044711  
UL "C", Sec. 15, T23S, R32E  
32.308815, -103.66394  
Lea County, New Mexico

September 16, 2024

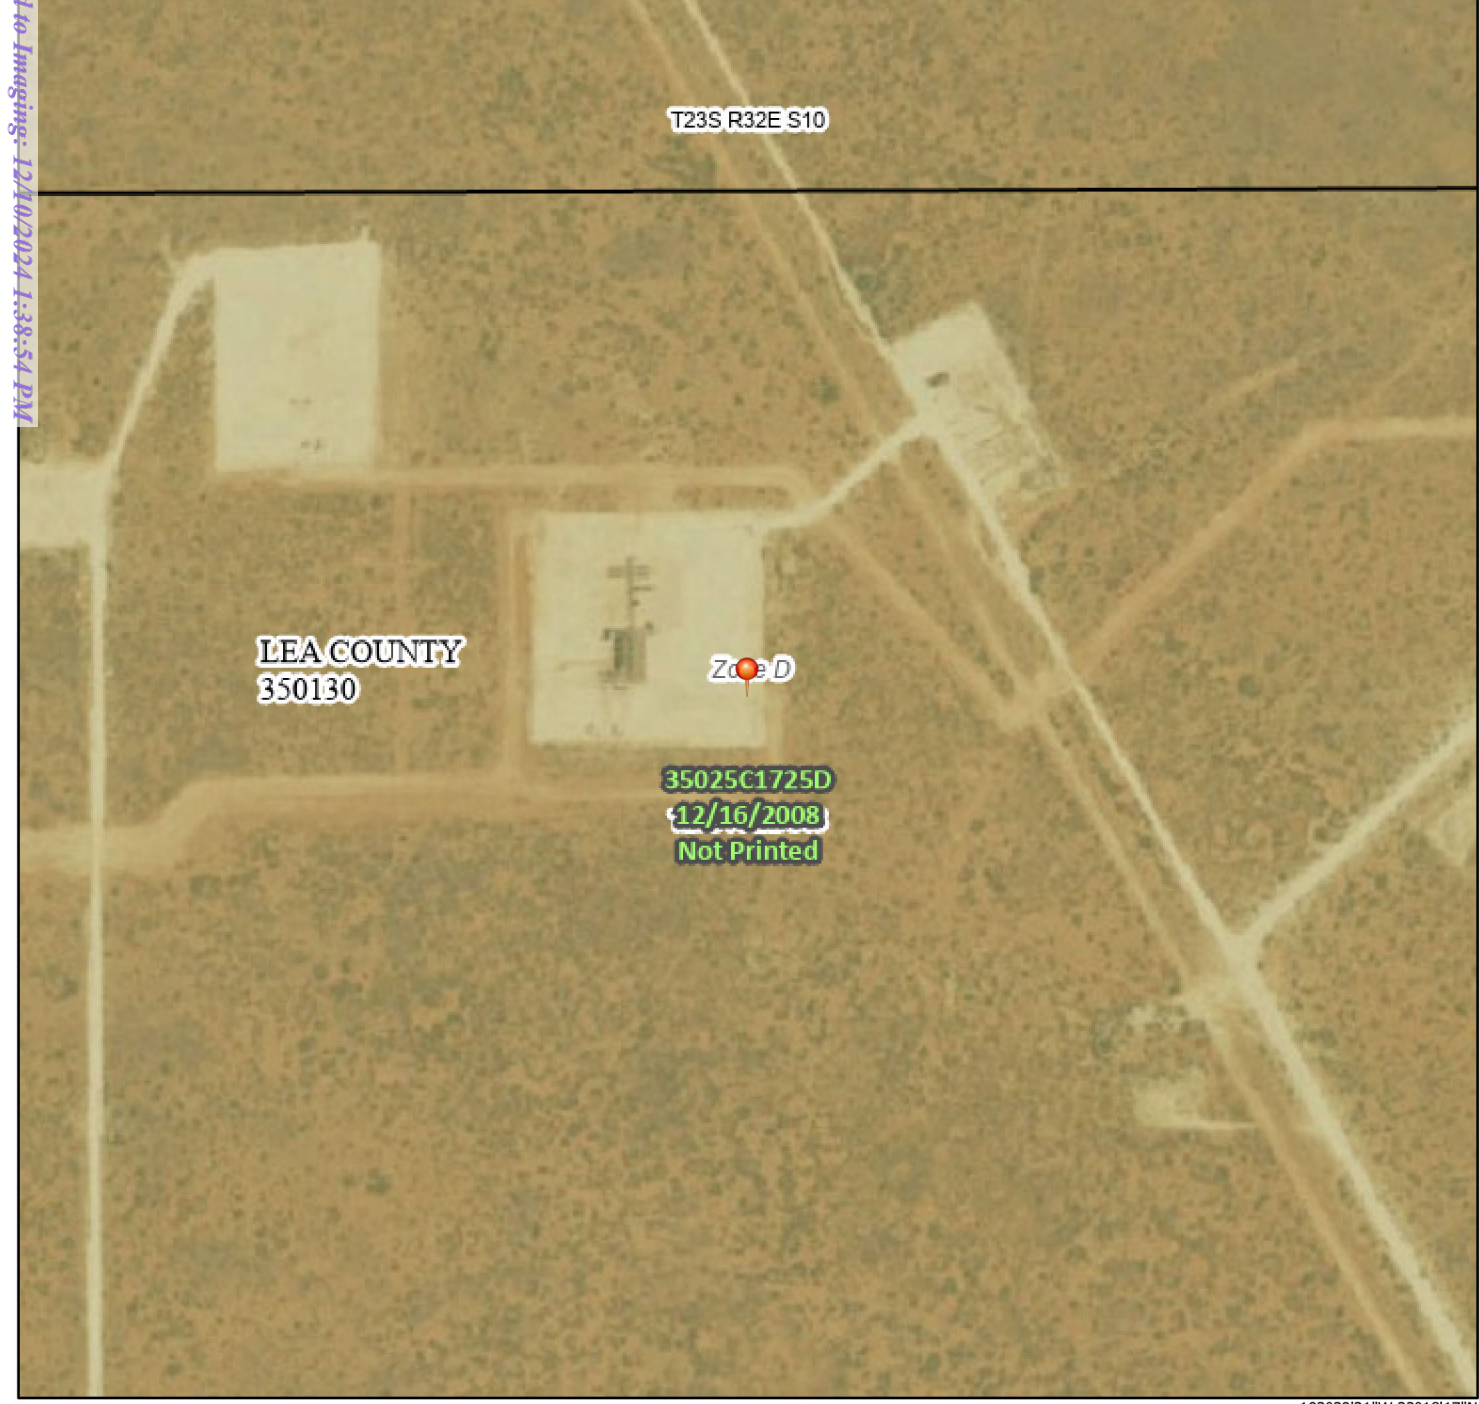
# National Flood Hazard Layer FIRMMette

Review of flood map data published by the Federal Emergency Management Agency (FEMA) indicates the site is not located within a 100-year floodplain. A copy of the FEMA FIRMeTe Map can be found attached as Figure 4.

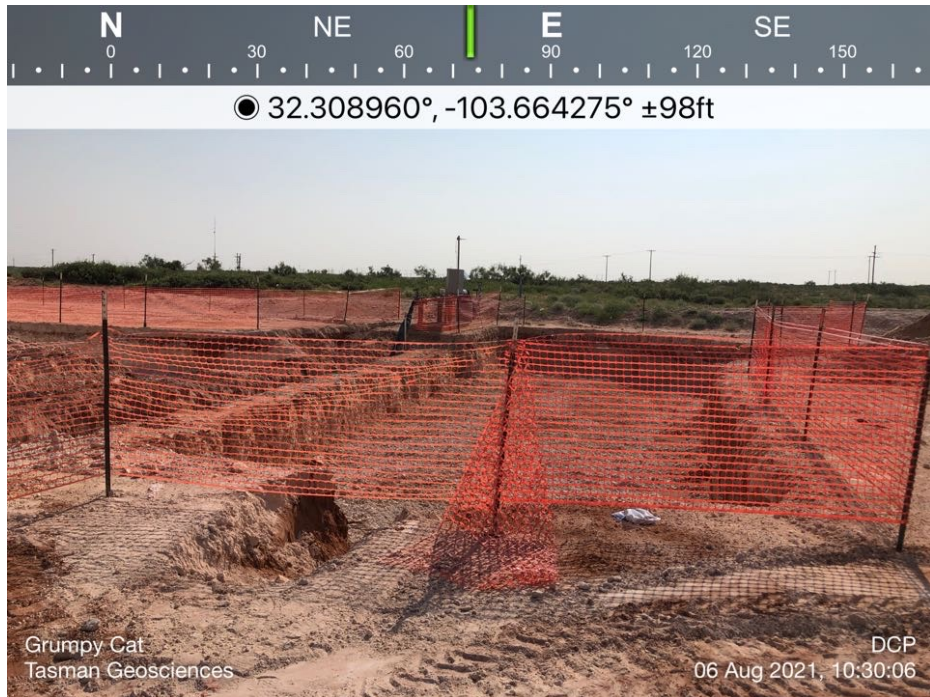
Final Excavation

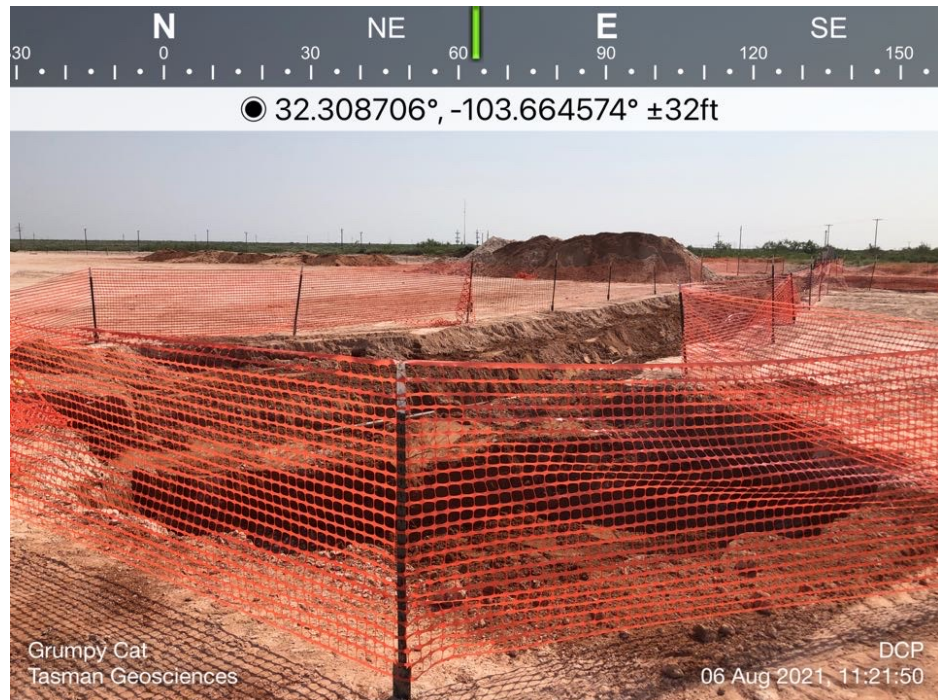
Final Excavation

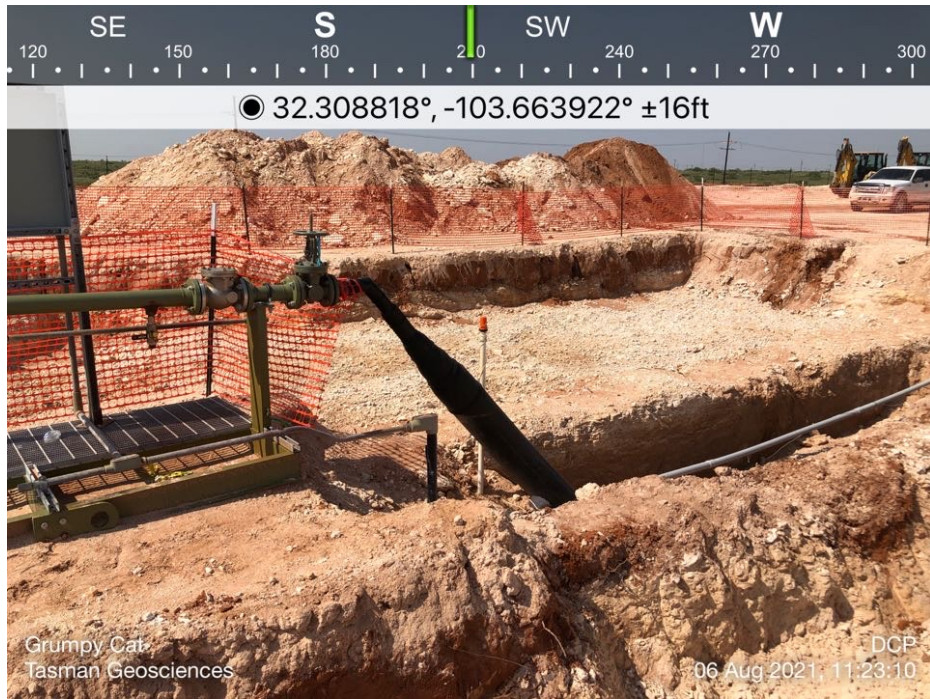
Final Excavation

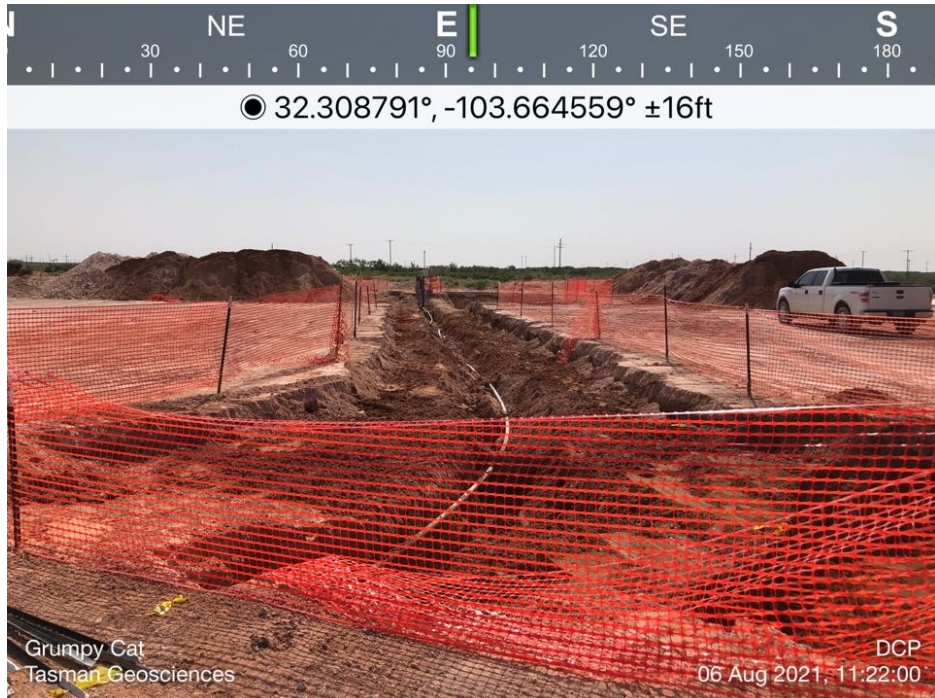
Final Excavation
