**Re: Release Characterization and Closure Request
BTA Oil Producers, LLC
Grama 8817 16-9 Fed Com #5H Tank Battery Release
Unit Letter M, Section 16, Township 22 South, Range 34 East
Lea County, New Mexico
Incident ID# nRM2014056076**

**GRAMA 8817 16-9 FED COM #5H TANK BATTERY
OVERVIEW MAP**

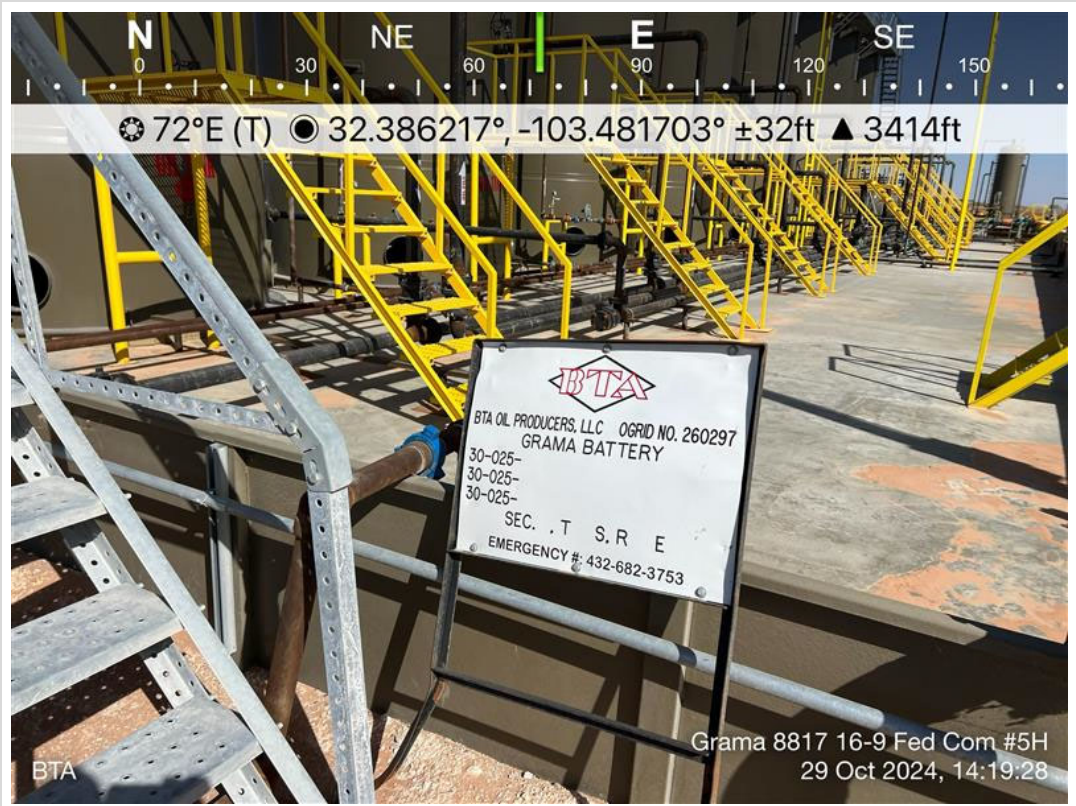
TETRA TECH, INC. PROJECT NO. 212C-MD-03604	DESCRIPTION	Site Signage and Location Information. Adjacent Grama Battery.	1
	SITE NAME	Grama 8817 16-9 Fed Com #5H Tank Battery	10/29/2024

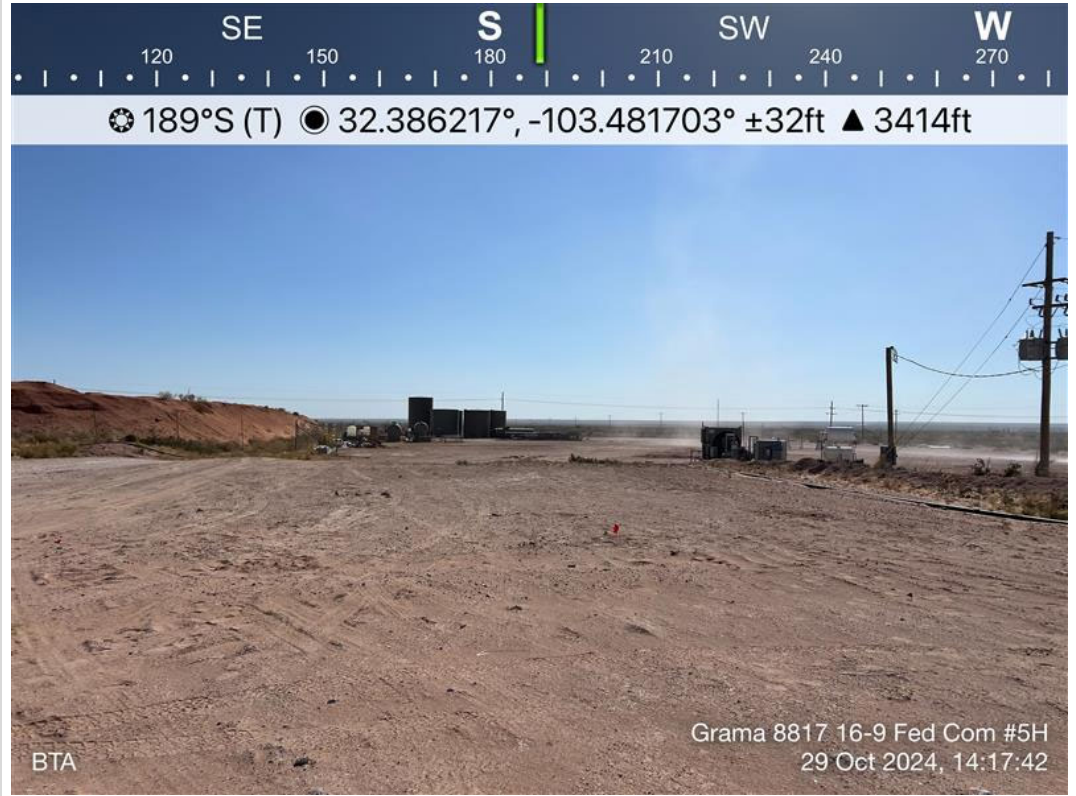
TETRA TECH, INC. PROJECT NO. 212C-MD-03604	DESCRIPTION	View South. Pad area, no visible Surface staining.	2
	SITE NAME	Grama 8817 16-9 Fed Com #5H Tank Battery	10/29/2024

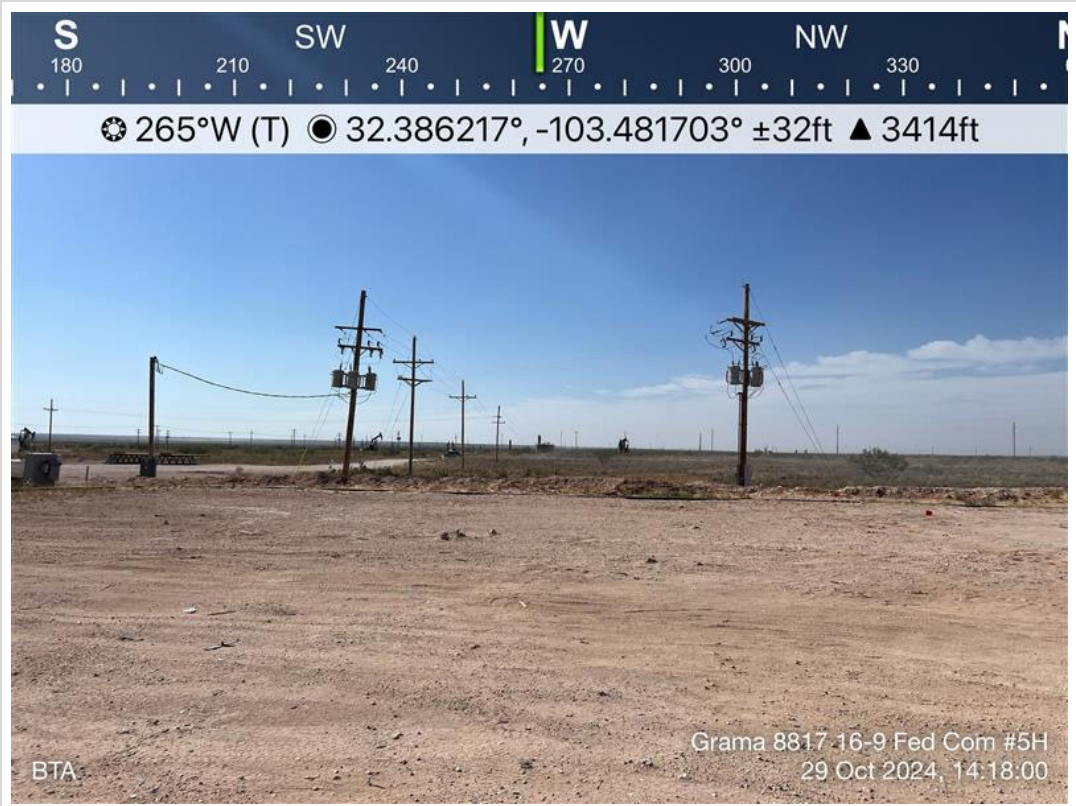
TETRA TECH, INC. PROJECT NO. 212C-MD-03604	DESCRIPTION	View west. Pad area, no visible Surface staining.	3
	SITE NAME	Grama 8817 16-9 Fed Com #5H Tank Battery	10/29/2024

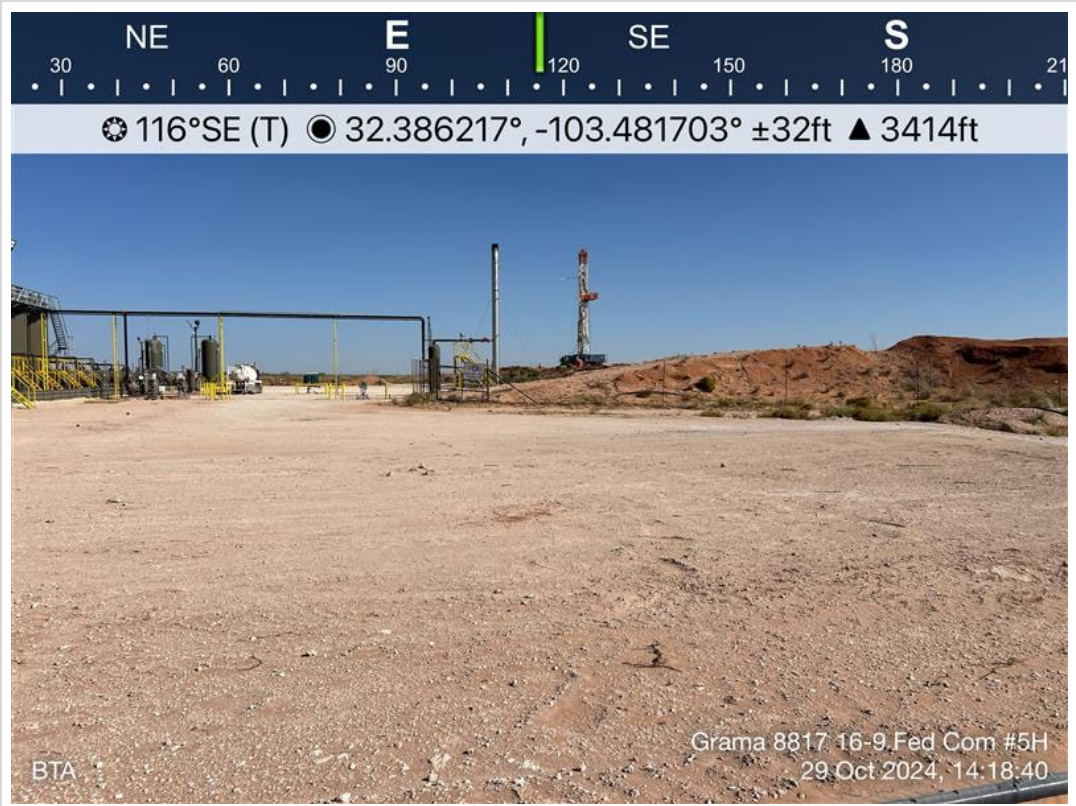
TETRA TECH, INC. PROJECT NO. 212C-MD-03604	DESCRIPTION	View east southeast. Pad area, no visible Surface staining.	5
	SITE NAME	Grama 8817 16-9 Fed Com #5H Tank Battery	10/29/2024

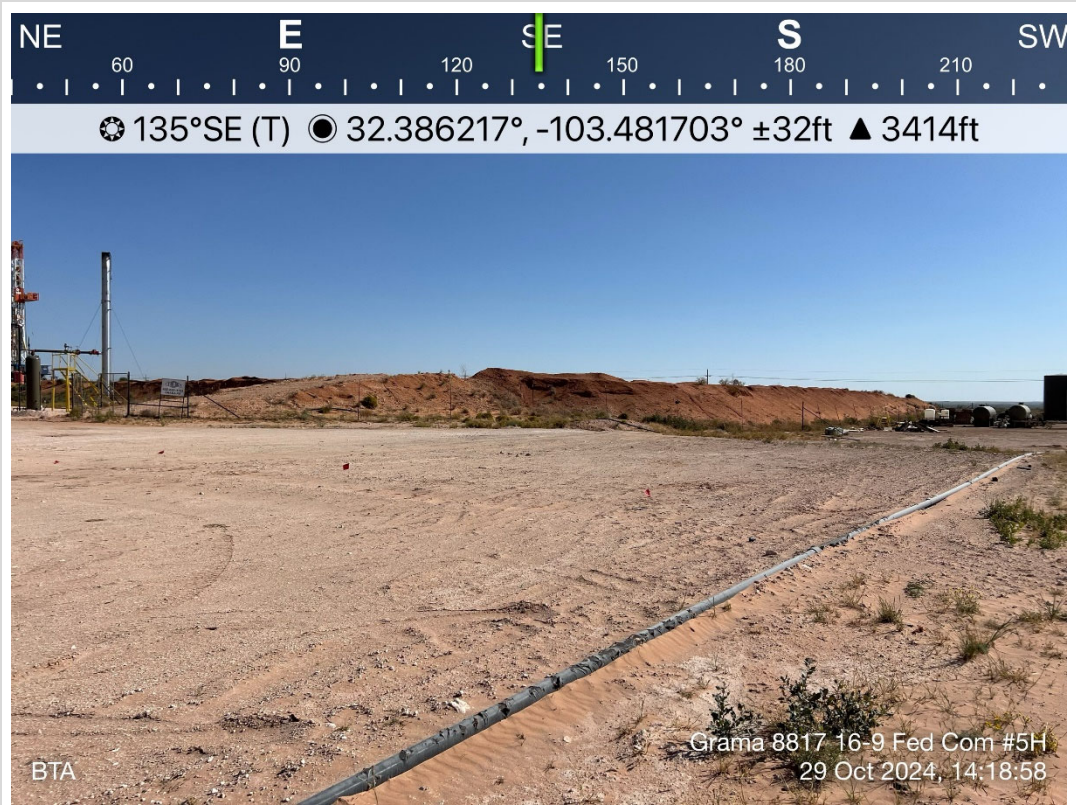
TETRA TECH, INC. PROJECT NO. 212C-MD-03604	DESCRIPTION	View southeast. Pad area, no visible Surface staining.	6
	SITE NAME	Grama 8817 16-9 Fed Com #5H Tank Battery	10/29/2024
