**JMB Transport
Merchant Gap 25 State Com #1H
Closure Report
RP 3405
Section 25, T22S, R34E
Lea County, New Mexico**

December 8, 2014

**JMB Transport
800 West Airport Freeway Suite 1100
Irving, Texas 75062**

**Safety & Environmental Solutions, Inc.
703 East Clinton Street
Hobbs, New Mexico 88240
(575) 397-0510**

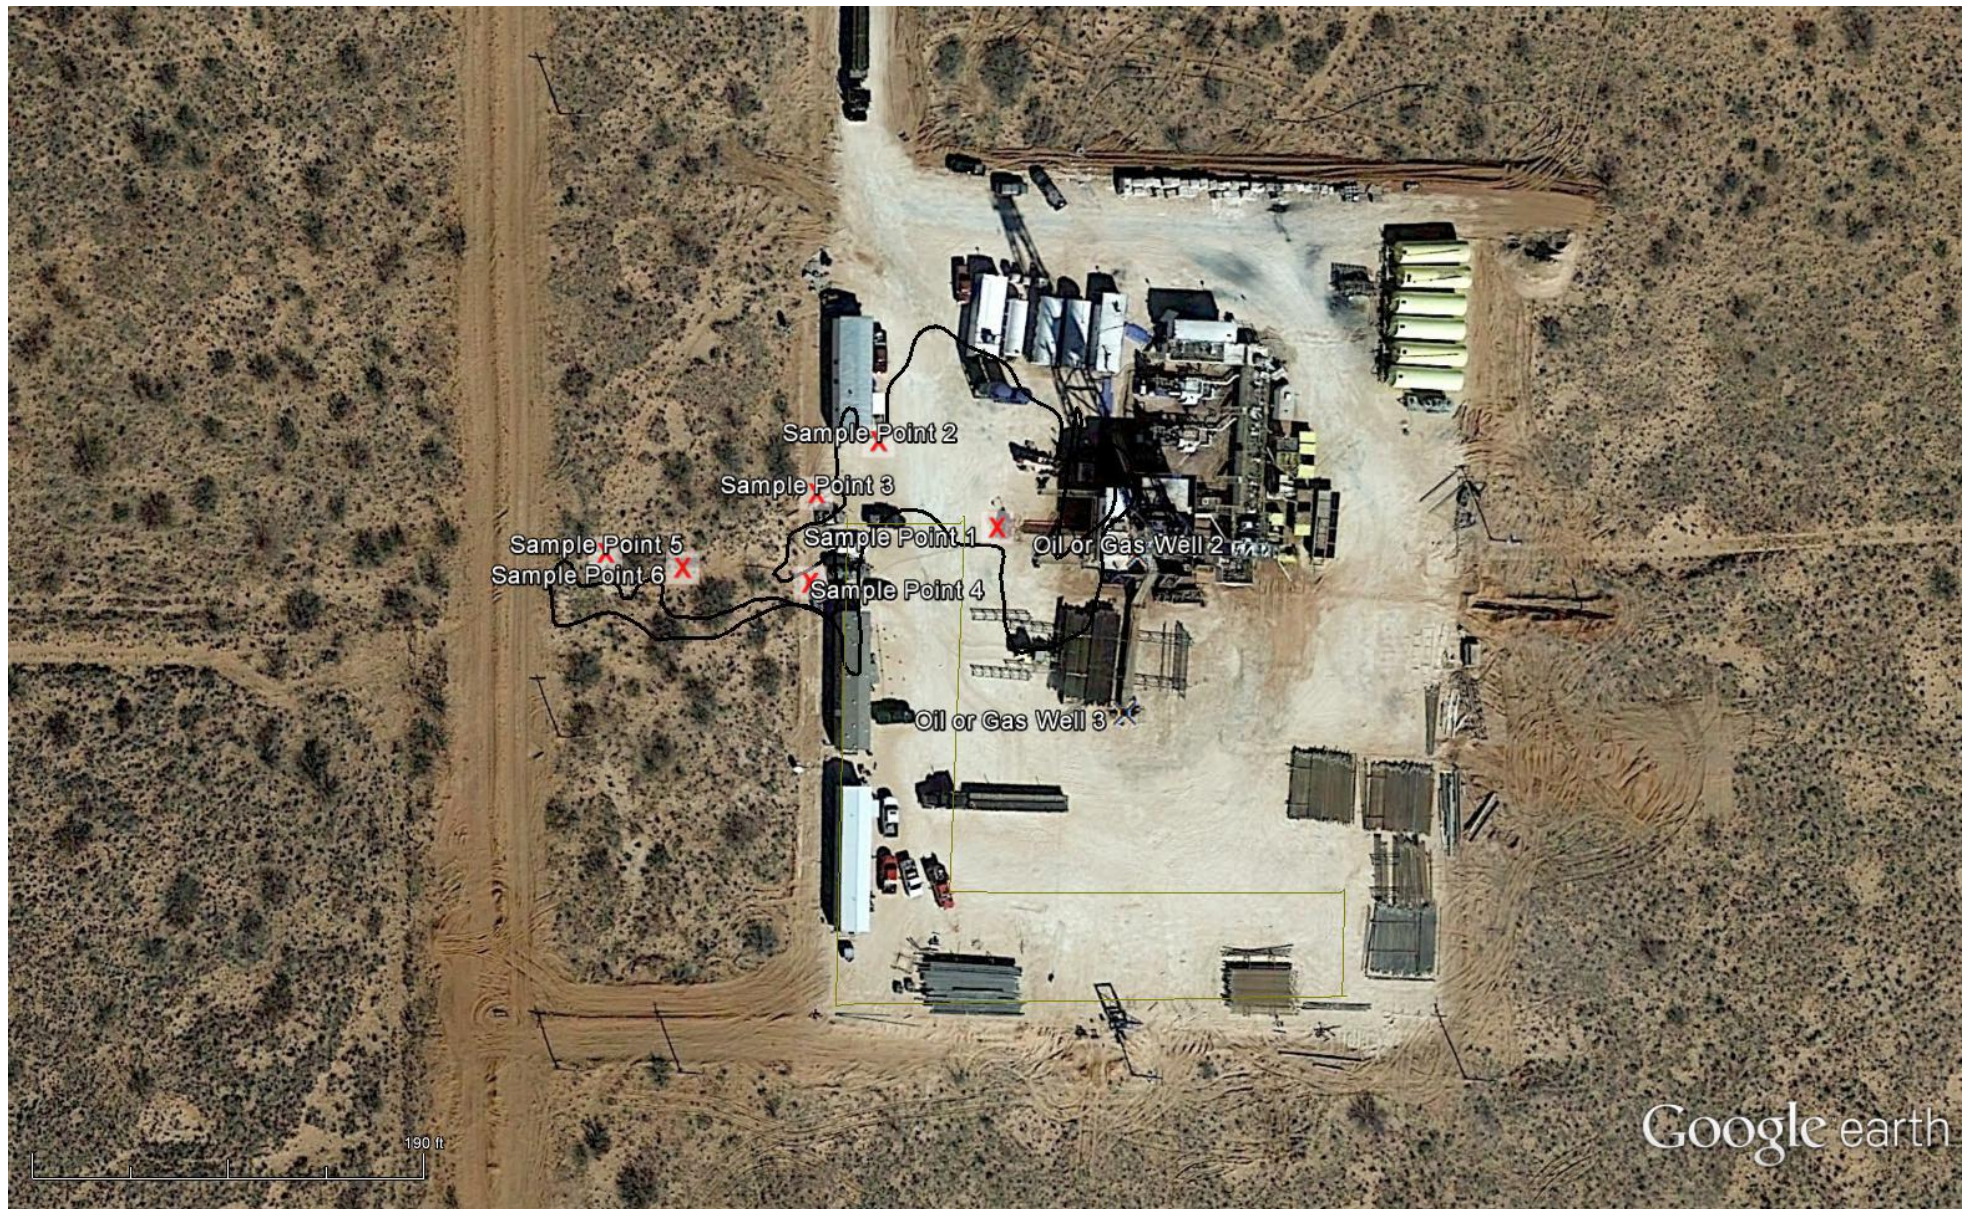
Figure 2 Site Plan

Merchant Gap 25 State Com # 1 H
