**Re: Remediation Work Plan
JRUI 124 Battery
Incident Number nAPP2428369219
Eddy County, New Mexico**

XTO Energy, Inc.
Remediation Work Plan
JRU 124 Battery

XTO Energy, Inc
JRU 124 Battery
Incident Number: nAPP2428369219
Unit F, Section 17, T 23S, R 31E
Eddy County, New Mexico

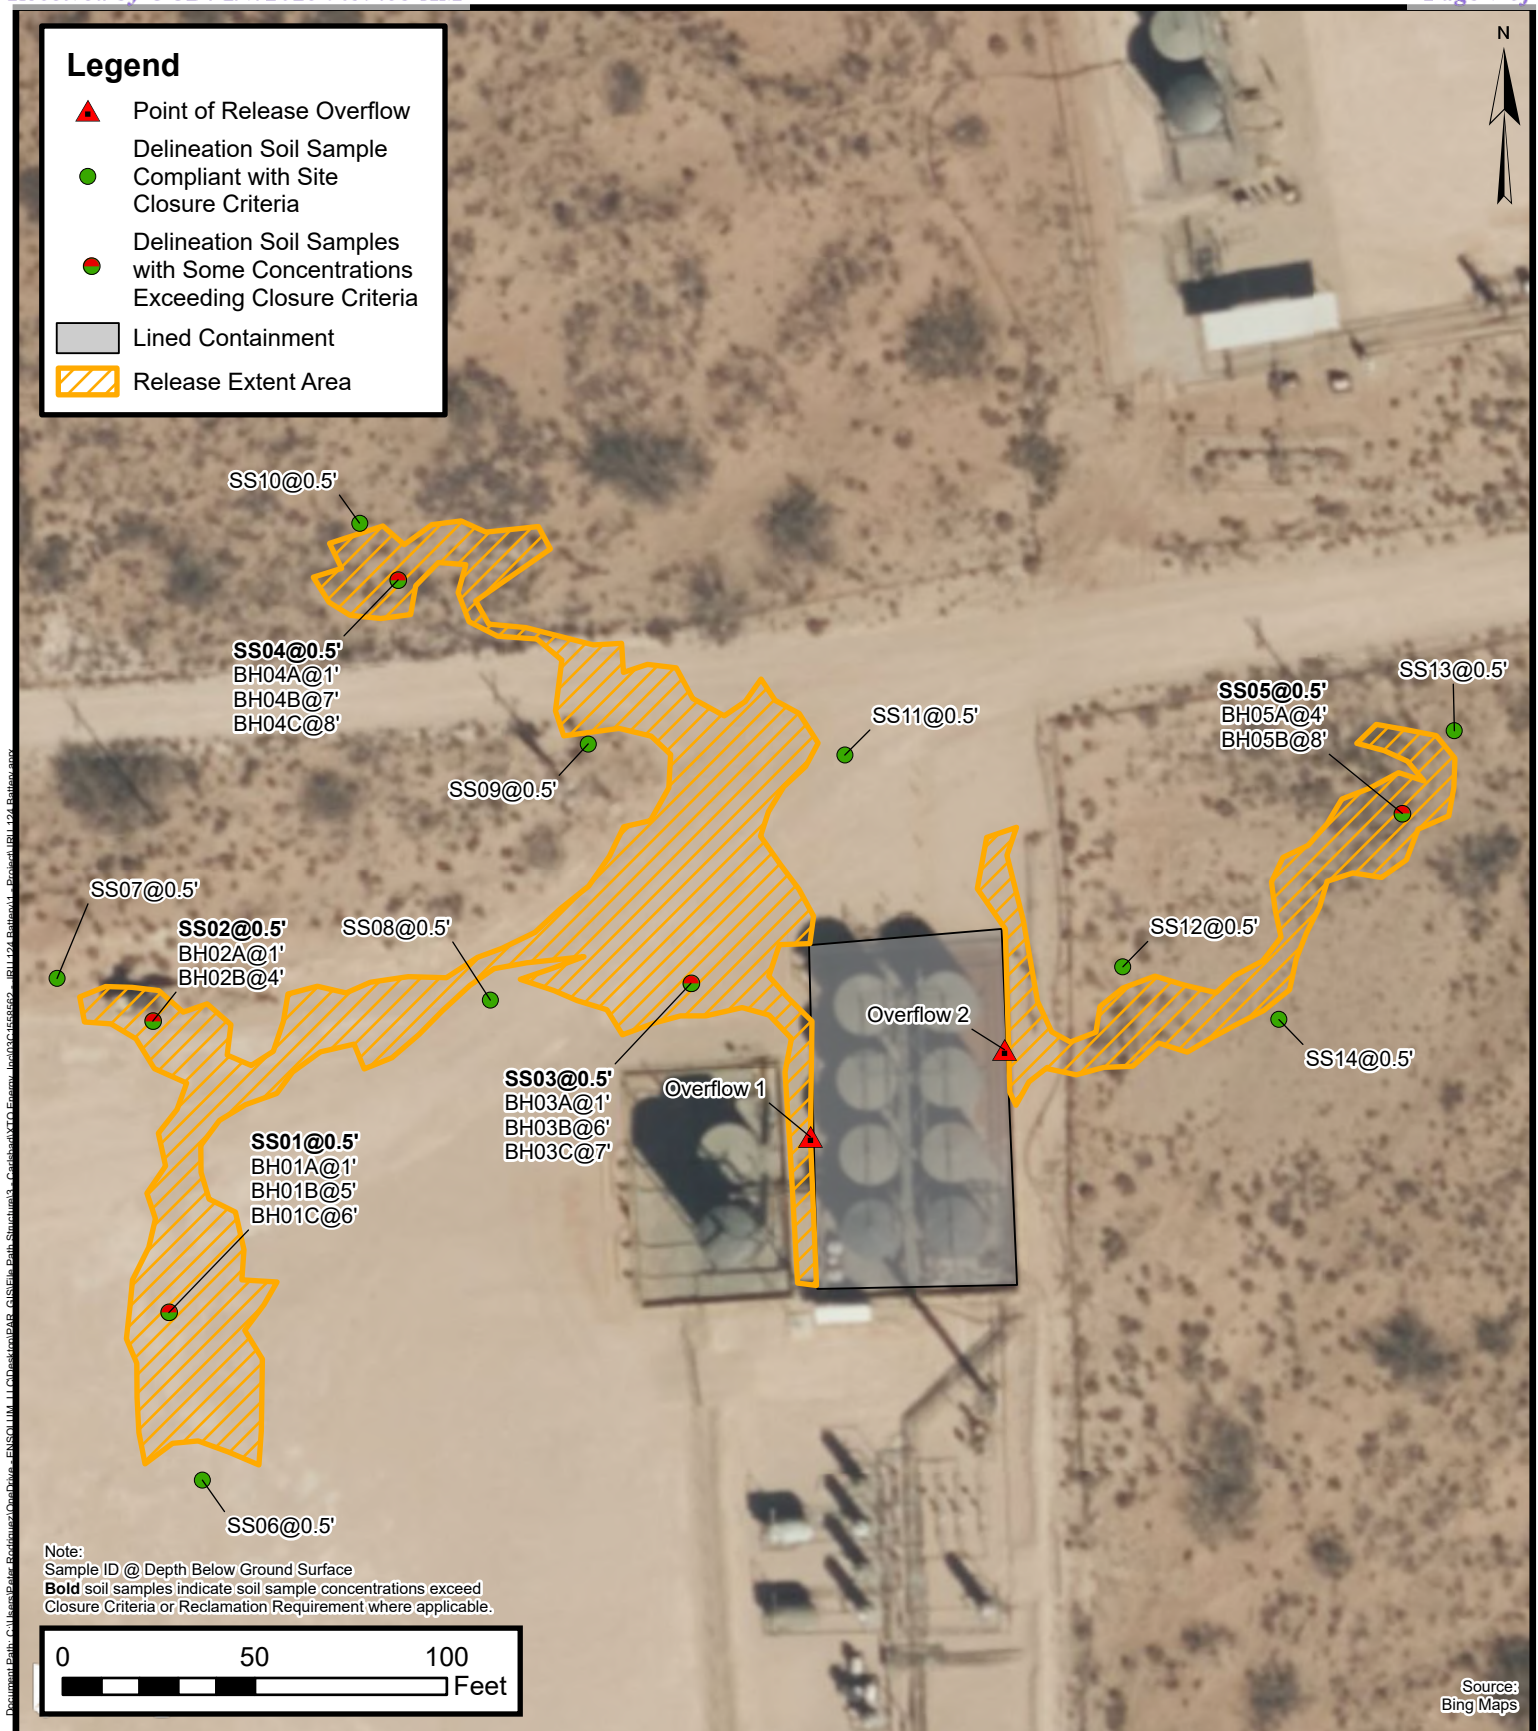
FIGURE
2

Delineation Soil Sample Locations

On October 25, 2024, Ensolum personnel conducted a site assessment to evaluate the release extent based on information provided on the C-141 and visual observations. Ensolum personnel collected five discrete delineation soil samples (SS01 through SS05) within the release extent from a depth of 0.5 feet bgs to assess soil impacts caused by the release. The soil samples were field screened for volatile organic compounds (VOCs) utilizing a calibrated photoionization detector (PID) and chloride using Hach® chloride QuanTab® test strips. The release extent and delineation soil sample locations were mapped utilizing a handheld Global Positioning System (GPS) unit and are depicted on Figure 2.

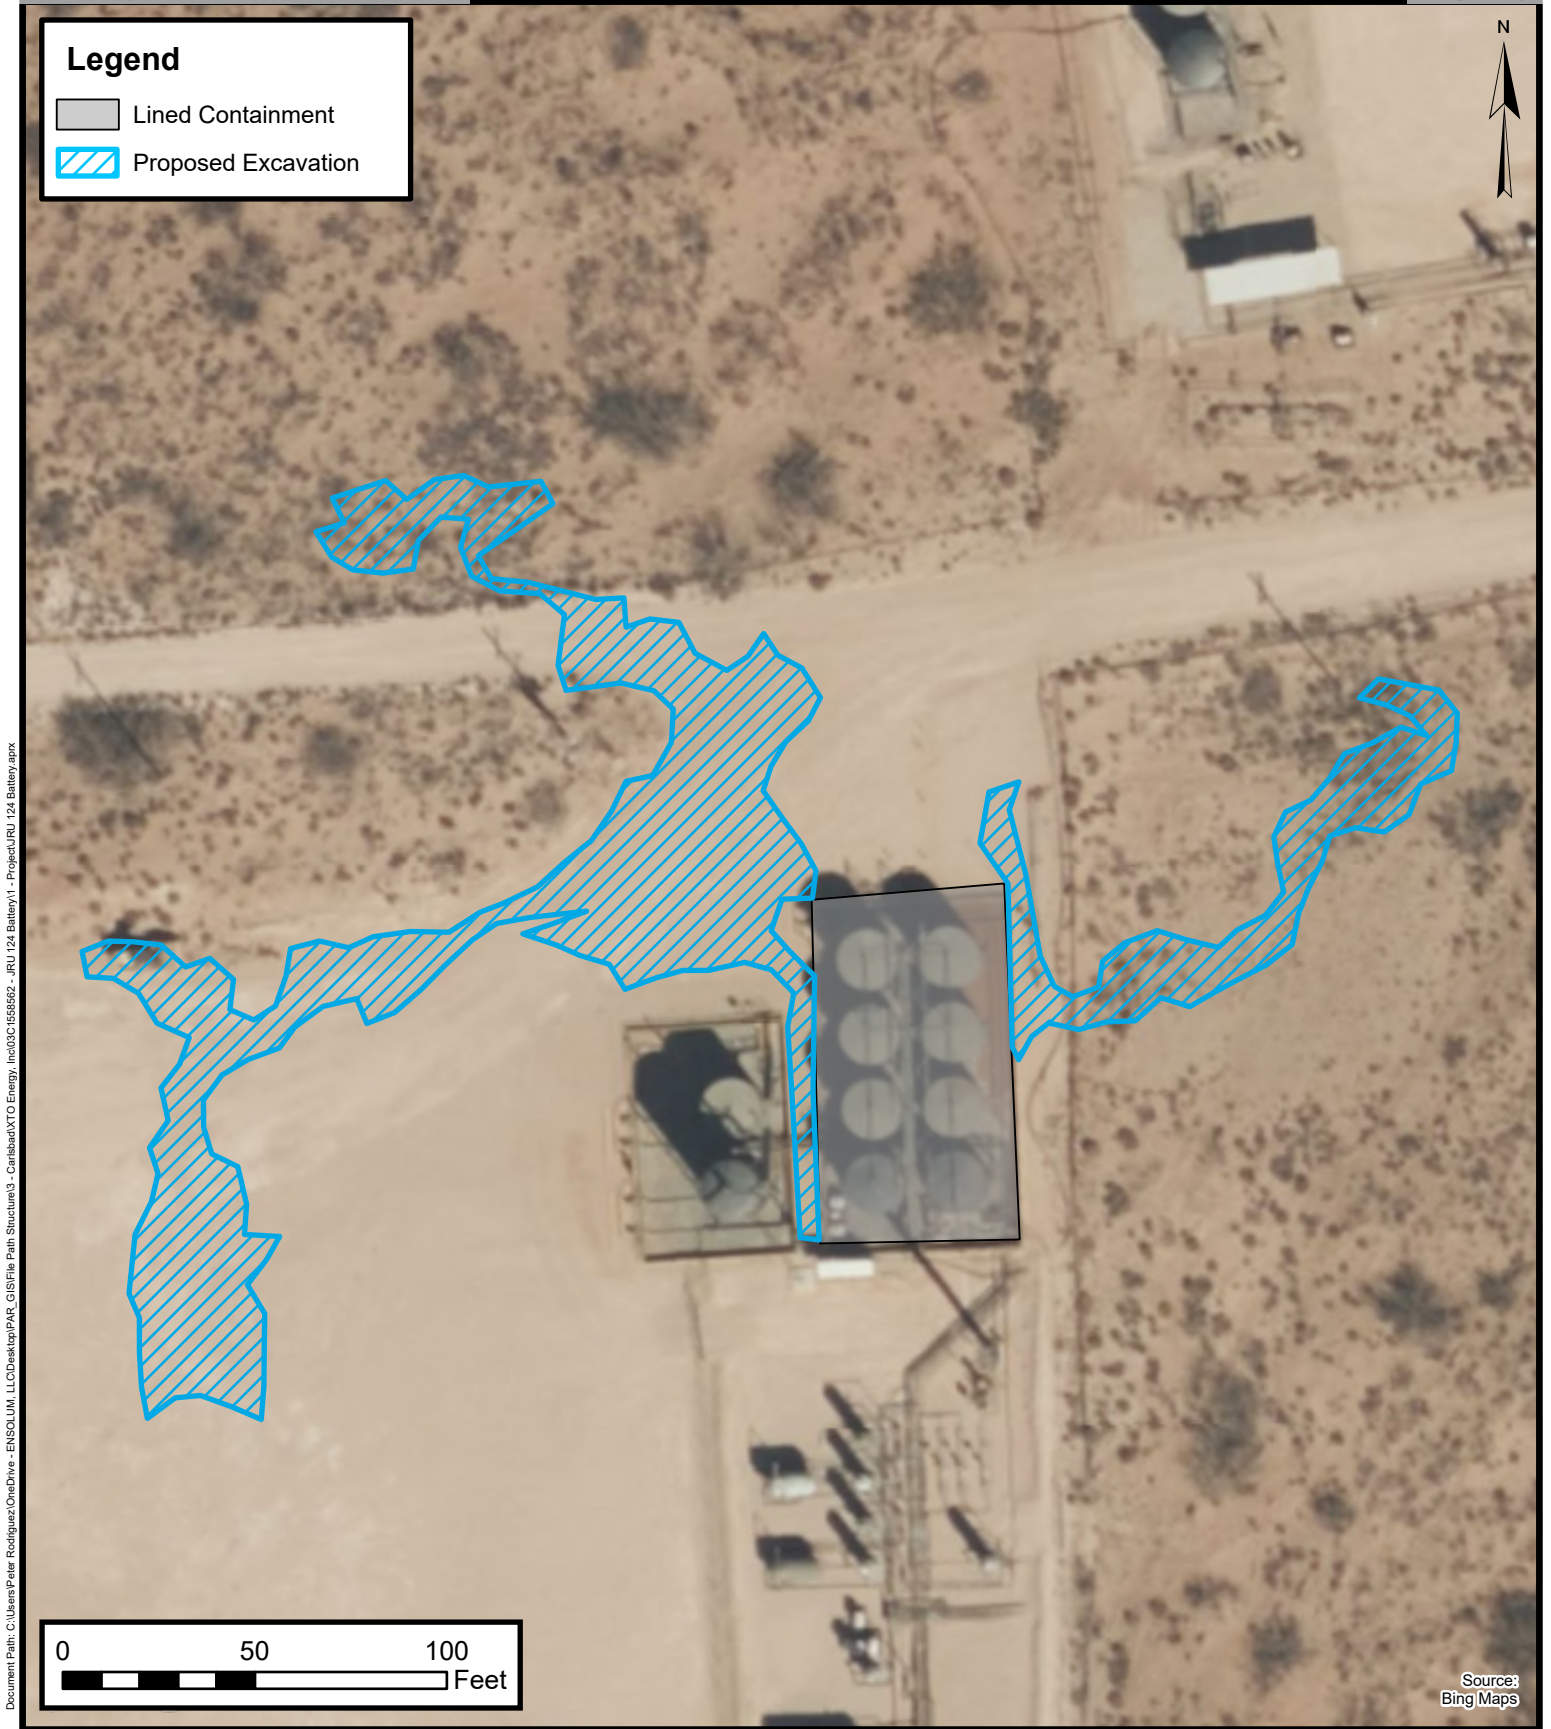
Proposed Excavation Extent

Ensolum, LLC (Ensolum), on behalf of XTO Energy, Inc. (XTO), has prepared the following *Remediation Work Plan (Work Plan)* to document site assessment and delineation activities completed to date and propose a work plan to address impacted soil identified at the JRUI 124 Battery (Site). The purpose of the site assessment and delineation activities was to delineate the lateral and vertical extent of impacted soil resulting from a release of crude oil and produced water at the Site. The following *Work Plan* proposes to excavate impacted soil within the top 4 feet of the release extent.

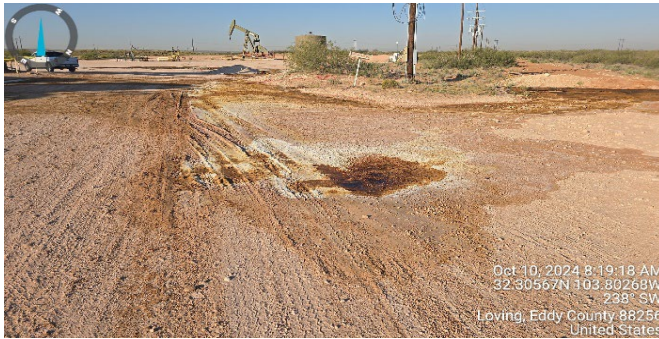
Photograph: 1 Date: 10/10/2024
Description: Release extent area near pad entrance.
View: Southwest

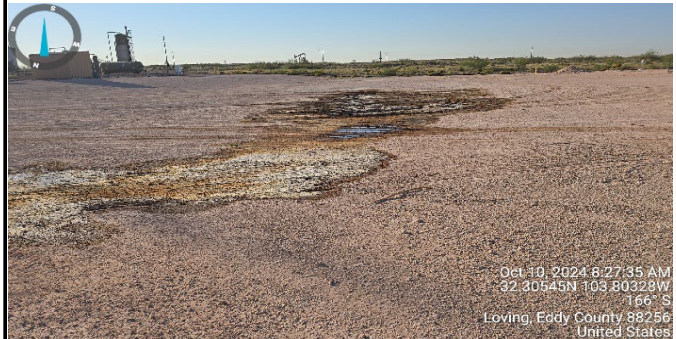
Photograph: 2 Date: 10/10/2024
Description: Release extent area on pad.
View: South

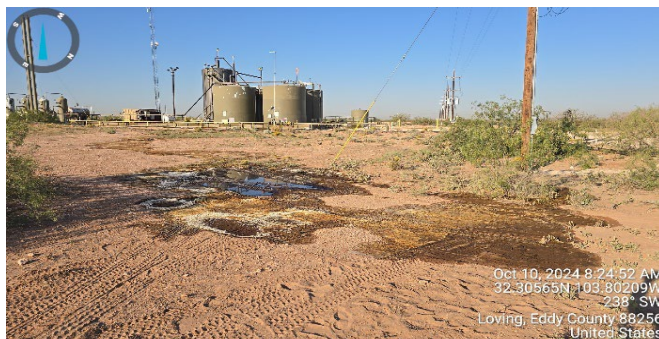
Photograph: 3 Date: 10/10/2024
Description: Release extent area in pasture.
View: Southwest

- The excavation will be backfilled and recontoured to match pre-existing condition and the pasture area will be reseeded with a BLM-approved seed mixture.

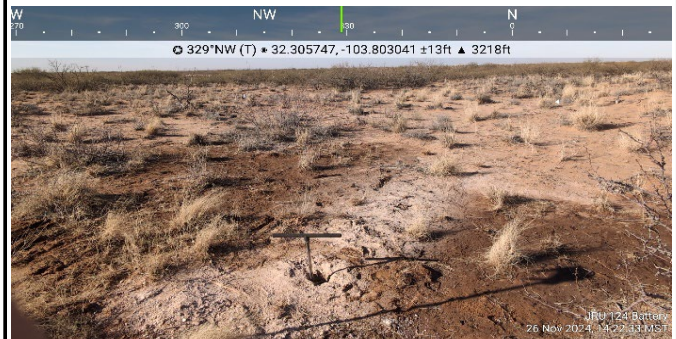
Photograph: 4 Date: 11/26/2024
Description: Delineation activities, SS04/BH04.
View: Northwest
