**Re: Closure Request
PLU BS 23 Battery
Incident Number nAPP2429826847
Eddy County, New Mexico**

Ensolum, LLC (Ensolum) on behalf of XTO Energy, Inc. (XTO), has prepared this *Closure Request* to document the findings of a liner integrity inspection and delineation activities completed at the *PLU BS 23 Battery* (Site) following a release of produced water within a lined containment. Based on liner integrity inspection results and delineation soil sample analytical results, XTO is submitting this *Closure Request*, describing activities that have occurred and requesting no further action and closure for Incident Number nAPP2429826847.

XTO Energy, Inc.
Closure Request
PLU BS 23 Battery

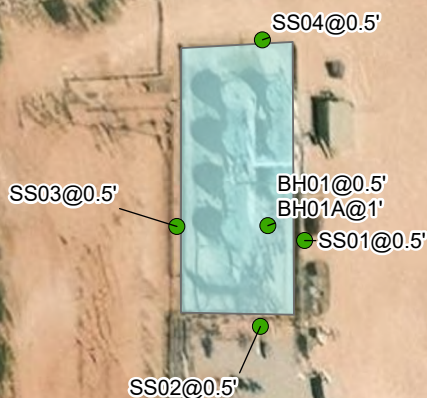
FIGURE
2

On December 18, 2024, Ensolum personnel completed delineation activities at the Site. Four delineation soil samples (SS01 through SS04) were collected around the lined containment from a depth of approximately 0.5 feet bgs to confirm the release was contained within the lined containment. One borehole (BH01) was advanced via hand auger to a terminal depth of 1-foot bgs in the location of the tear in the liner. Discrete delineation soil samples were collected within the borehole at 0.5 feet and 1-foot bgs. The delineation soil samples were field screened for volatile organic compounds (VOCs) utilizing a calibrated photoionization detector (PID) and chloride utilizing Hach® chloride QuanTab® test strips. Field screening results and observations of soil samples collected from the borehole were logged on a lithologic/soil sampling log, which is included in Appendix C. The delineation soil sample locations were mapped utilizing a handheld Global Positioning System (GPS) unit and are depicted on Figure 2. Photographic documentation is included in Appendix B.

Delineation Soil Sample Locations

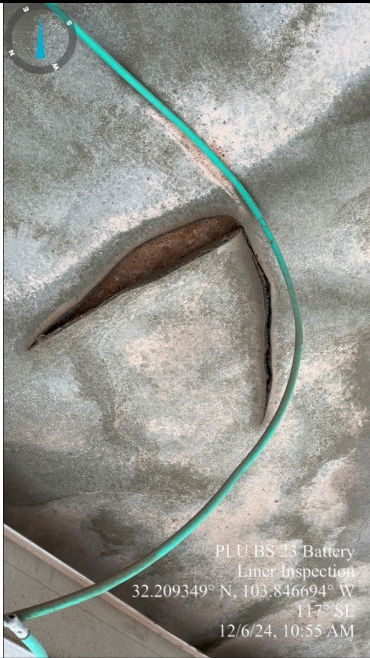
A review of the C-141, internal documents, and initial release photographs confirmed the release occurred within the lined containment. The lined containment was cleaned of all debris, power washed, and a 48-hour advance notice of the liner inspection was submitted on December 2, 2024. On December 6, 2024, Ensolum personnel inspected the lined containment and observed a tear. Delineation activities to determine the extent of the release was warranted. Photographic documentation of the inspection is included in Appendix B.

Photograph: 1 Date: 12/6/2024
Description: Liner Inspection
View: Direct

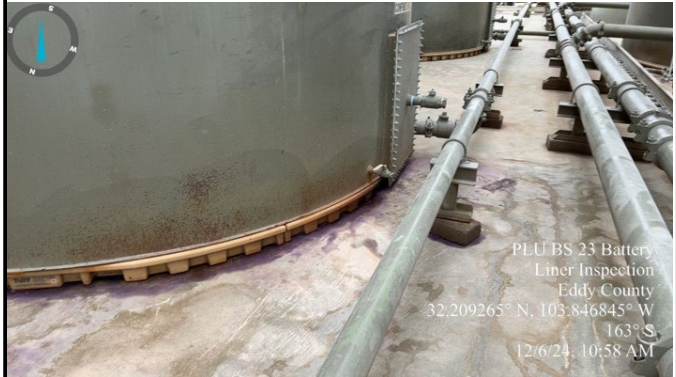
Photograph: 2 Date: 12/6/2024
Description: Liner Inspection
View: South

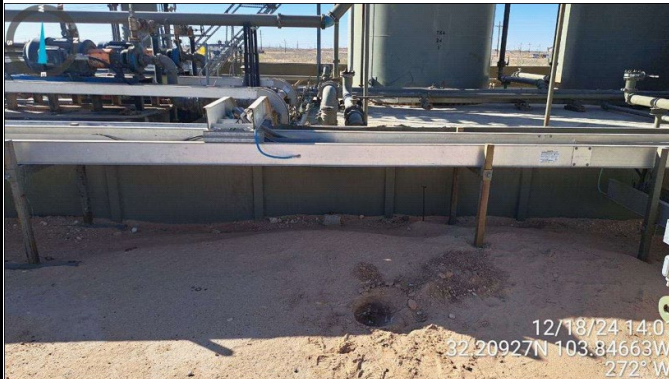
Photograph: 3 Date: 12/18/2024
Description: Delineation activities
View: West

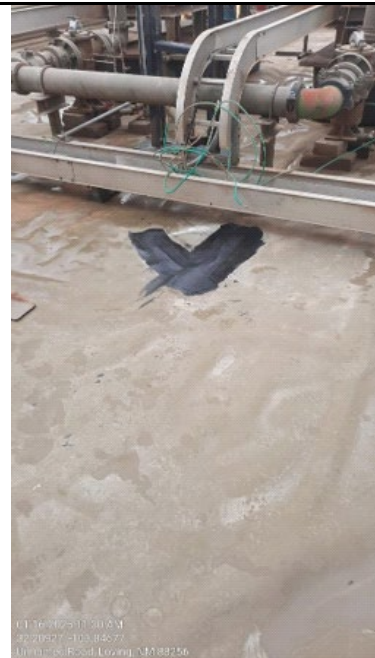
Photograph: 4 Date: 1/16/2025
Description: Liner Patch
View: Direct
