**Re: REVISED Release Characterization and Remediation Work Plan  
ADDENDUM  
BTA Oil Producers, LLC  
Vacuum SWD H #035  
Unit Letter H, Section 35, Township 17 South, Range 35 East  
Lea County, New Mexico  
API #30-025-20207  
Incident ID NAPP2313058428**

Tetra Tech, Inc. (Tetra Tech) was contacted by BTA Oil Producers, LLC (BTA) to assess and evaluate current conditions associated with a historical release associated with the Vacuum SWD H #035 (API # 30-025-20207). The approximate release site coordinates are 32.793423°, -103.422657°, located in the Public Land Survey System (PLSS) Unit Letter H, Section 35, Township 17 South, Range 35 East Lea County, New Mexico (Site). The Site location is shown in Figures 1 and 2. The site is located on State land.

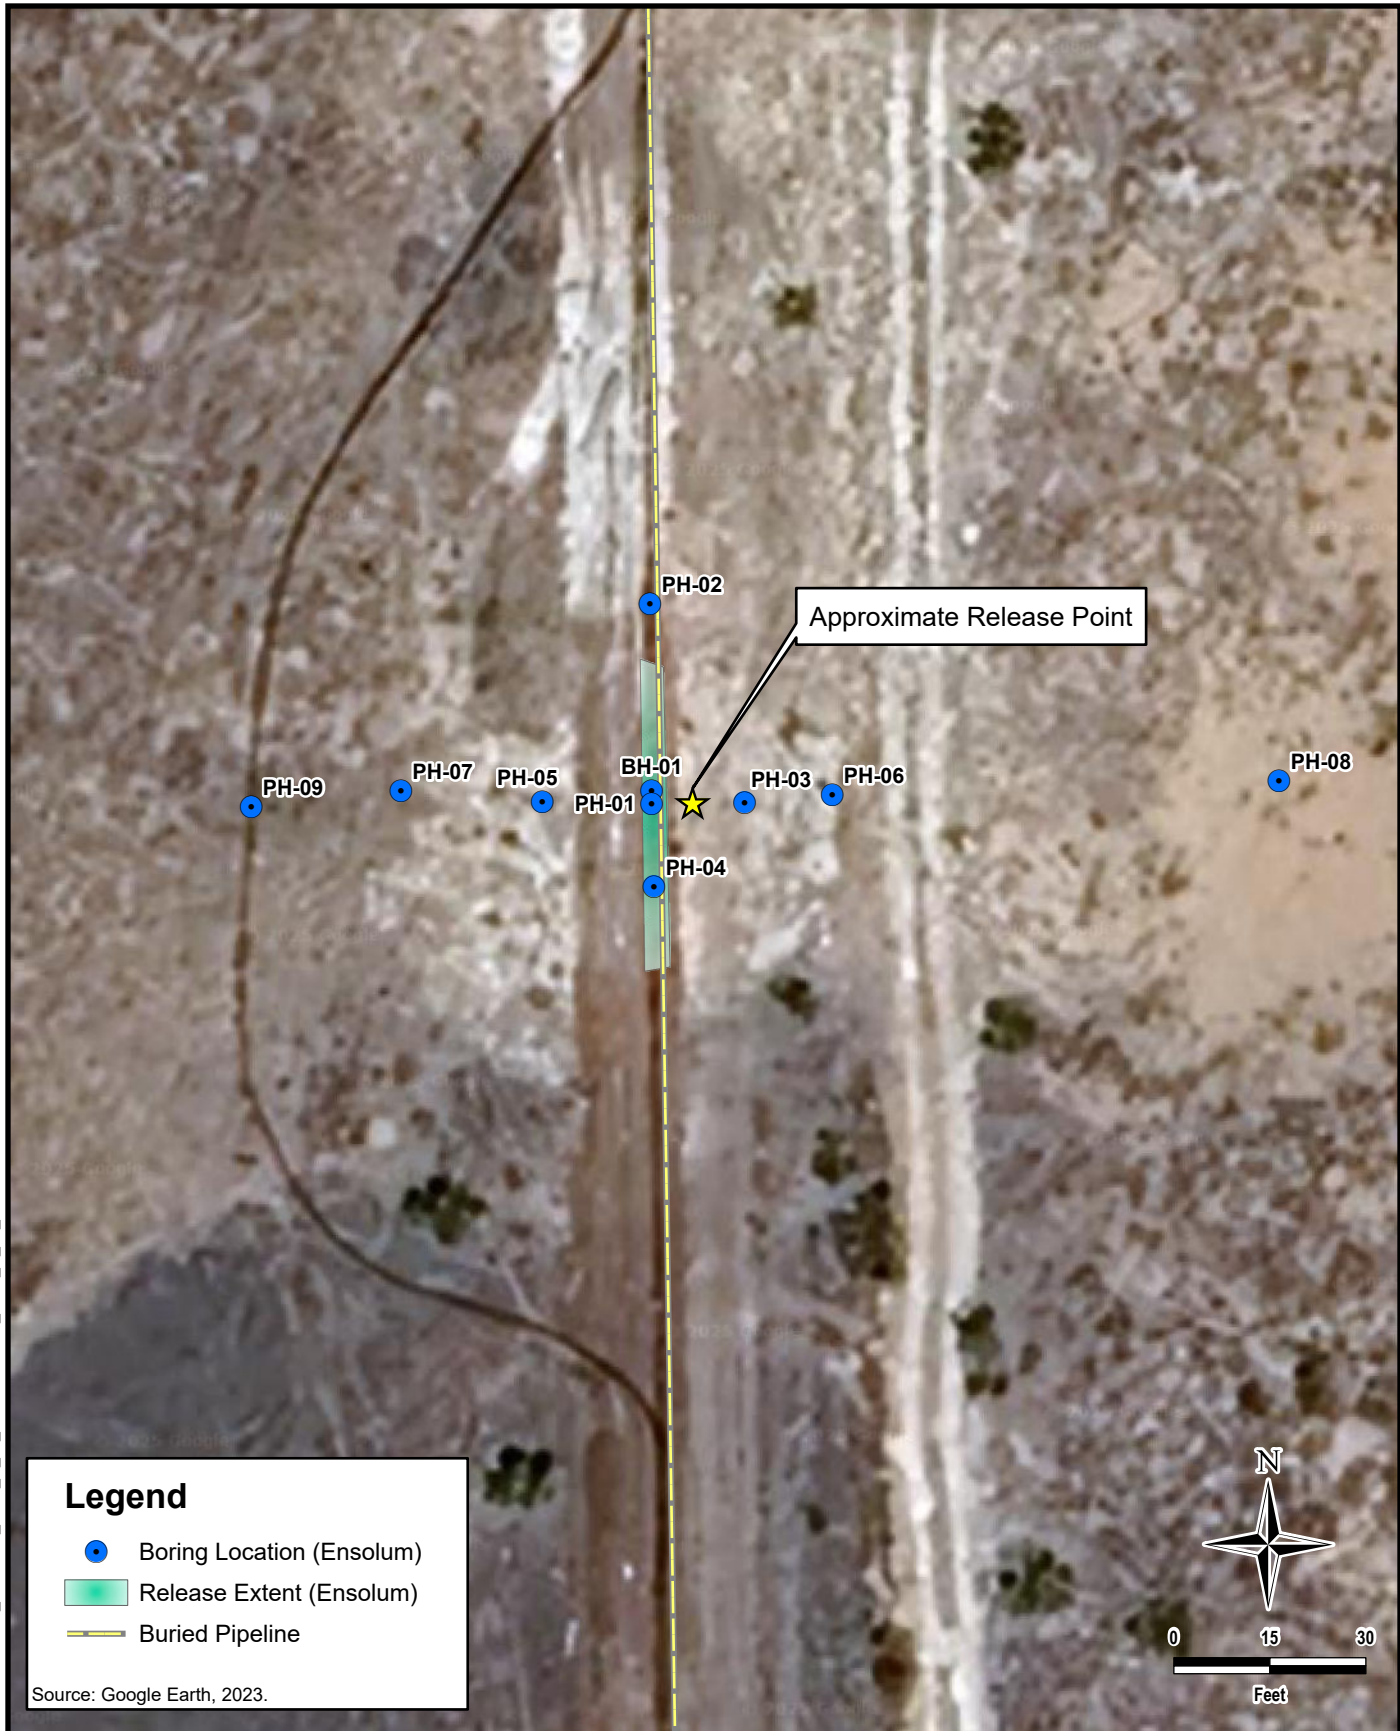
**3**

Ensolum was on site to conduct assessment activities on May 18, 2023. Ensolum advanced one soil boring (BH01) via hand auger to a depth of 3 feet bgs (Figure 3). Two samples were taken from BH01 at depths of 1 foot, and 3 feet bgs. Soil samples were submitted to Cardinal Laboratories in Hobbs, New Mexico for chloride analysis via Standard Method SM4500Cl-B, TPH via EPA Method 8015M, and BTEX via EPA Method 8021B. Laboratory analytical results associated with BH01 were above the NMOCD reclamation requirements for chloride (600 mg/kg) and/or TPH (100 mg/kg). As a result, additional delineation activities appeared to be warranted. Soil analytical results are summarized in Table 1. The laboratory analytical report is included in Appendix A.

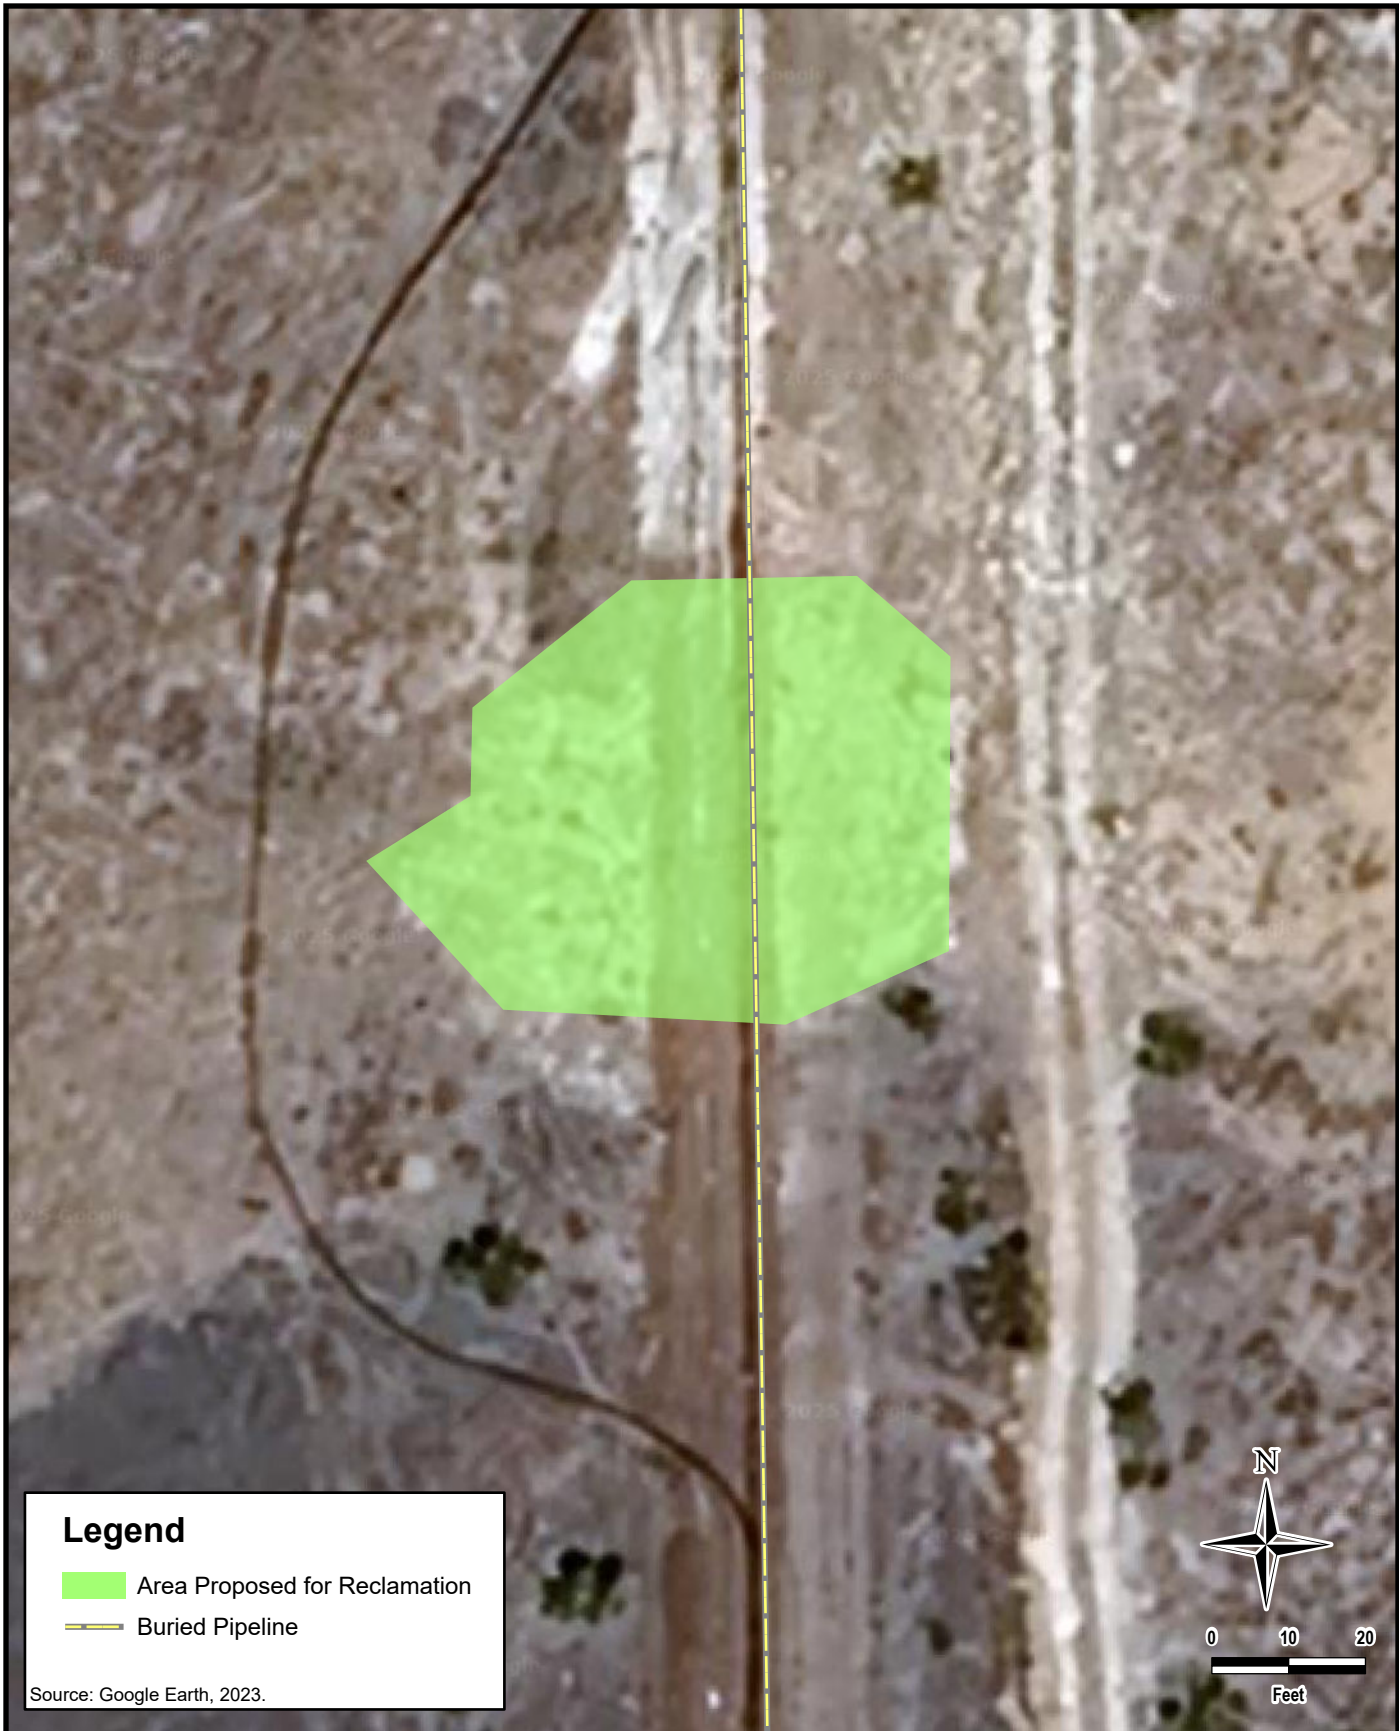
<div><div><div><div><div><div><span>Tt</span></div></div></div><div><div><span>TETRA TECH</span></div></div></div><div><a href="http://www.tetrattech.com">www.tetrattech.com</a></div><div>901 West Wall Street, Suite 100 Midland, Texas 79701 Phone: (432) 682-4559 Fax: (432) 682-3946</div></div></div>	BTA OIL PRODUCERS, LLC		PROJECT NO.: 212C-MD-03738
	NAPP2313058428 (32.793423°, -103.422657°) LEA COUNTY, NEW MEXICO		DATE: JANUARY 20, 2025
	VACUUM SWD H #035 PIPELINE ALTERNATIVE CONFIRMATION SAMPLING PLAN		DESIGNED BY: LMV
			Figure No. <b>6</b>

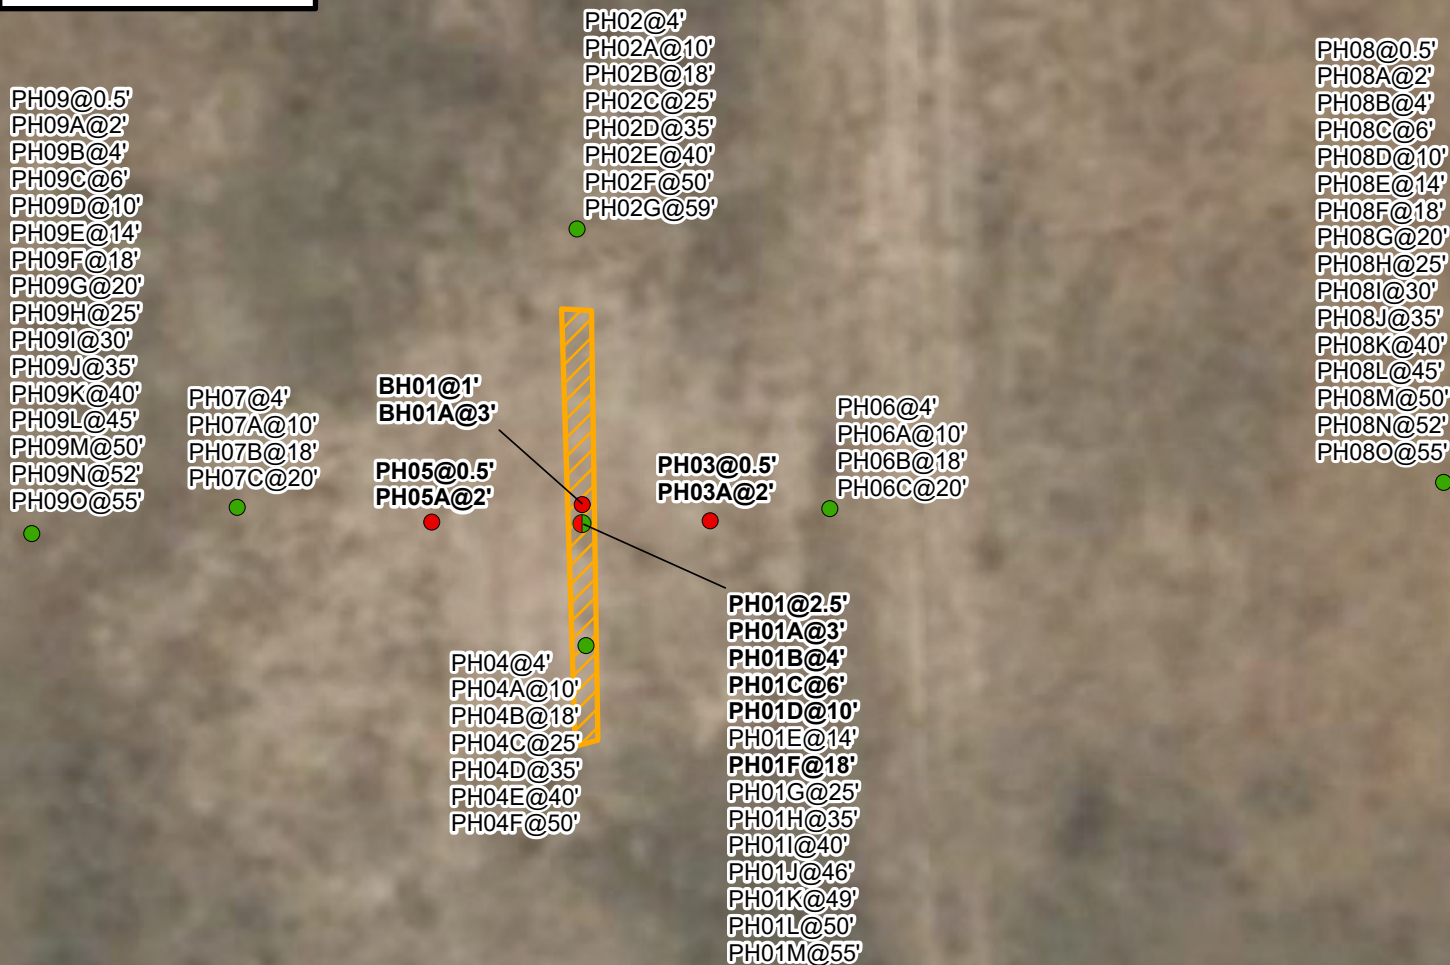
Notes:  
 Sample ID @ Depth Below Ground Surface.  
 Samples in bold indicate sample exceeded applicable closure criteria.

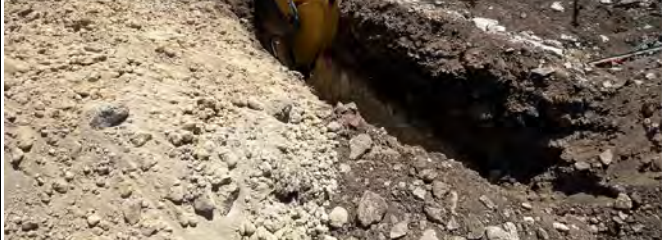
Photograph: 3  
 Description: Pothole PH01  
 View: southwest

Laboratory analytical results for pothole PH01 indicated concentrations of all COCs exceeded Closure Criteria in the upper 20 feet of the subsurface. Samples collected below that depth were in compliance with the Closure Criteria. Chloride was vertically delineated to 600 mg/kg in pothole PH01 in the sample collected from 55 feet bgs. No groundwater was observed in PH01 and the sample depth is above the depth of groundwater observed in pothole PH02. Laboratory analytical results for all other samples collected with the sonic drill rig indicated all COCs were in compliance with Closure Criteria and provided lateral definition of the historical release.
