Pilum 15 Fee 2H Battery

Incident ID NAPP2429738206

Site Assessment, Remediation, and Closure Report

Re: Site Assessment, Remediation, and Closure Report
Pilum 15 Fee 2H Battery
Facility ID: fAPP2203440160
GPS: Latitude 32.74196 Longitude -104.38426
UL "O", Sec. 16, T18S, R26E
Eddy County, NM
NMOCD Ref. No. NAPP2429738206

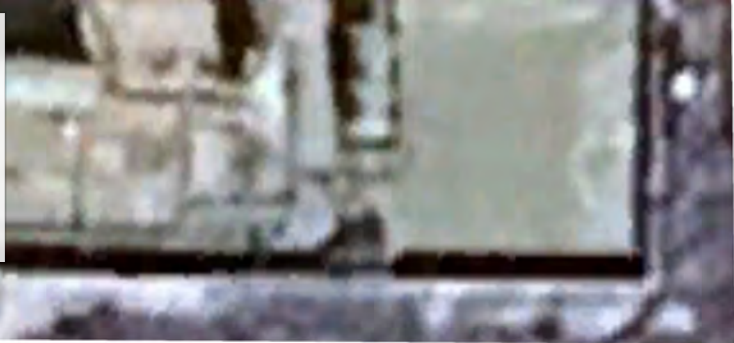
Spur Energy
Facility ID: fAPP2203440160
Eddy County
Initial Site Map

NAPP2429738206: On October 21, 2024, high pressure caused a poly discharge line to split, resulting in a fluid release into the pasture. Approximately 9 barrels of produced water and 2 barrels of crude oil were released, with no fluids recovered. The impacted area is shown in Figure 5.

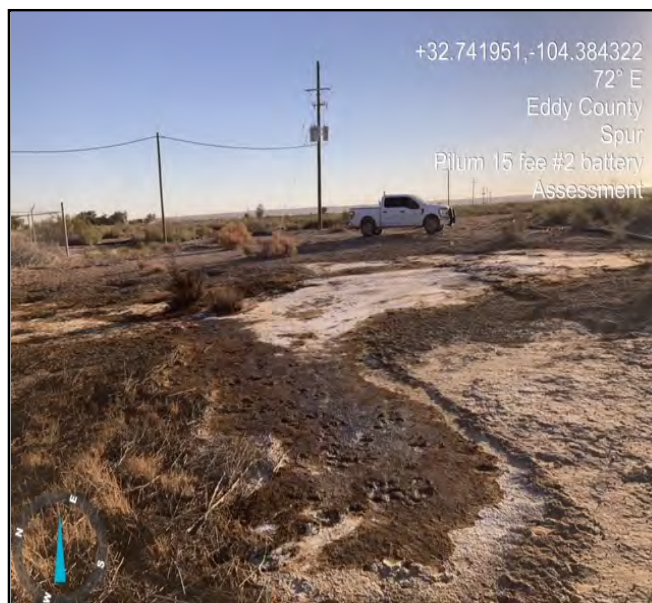
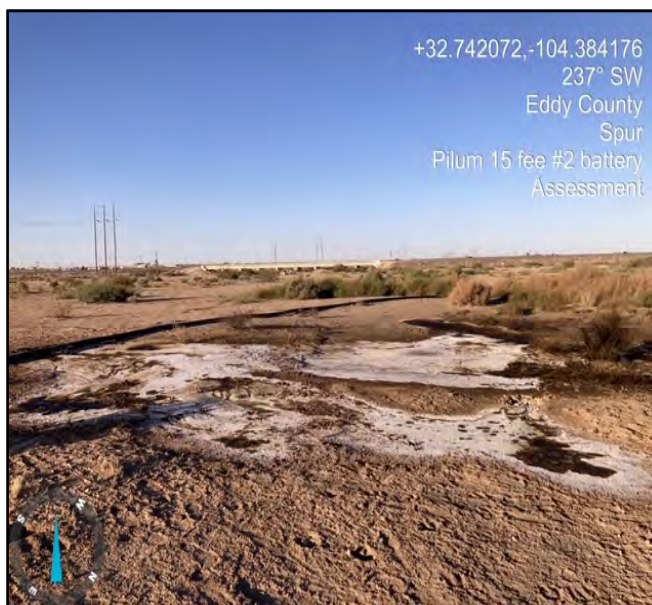
Assessment :

Photograph of the site tech assessing the release incident, facing East.

Photograph of the site tech assessing the release incident, facing West.

Photograph of the site tech assessing the release incident, facing Southwest.

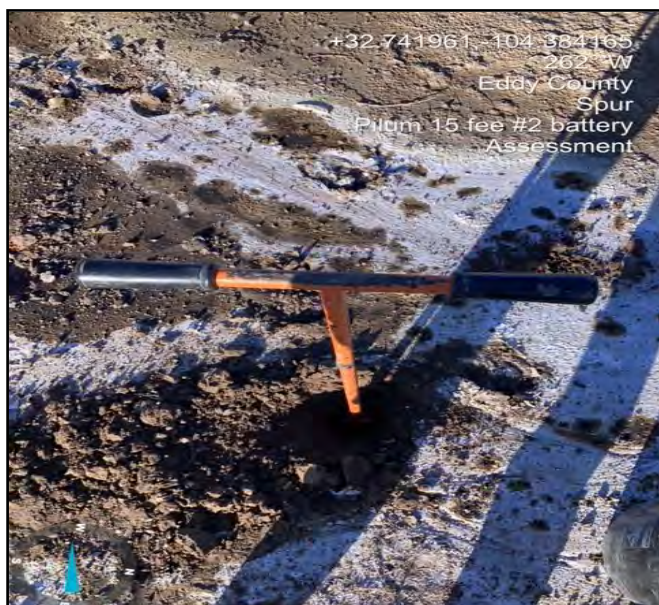
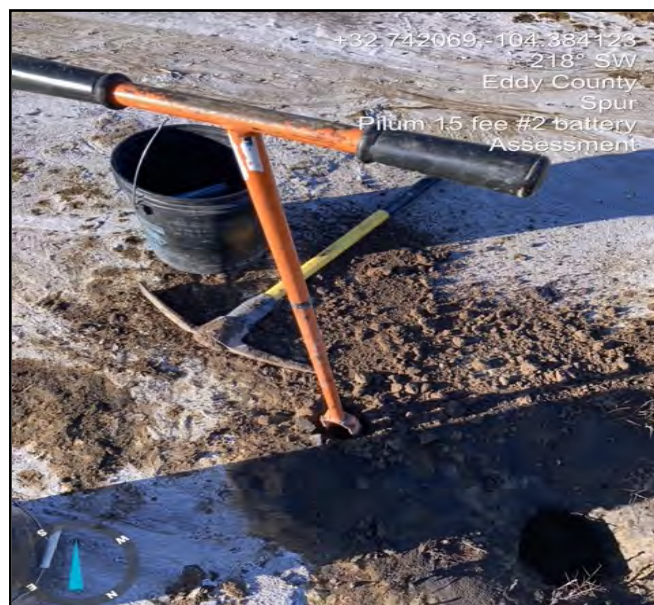
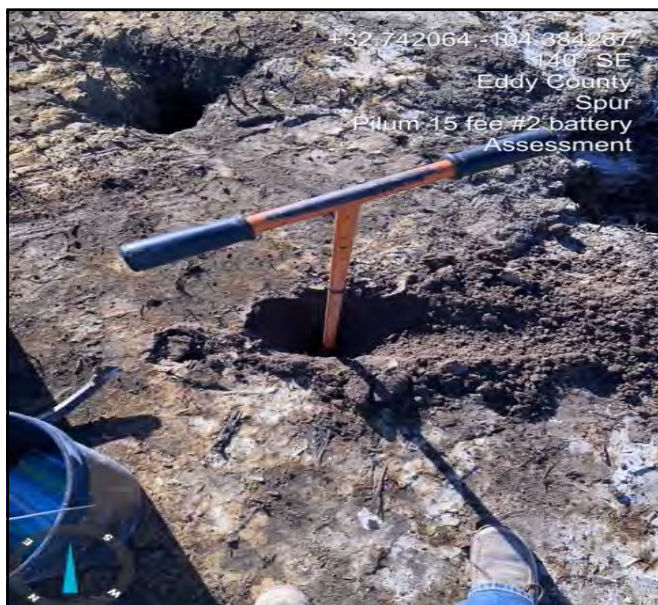
Photograph of a hand auger in the ground, facing West, to gather samples.

Photograph of a hand auger in the ground, facing Southwest, to gather samples.

Photograph of a hand auger in the ground, facing Southeast, to gather samples.

Photograph of a hand auger in the ground, facing East, to gather samples.

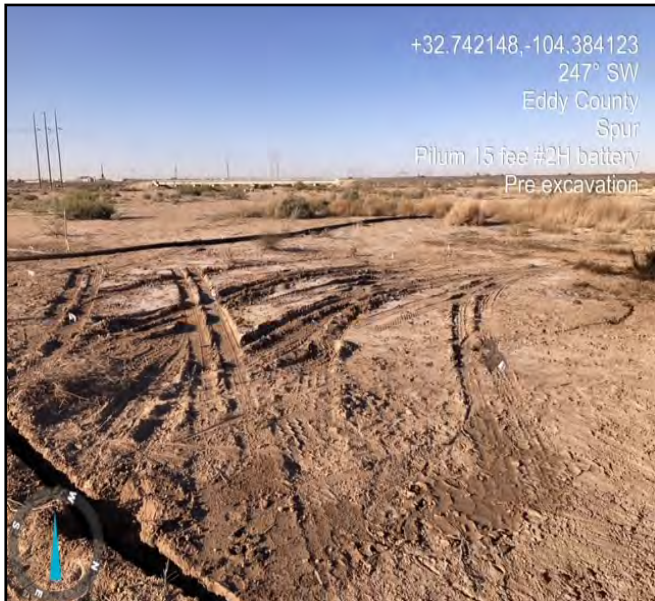
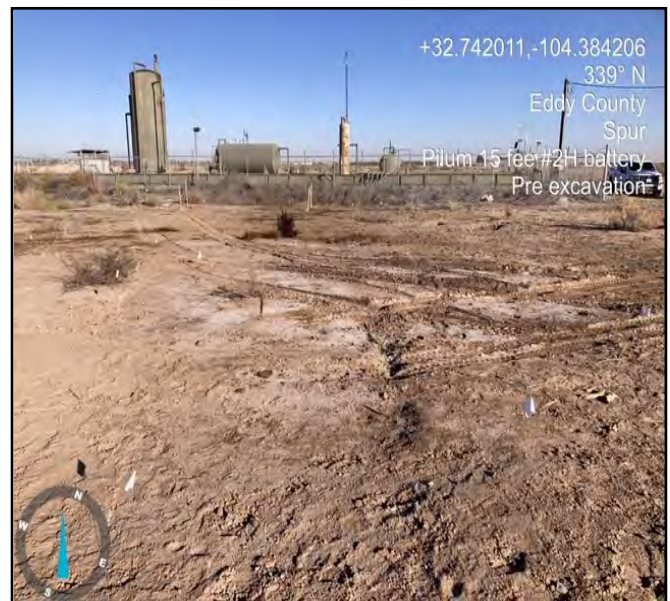
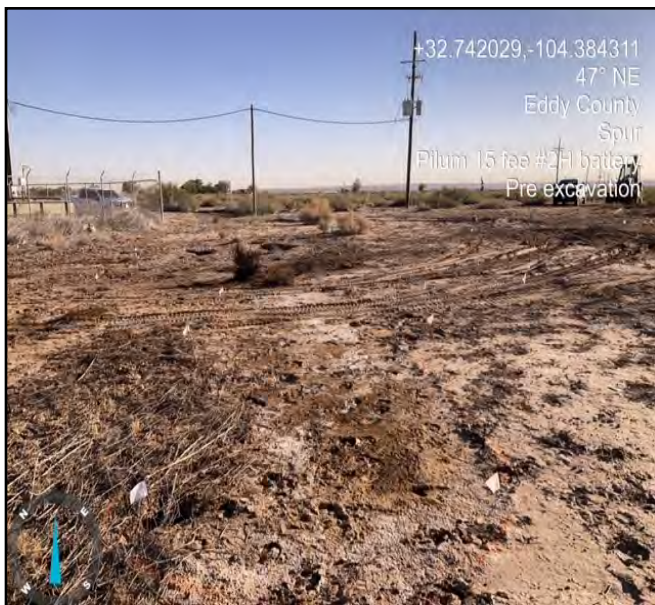
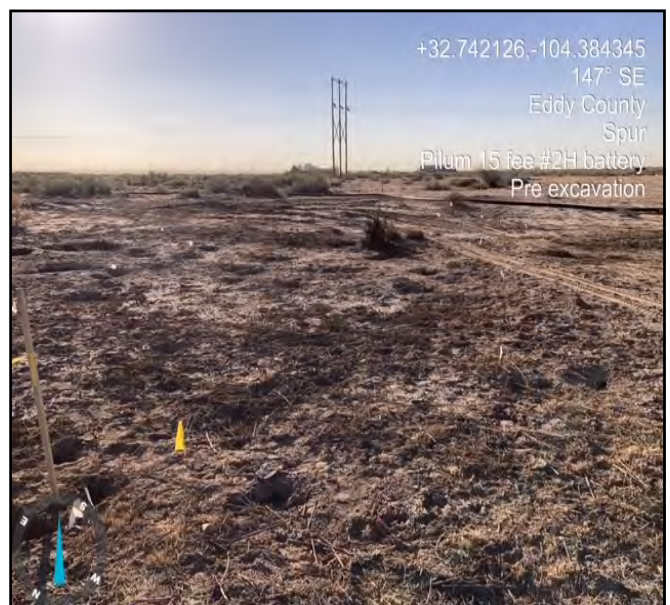
Pre- Excavtion :

Photograph showing the site being flagged to delineate the excavation area, facing Southwest.

Photograph showing the site being flagged to delineate the excavation area, facing North.

Photograph showing the site being flagged to delineate the excavation area, facing Northeast.

Photograph showing the site being flagged to delineate the excavation area, facing Southeast

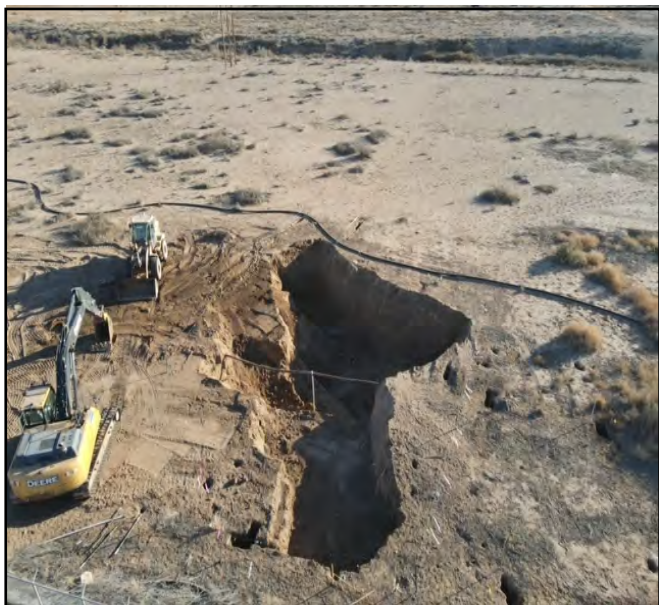
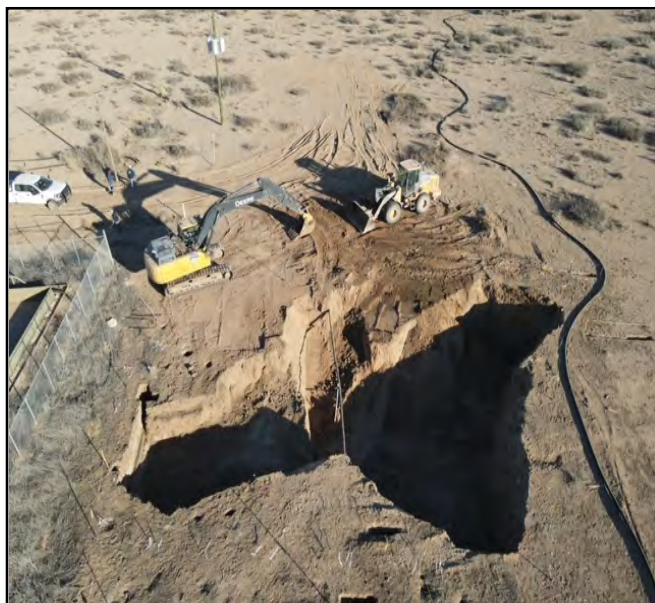
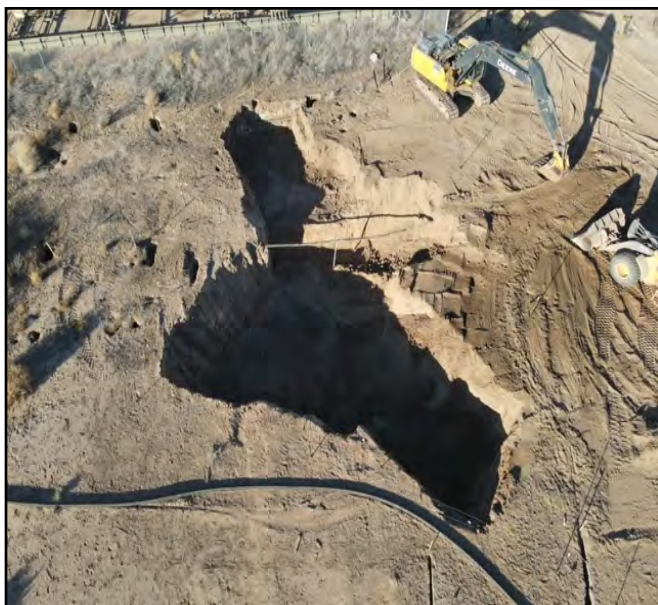
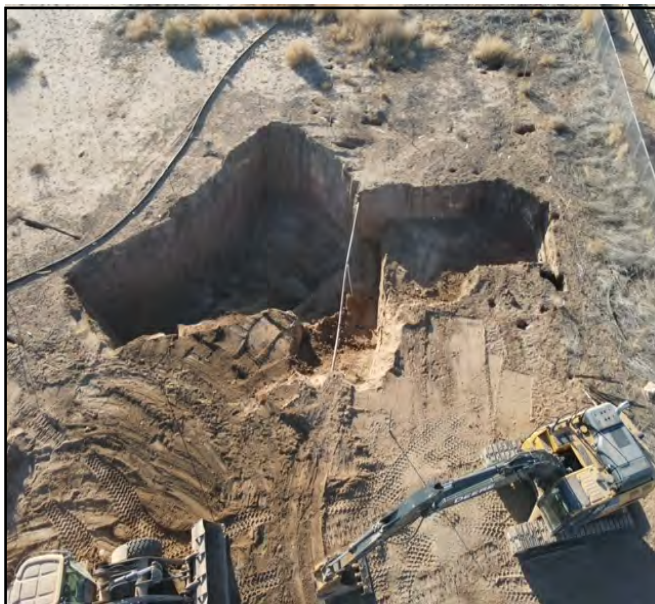
Excavation :

Photo of the release area being completely excavated.

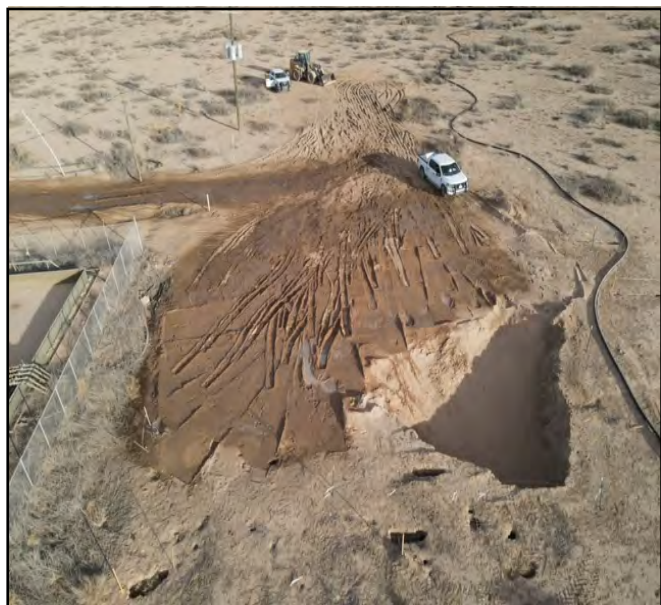
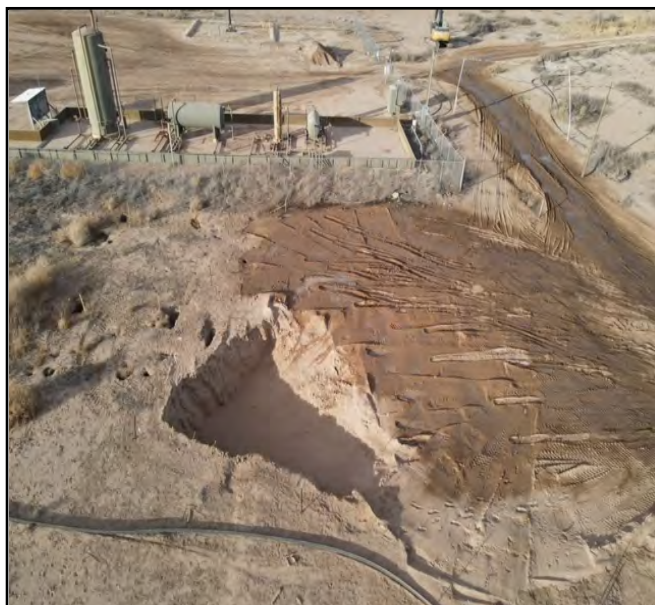
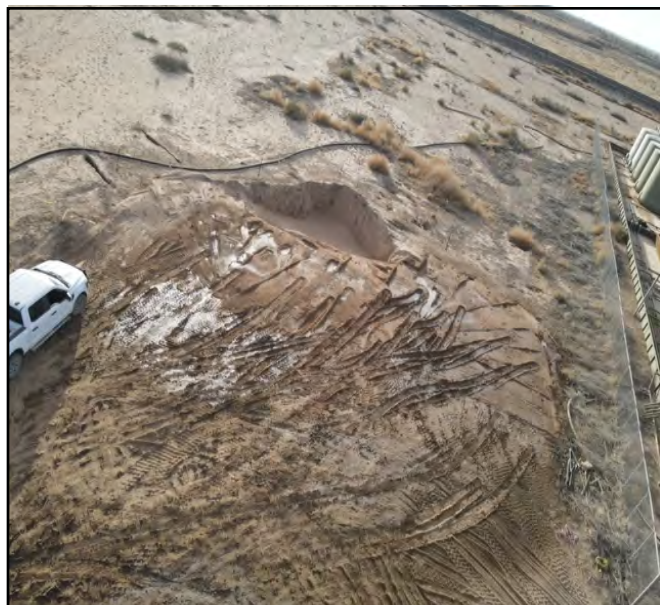
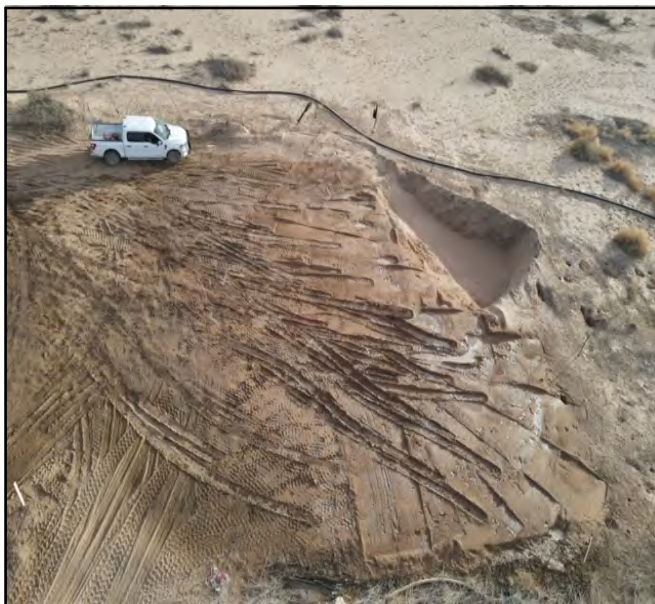
Backfill :

Photo of the release area being backfilled.

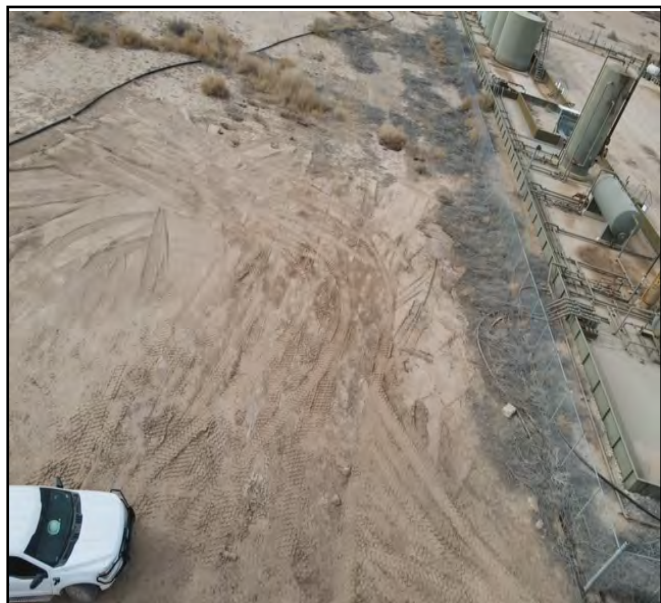
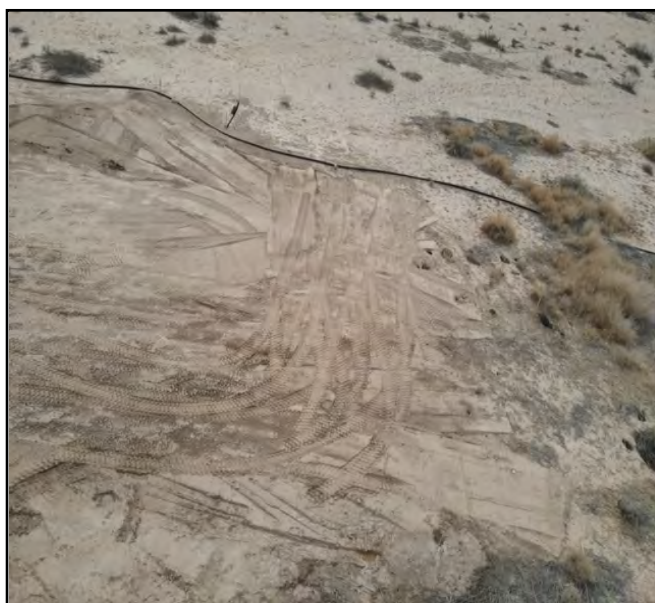
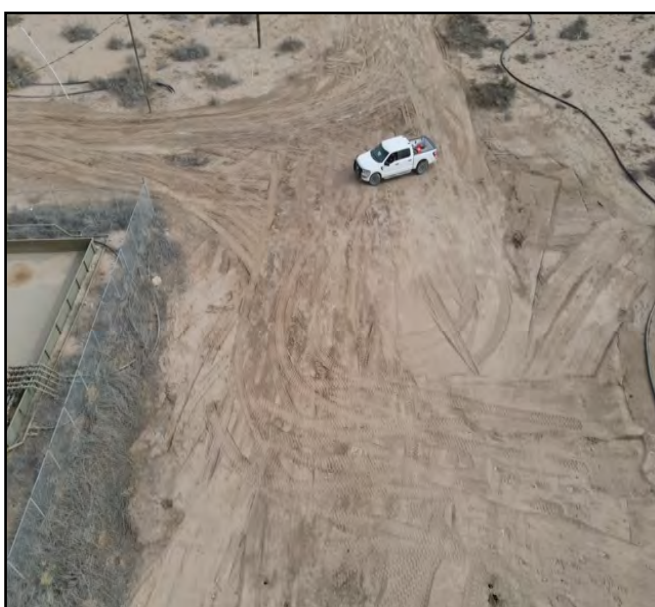
Post Excavation :

Aerial photo taken post excavation.
