Re: Status Report – 4<sup>th</sup> Quarter 2024  
Fifield 5 No. 1 (SE ¼, SW ¼, Sec. 5, T29N, R11W)  
Hilcorp Energy Company  
San Juan County, New Mexico  
OCD Incident No. NVF1718155324

On behalf of Hilcorp Energy Company (Hilcorp), Timberwolf Environmental, LLC (Timberwolf) presents this report to document activities conducted during the 4<sup>th</sup> quarter of 2024 (4Q24) at the Fifield 5 No. 1 (Site). The Site is a plugged well site in northeast San Juan County, New Mexico (Figures 1 through 3).

**Table A-1. Operation and Maintenance Events  
Status Report - 4th Quarter 2024  
Fifield 5 No. 1 (OCD Incident No. NVF1718155324)  
San Juan County, New Mexico**

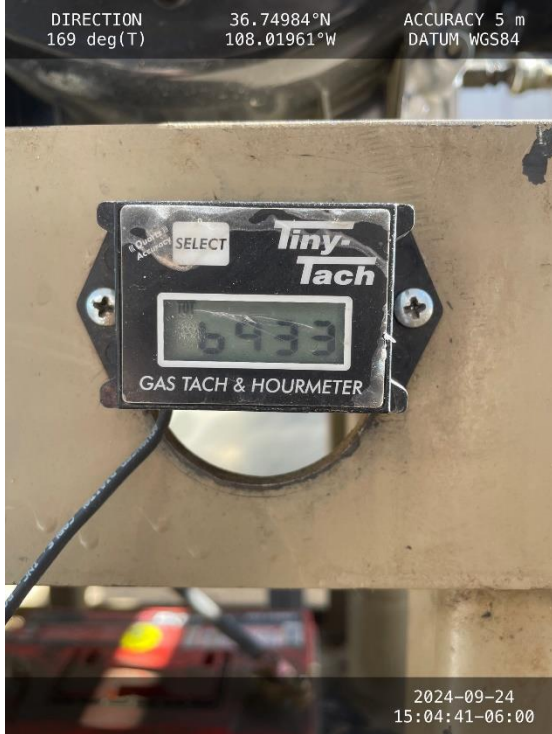
<b>Project No.:</b>	HEC-190009	<b>Client:</b>	Hilcorp Energy Company
<b>Project Name:</b>	Fifield 5 No. 1	<b>Site Location:</b>	San Juan County, New Mexico
<b>Task Description:</b>	Status Report – 4th Quarter 2024	<b>Date:</b>	October – December, 2024
<b>Photo No.:</b> 1

<b>Direction:</b> N/A			
<b>Comments:</b> View of hour meter on 09/24/24.			
<b>Photo No.:</b> 2

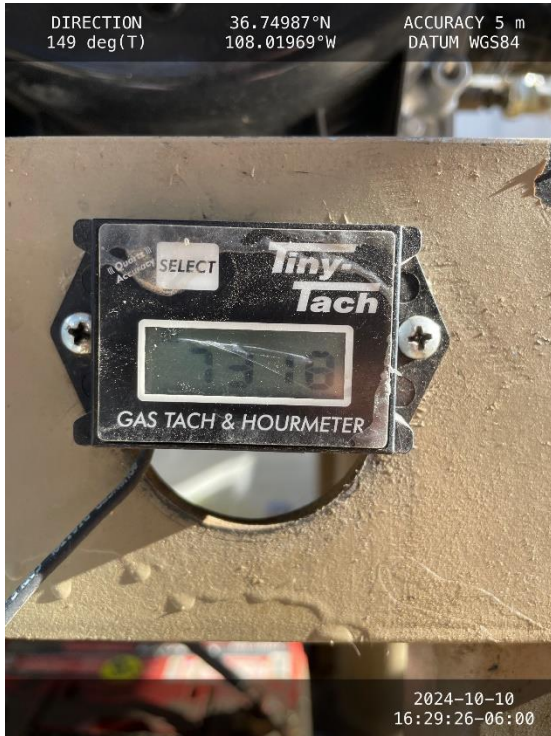
<b>Direction:</b> N/A			
<b>Comments:</b> View of hour meter on 10/10/24.

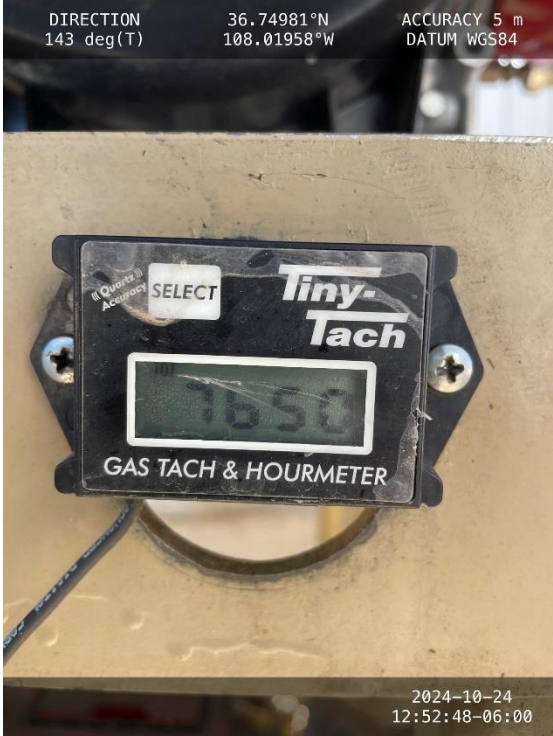
<b>Project No.:</b>	HEC-190009	<b>Client:</b>	Hilcorp Energy Company
<b>Project Name:</b>	Fifield 5 No. 1	<b>Site Location:</b>	San Juan County, New Mexico
<b>Task Description:</b>	Status Report – 4th Quarter 2024	<b>Date:</b>	October – December, 2024
<b>Photo No.:</b> 3

DIRECTION 143 deg(T) 36.74981°N 108.01958°W ACCURACY 5 m DATUM WGS84	
<b>Direction:</b> N/A			
<b>Comments:</b> View of hour meter on 10/24/24.		2024-10-24 12:52:48-06:00	
<b>Photo No.:</b> 4

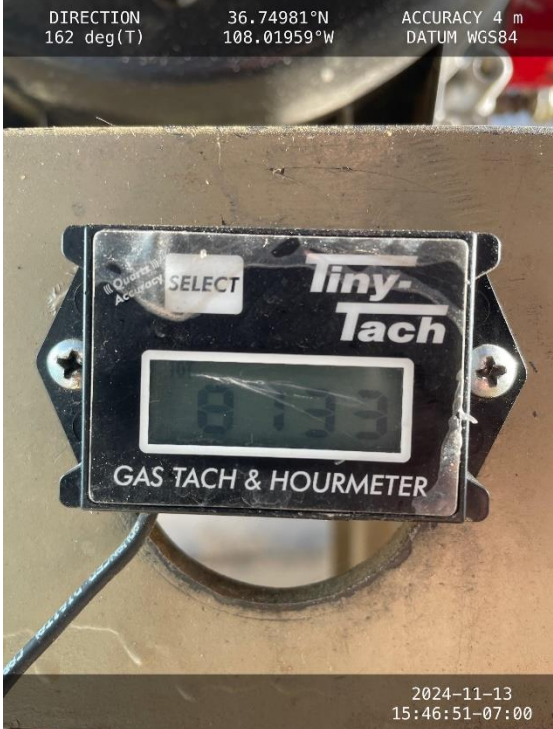
DIRECTION 162 deg(T) 36.74981°N 108.01959°W ACCURACY 4 m DATUM WGS84	
<b>Direction:</b> N/A			
<b>Comments:</b> View of hour meter on 11/13/24.		2024-11-13 15:46:51-07:00

An hour meter failure occurred on or before 12/04/24; Hilcorp personnel replaced the hour meter on 12/05/24. Additional maintenance during the quarter included replacement of the alternator to restore power to the system's automation on 12/19. Due to the hour meter failure, Cygnet telemetry data was used to verify system runtime for the quarter. Cygnet data showed a total of 6 hours of downtime during the quarter, but otherwise verified continuous operation throughout the quarter. Photographs of relevant meter readings are documented in the attached Photographic Log.
