**Re: Closure Report
ConocoPhillips Company (COG Operating, LLC)
King Tut Federal CTB Pasture Release
Unit Letter D, Section 30, Township 24 South, Range 32 East
Lea County, New Mexico
Incident ID# NAPP2319132381**

Closure Report
October 24, 2024

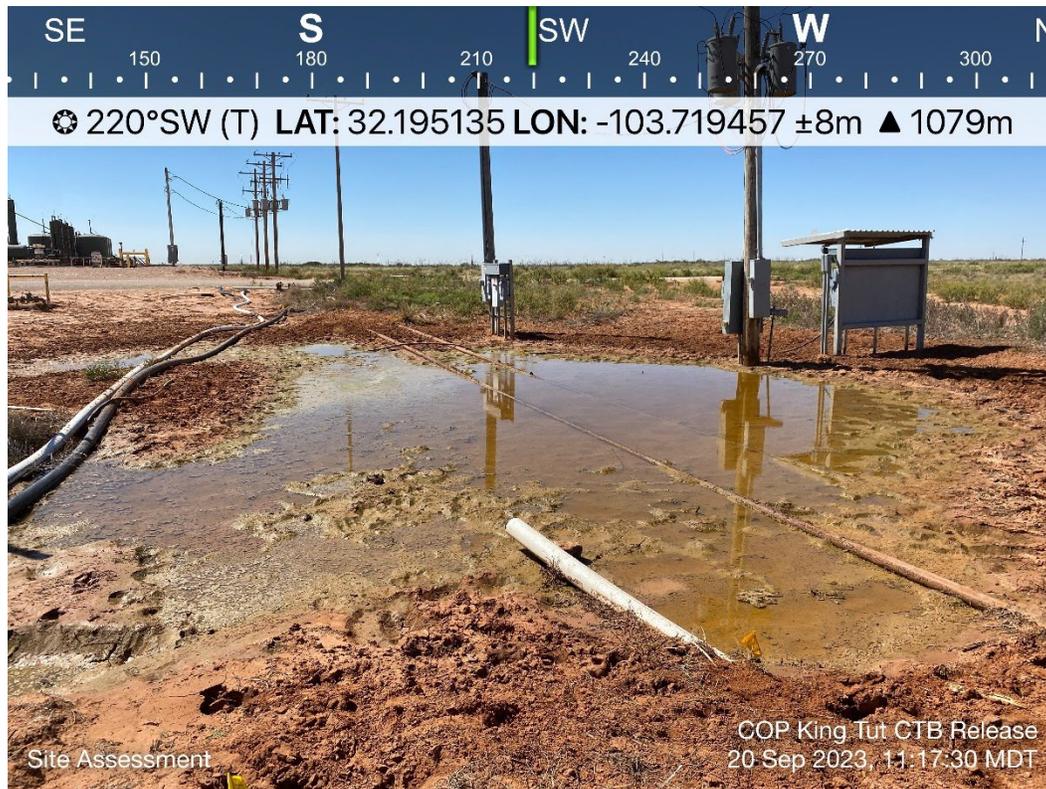
TETRA TECH, INC. PROJECT NO. 212C-MD-03225	DESCRIPTION	View southwest. Surface lines, overhead electrical, surface steel lines, and water retention post-rain event.	3
	SITE NAME	KING TUT FEDERAL #1 RELEASE	9/20/2023

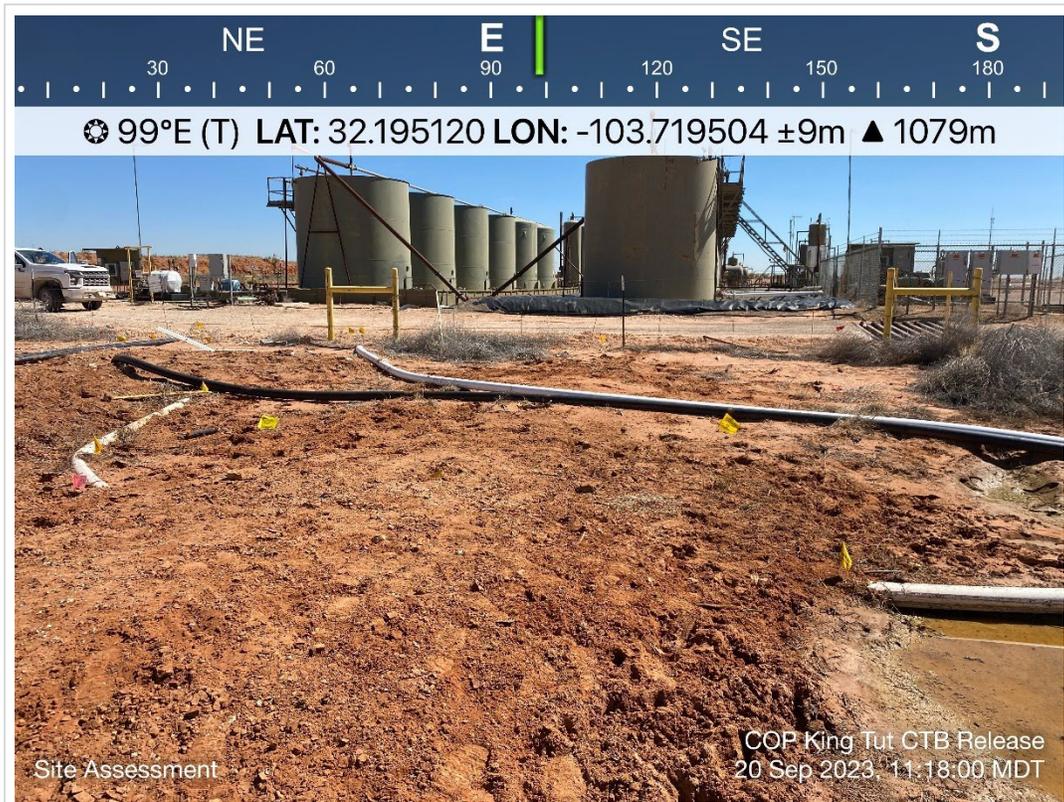
TETRA TECH, INC. PROJECT NO. 212C-MD-03225	DESCRIPTION	View east, northeast corner of release extent. Adjacent tank battery, surface polylines.	4
	SITE NAME	KING TUT FEDERAL #1 RELEASE	9/20/2023

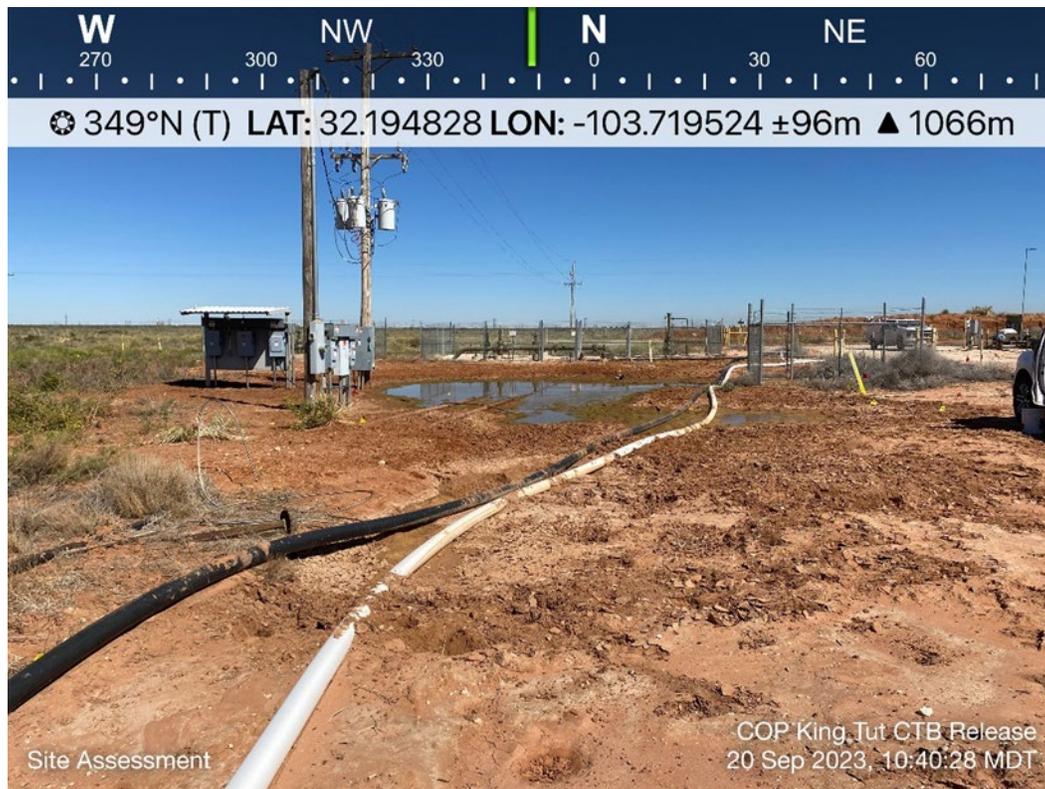
TETRA TECH, INC. PROJECT NO. 212C-MD-03225	DESCRIPTION	View north from release point. Surface lines, overhead electrical, and water retention post rain event.	5
	SITE NAME	KING TUT FEDERAL #1 RELEASE	9/20/2023

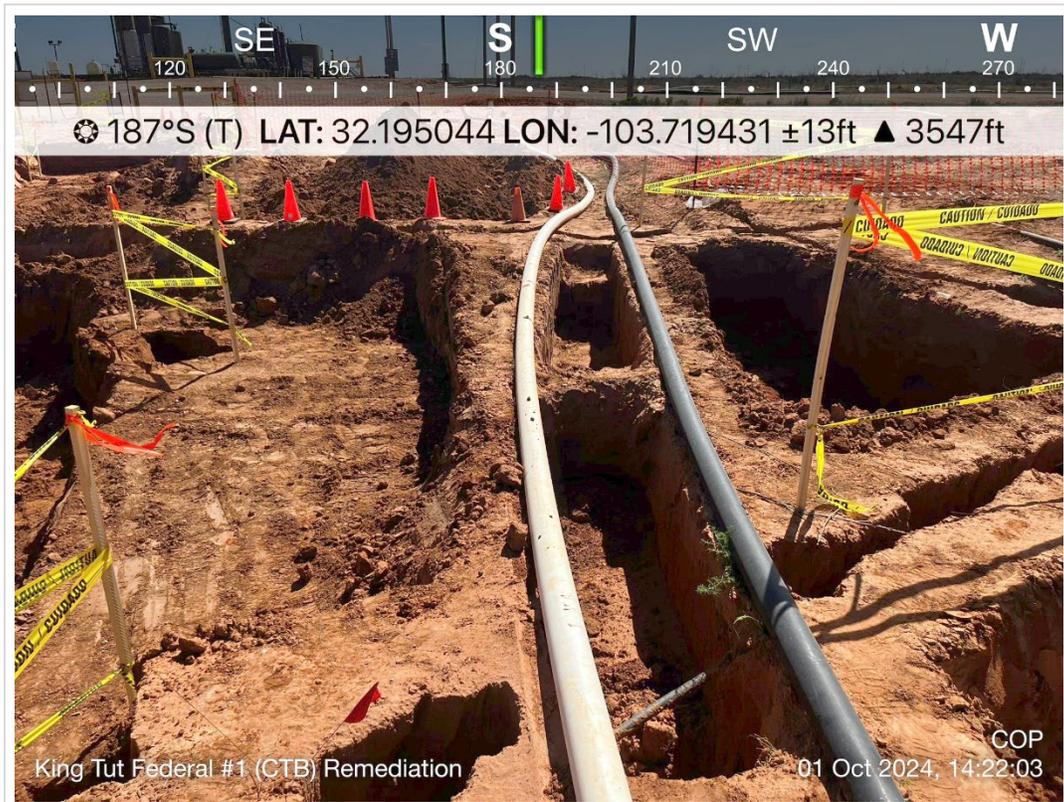
TETRA TECH, INC. PROJECT NO. 212C-MD-03225	DESCRIPTION	View South. Subsurface utility markings during excavation progress.	6
	SITE NAME	KING TUT FEDERAL #1 RELEASE	10/1/2024

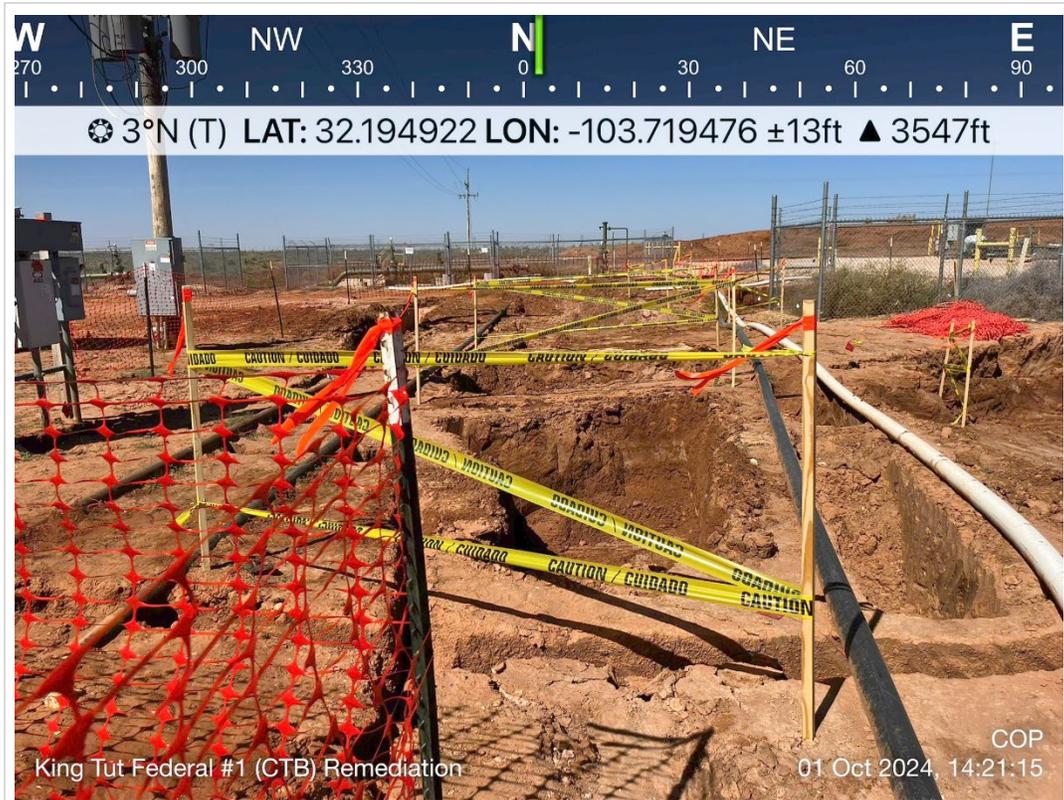
TETRA TECH, INC. PROJECT NO. 212C-MD-03225	DESCRIPTION	View North. Subsurface utility markings during excavation progress.	7
	SITE NAME	KING TUT FEDERAL #1 RELEASE	10/1/2024

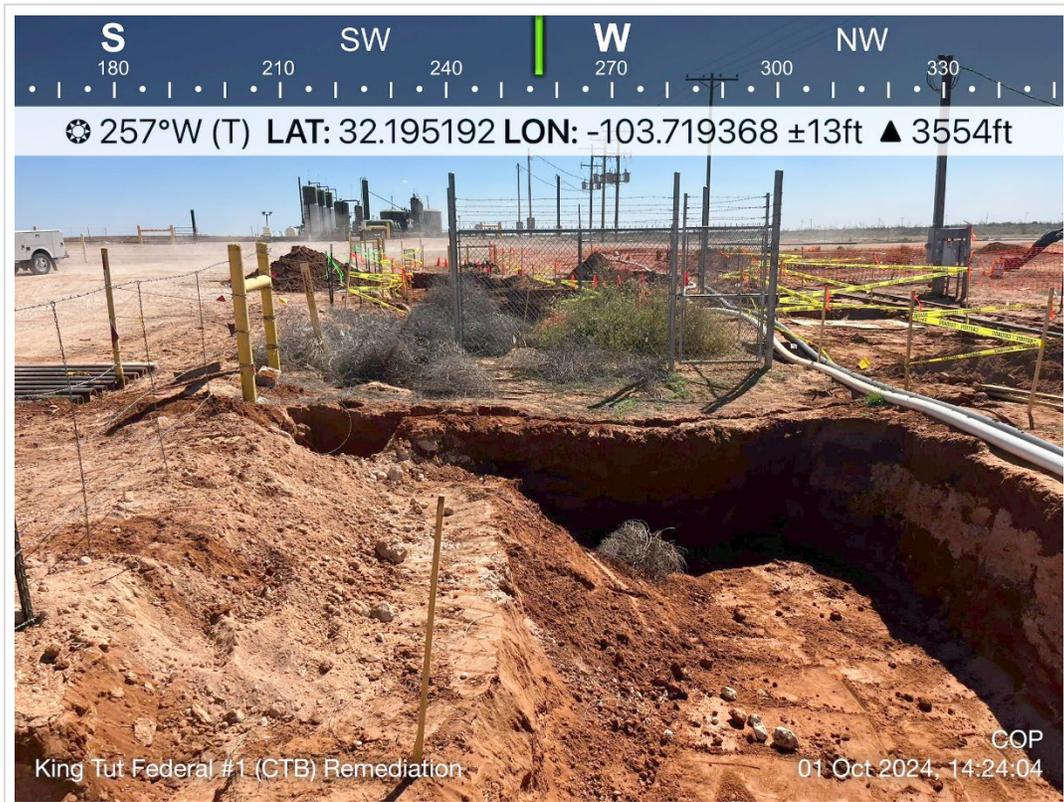
TETRA TECH, INC. PROJECT NO. 212C-MD-03225	DESCRIPTION	View west-southwest. Subsurface utility markings during excavation progress.	8
	SITE NAME	KING TUT FEDERAL #1 RELEASE	10/1/2024

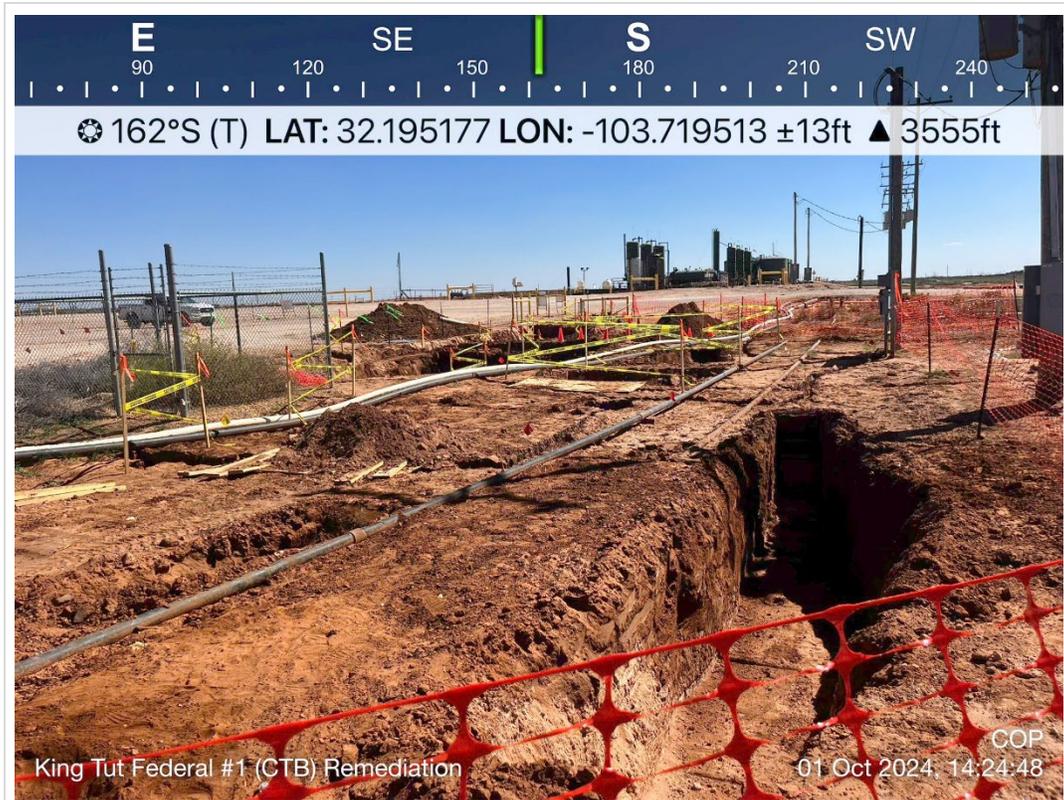
TETRA TECH, INC. PROJECT NO. 212C-MD-03225	DESCRIPTION	View south-southeast. Subsurface utility markings during excavation progress.	8
	SITE NAME	KING TUT FEDERAL #1 RELEASE	10/1/2024

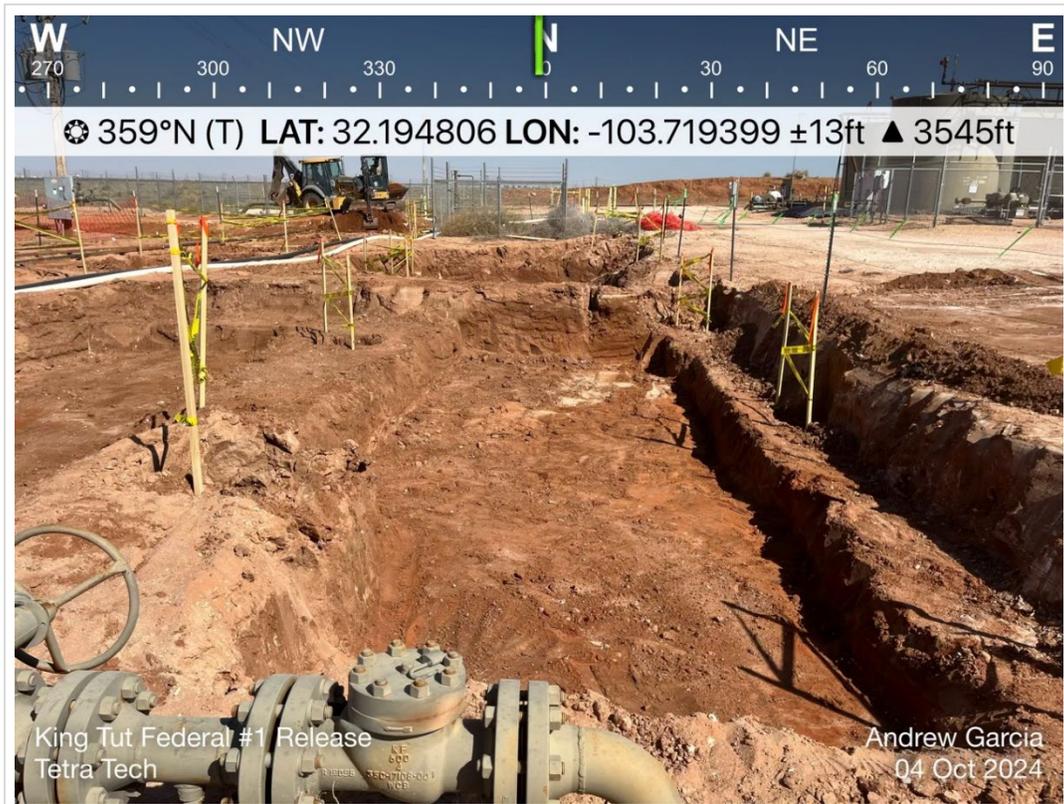
TETRA TECH, INC. PROJECT NO. 212C-MD-03225	DESCRIPTION	View North. Subsurface utility markings during excavation progress.	9
	SITE NAME	KING TUT FEDERAL #1 RELEASE	10/4/2024

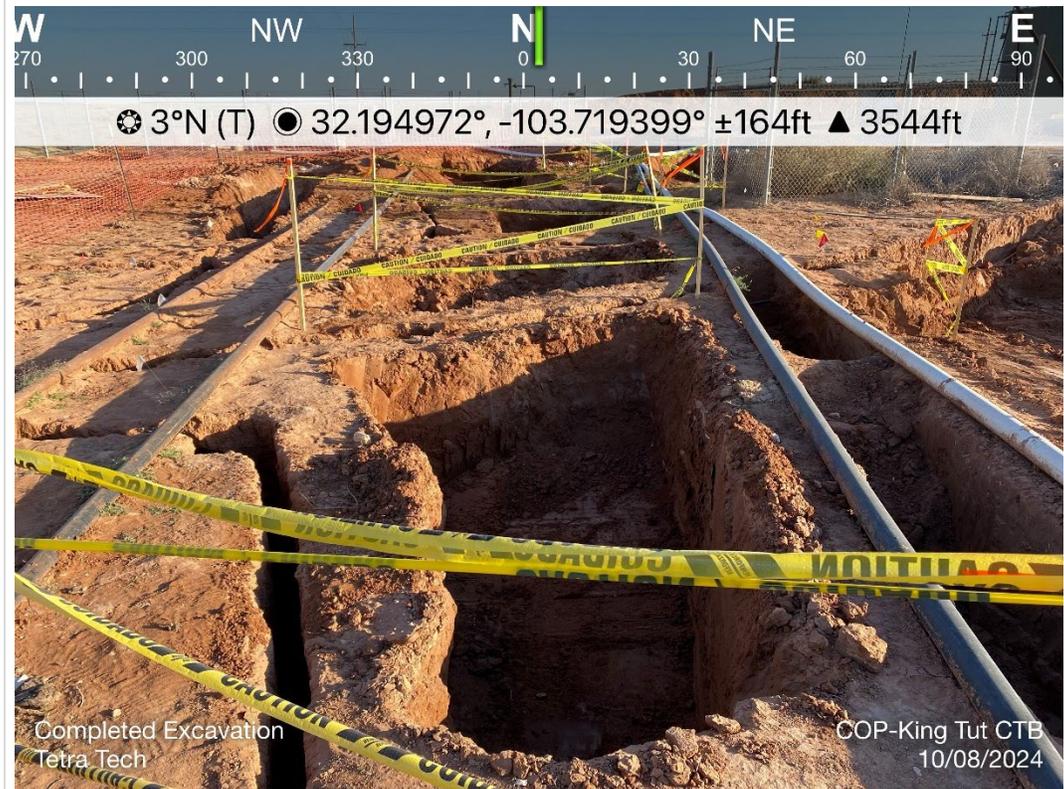
TETRA TECH, INC. PROJECT NO. 212C-MD-03225	DESCRIPTION	View north. Subsurface utility markings of completed excavation.	10
	SITE NAME	KING TUT FEDERAL #1 RELEASE	10/8/2024

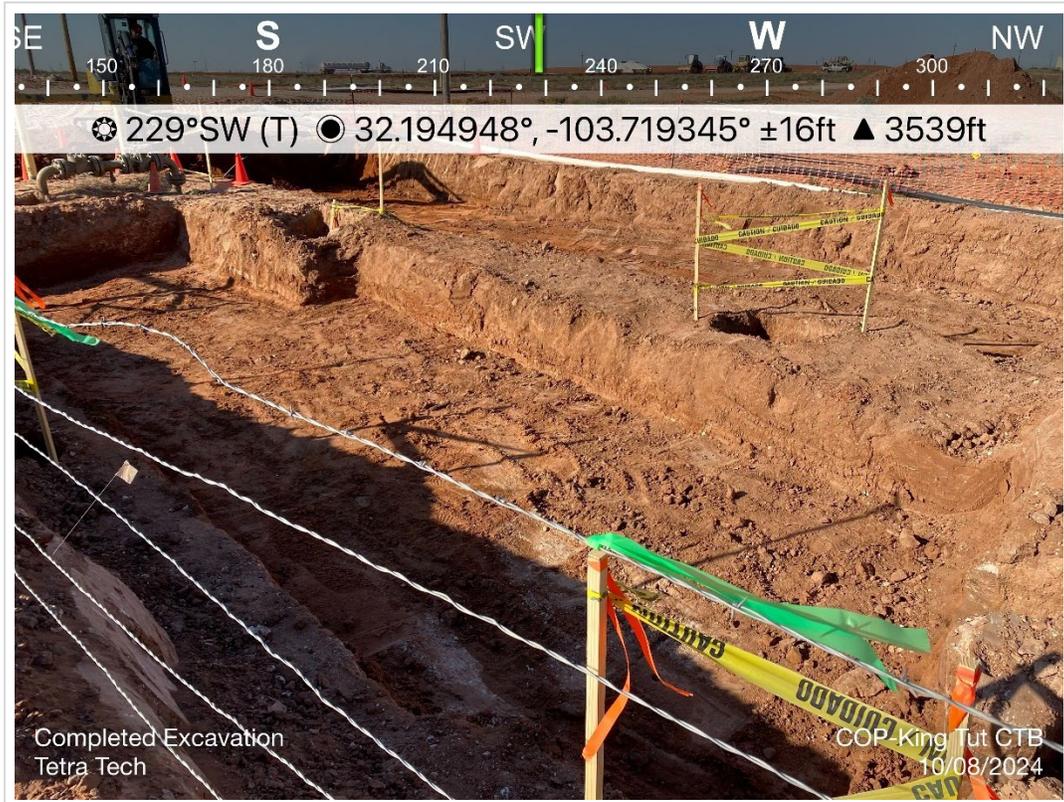
TETRA TECH, INC. PROJECT NO. 212C-MD-03225	DESCRIPTION	View southwest. Subsurface utility markings of completed excavation.	11
	SITE NAME	KING TUT FEDERAL #1 RELEASE	10/8/2024

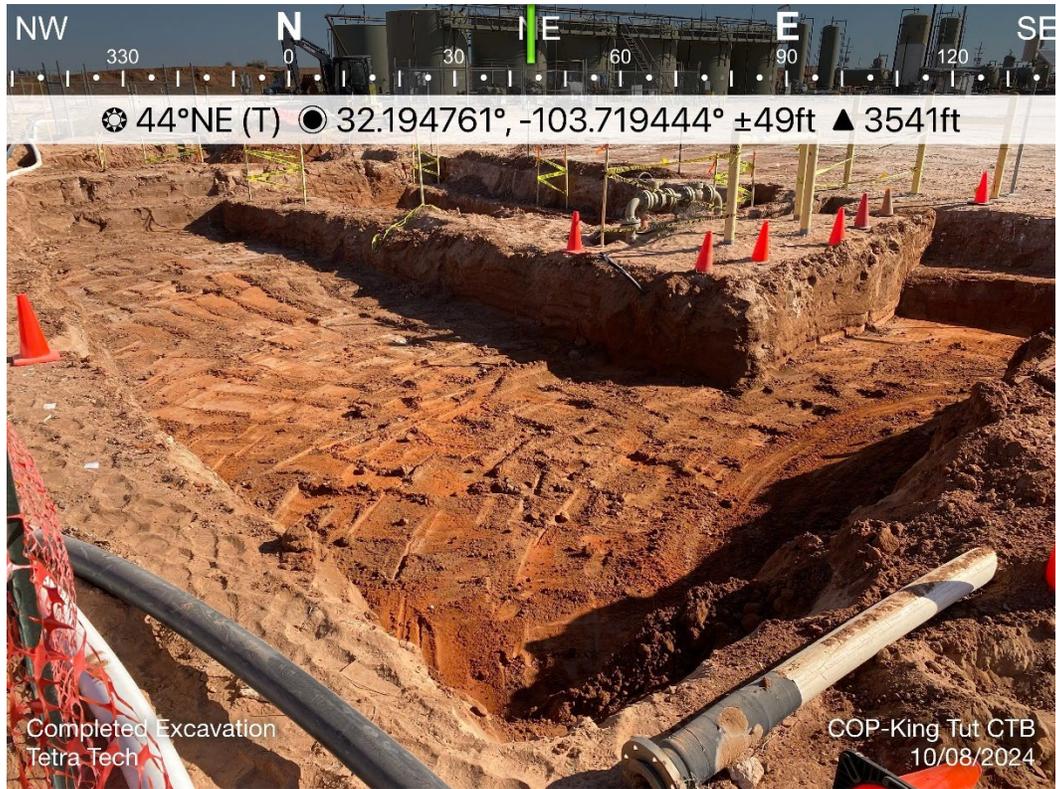
TETRA TECH, INC. PROJECT NO. 212C-MD-03225	DESCRIPTION	View northeast. Subsurface utility markings of completed excavation.	12
	SITE NAME	KING TUT FEDERAL #1 RELEASE	10/8/2024

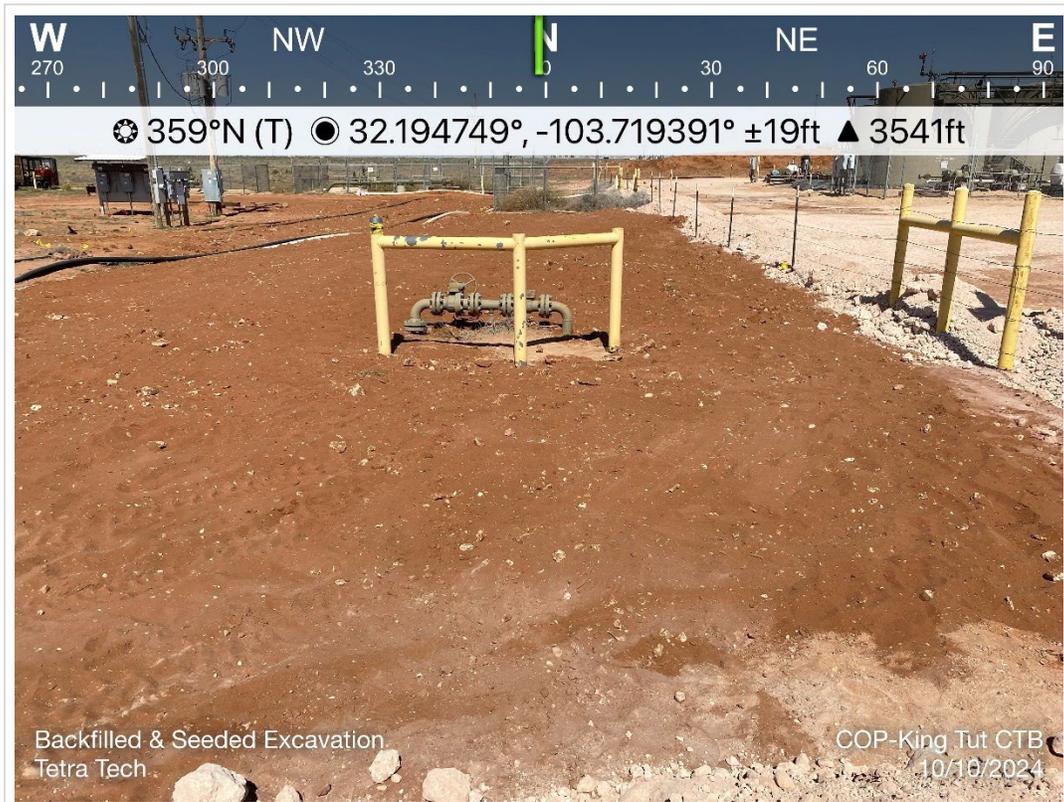
TETRA TECH, INC. PROJECT NO. 212C-MD-03225	DESCRIPTION	View north of backfilled and seeded excavation.	13
	SITE NAME	KING TUT FEDERAL #1 RELEASE	10/10/2024

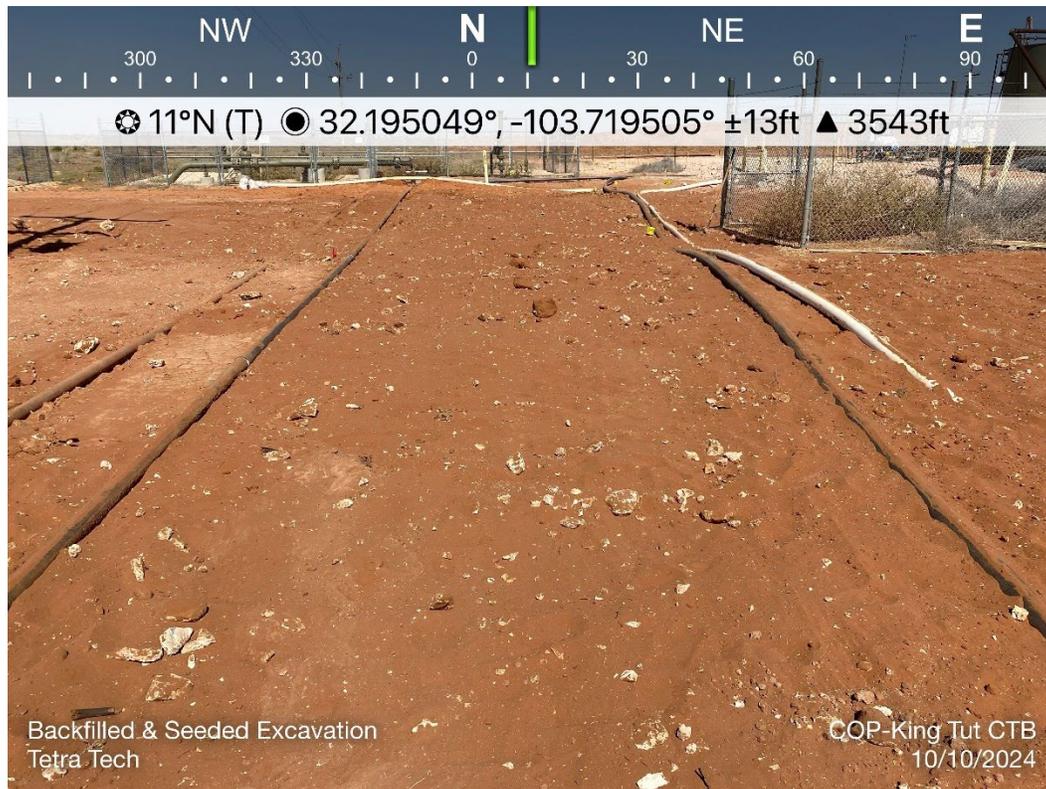
TETRA TECH, INC. PROJECT NO. 212C-MD-03225	DESCRIPTION	View north-northeast of backfilled and seeded excavation.	14
	SITE NAME	KING TUT FEDERAL #1 RELEASE	10/10/2024

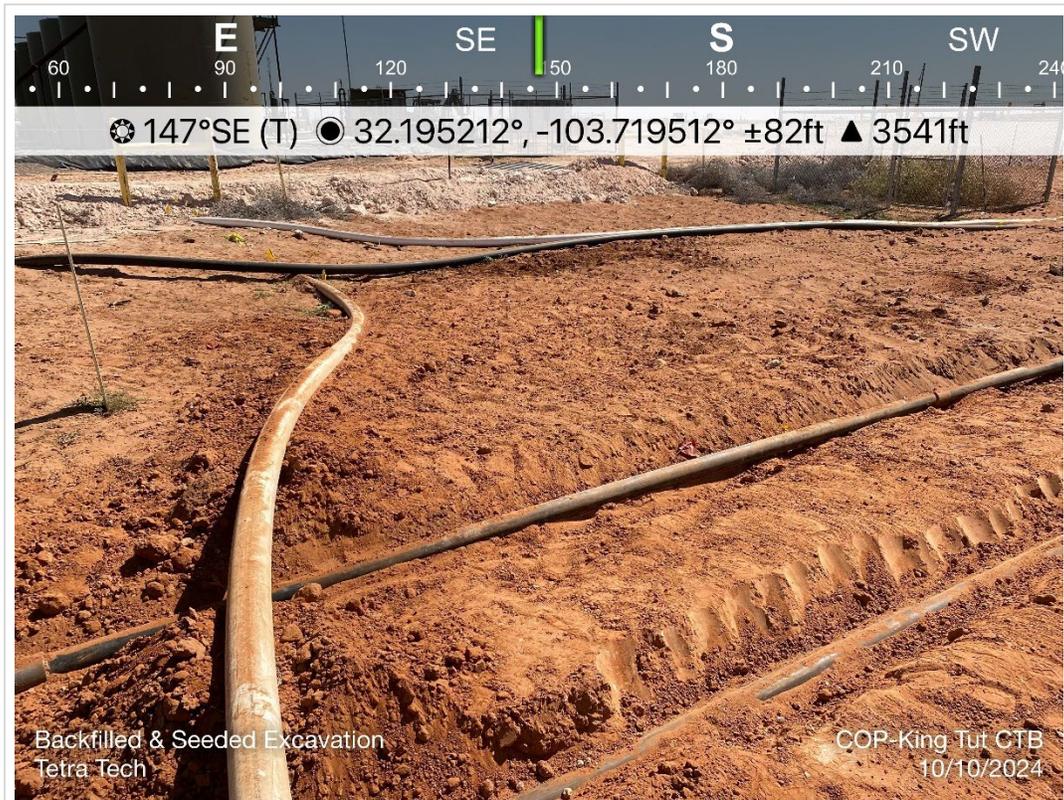
TETRA TECH, INC. PROJECT NO. 212C-MD-03225	DESCRIPTION	View south-southeast of backfilled and seeded excavation.	15
	SITE NAME	KING TUT FEDERAL #1 RELEASE	10/10/2024

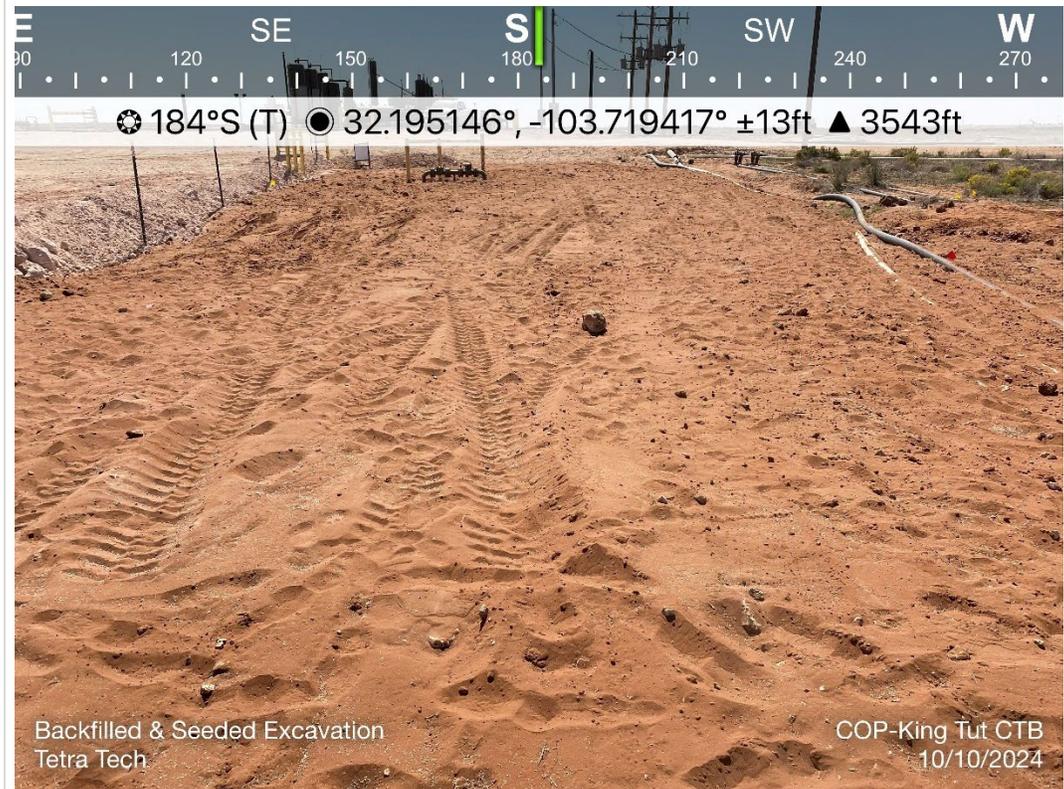
TETRA TECH, INC. PROJECT NO. 212C-MD-03225	DESCRIPTION	View south of backfilled and seeded excavation.	16
	SITE NAME	KING TUT FEDERAL #1 RELEASE	10/10/2024
