LEAK #58

Remediation Action Plan

NMOCD Incident No. nAPP2424237514

Lea, New Mexico

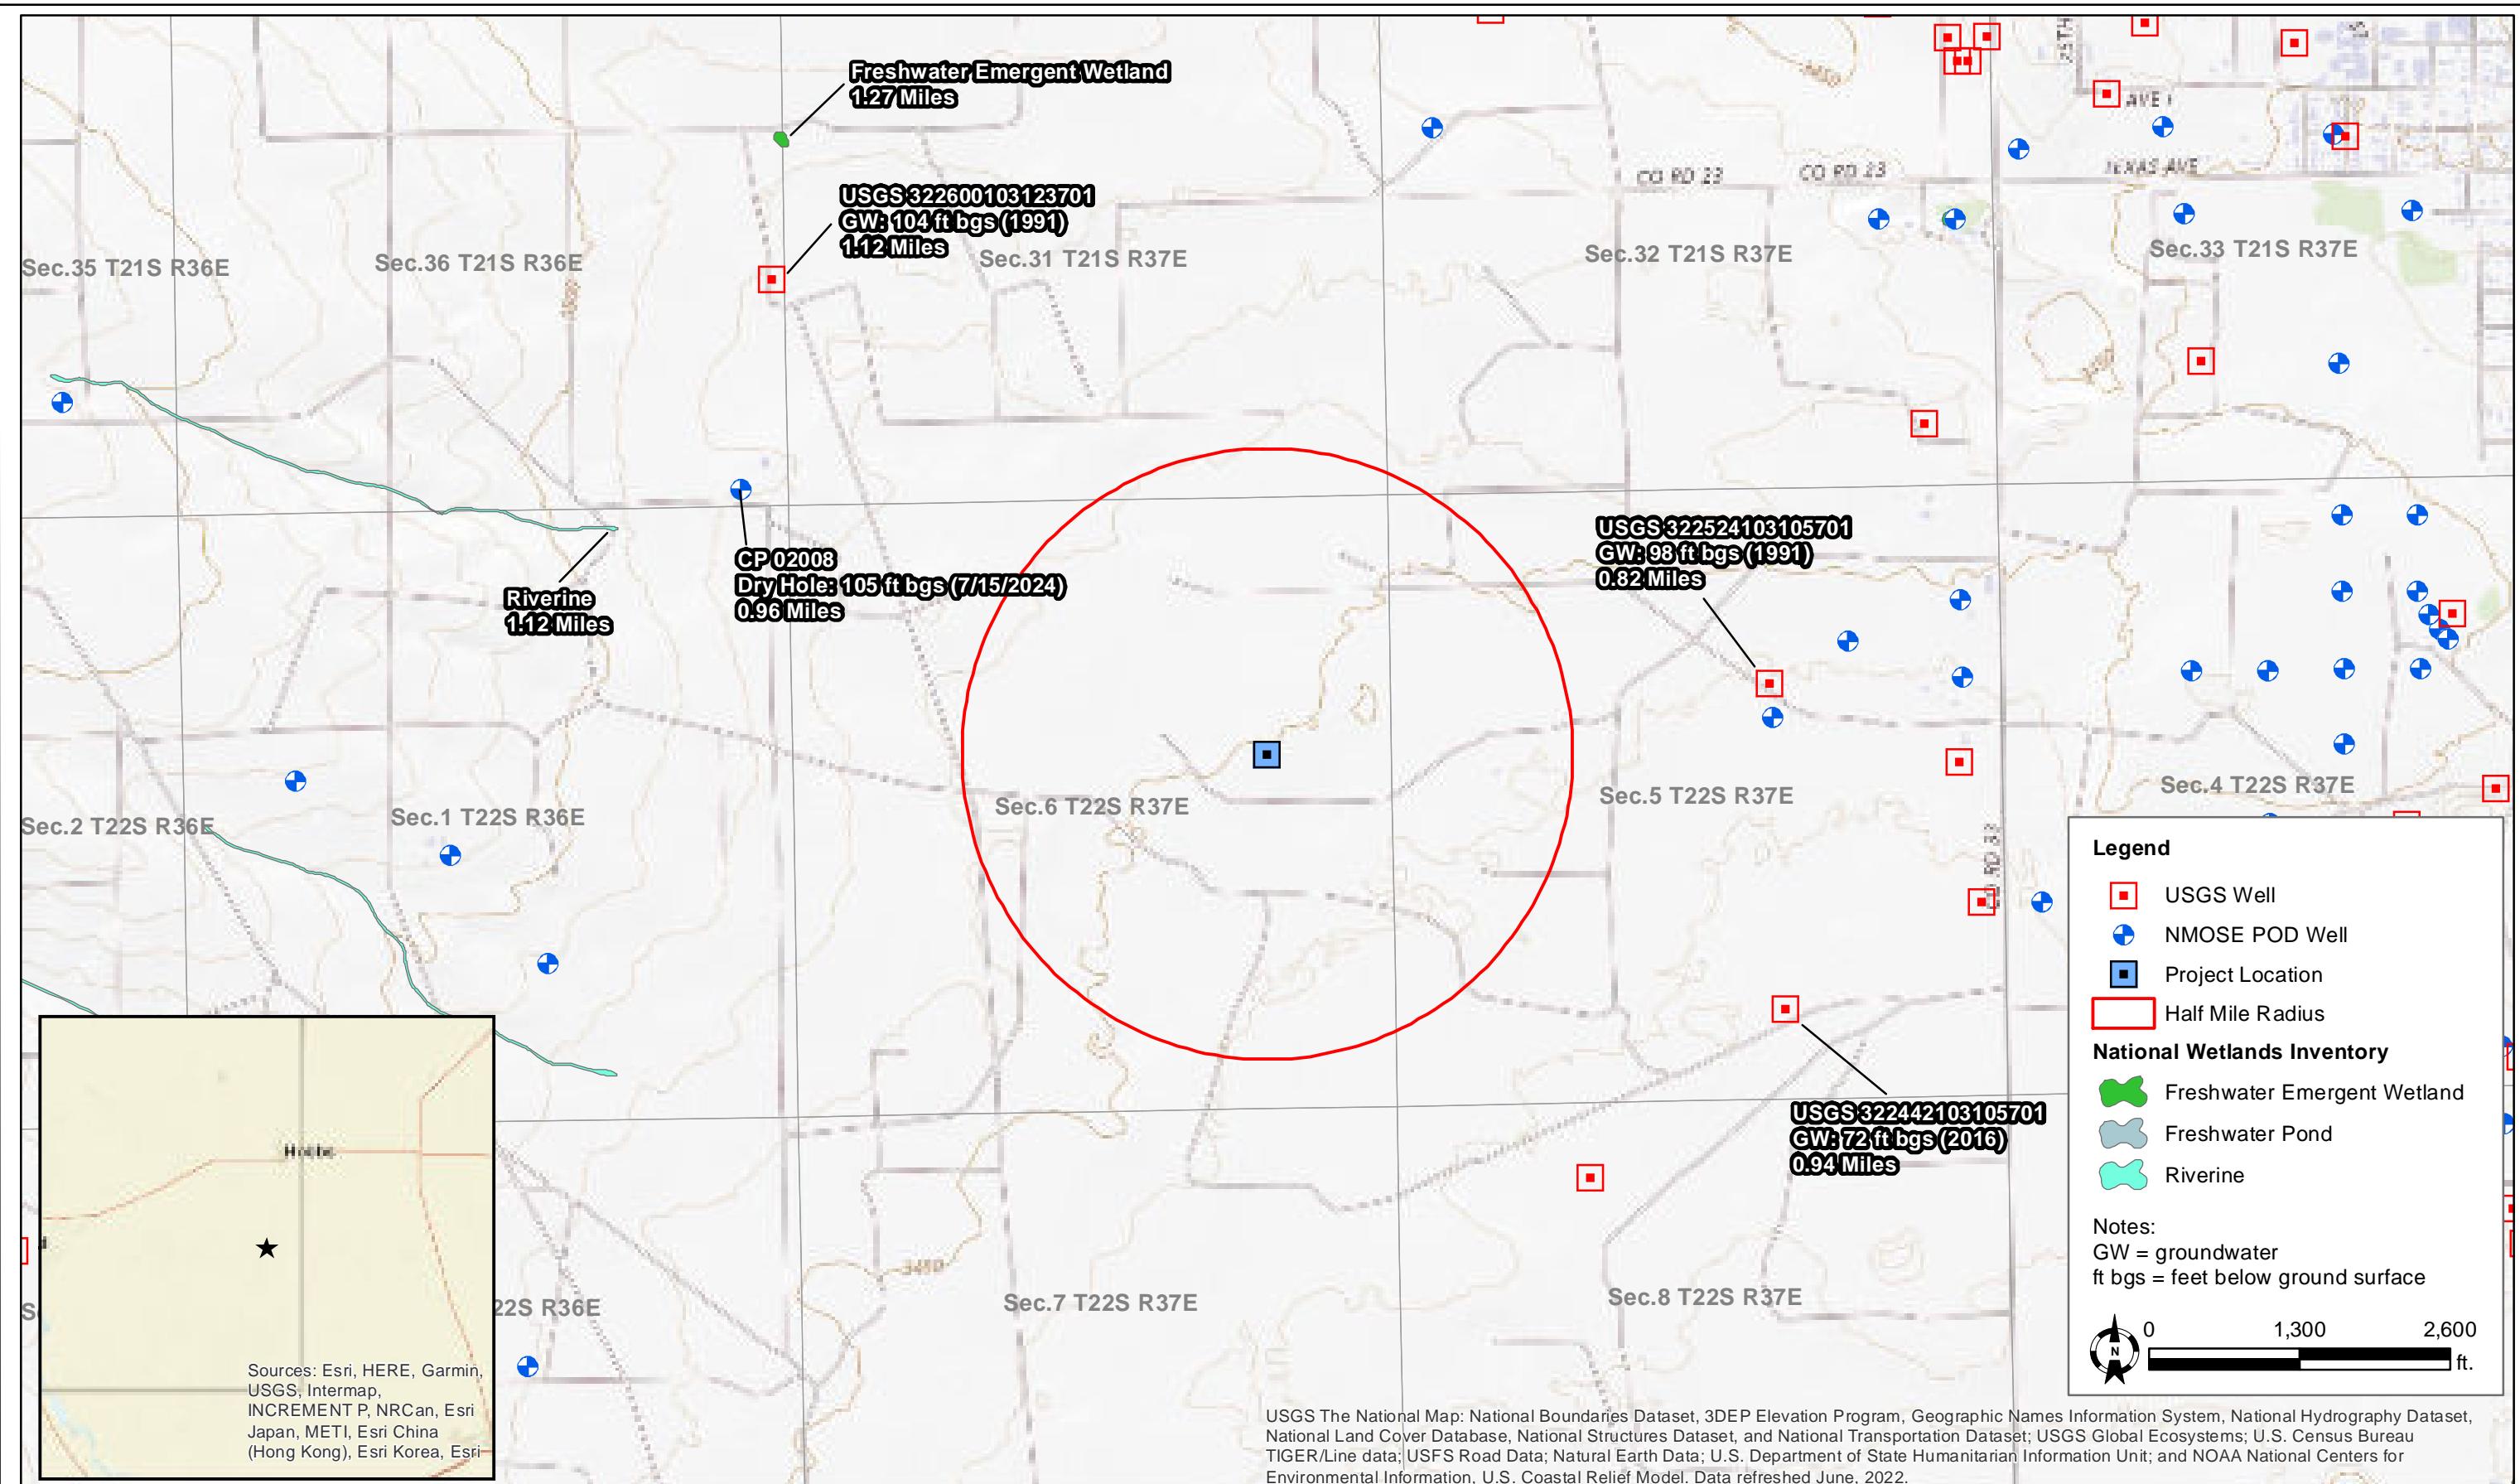
Figure 1

Site Location & Groundwater Map

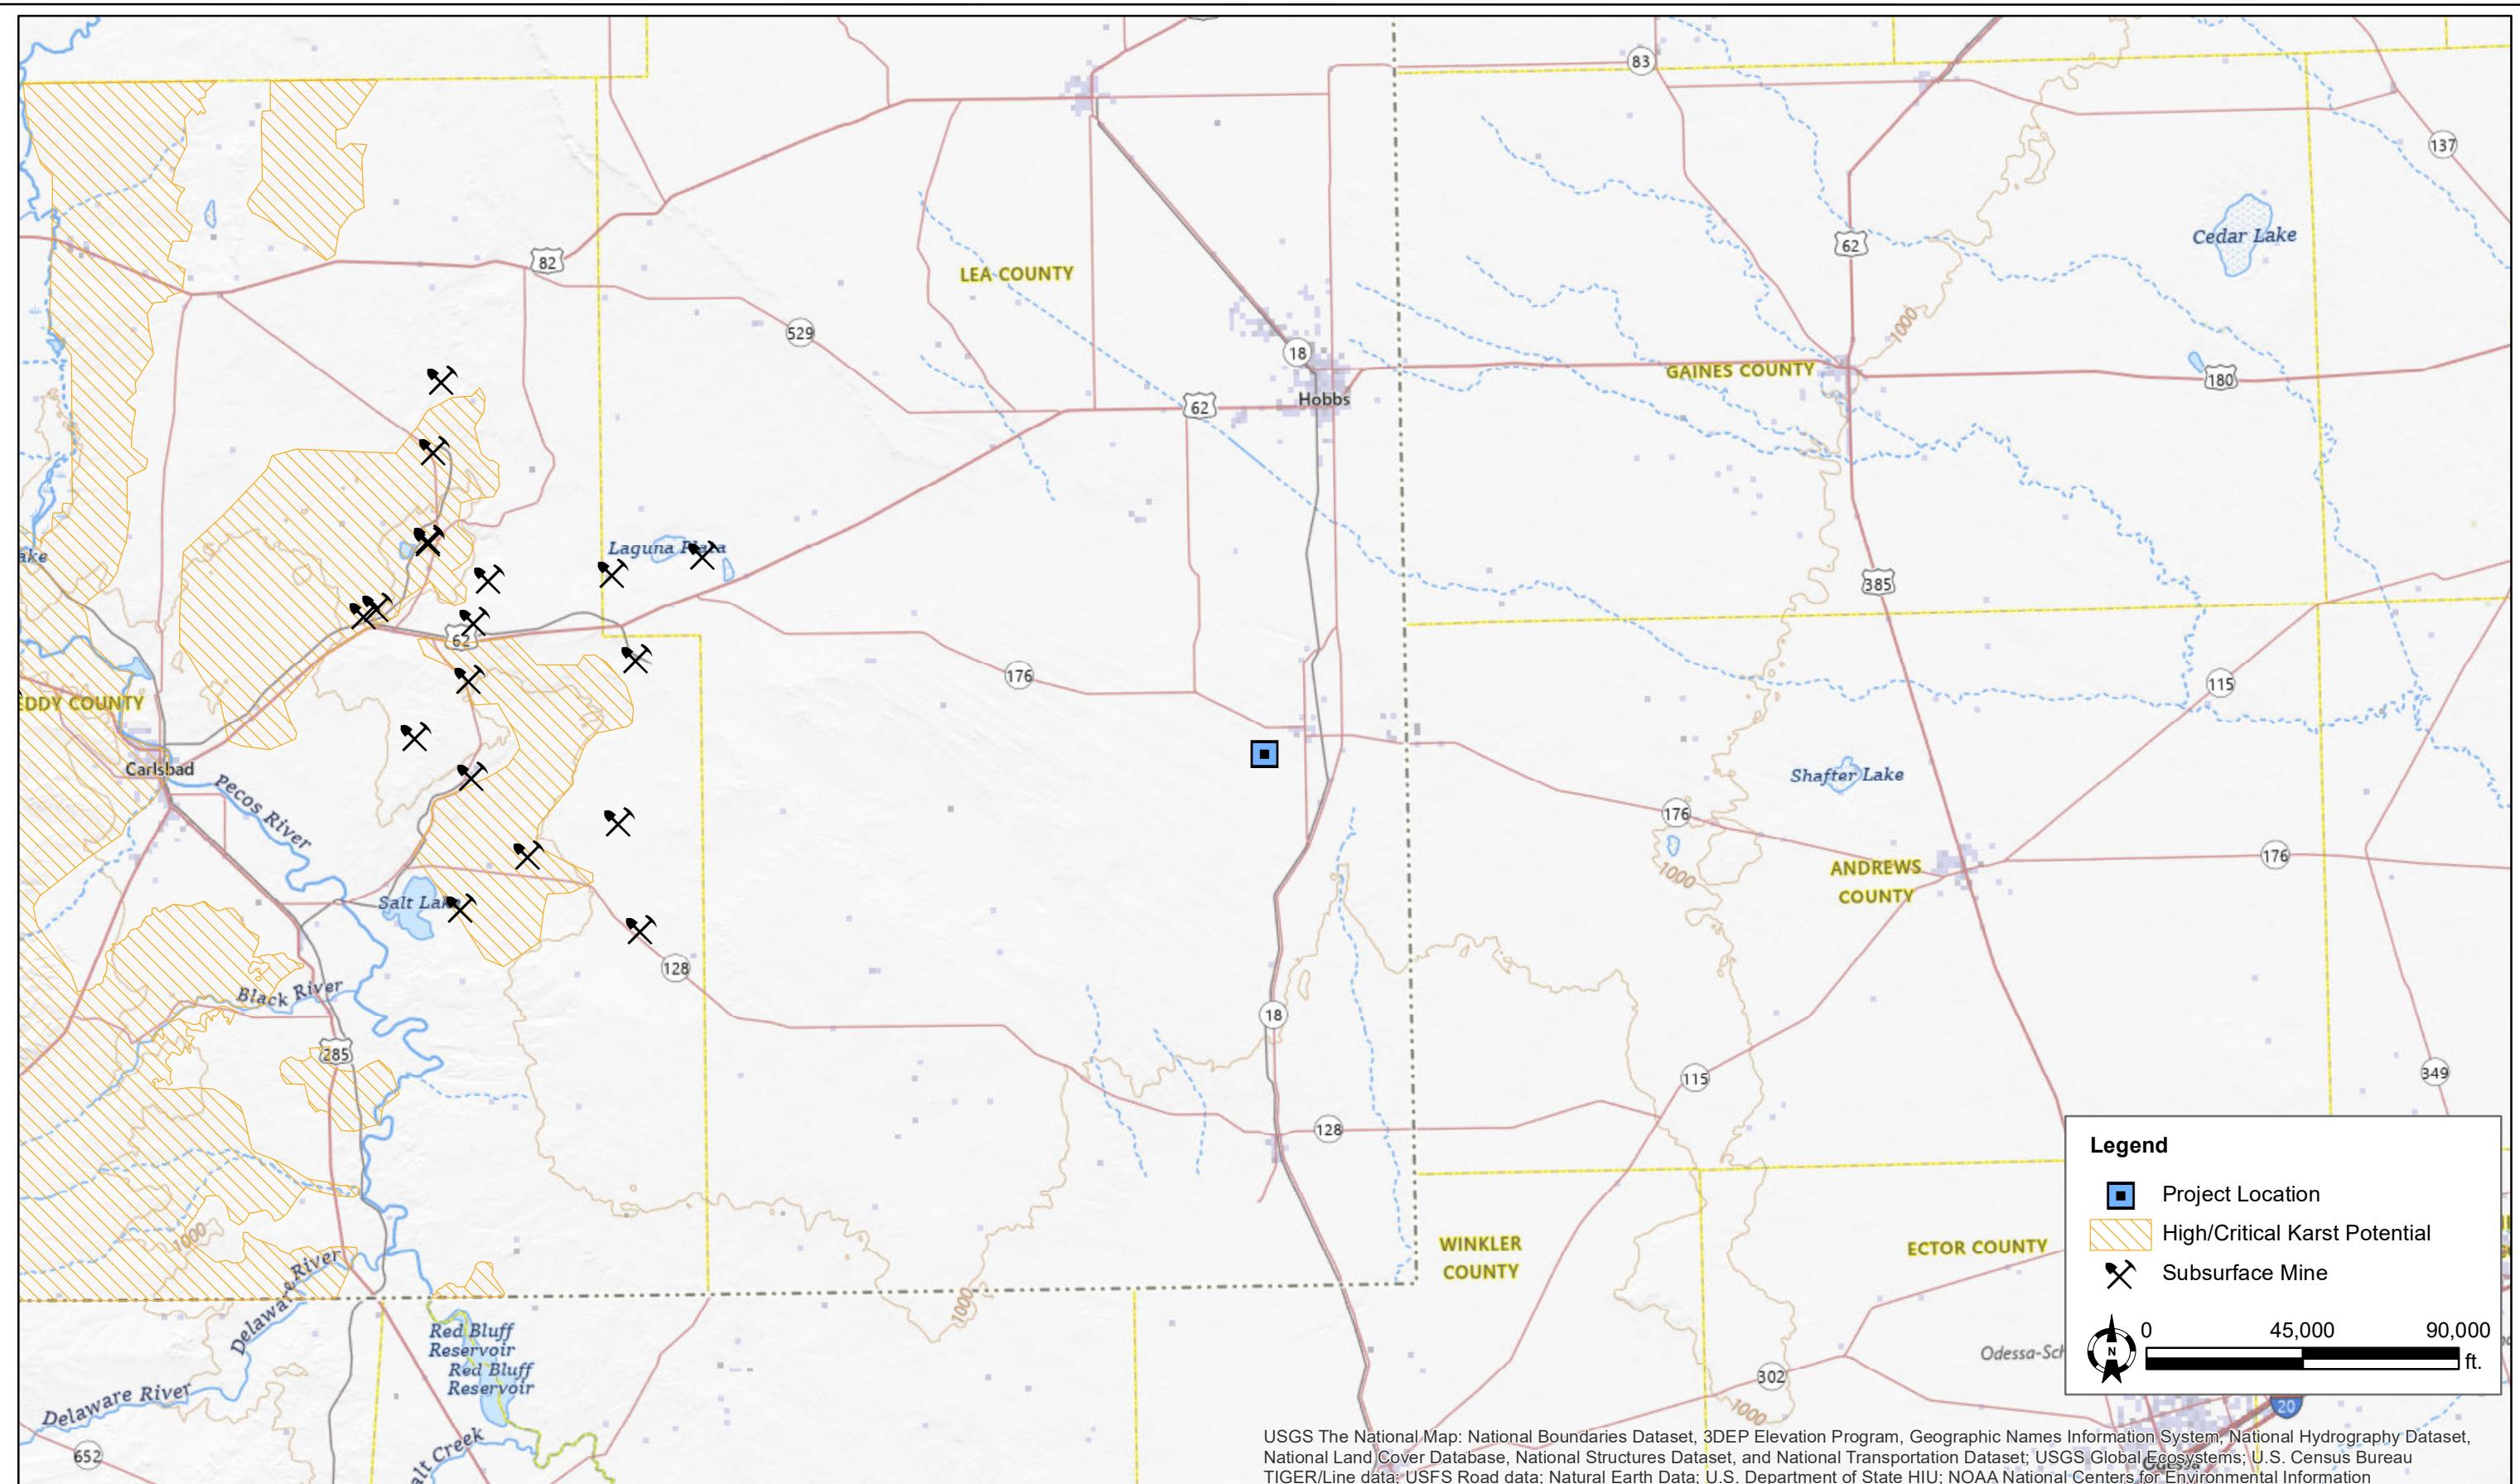
Figure 2

Karst Potential & Subsurface Mine Map

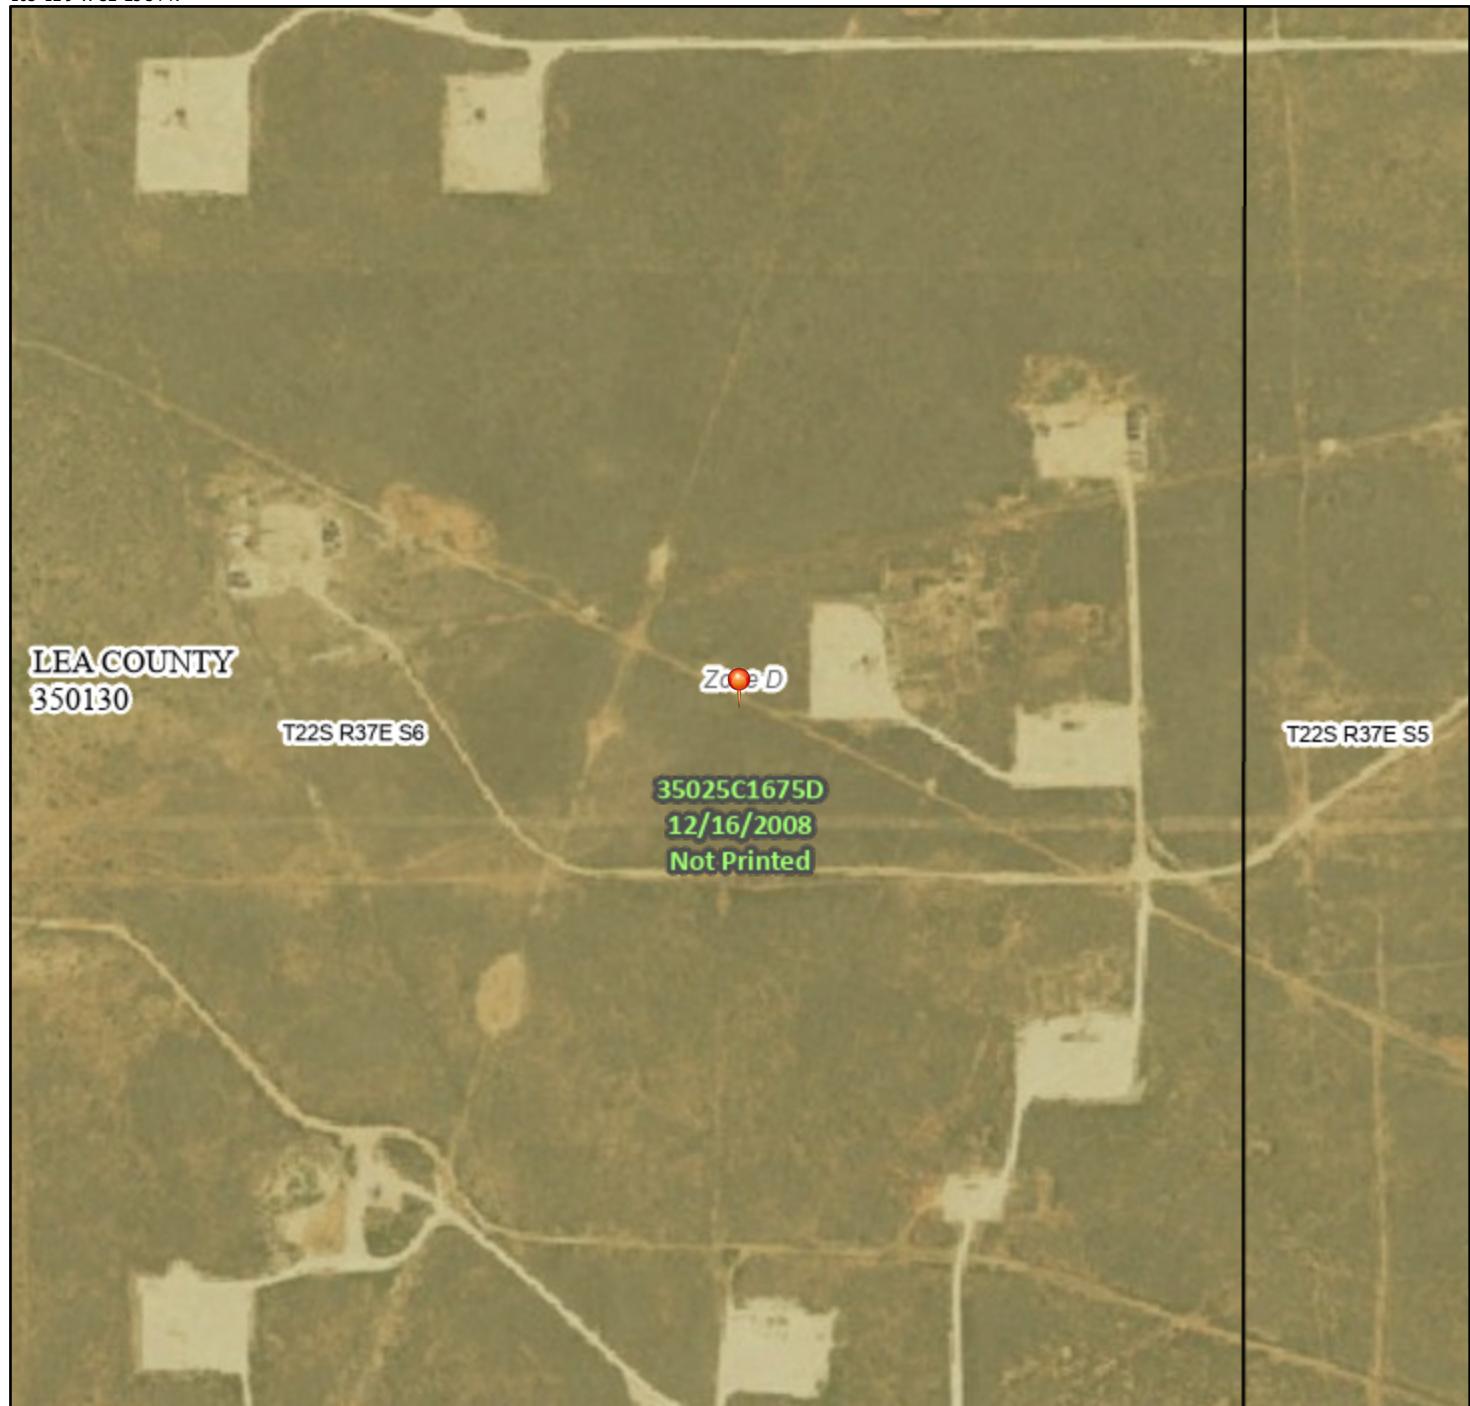
National Flood Hazard Layer FIRMette

Review of flood map data published by the Federal Emergency Management Agency (FEMA) indicates the site is not located within a 100-year floodplain. A copy of the FEMA FIRMap can be found attached as Figure 4.

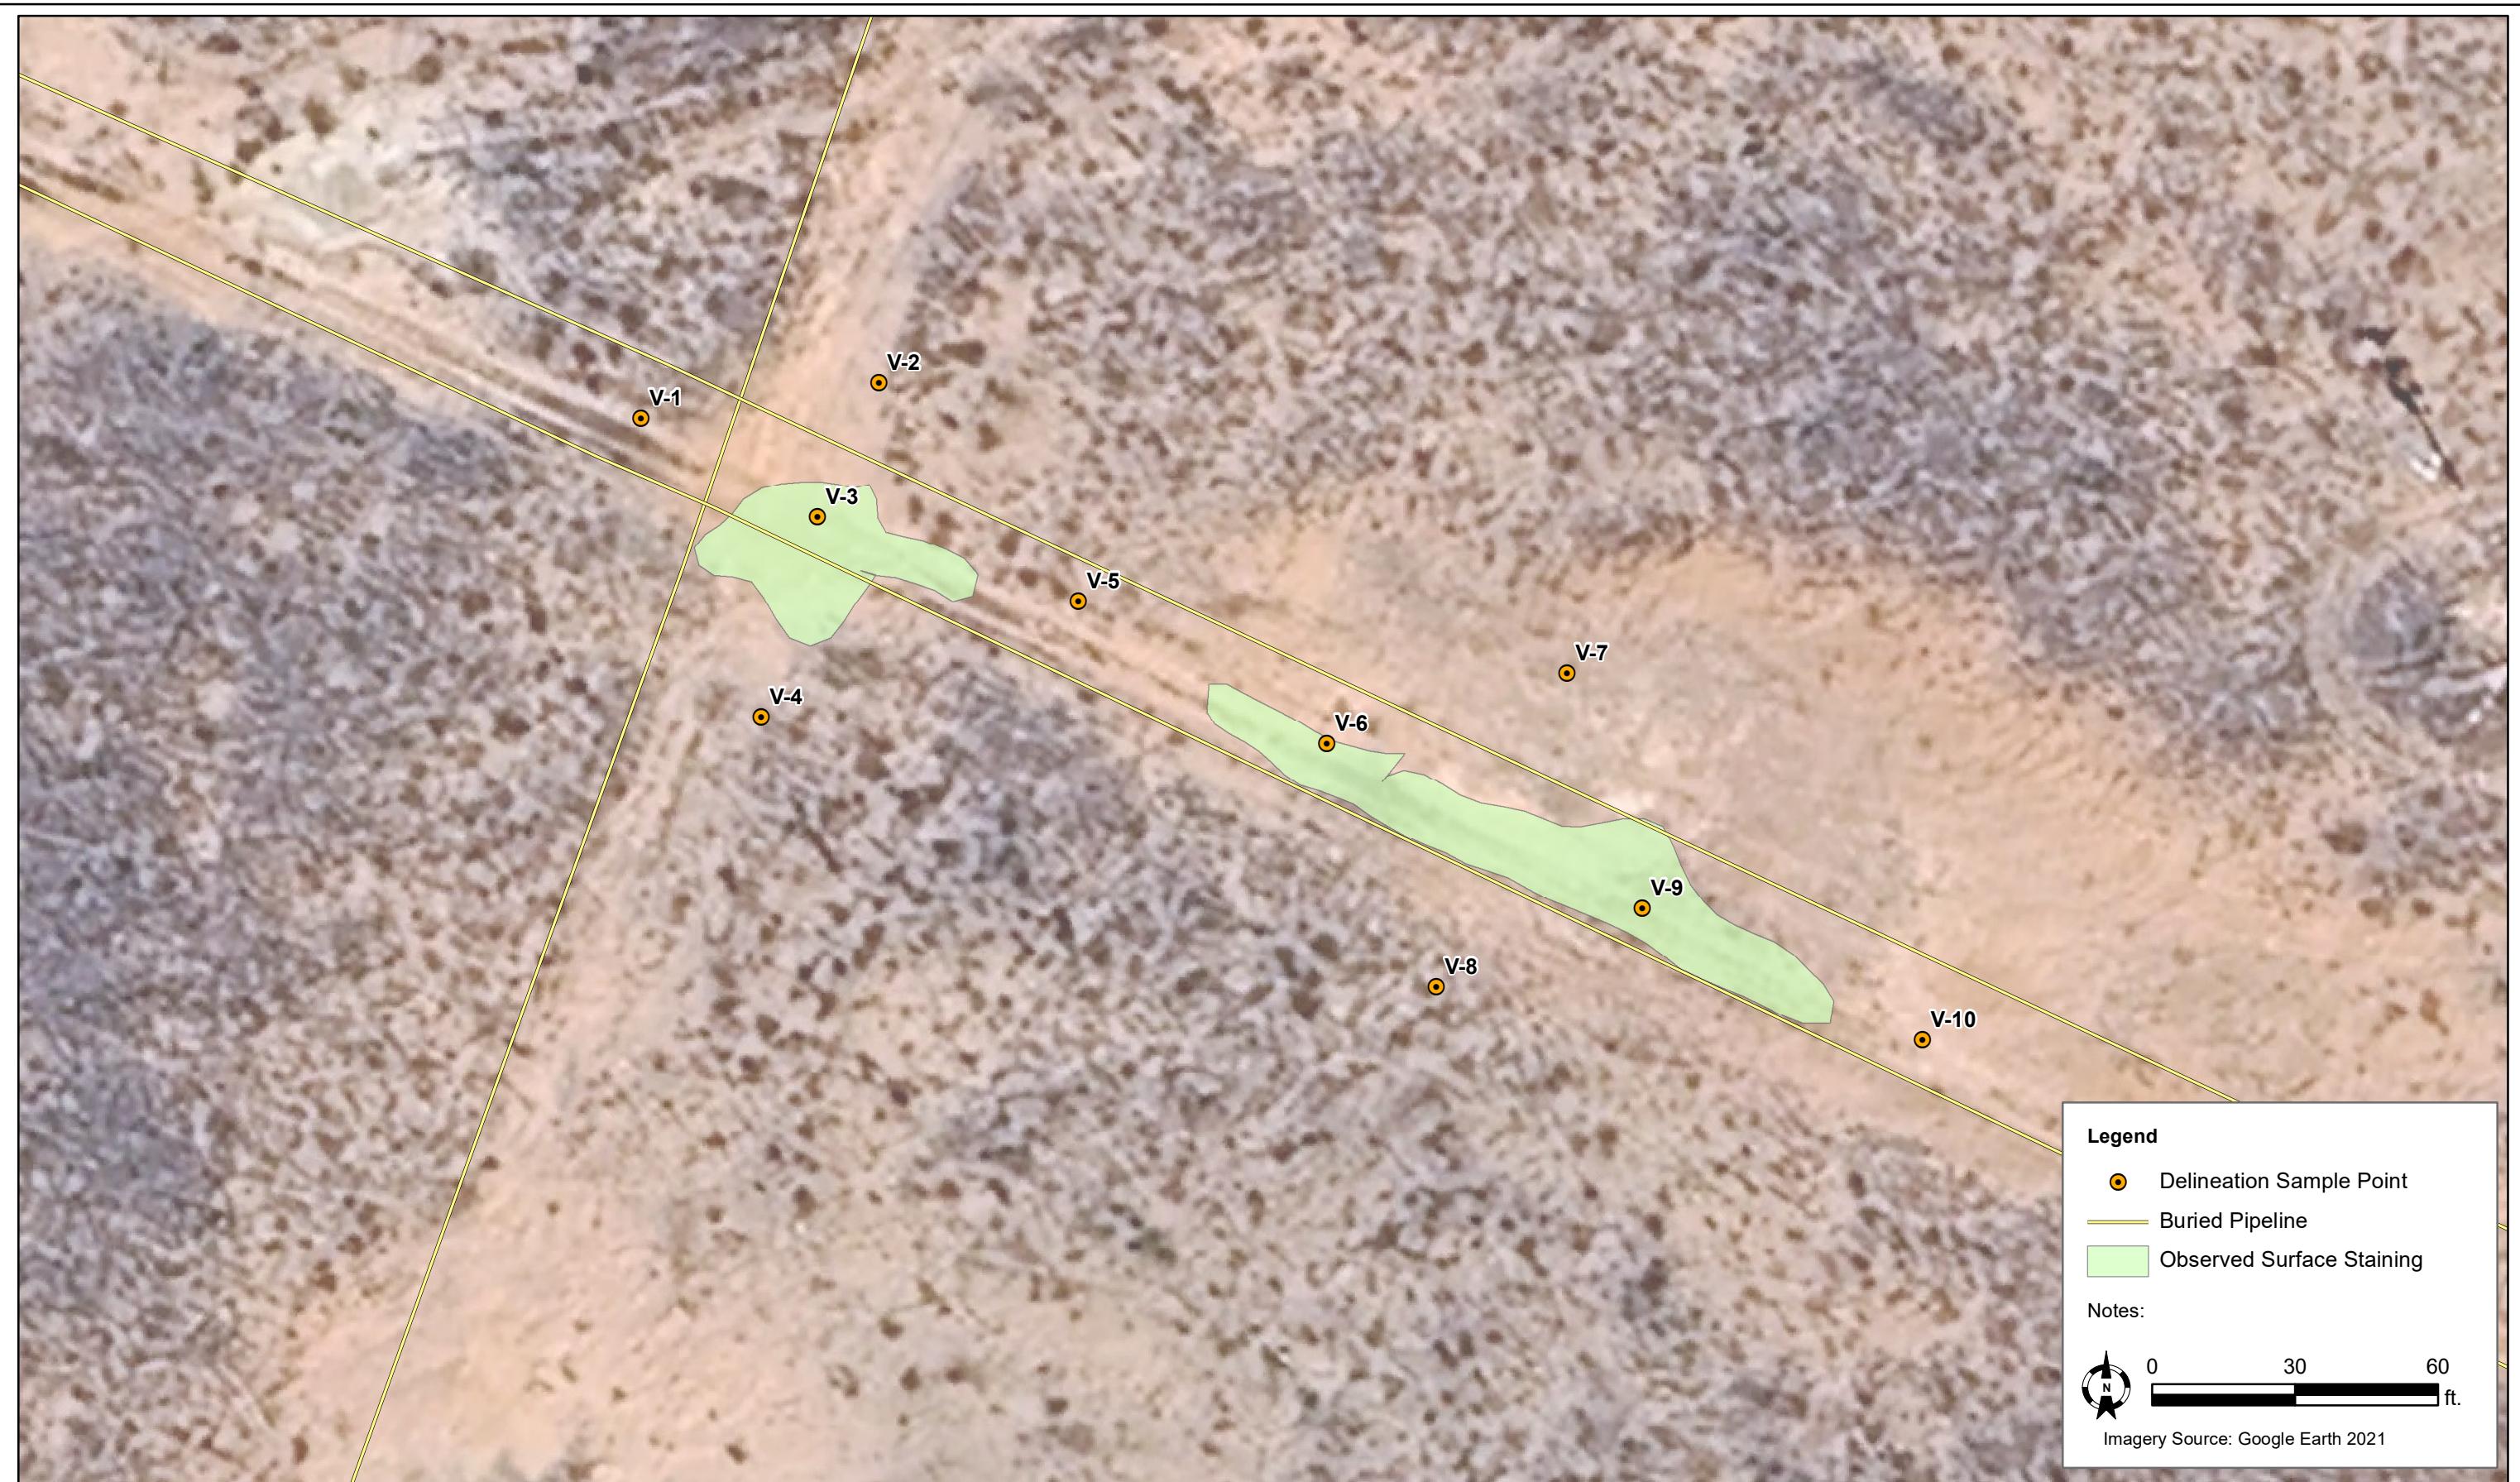
DATE: December 2024	Targa Resources Leak #58 - nAPP2424237514 UL "H", Sec. 6, T22S, R37E Lea County, New Mexico	Delineation Overview Map	Figure 5
DESIGNED BY: K. Stark			
DRAWN BY: K. Stark

The attached Figure 5 illustrates the observed release and location of soil sample locations.
