**DCP Operating Company, LP**  
**C-24-1 Line Leak - nAPP2417743733**  
 UL "N", Sec. 8, T18S, T33E  
 Lea County, New Mexico

DCP Operating Company, LP (DCP), is developing a remediation plan for the '7717\_C-24-1 Line Leak' inadvertent pipeline release, which occurred on June 23, 2024. The line leak is entirely on Bureau of Land Management (BLM)-managed lands in Lea County, New Mexico. DCP has identified the area for remediation activities (project area) (Figure 1). The project area consists of a 773-square-foot (feet<sup>2</sup>) release area, which has been heavily saturated with released fluids that penetrated the subsurface within a broader overspray area where smaller quantities of fluids were released, affecting the surface. DCP has a proposed access route to the project area originating from a caliche road to the south that passes along DCP's existing pipeline right-of-way. The overspray area is 318,000 feet<sup>2</sup>. DCP has communicated with the BLM on the necessary steps for remediation activities.

DCP\_P66 7717 C-24-1 Pipeline Dunes Sagebrush Lizard Surveys and Endangered Species Act Compliance Technical Memorandum

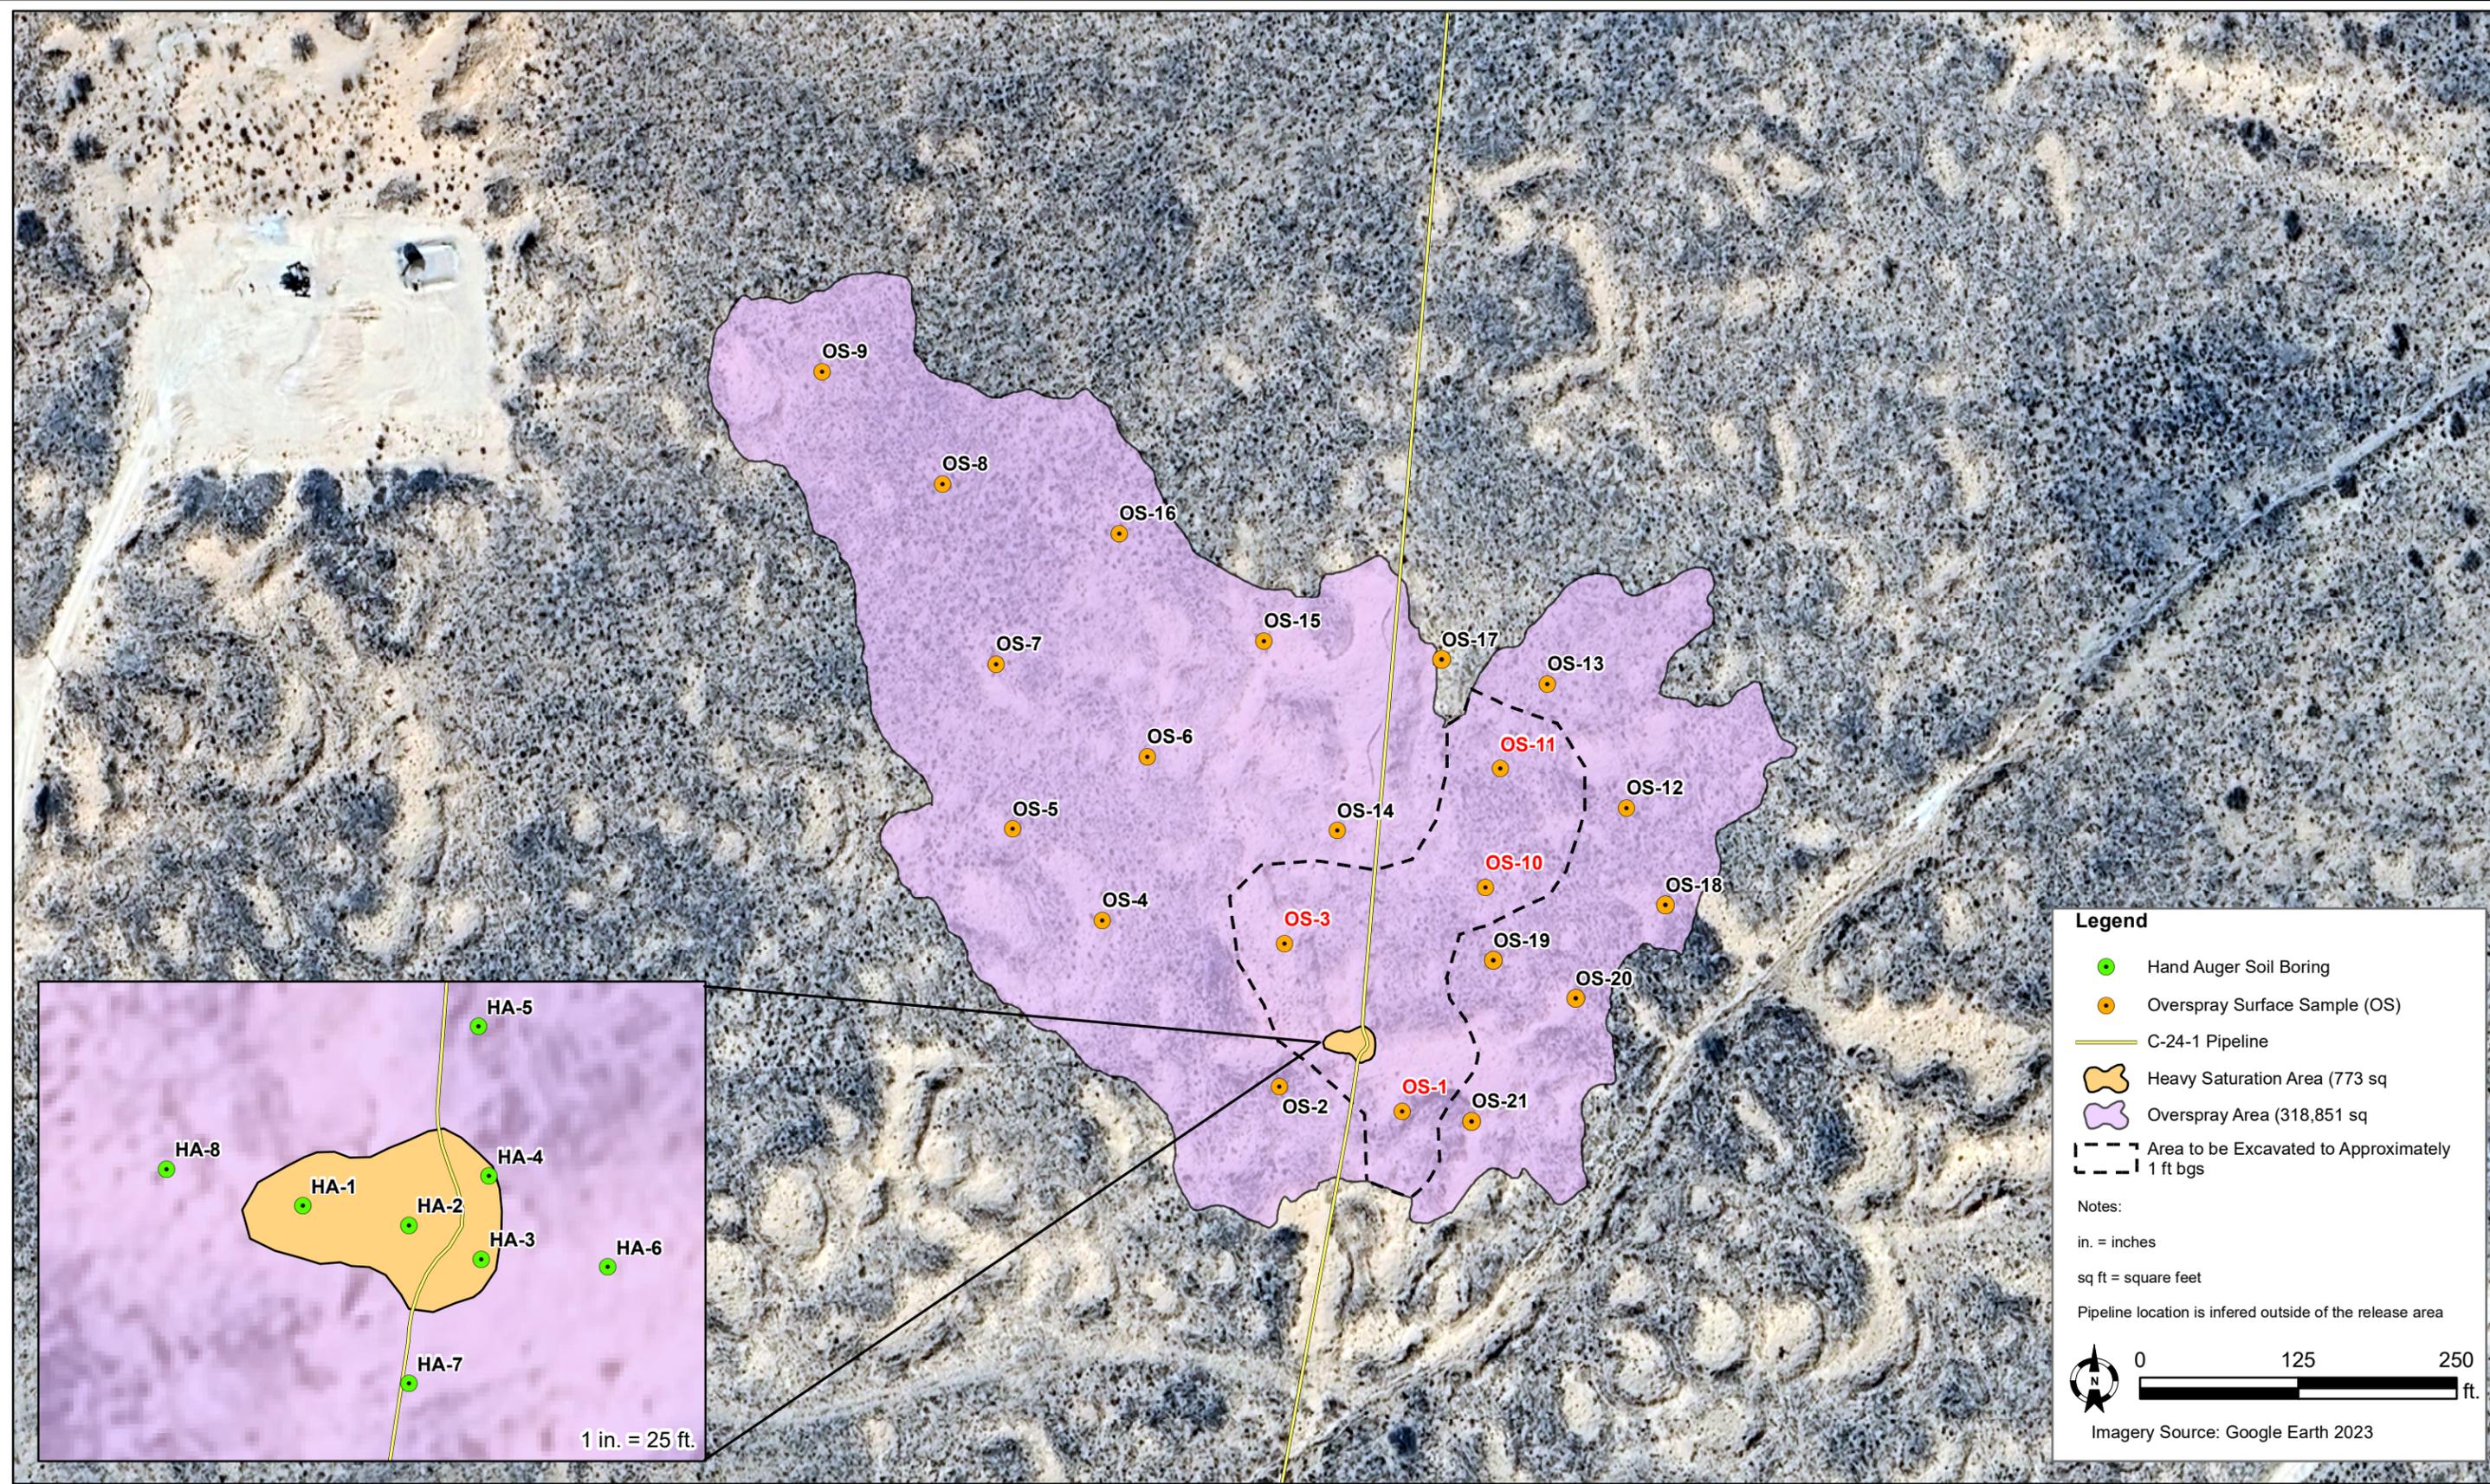
Please see the attached delineation figure, table and analytical report on the samples that were OS-17 through OS-21. The site is fully delineated with the samples collected on February 5, 2025. Tasman on behalf of Phillips 66 request a confirmation sample variance to collect 5-point composite samples at 400 sq. ft. area.

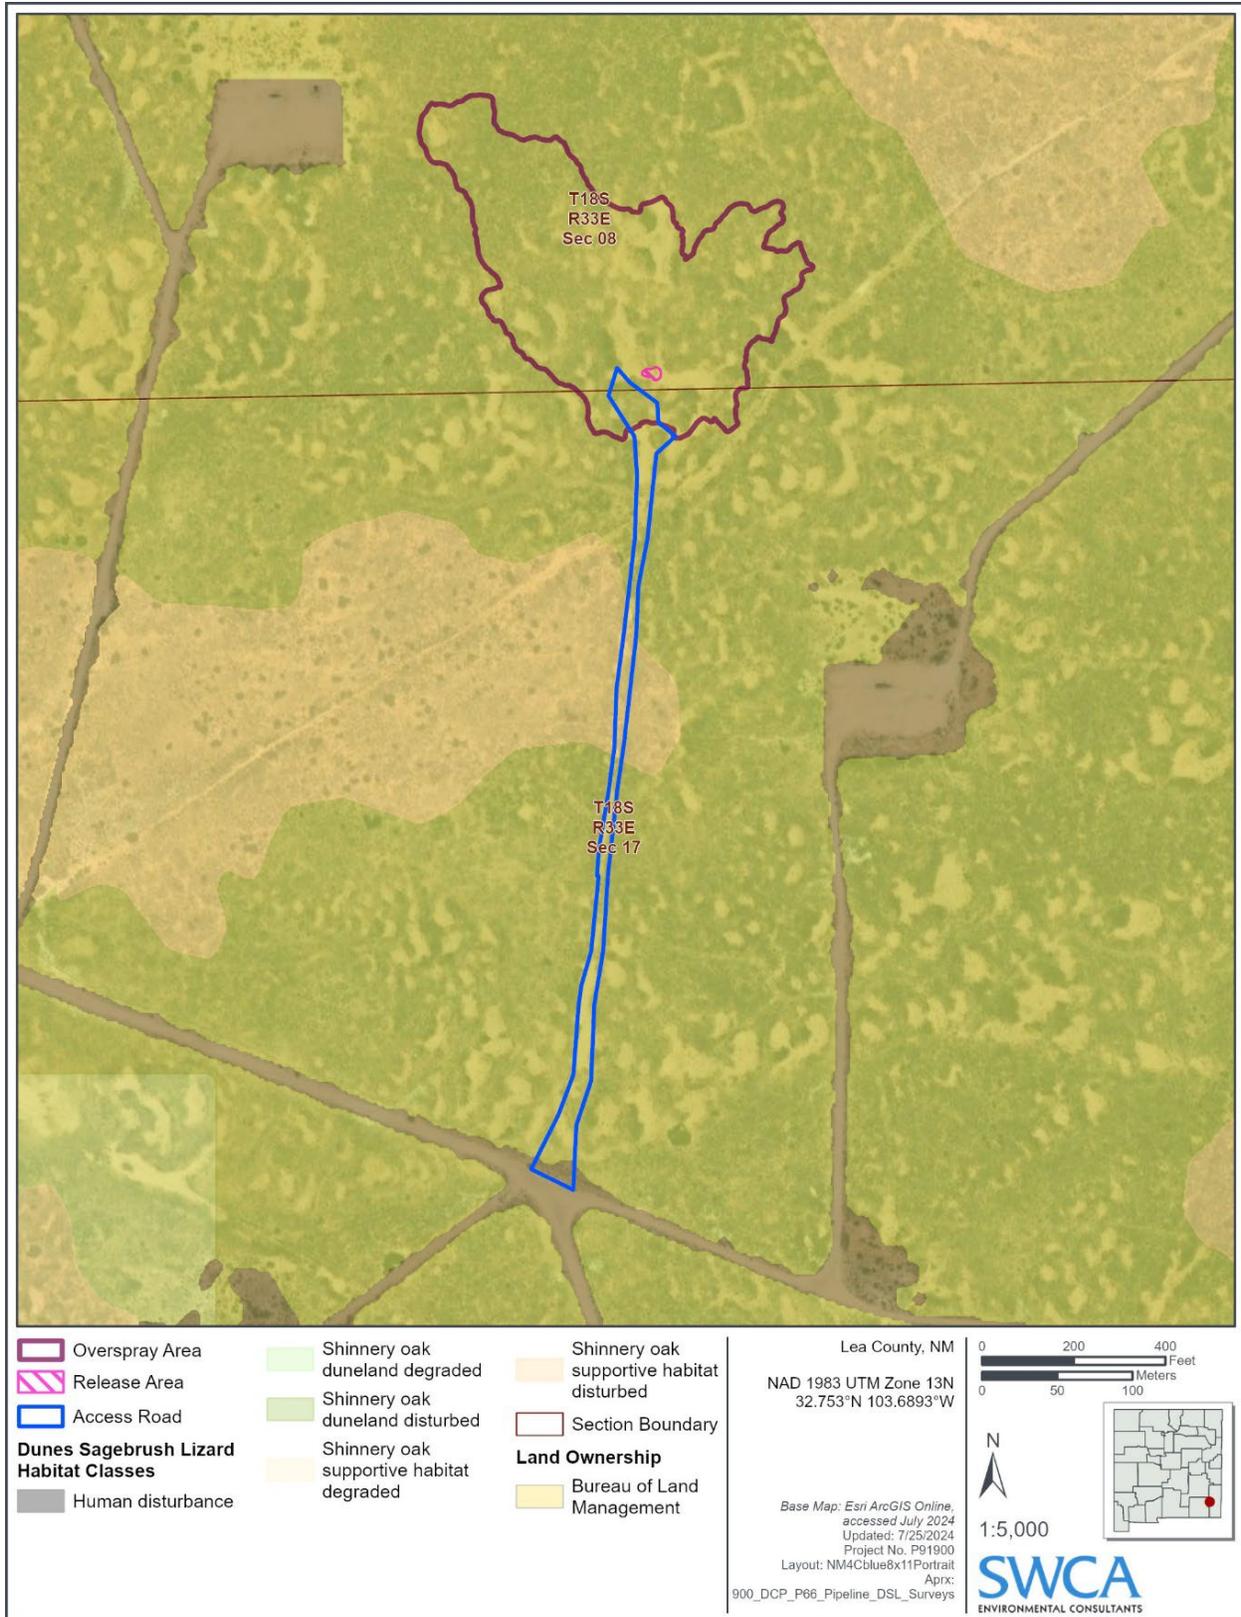
Figure 1. Project area, proposed access pathway, and U.S. Fish and Wildlife Service–modeled dunes sagebrush lizard habitat in the vicinity of the project area.

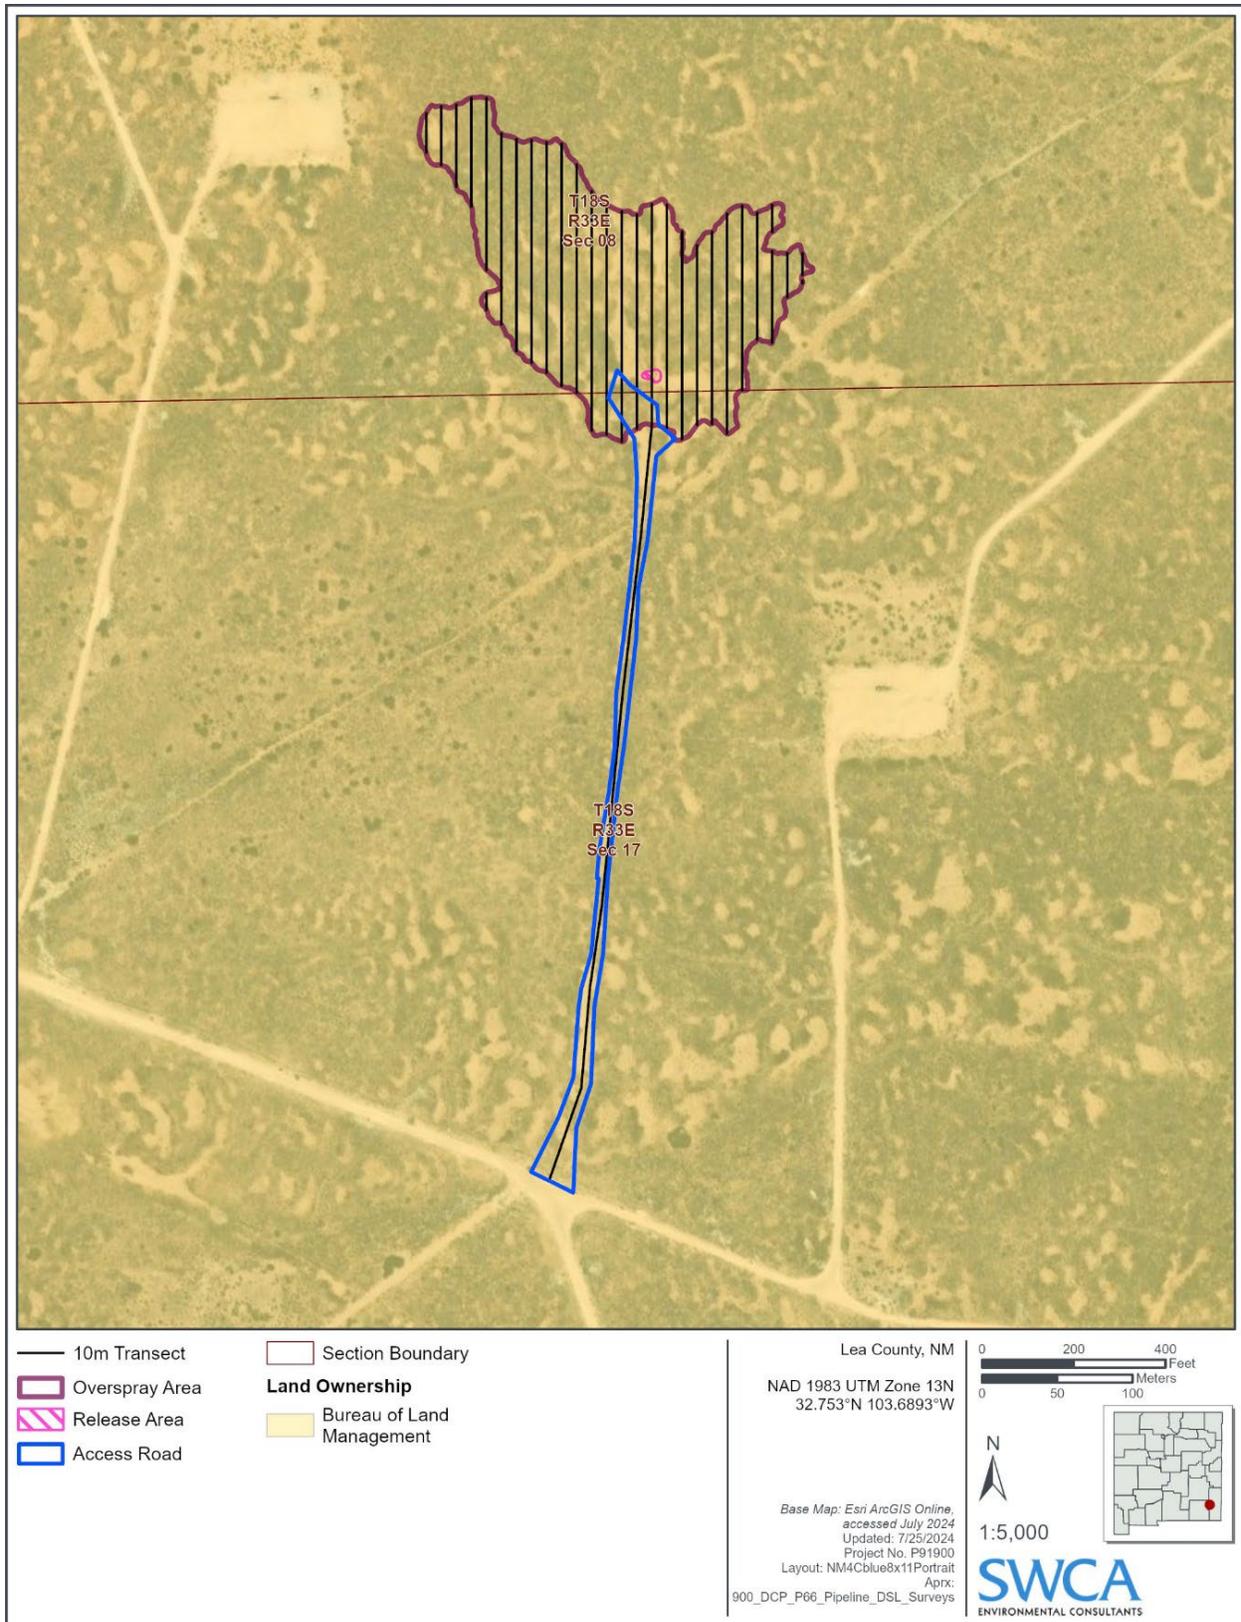
Figure 2. Project area with pedestrian survey transect locations.

SWCA biologists conducted the surveys on July 30 and July 31, 2024. SWCA biologists conducted the pedestrian surveys each day between approximately 8:00 a.m. and 12:00 p.m. The survey effort consisted of 16-person hours (i.e., total number of hours spent on site × two biologists) of visual searching along the 27 transects that spanned the project area. Weather conditions during the survey period, as recorded by the nearest local weather station (Lea County Regional Airport-KHOB) (Weather Underground 2024), were suitable for DSL activity (Fitzgerald and Painter 2009; Fitzgerald et al. 2011; Sartorius et al. 2002) (Table 1).

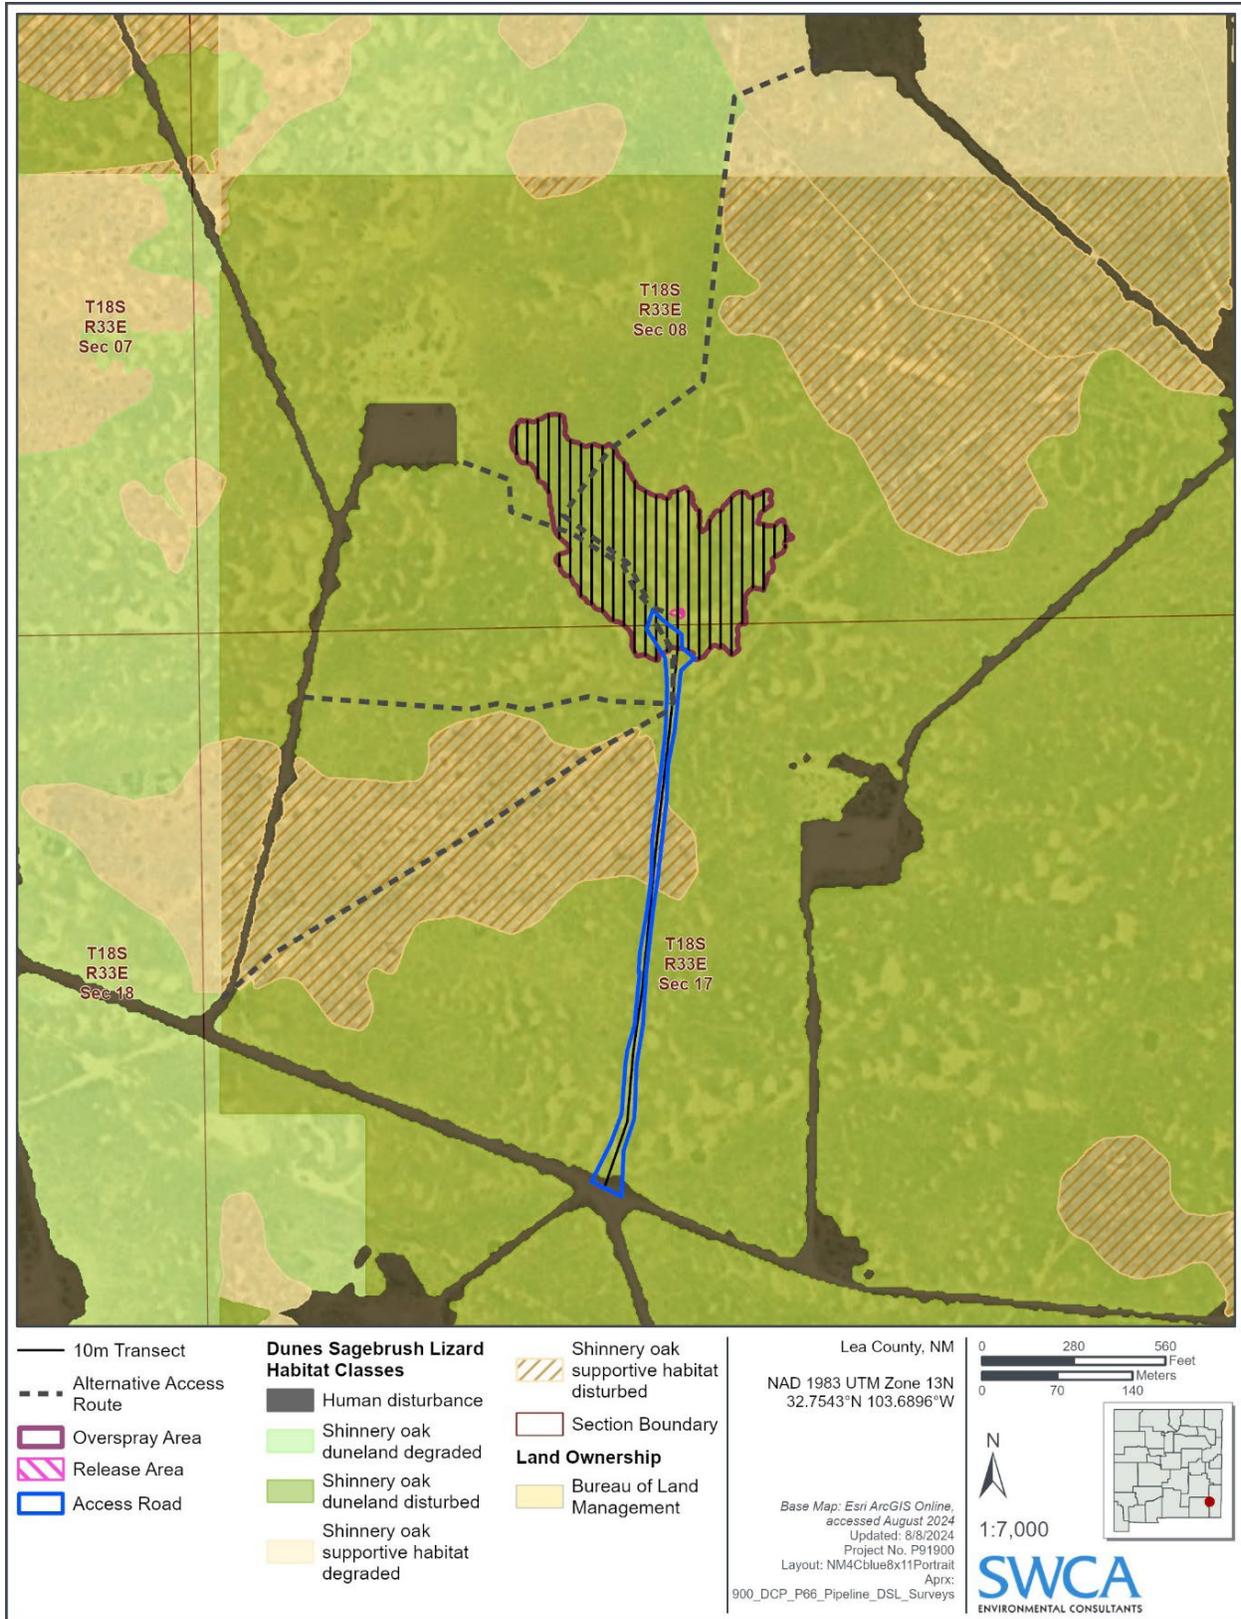
Figure 3. Project area, proposed access pathway, and U.S. Fish and Wildlife Service-modeled dunes sagebrush lizard habitat in the vicinity of the project area.

DSL use shinnery oak dunelands for breeding, feeding, sheltering (Degenhardt and Jones 1972; Fitzgerald et al. 2022; Hill and Fitzgerald 2007; Ryberg et al. 2012; USFWS 2024). Shinnery oak supportive habitat may be used by DSL for dispersal (Fitzgerald et al. 2005; Johnson et al. 2016; USFWS 2024). Although no DSL were detected in shinnery oak dunelands and shinnery oak supportive habitat during the pedestrian survey, project activities may still adversely affect DSL. To minimize effects to DSL, SWCA biologists propose four alternative access routes to the project area (Figure 3). These access routes are intended to skirt or minimally span the shinnery oak duneland and pass through shinnery oak supportive habitat. By doing so, effects to the habitats that support key behaviors of DSL may be minimized. Some routes originate at well pads that may be used for staging. Staging equipment outside of the shinnery oak dunelands where practicable would also minimize impacts to DSL.

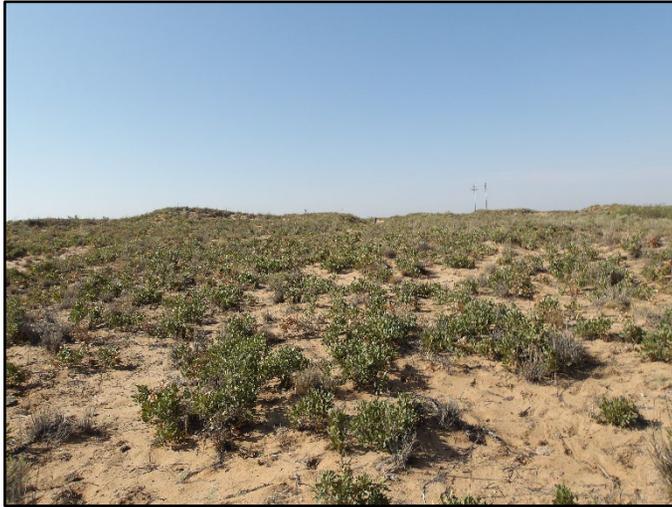
**Figure B-1. Representative photograph of shinnery oak dunelands along the proposed access road as seen from an offset point; view facing south toward the proposed access route.**

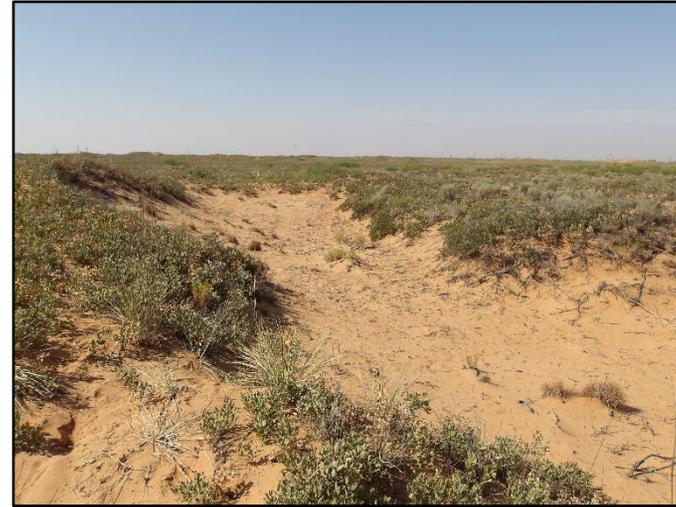
**Figure B-2. Representative photograph of shinnery oak dunelands in the overspray portion of the project area; view facing south toward the proposed access route.**

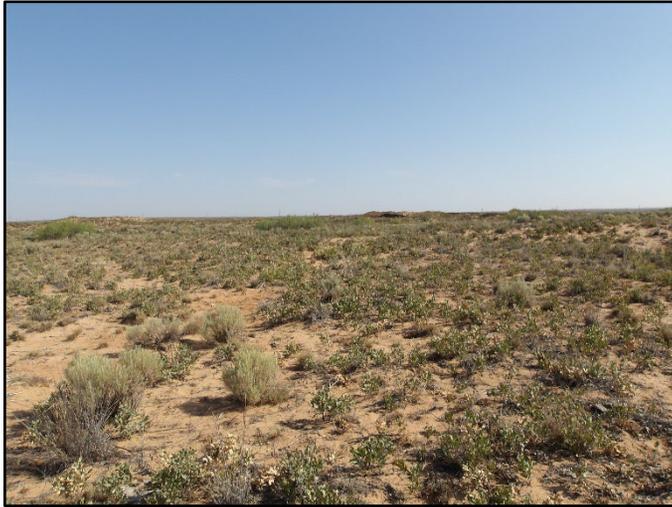
**Figure B-3. Representative photograph of shinnery oak supportive habitat along the proposed access route to the project area; view facing north.**

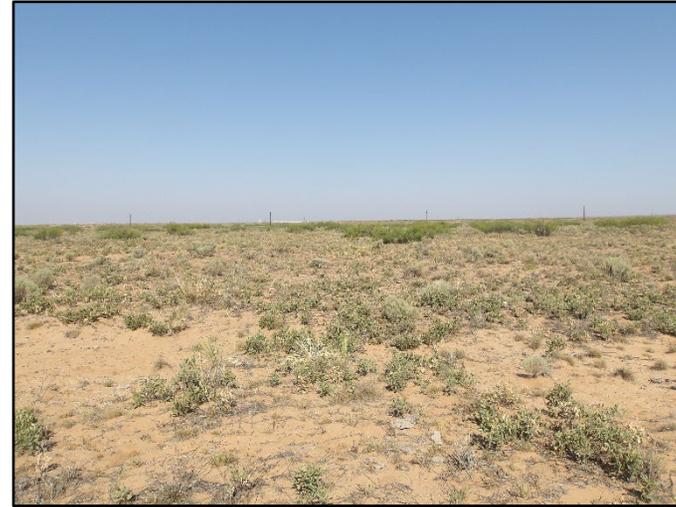
**Figure B-4. Representative photograph of shinnery oak supportive habitat along the proposed access route to the project area; view facing west.**

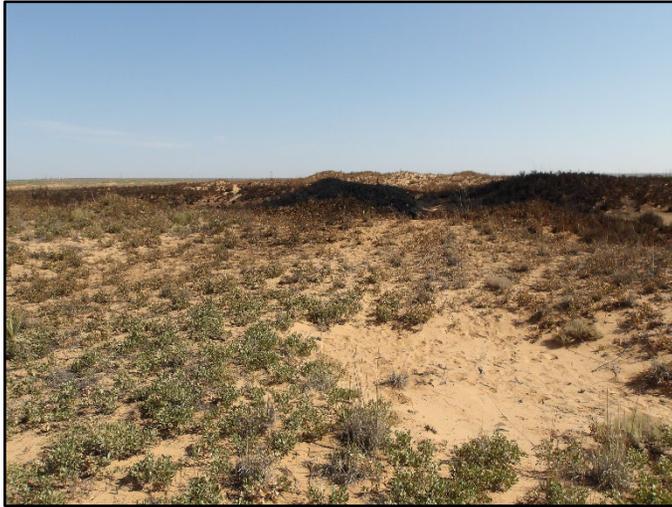
The release area had very little evidence of current use by wildlife. There were no live, physically wounded, or dead vertebrate wildlife, including lizards in the release area (see Appendix B). There were some live aerial insects flying near to but over the dead vegetation in the release area and a few dead insects in the release area where pooled fluids remain. SWCA biologists also observed some footprints of coyote (*Canis latrans*) and rabbit in the release area.

**Figure B-5. Representative photograph of shinnery oak dunelands in the release area within the project area; view facing north from the proposed access route.**

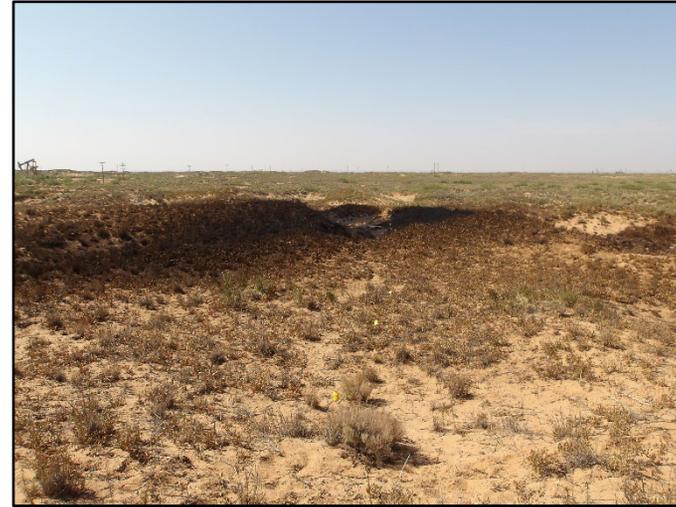
**Figure B-6. Representative photograph of shinnery oak dunelands in the release area within the project area; view facing south from a location in the overspray area.**

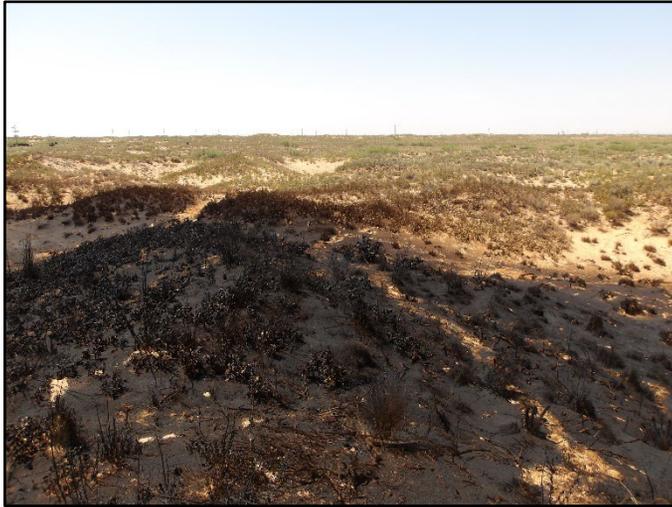
Immediately adjacent to the release area where the soil was minimally covered with release fluids and where some live vegetation persists, SWCA biologists observed side-blotched lizards, whiptail lizards, and other vertebrate wildlife and insects (see Appendix B).

**Figure B-7. Representative photograph demonstrating gradation of released fluids across the surface in foreground and background in the project area. Some wildlife tracks present; view facing south.**

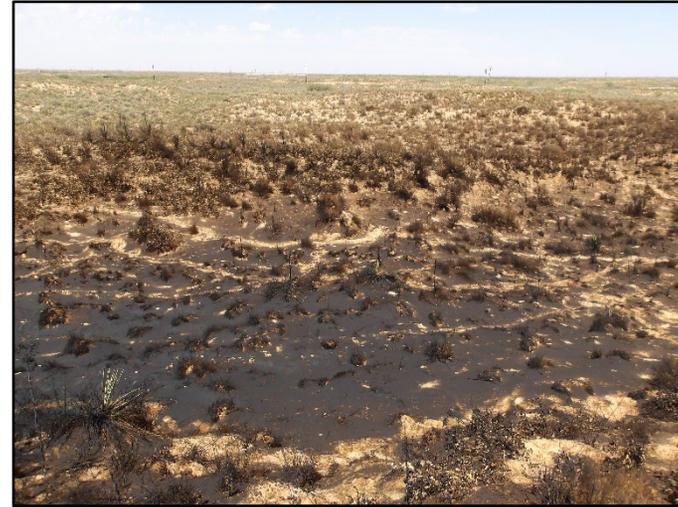
**Figure B-8. Representative photograph demonstrating gradation of released fluids across the surface in foreground and background in the project area. Some wildlife track present; view facing west.**
