Remediation Summary & Soil Closure Request

Mewbourne Oil Company Victory 26 Federal #1

Eddy County, New Mexico
Unit Letter "A", Section 26, Township 20 South, Range 28 East
Latitude 32.55003 North, Longitude 104.14199 West
NMOCD Reference No. nAPP2424030602

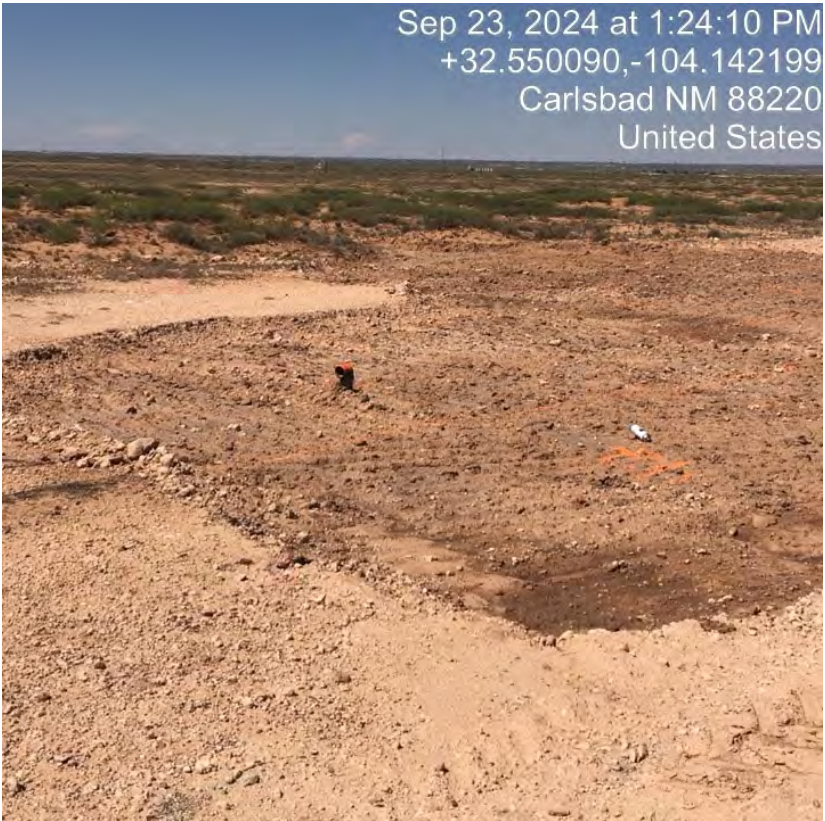
Photo Number: 6

Photo Direction: Northwest	
Photo Description: View of the excavated area.

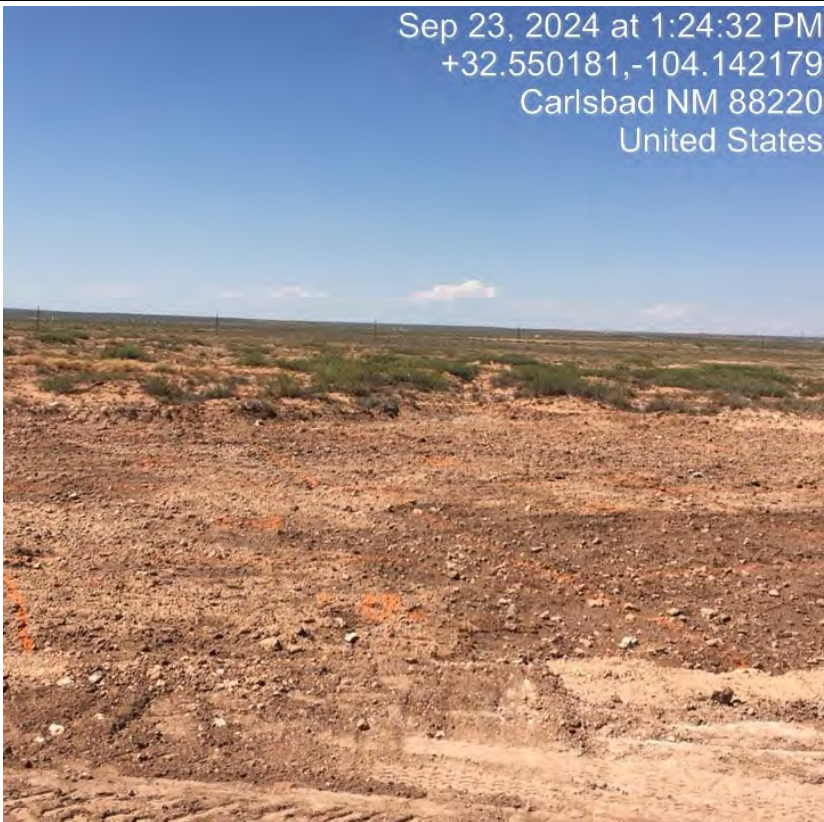
Photo Number: 7

<p>Sep 23, 2024 at 1:24:32 PM +32.550181,-104.142179 Carlsbad NM 88220 United States</p>
Photo Direction: West	
Photo Description: View of the excavated area.

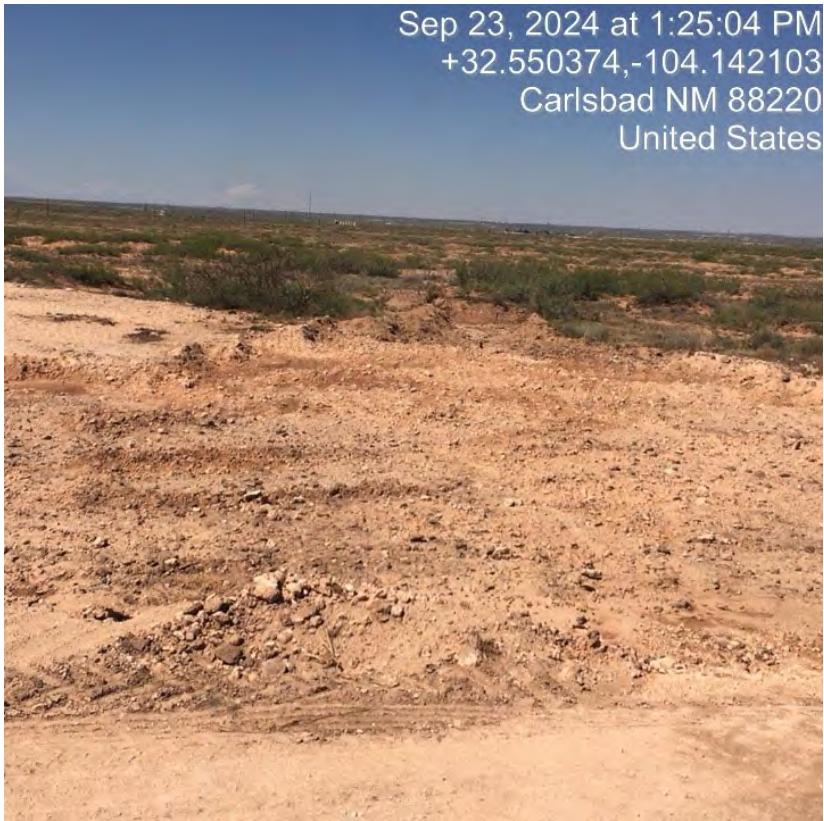
Photo Number: 8

<p>Sep 23, 2024 at 1:25:04 PM +32.550374,-104.142103 Carlsbad NM 88220 United States</p>
Photo Direction: North	
Photo Description: View of the excavated area.

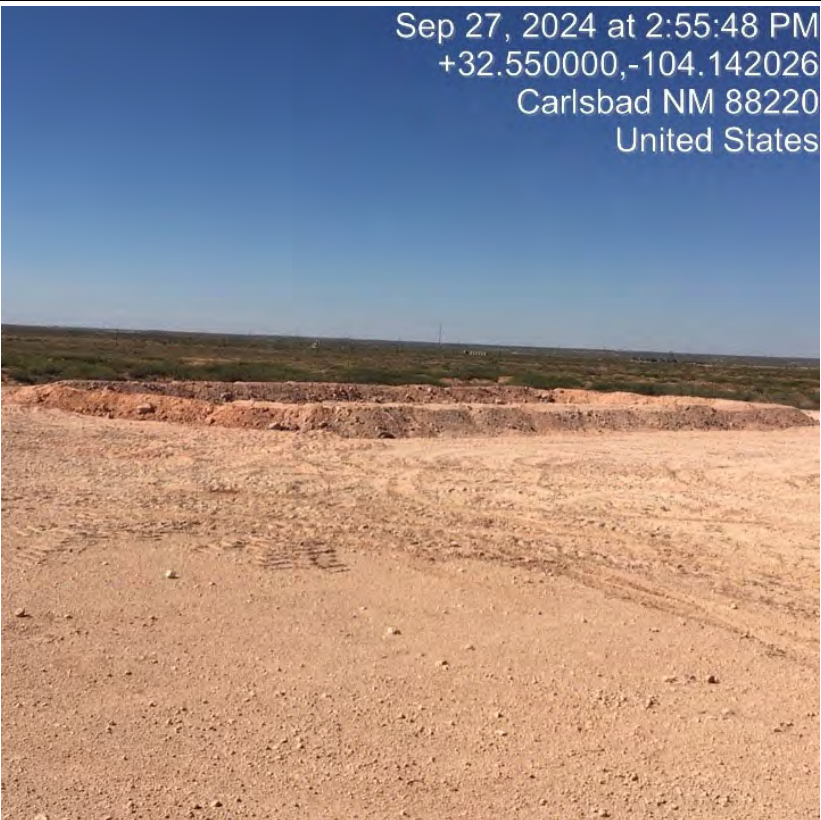
Photo Number: 9

<p>Sep 27, 2024 at 2:55:48 PM +32.550000,-104.142026 Carlsbad NM 88220 United States</p>
Photo Direction: Northwest	
Photo Description: View of the remediated area following backfilling and regrading.

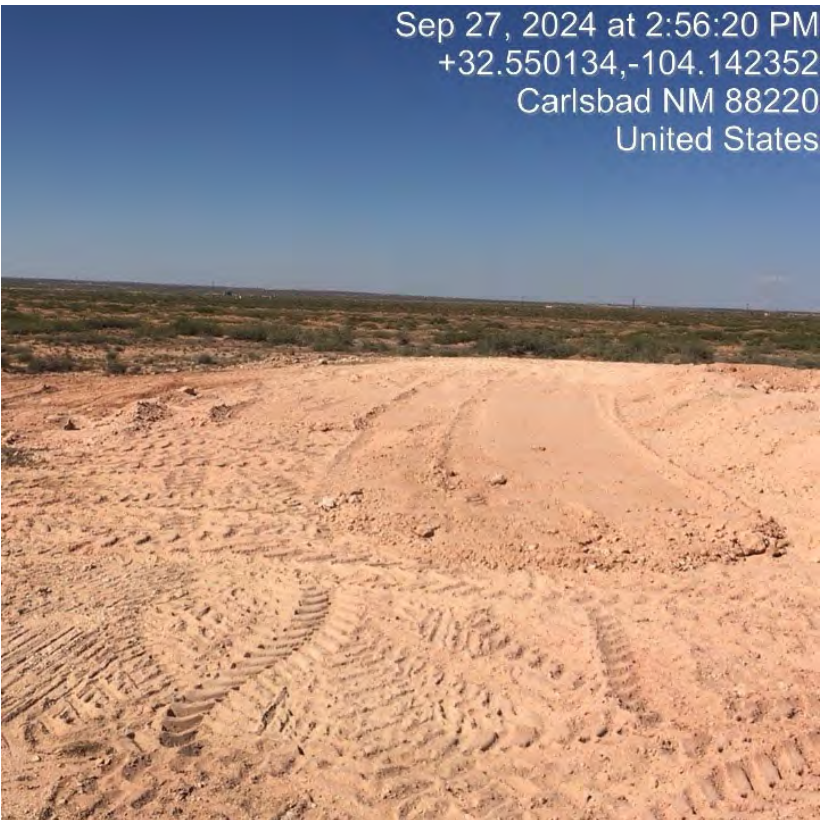
Photo Number: 10

<p>Sep 27, 2024 at 2:56:20 PM +32.550134,-104.142352 Carlsbad NM 88220 United States</p>
Photo Direction: North	
Photo Description: View of the remediated area following backfilling and regrading.

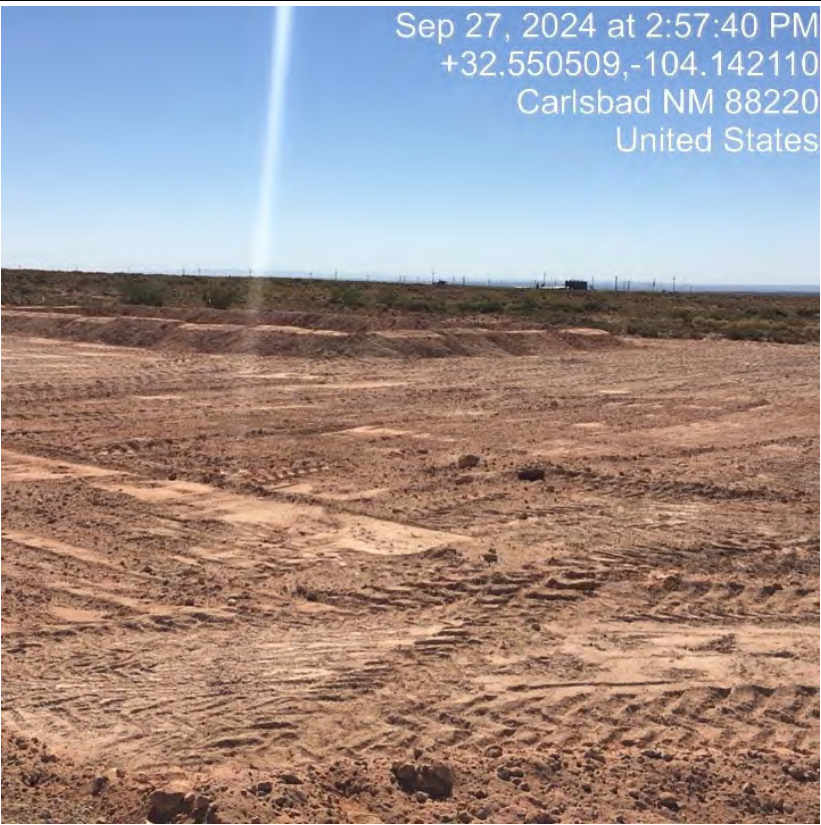
Photo Number: 11

Photo Direction: Southwest	
Photo Description: View of the remediated area following backfilling and regrading.

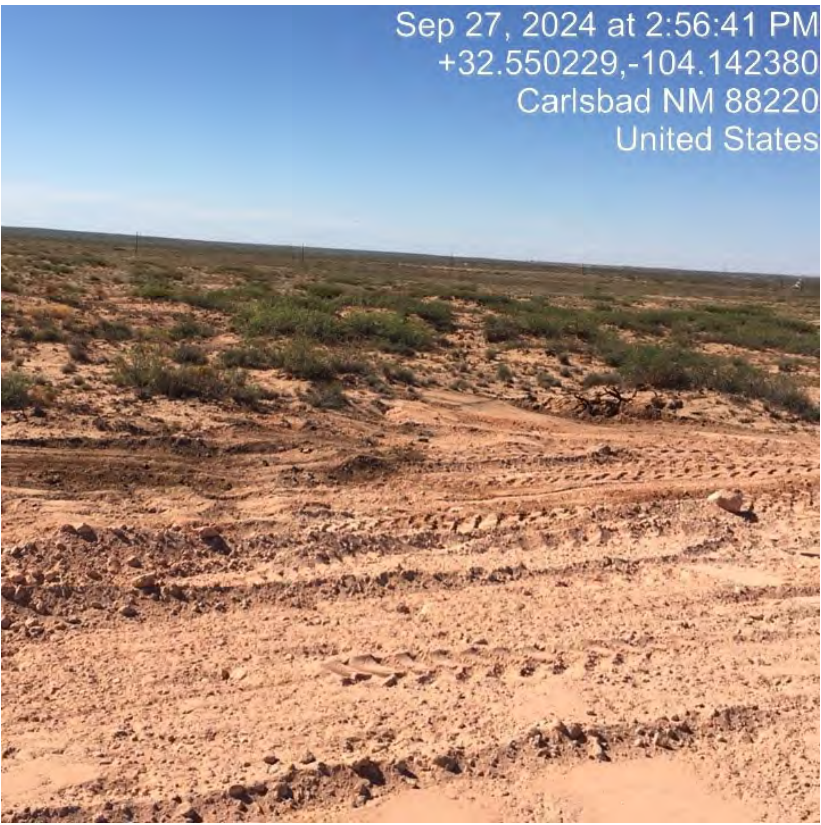
Photo Number: 12

Photo Direction: West-Northwest	
Photo Description: View of the remediated area following backfilling and regrading.

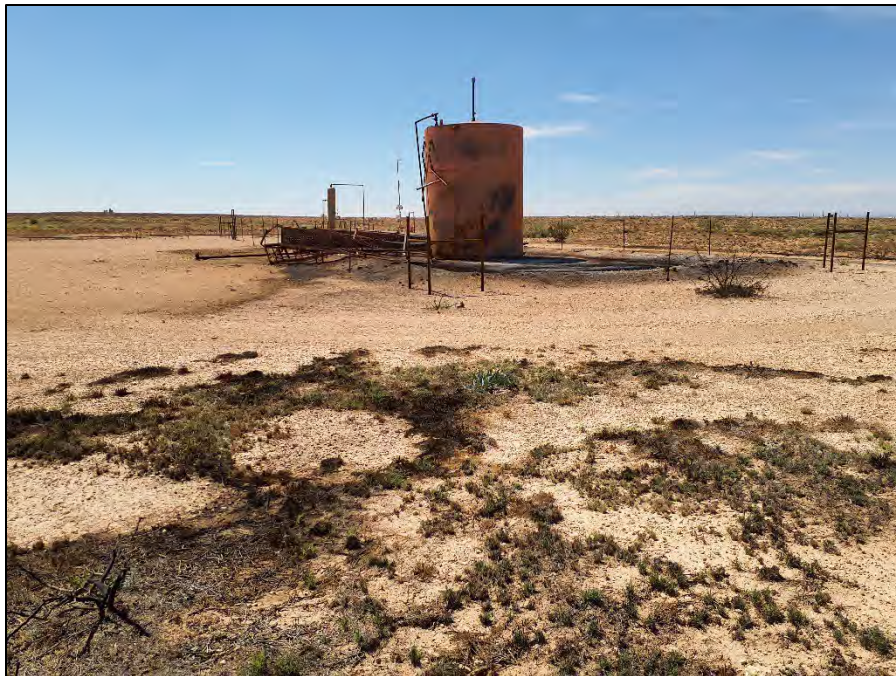
Figure 1. Survey area overview within inadvertent release area, facing southwest (Frame -0140).
