**Closure Report**  
**Irwin 13 Federal Com CTB**  
**Incident ID: nAPP2434729375**  
**Eddy County, New Mexico**  
**Unit A Sec 13 T19S R30E**  
**32.65666°, -103.91809°**

**Point of Release:**  
**Pump failed resulting in a release**  
**Release Date: 12.11.2024**  
**Volume Released: 8 Barrels of Produced Water**  
**Volume Recovered: 5 Barrels of Produced Water**

**Re: Closure Report**  
**Irwin 13 Federal Com CTB**  
**Incident ID: nAPP2434729375**  
**Cimarex Energy Co.**  
**Site Location: Unit A, S13, T19S, R30E**  
**(Lat 32.65666°, Long -103.91809°)**  
**Eddy County, New Mexico**

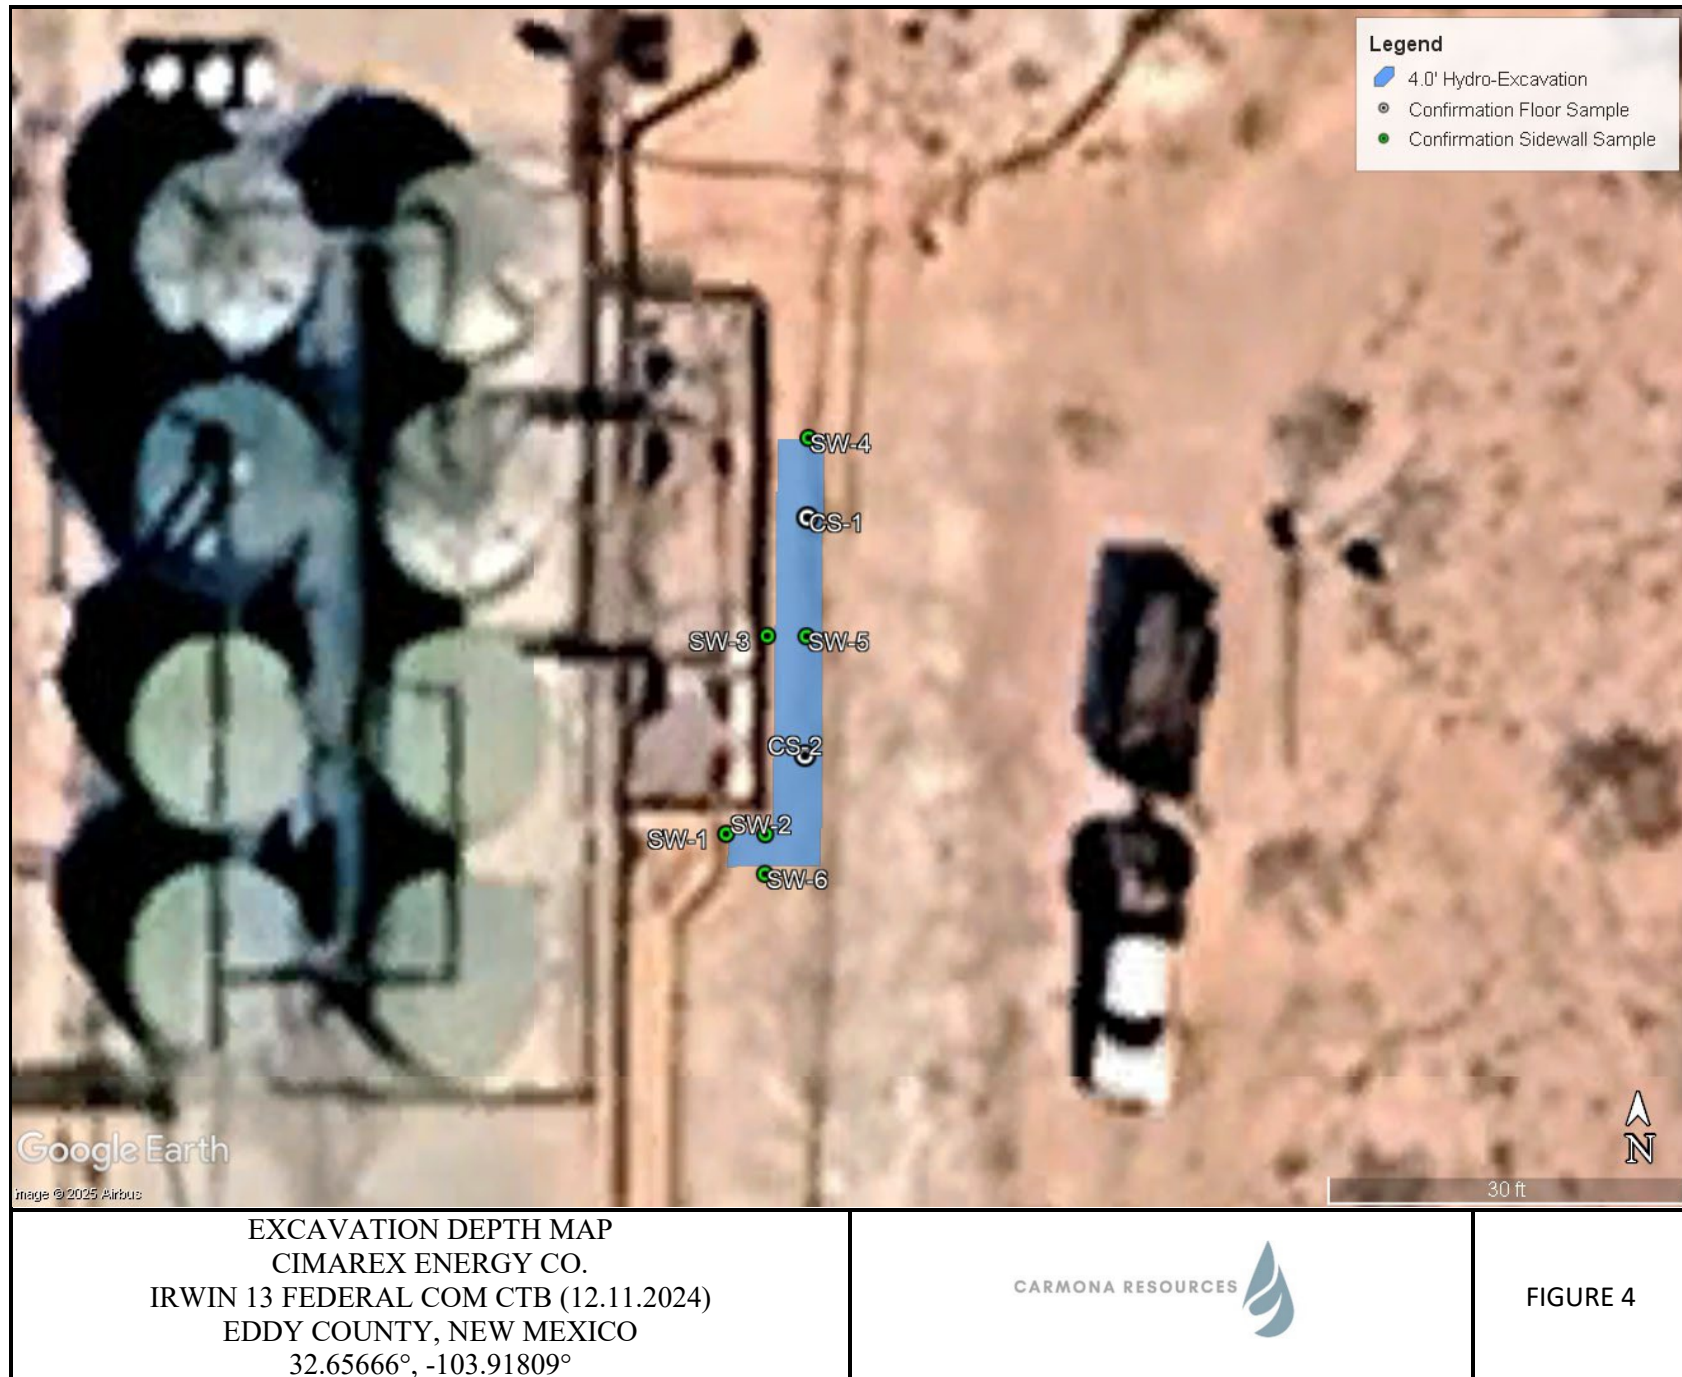
contaminated soils. For chemical analysis, the soil samples were collected and placed directly into laboratory-provided sample containers, stored on ice, and transported under the proper chain-of-custody protocol to Cardinal Laboratories in Hobbs, New Mexico. The samples were analyzed for TPH analysis by EPA method 8015 modified, BTEX by EPA Method 8021B, and chloride by EPA Method 4500. Copies of laboratory analysis and chain-of-custody documentation are included in Appendix E. The excavation depths and confirmation sample locations are shown in Figure 4.

Approximately 209 square feet and 30 cubic yards of material were excavated and transported offsite for proper disposal at Lea Land Landfill.

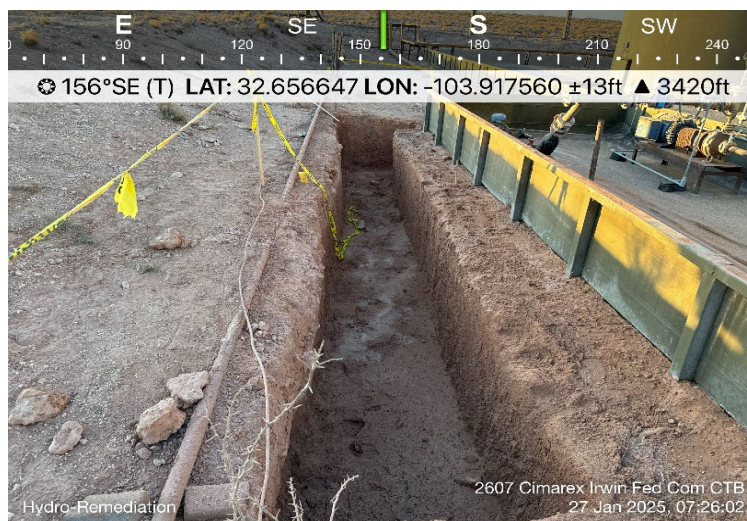
## Photograph No. 1

View Southeast, area of CS-1 and CS-2.

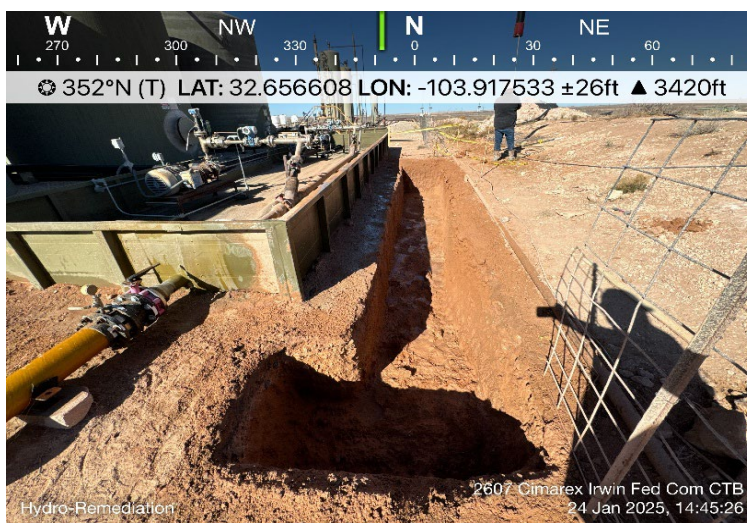
## Photograph No. 2

View North, area of CS-1 and CS-2.

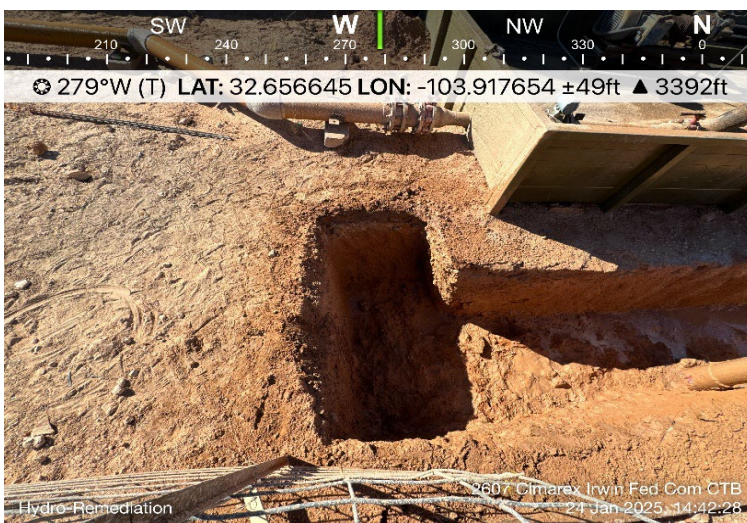
## Photograph No. 3

View West, area of CS-2.

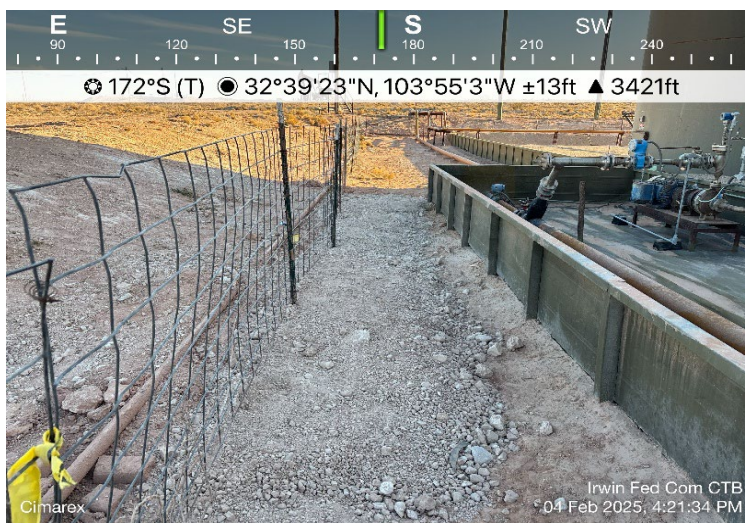
## Photograph No. 4

View South, backfilled area.

Once the remediation activities were completed, the excavated areas were backfilled with clean material to surface grade. Backfill material was collected from the Fred Beard backfill pit located at 32.161928, -104.316363. A composite backfill sample was collected at the backfill pit before being utilized and was analyzed for TPH analysis by EPA method 8015 modified, BTEX by EPA Method 8021B, and chloride by EPA Method 4500. Copies of laboratory analysis and chain-of-custody documentation are included in Appendix E. See Table 1.

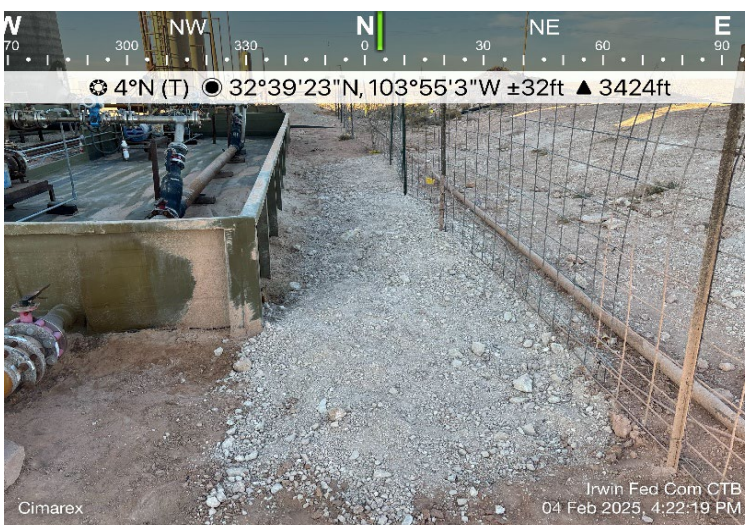
## Photograph No. 5

View North, backfilled area.

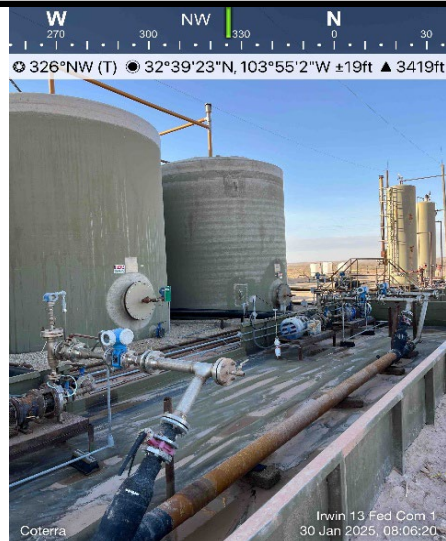
View Northwest of lined containment.

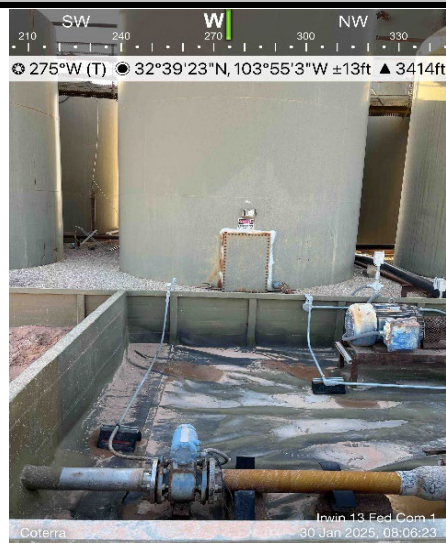
## Photograph No. 2

View West of lined containment.

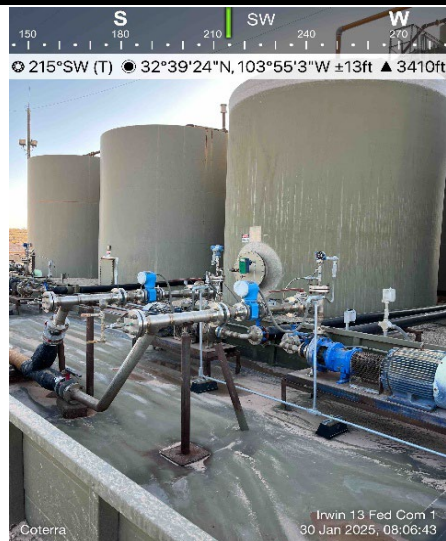
## Photograph No. 3

View Southwest of lined containment.

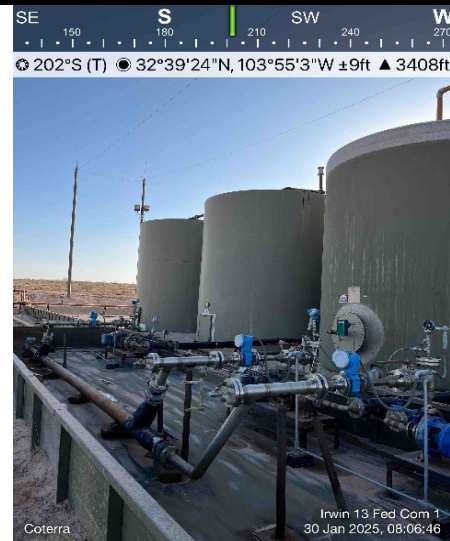
View South of lined containment.

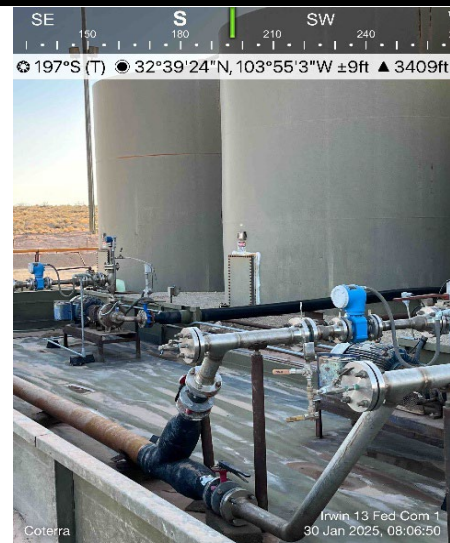
## Photograph No. 5

View South of lined containment.
