Closure Report
Eagle Claw 5-8 Federal 1H-2H Production Facility
Incident #: nAPP2500842081
Lea County, New Mexico
Unit D Sec 5 T20S R35E
32.609033°, -103.487268°

Produced Water Release
Point of Release: Equipment Failure
Release Date: 01.08.2025
Volume Released: 10 Barrels of Produced Water
Volume Recovered: 0 Barrels of Produced Water

Re: Closure Report
Eagle Claw 5-8 Federal 1H-2H Production Facility
Caza Operating, LLC
Incident # nAPP2500842081
Site Location: Unit D, S05, T20S, R35E
(Lat 32.609033°, Long -103.487268°)
Lea County, New Mexico

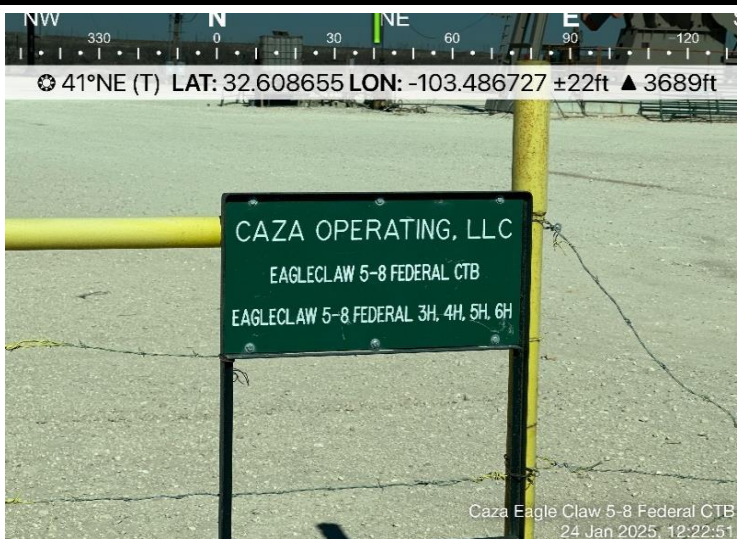
View South, area of CS-1 through CS-5.

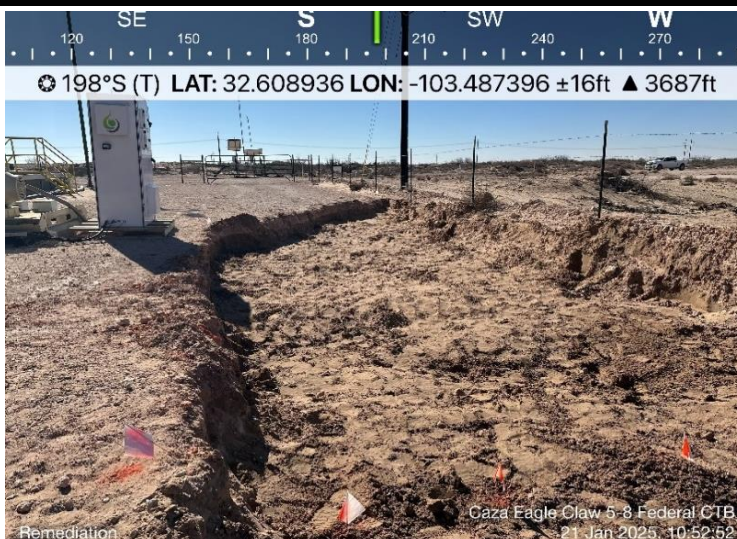
View South, area of CS-6 through CS-8.

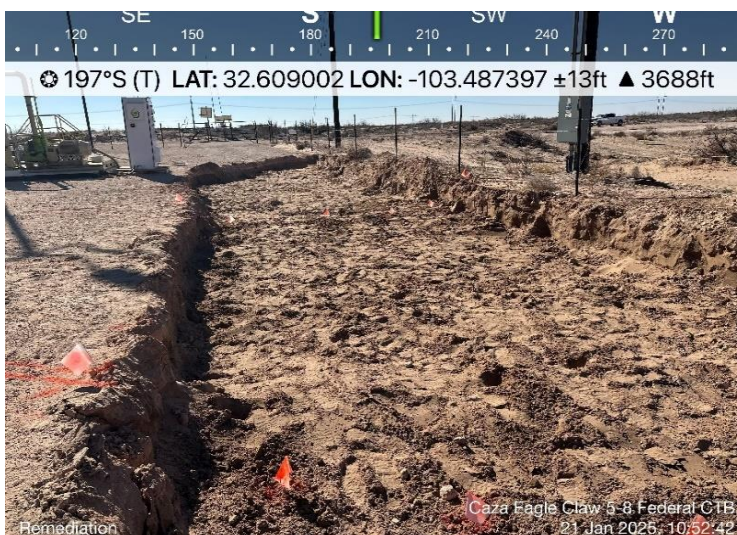
View South, area of CS-9 through CS-12.
