Remediation Summary and Closure Request

**Harvard Petroleum Company, LLC
Pure Gold C-17 Fed #003
Eddy County, New Mexico
Unit L, Section 17, Township 23 South, Range 31 East
Latitude 32.30236° North, Longitude -103.793167° West
NM OCD Incident #nAPP2334138591**

Remediation Closure Report: Pure Gold C-17 Fed #003
Unit L, Section 17, Township 23 South, Range 31East
Eddy County, New Mexico
API: 30-015-27152
Incident: nAPP2334138591

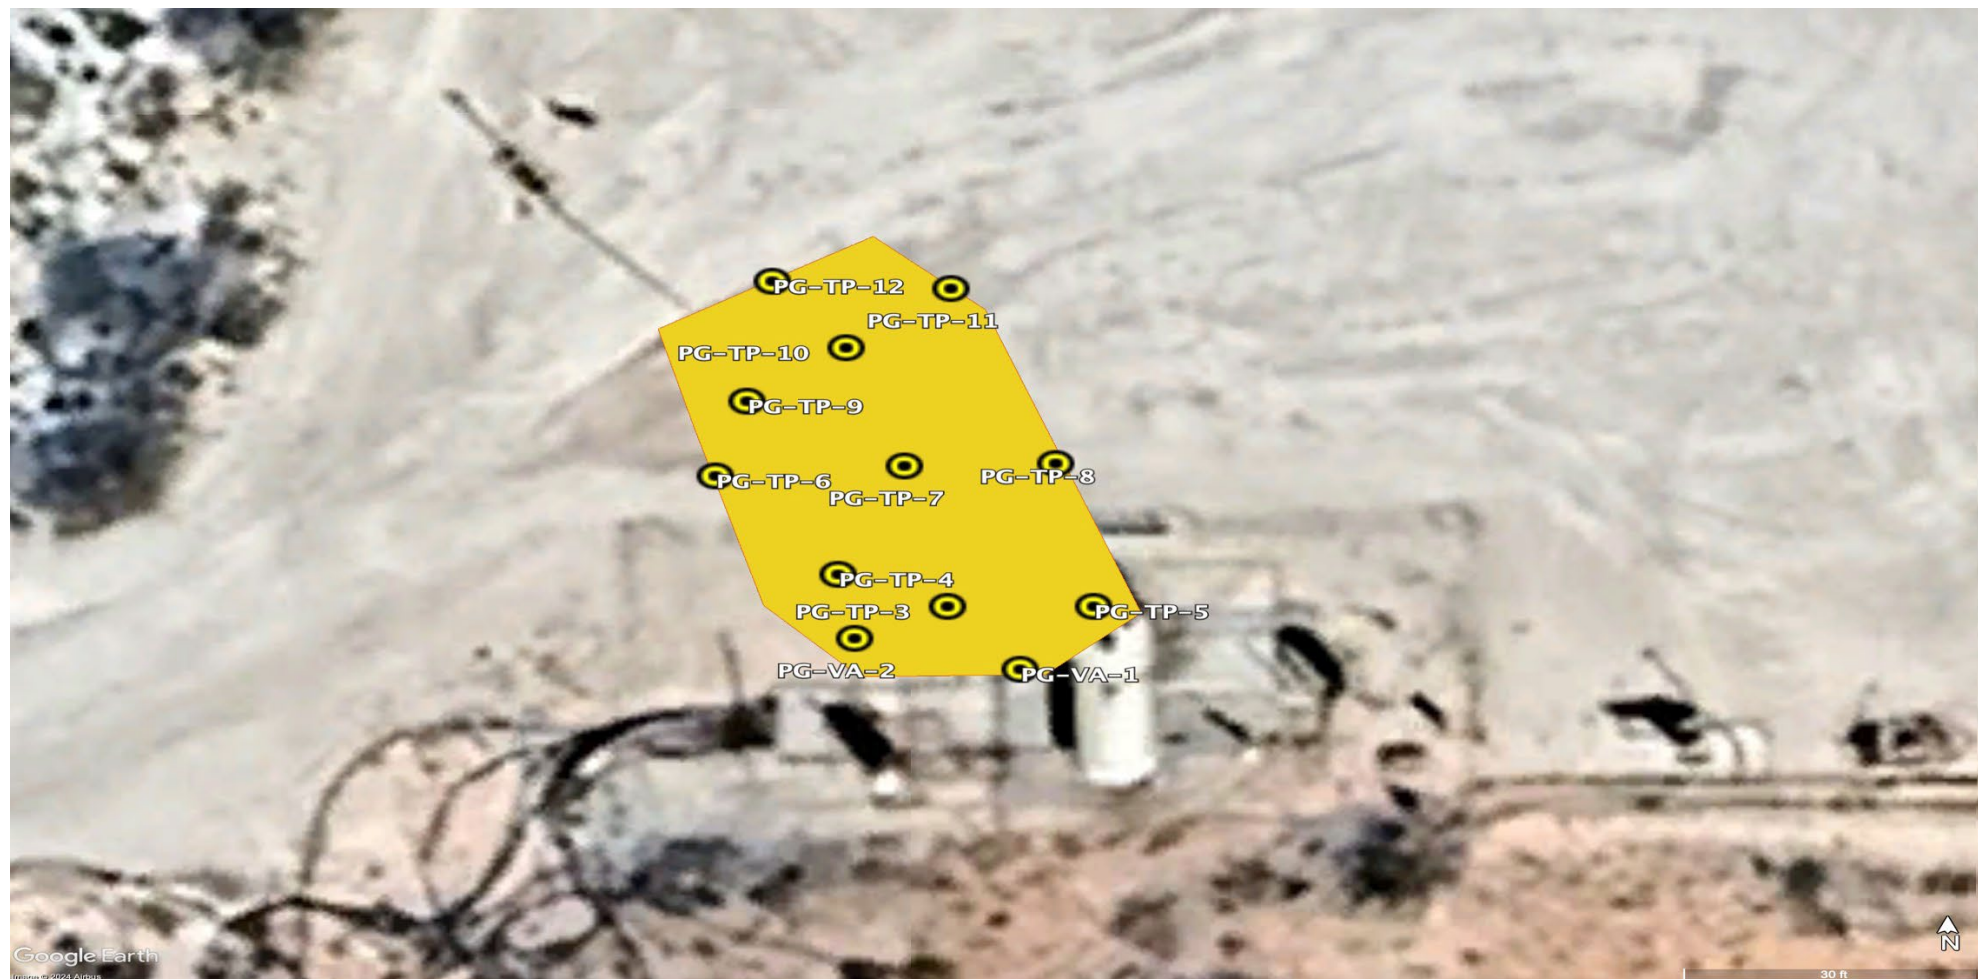
7

Confirmation Sample Points

The excavated area measuring 2,304 ft², requiring 12 five-point composite samples to be obtained was completed on 6/18/2024. Following the removal of impacted soil, five-point composite soil samples were collected by placing five equivalent aliquots of soil into a 1-gallon, resealable plastic bag and homogenizing the samples by thoroughly mixing. Due to the shallow depth of the excavation, sidewall samples were incorporated into the floor samples.

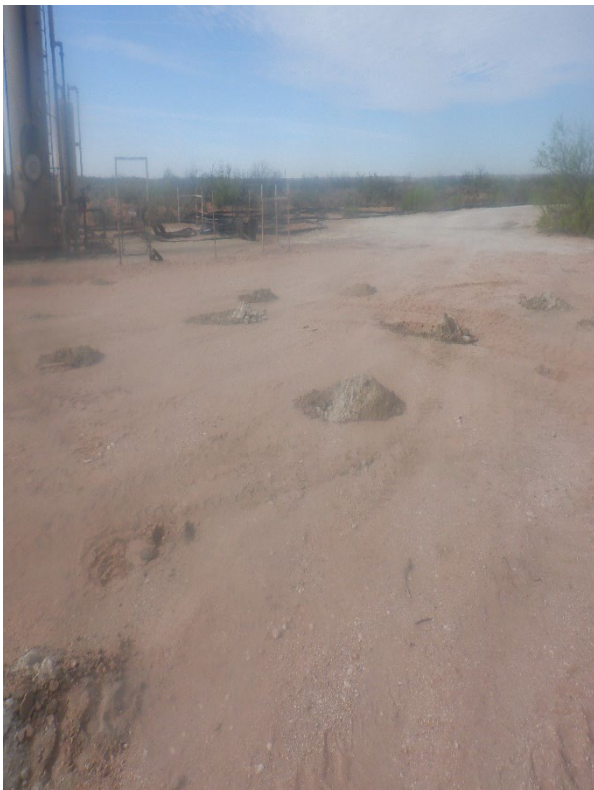
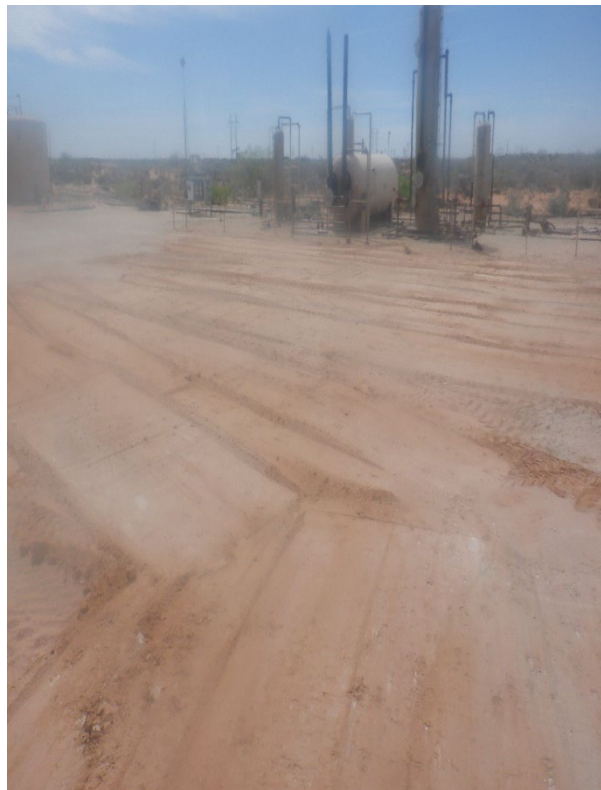
Photograph: 1	Date: 04/16/2024
---------------	------------------

Description: Showing excavated area and some of the sample points.
--

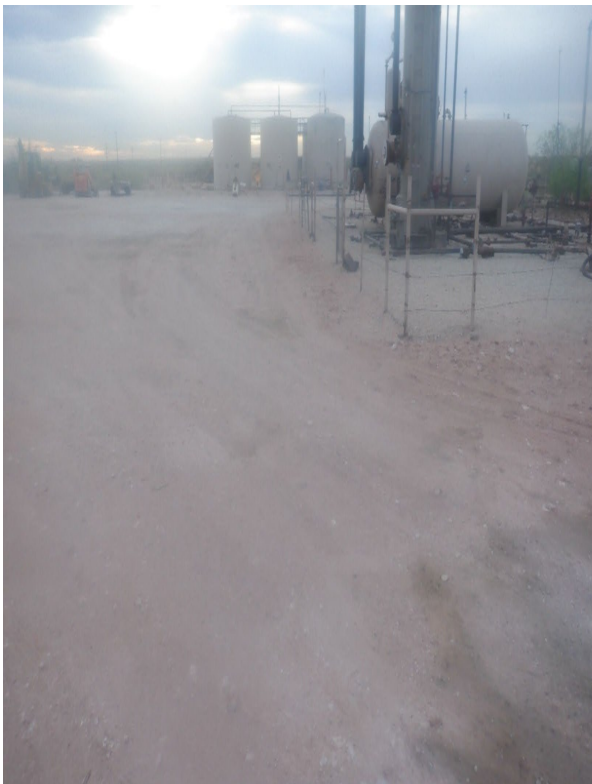
- The light oil staining to the northwest measured 64 feet by 36 feet, equaling 2,304 sq ft.
- The soil in this area was tested and identified to contain TPH levels exceeding State of New Mexico (OCD) Oil Conservation Division thresholds.

Photograph: 3	Date: 06/18/2024
Description: Showing impacted area before excavation.	
View: East

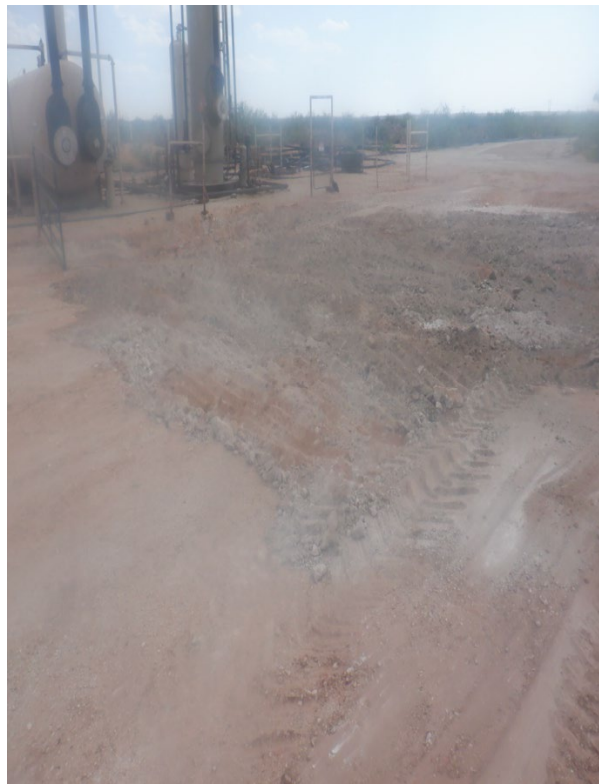
Photograph: 4	Date: 06/18/2024
Description: Showing impacted area after excavation.	
View: Southwest

- Excavated and removed 21.33 cu yds of contaminated soil.
- Soil samples were obtained and analytical was found within range of soil thresholds established within *19.15.29 NMAC Table I Closure Criteria for Soils Impacted by a Release* for depth to water at 51-100 ft bgs.
- Area was backfilled and leveled with fresh caliche.
- Re-excavated and removed 53.33 cu yds of contaminated soil.
- Soil samples were obtained and analytical was found within range of soil thresholds established within *19.15.29 NMAC Table I Closure Criteria for Soils Impacted by a Release* for depth to water at < 50 ft bgs.
- Area was backfilled and leveled with fresh caliche.

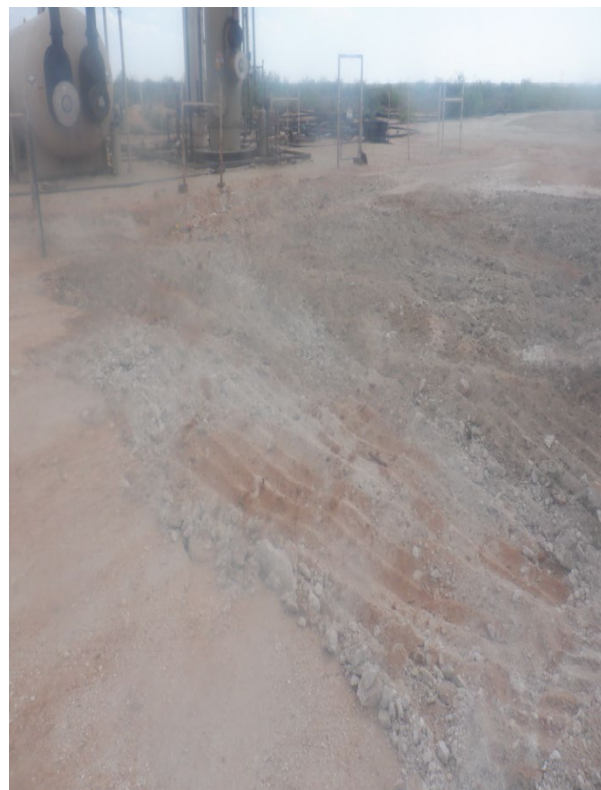
Photograph: 5	Date: 06/18/2024
Description: Showing impacted area after excavation.	
View: Southwest

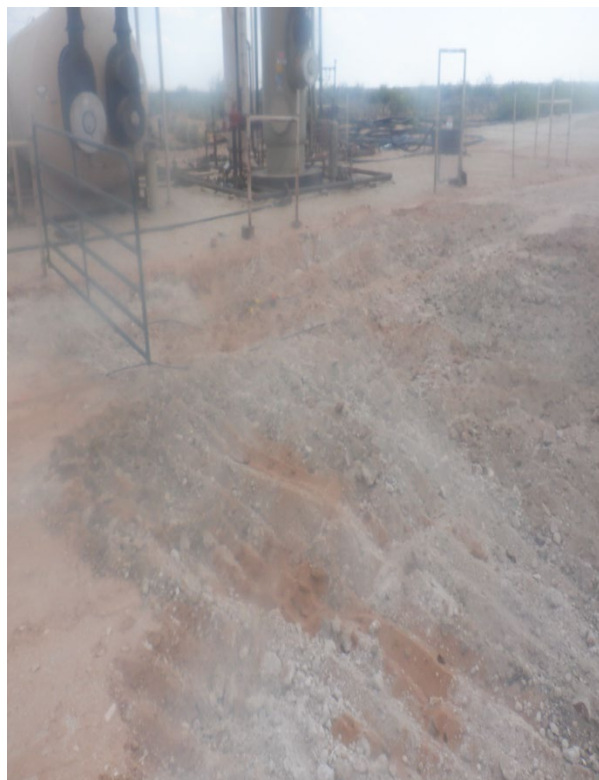
Photograph: 6	Date: 06/18/2024
Description: Showing impacted area after excavation.	
View: Southwest

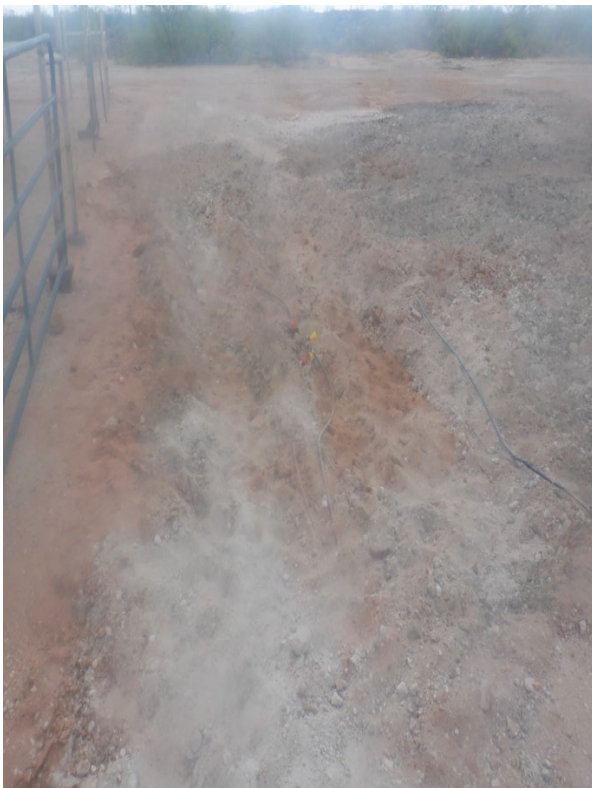
Photograph: 7	Date: 06/18/2024
Description: Showing impacted area after excavation.	
View: West

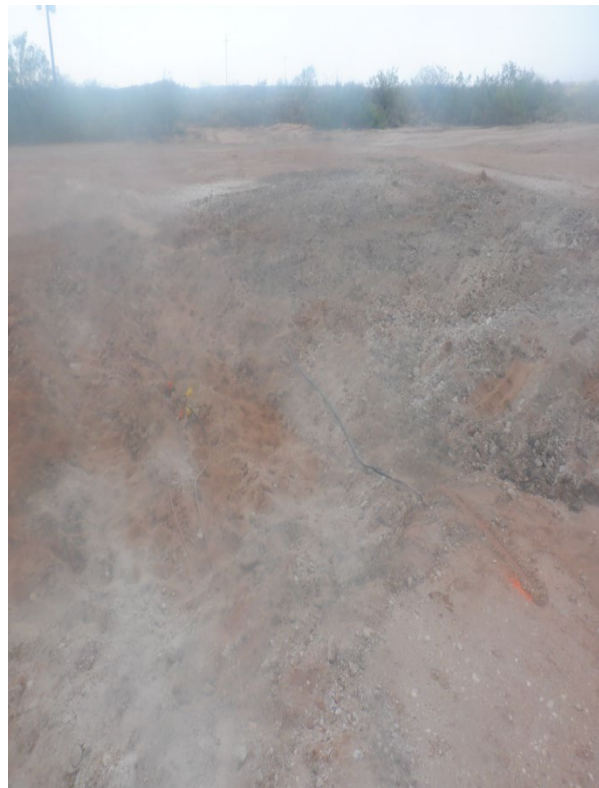
Photograph: 8	Date: 06/18/2024
Description: Showing impacted area after excavation.	
View: West

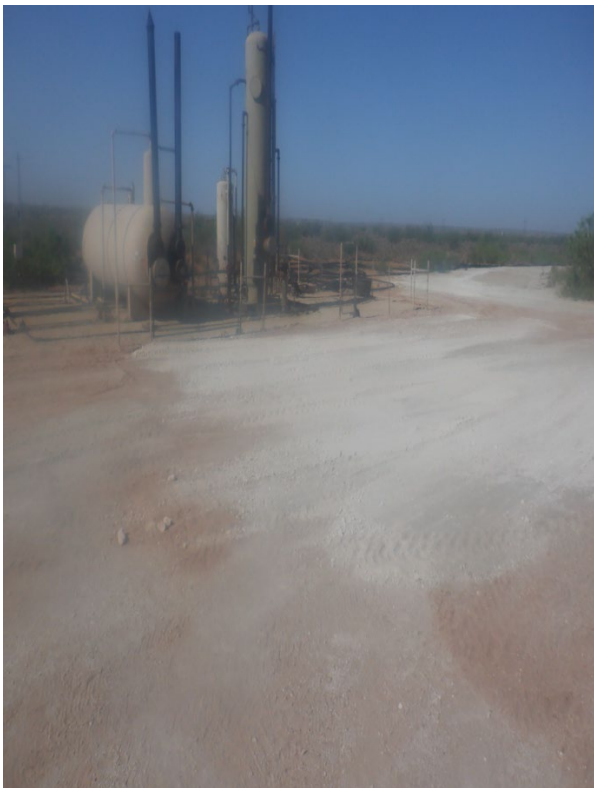
Photograph: 9	Date: 06/29/2024
Description: Showing impacted area after backfilling.	
View: Southwest

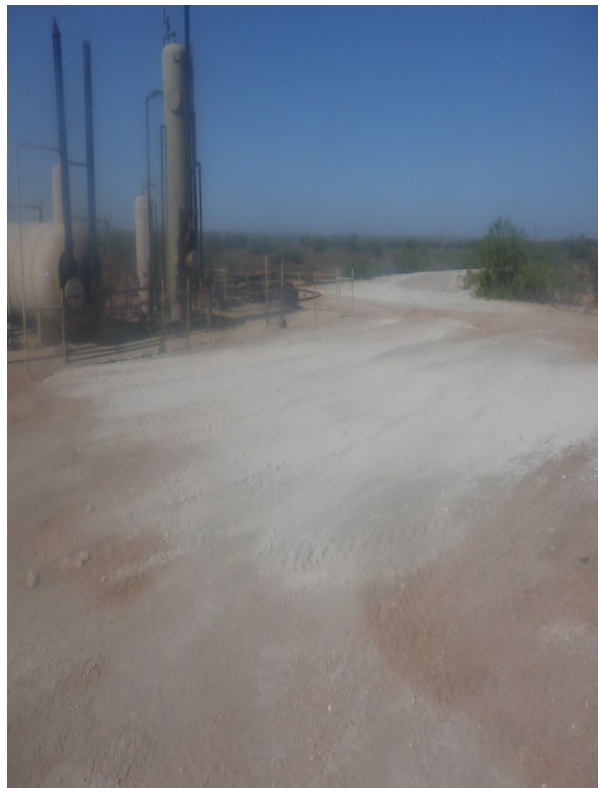
Photograph: 10	Date: 06/29/2024
Description: Showing impacted area after backfilling.	
View: Southwest

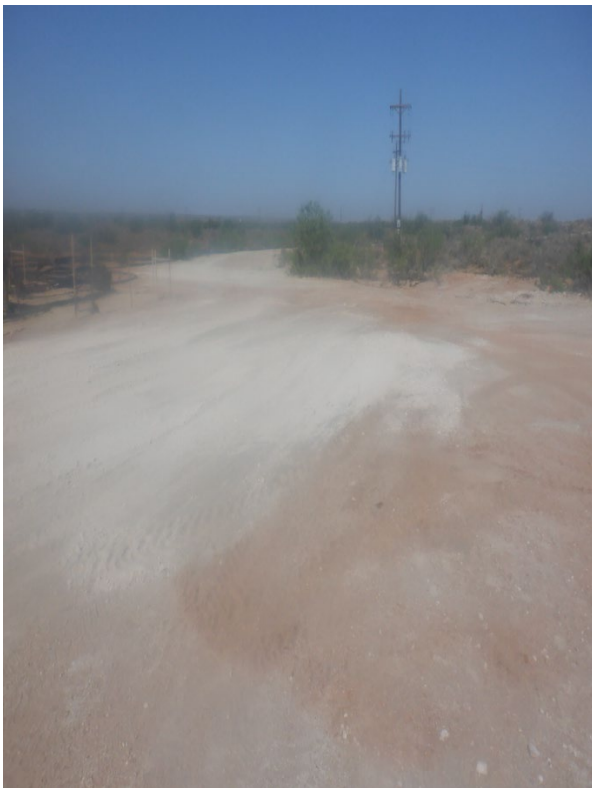
Photograph: 11	Date: 06/29/2024
Description: Showing impacted area after backfilling.	
View: Southwest

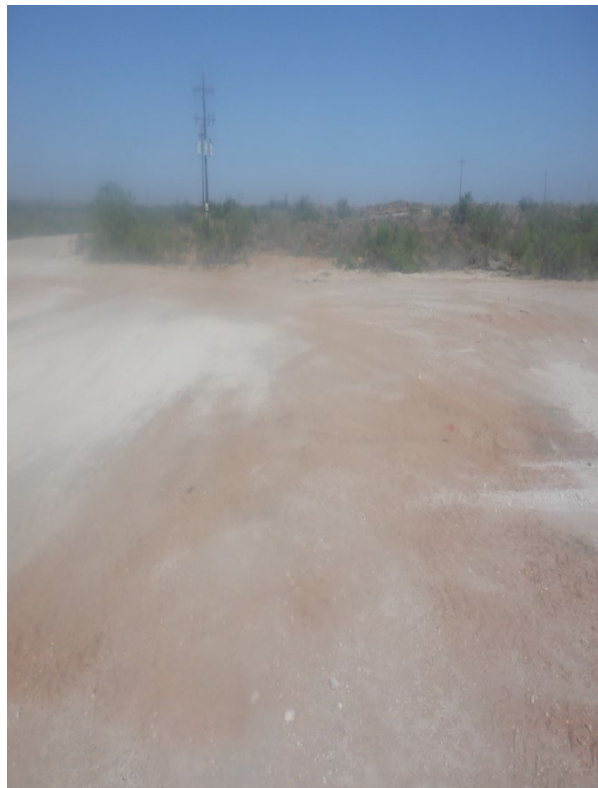
Photograph: 12	Date: 06/29/2024
Description: Showing impacted area after backfilling.	
View: West

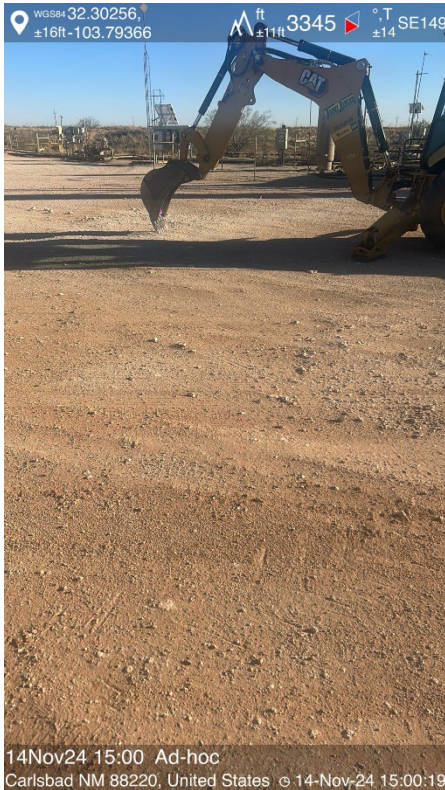
Photograph: 13	Date: 11/14/2024
Showing impacted area before excavation.

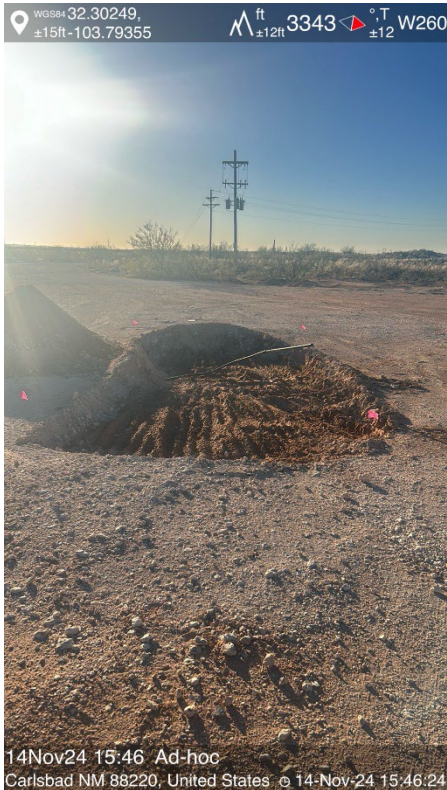
Photograph: 15	Date: 11/14/2024
Showing impacted area after excavation.

- Backfilled areas were compacted and stabilized to minimize dust and erosion.
- Excavated and removed 4.63 cu yds of contaminated soil.
- Soil samples were obtained and analytical was found within range of soil thresholds established within *19.15.29 NMAC Table I Closure Criteria for Soils Impacted by a Release* for depth to water at < 50 ft bgs.

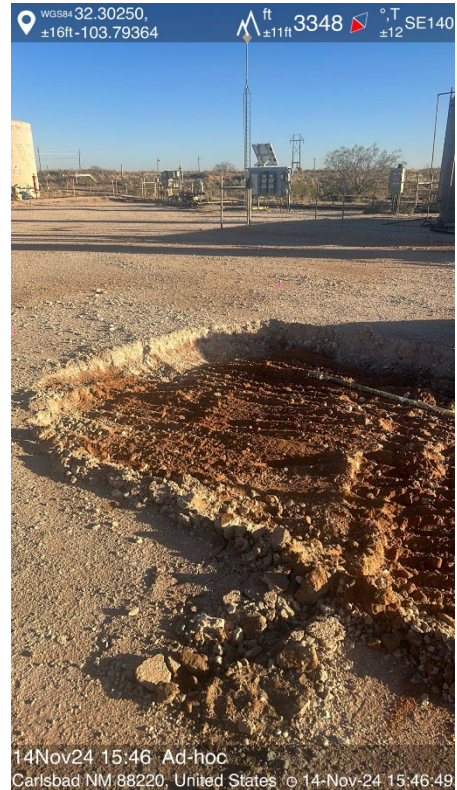
Photograph: 16	Date: 11/14/2024
Showing impacted area after excavation.

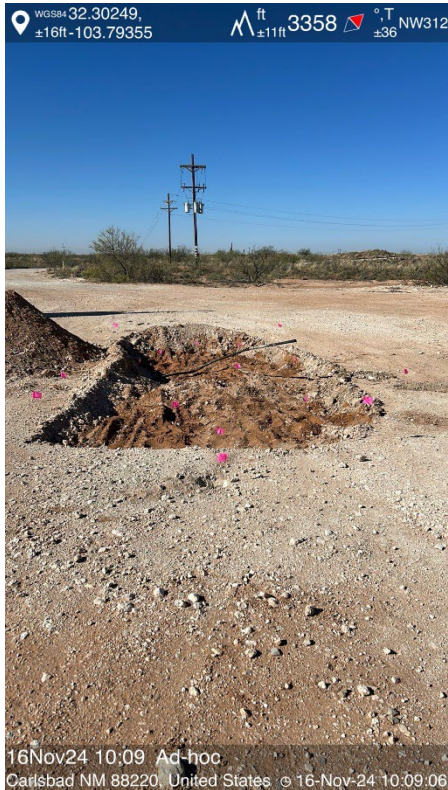
Photograph: 19	Date: 11/16/2024
Showing impacted area after excavation.

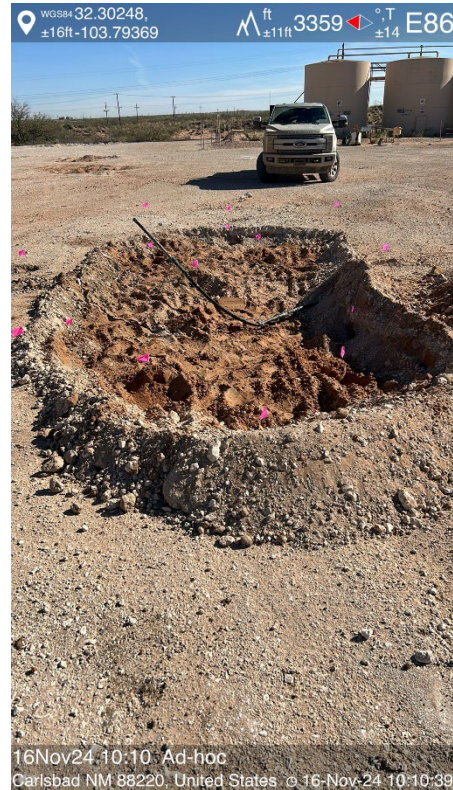
Photograph: 20	Date: 11/16/2024
Showing impacted area after excavation.
