**Re: Deferral Request
 Rigel 20 Fed 3H Battery
 Devon Energy Production Company
 Unit L, Section 20, Township 19S, Range 31E
 Site Coordinates: 32.64329948, -103.898984
 Eddy County, New Mexico
 Incident ID: nAPP2416525018**

On behalf of Devon Energy Production Company (Devon), New Tech Global Environmental, LLC (NTGE) has prepared this Site Characterization and Remediation Deferral Request for submittal to the New Mexico Oil Conservation Division (NMCOD) District 2 Office in Artesia, New Mexico to document site assessment, proposed remedial action activities, and sample analysis results for the Rigel 20 Fed 3H Battery (Site). The Site is located in Unit Letter L, Section 20, of Township 19 South and Range 31 East in Eddy County, New Mexico. The GPS coordinates for the release site are 32.64329948° N latitude and 103.898984° W longitude. The site location with respect to the nearest town is shown on Figure 1 and the topography of the area is shown on Figure 2.

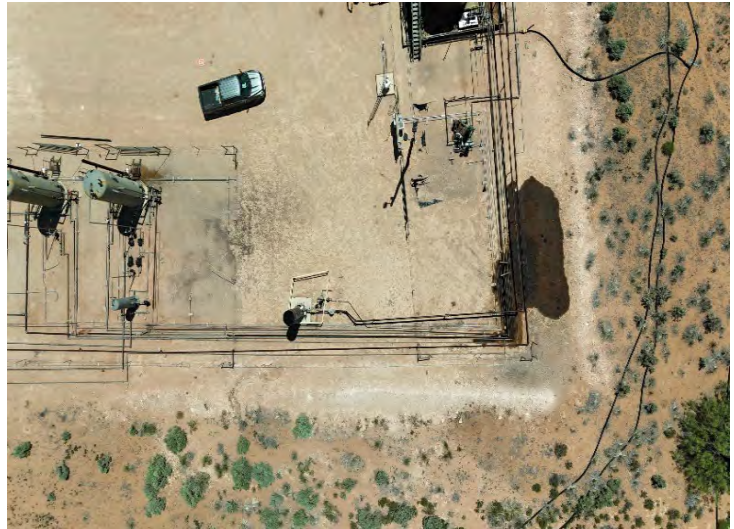
Description:
Area of Concern.

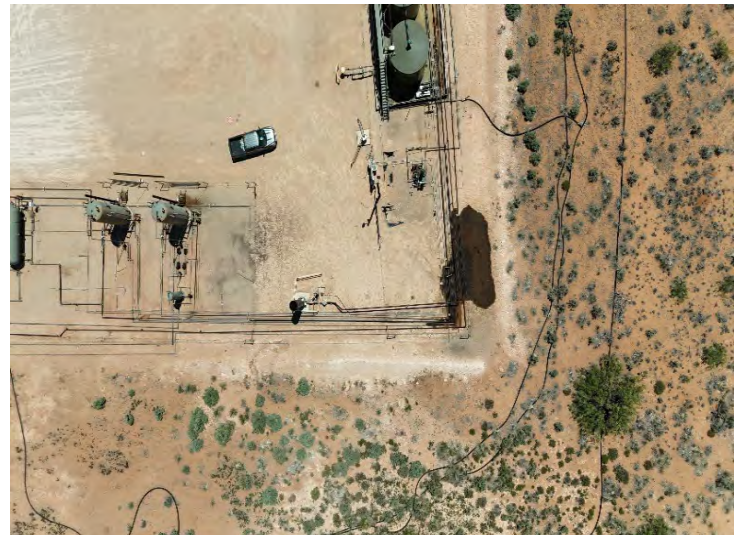
Photograph No. 2

Description:
Area of Concern.

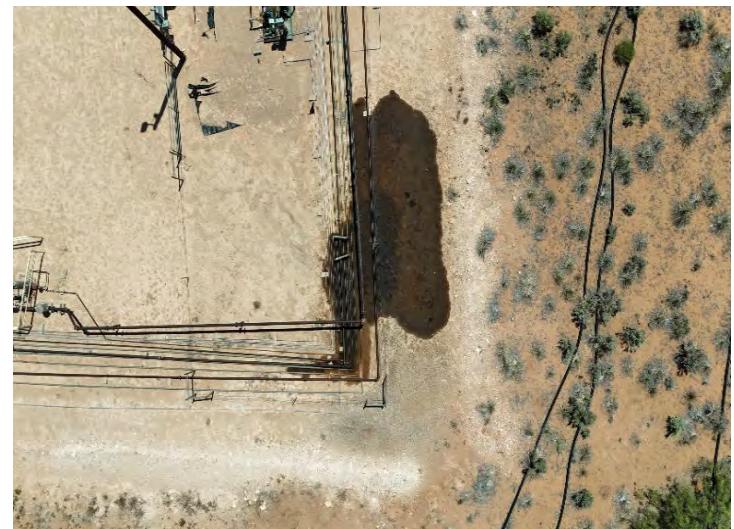
Photograph No. 3

Description:
Area of Concern.

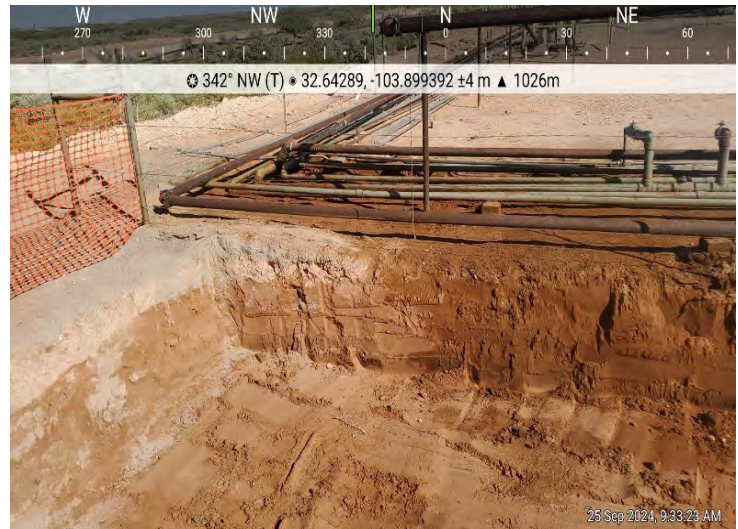
**Photograph No. 5**

Description:
Confirmation Sampling 9/25/24

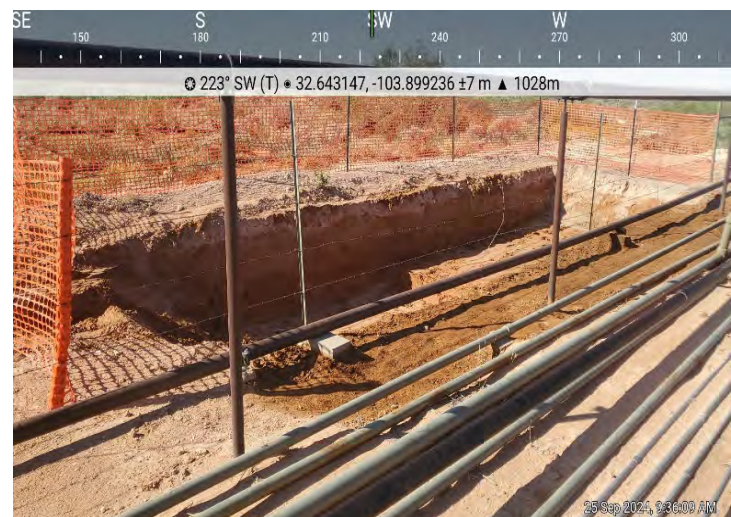
**Photograph No. 6**

Description:
Confirmation Sampling

Confirmation Sampling 9/25/24

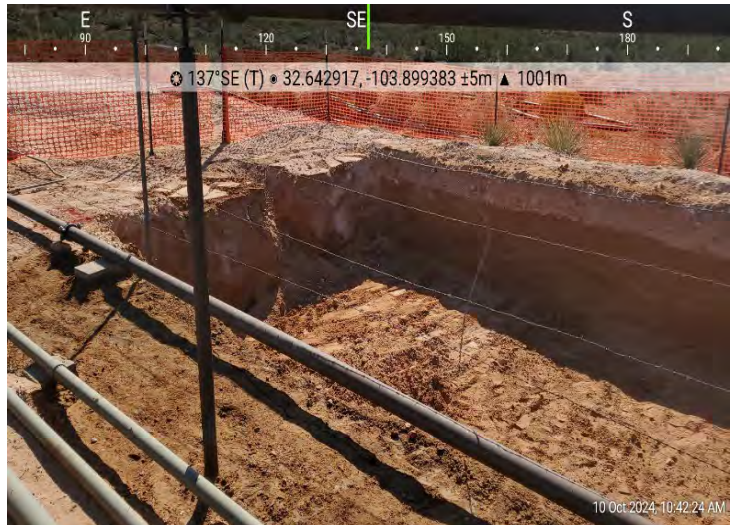
Photograph No. 7

Description:
Confirmation Sampling 10/10/24

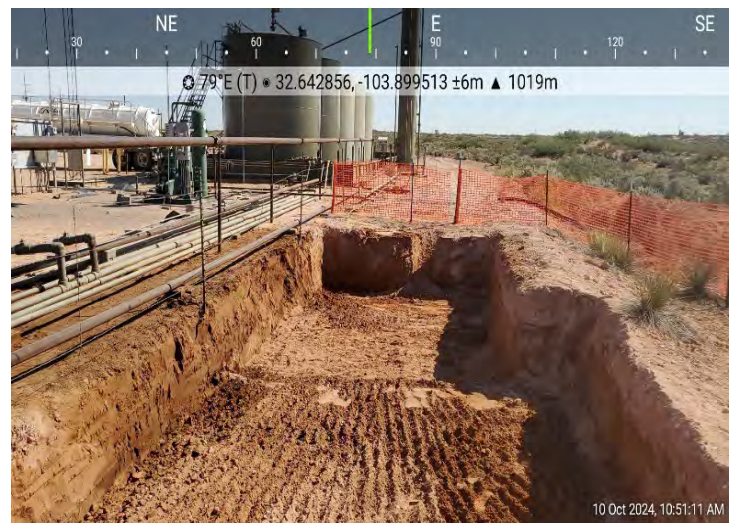
**Photograph No. 9**

Description:
Confirmation Sampling 10/10/24
