**Re: Closure Request Addendum
PLU CVX JV BS 015H
Incident Number NAB1821157574
Eddy County, New Mexico**

Ensolum, LLC (Ensolum), on behalf of XTO Energy, Inc. (XTO), has prepared this *Closure Request Addendum (Addendum)* as a follow-up to the *Deferral Request* dated December 6, 2019 and the *Closure Request* dated June 23, 2023. This *Addendum* provides clarifications regarding the excavation and soil sampling activities completed at the PLU CVX JV BS 015H (Site) in response to the New Mexico Oil Conservation Division (NMOCD) denial of the *Closure Request*. In the denial, NMOCD requested confirmation that the location of the excavation and sample PH05 are correct in the previous submittals. Based on the clarification of remediation and sampling activities described below, XTO is submitting this *Addendum* and requesting no further action and closure for Incident Number NAB1821157574.

XTO Energy, Inc.
Closure Request Addendum
PLU CVX JV BS 015H

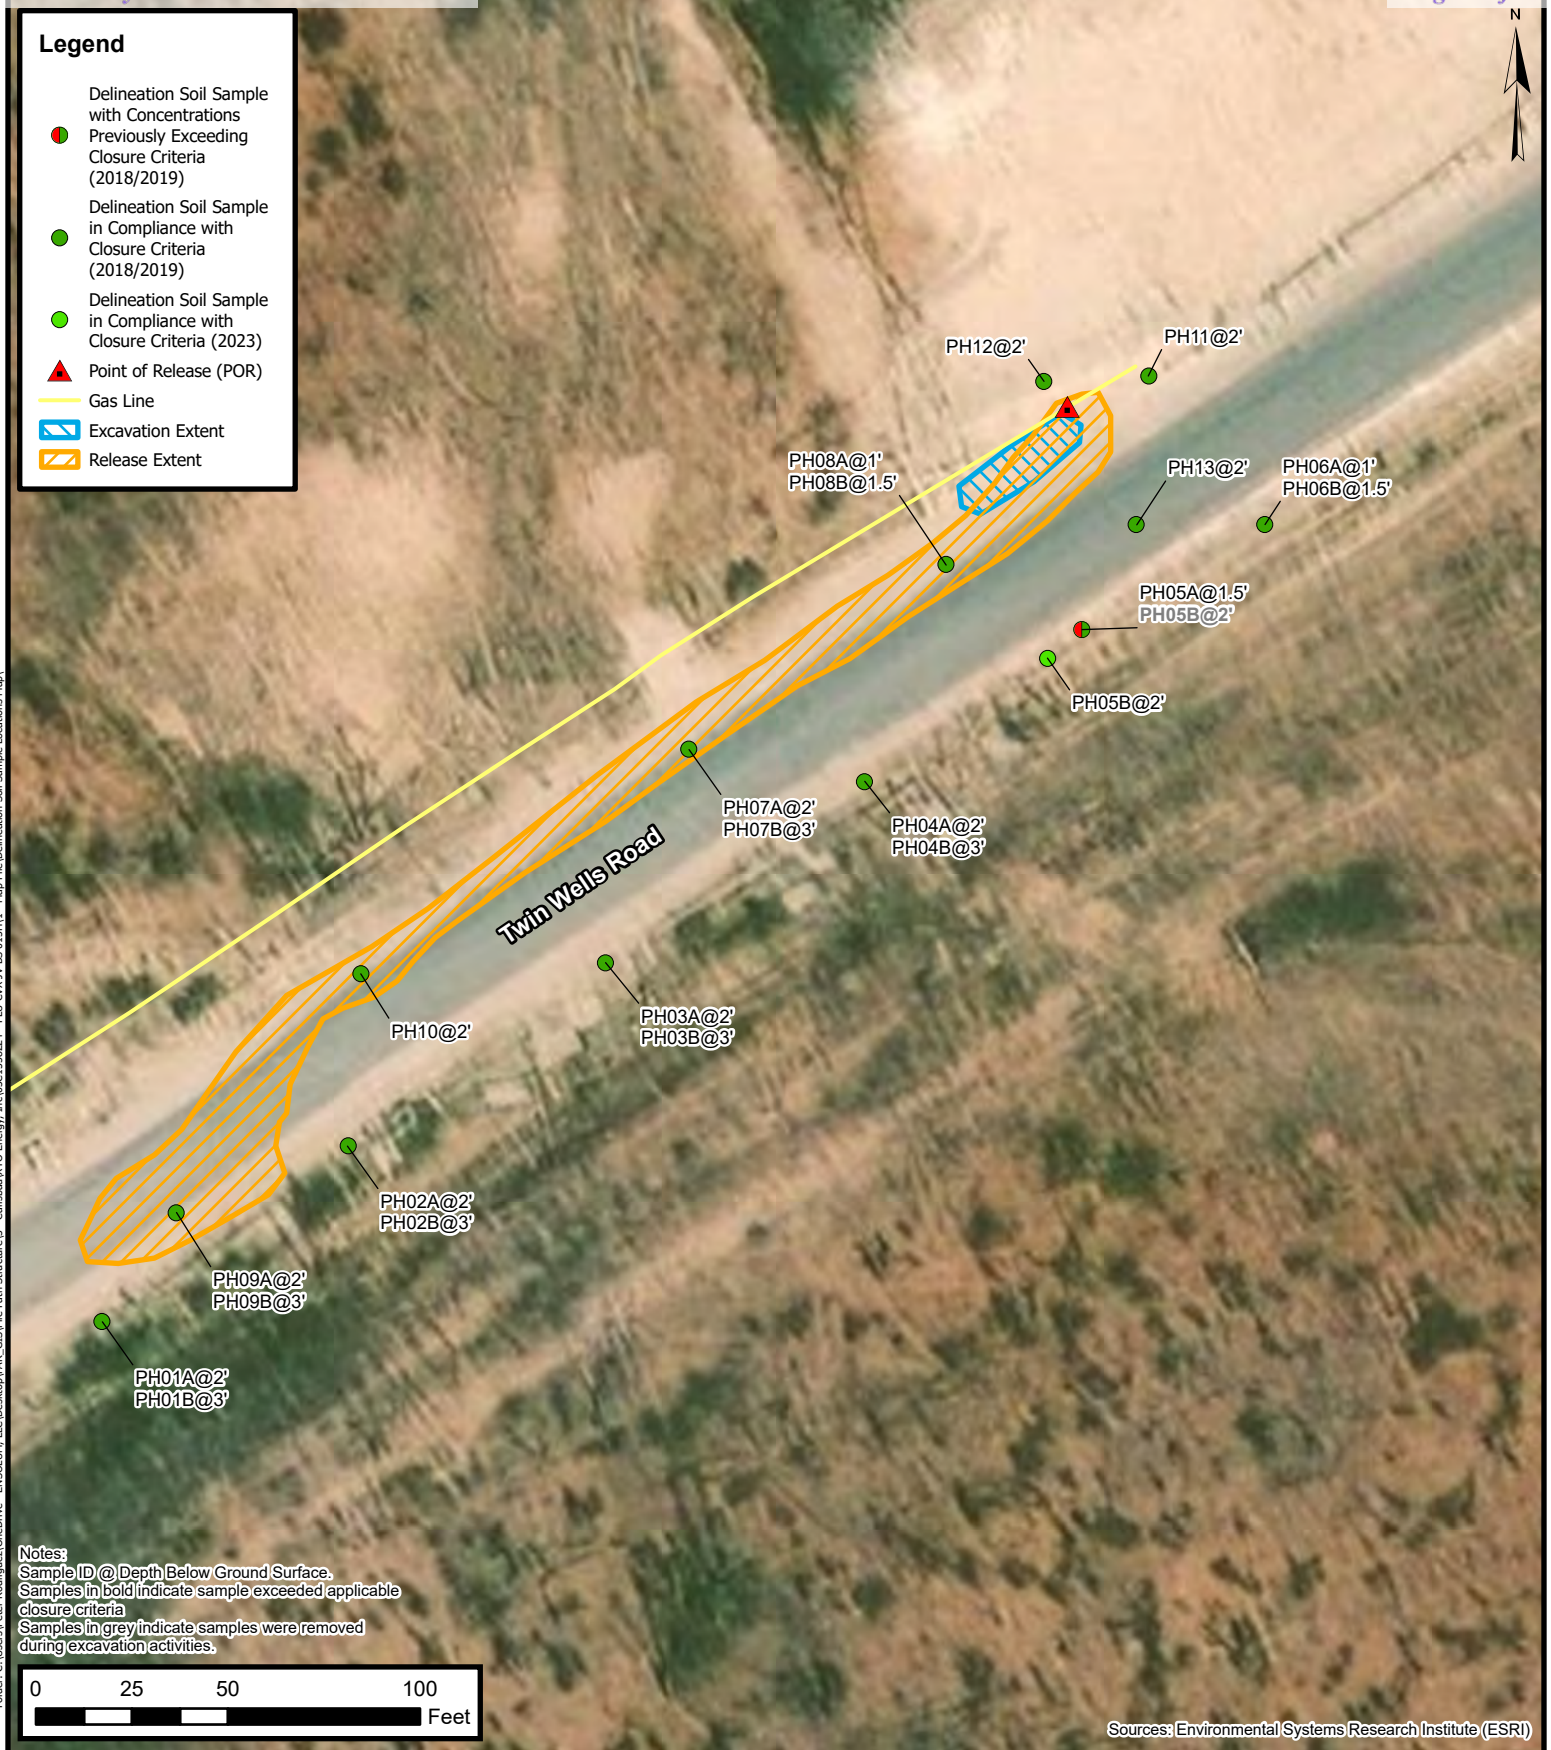
Delineation Soil Sample Locations

Request (Appendix A) and did not report staining, odor, or high levels of chloride and volatile organic compounds (VOC) during field screening. PH05 was advanced south of Twin Wells Road so compliance was anticipated at this location; however, TPH was reported above reclamation requirement in the soil sample collected from PH05 at 2 feet bgs. The impacts were not addressed during the 2019 excavation activities, as the NMOCD typically did not require excavation of waste-containing soil in 2019. The location of PH05 is accurately illustrated on the south side of Twin Wells Road in the *Closure Request* (Figure 2).

In 2023, following NMOCD's review of the *Deferral Request* and subsequent application of the reclamation requirement, Ensolum resampled location PH05 at 2 feet bgs in addition to four sidewall locations to verify the presence or absence of impacts. Analytical results reported COC concentrations in compliance with the Closure Criteria and reclamation requirement indicating natural attenuation remediated impacts previously observed at the Site. No additional remediation is required at the Site. Photographs of the 2019 and 2023 Site conditions are included in Appendix C.

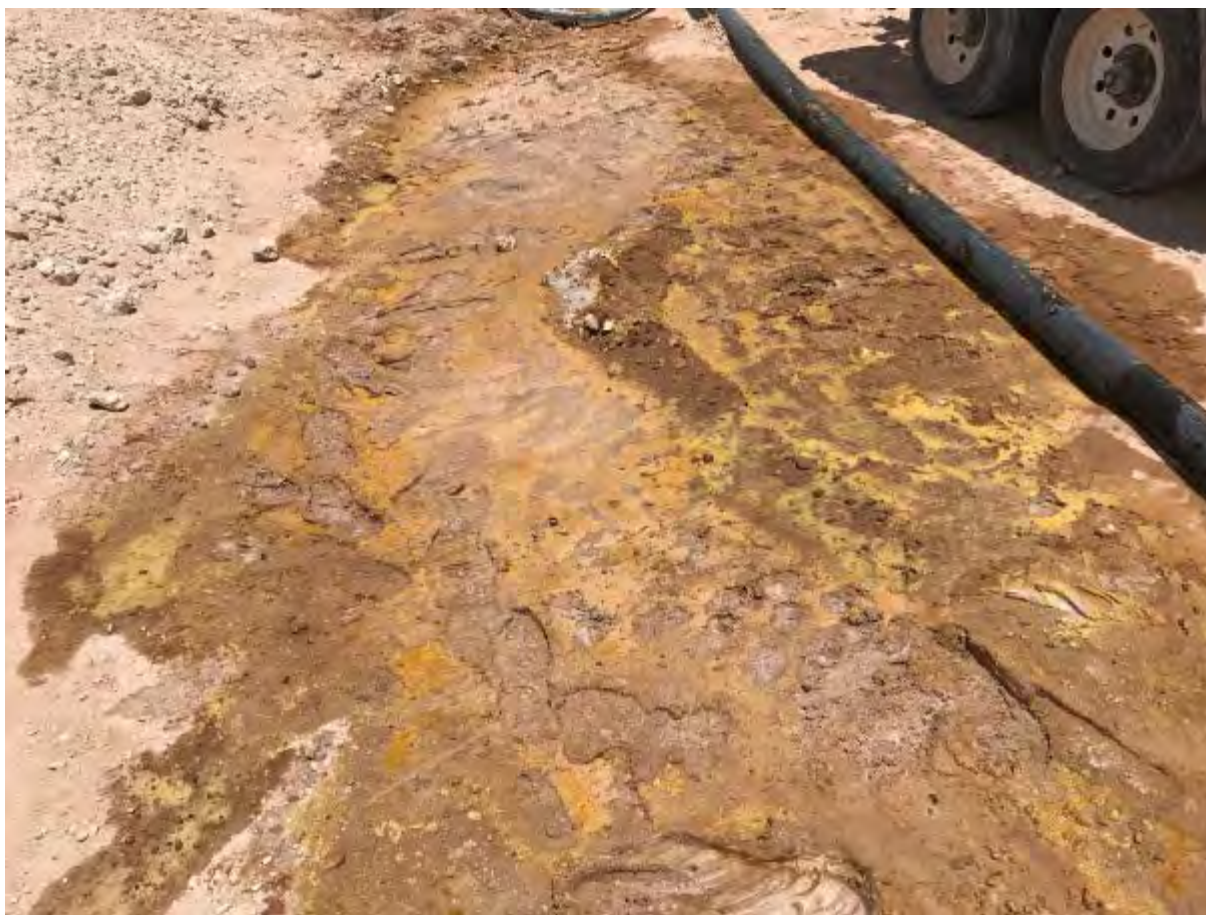
View of the release area at the release source.

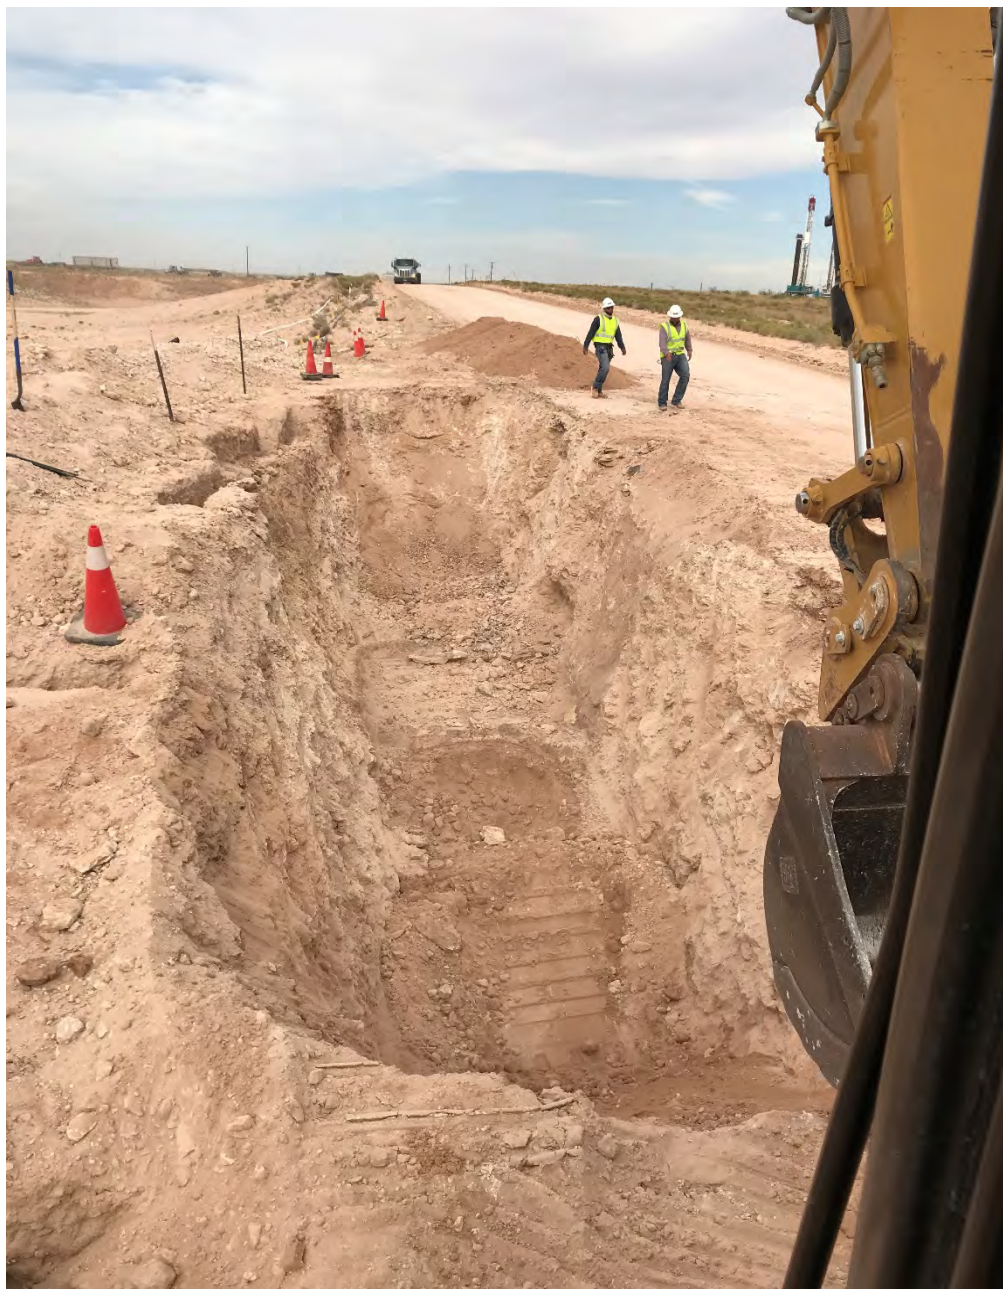
East facing view of the open excavation.

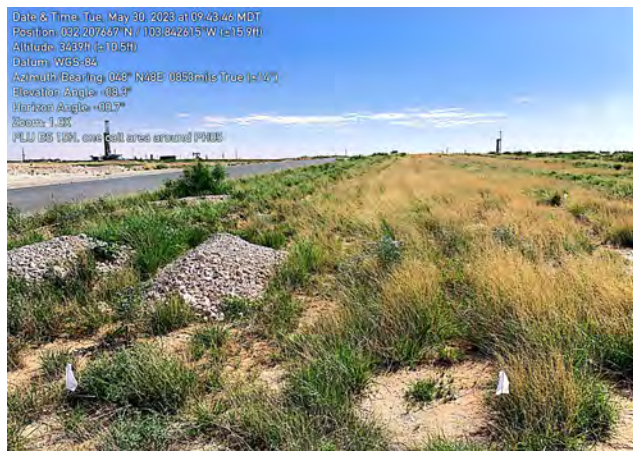
Photograph 1

Description: View of area around pothole PH05.

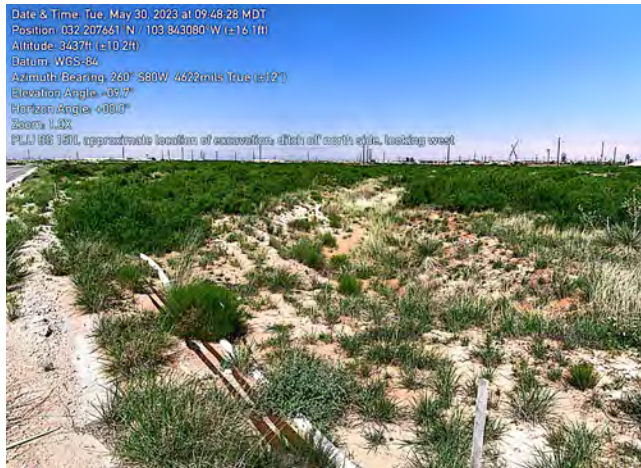
Photograph 2

Description: View of historical excavation area.

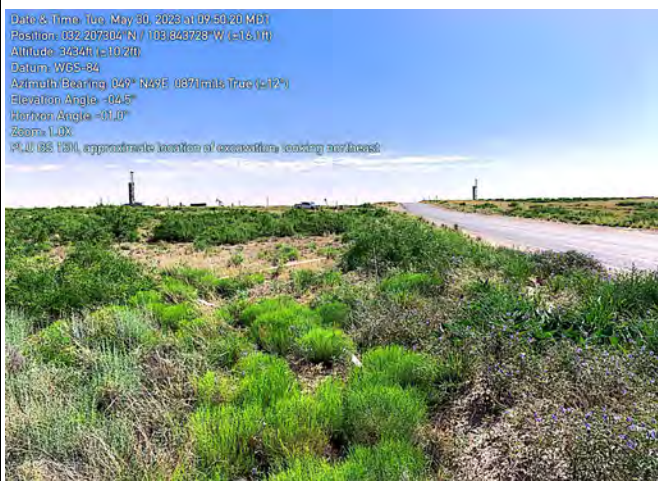
Photograph 3

Description: View of historical excavation area.
