**Re: Release Characterization, Remediation, Reclamation, and Revegetation Closure Report  
ConocoPhillips  
Tiger 11 Federal 001H  
Unit Letter F, Section 11, Township 20 South, Range 34 East  
DOR: 8/28/2024  
Lea County, New Mexico  
Incident ID: NAPP2426033046**

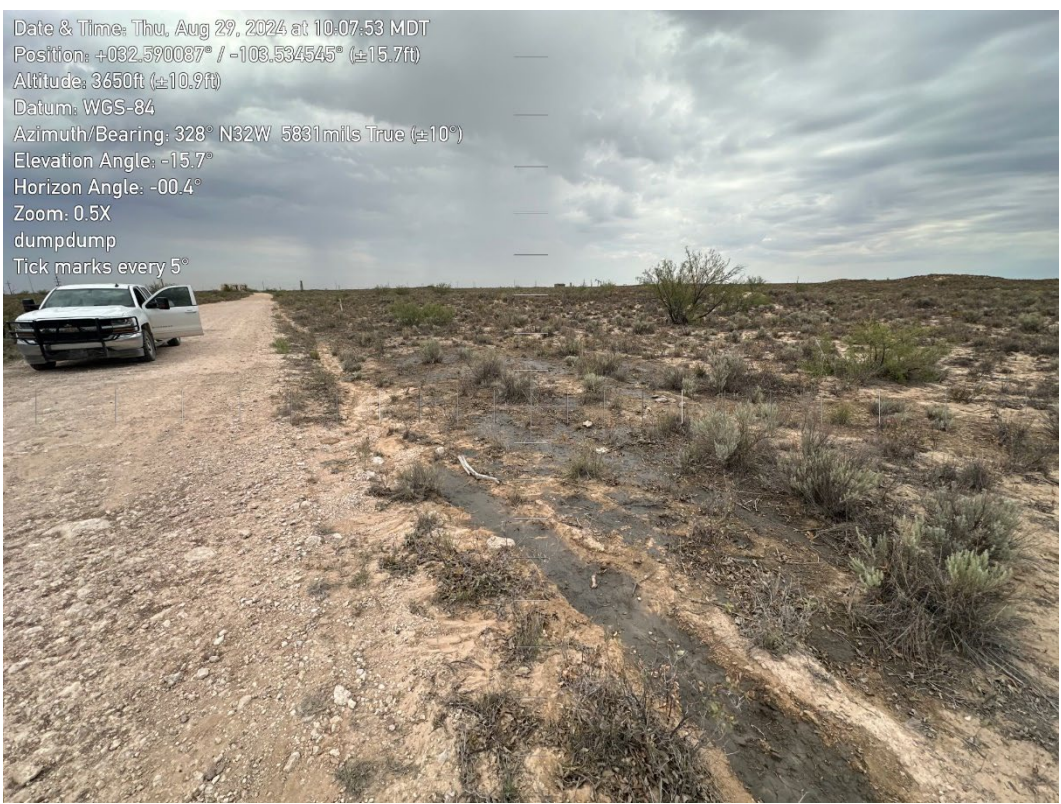
TETRA TECH, INC. PROJECT NO. 212C-MD-03607	DESCRIPTION	View of release area.	1
	SITE NAME	Tiger 11 Federal 001H	8/29/2024

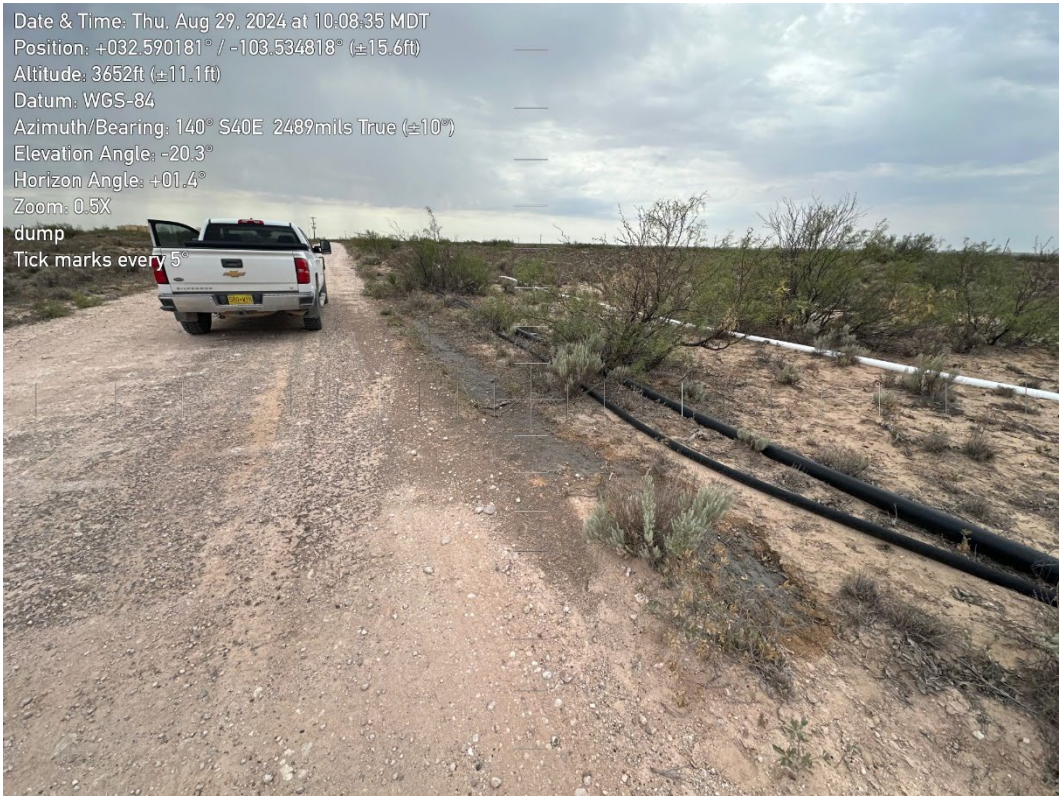
TETRA TECH, INC. PROJECT NO. 212C-MD-03607	DESCRIPTION	View of release area.	2
	SITE NAME	Tiger 11 Federal 001H	8/29/2024

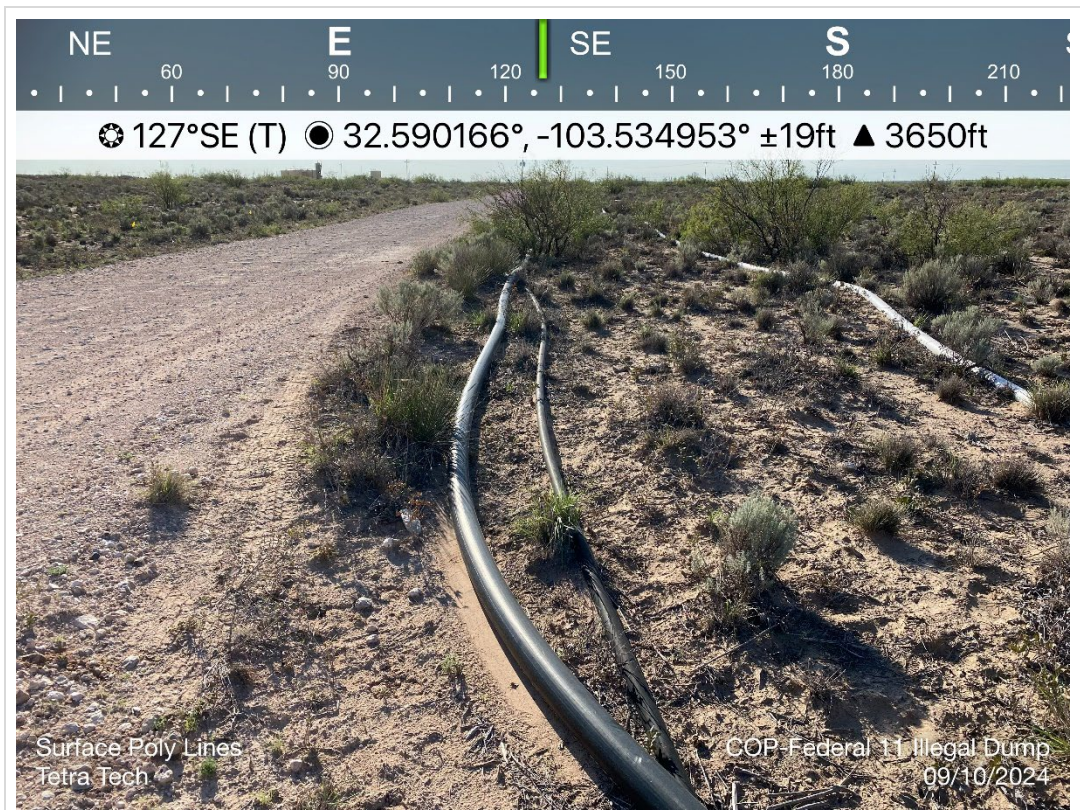
TETRA TECH, INC. PROJECT NO. 212C-MD-03607	DESCRIPTION	View east-southeast. View of approximate release extent. View of surface lines, vegetation present.	3
	SITE NAME	Tiger 11 Federal 001H	9/10/2024

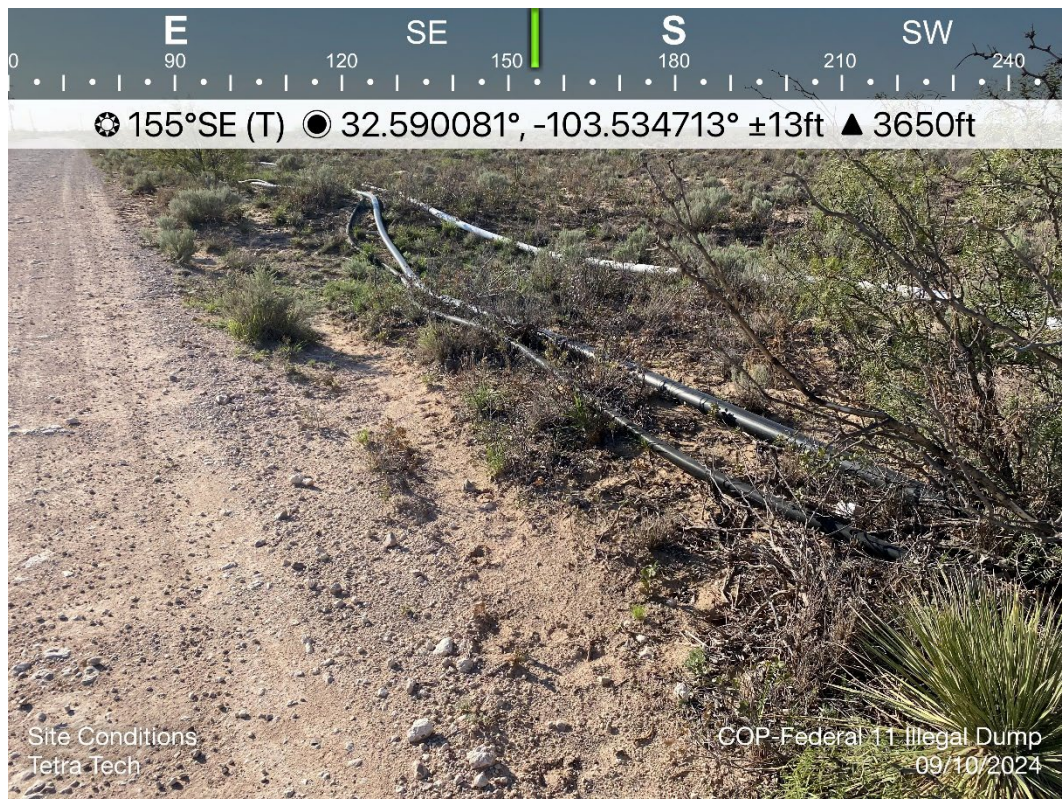
TETRA TECH, INC. PROJECT NO. 212C-MD-03607	DESCRIPTION	View southeast. View of approximate release extent. View of surface lines, vegetation present	4
	SITE NAME	Tiger 11 Federal 001H	9/10/2024

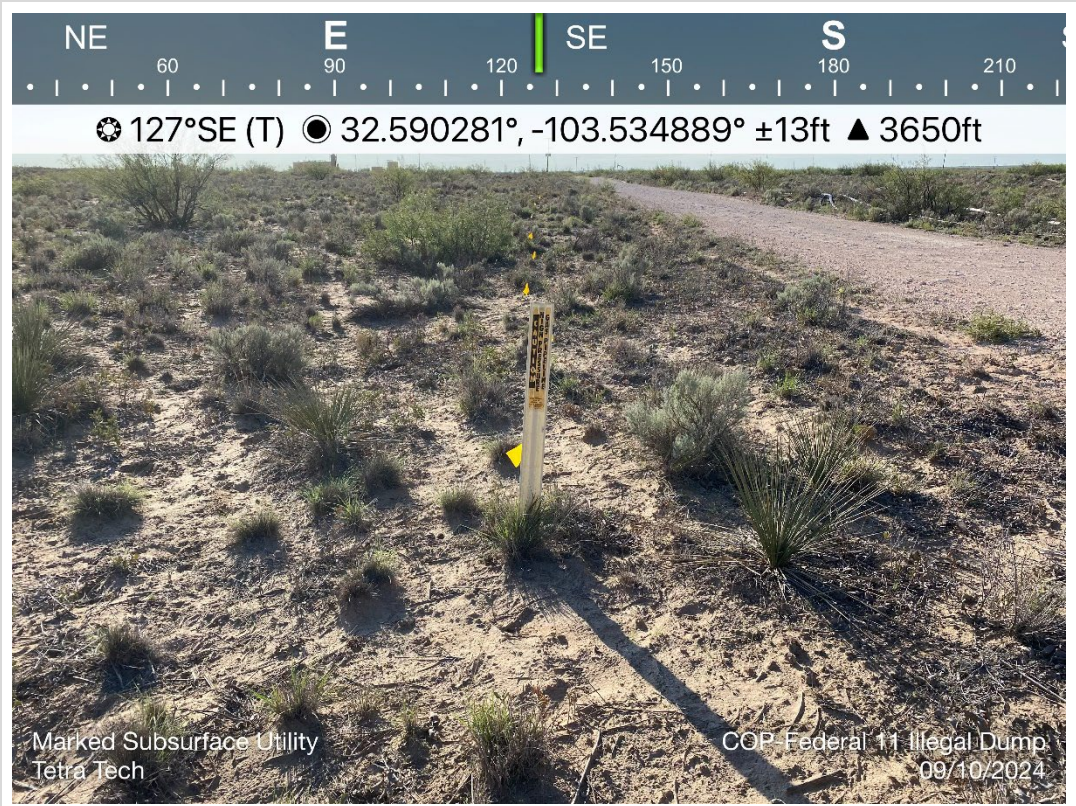
TETRA TECH, INC. PROJECT NO. 212C-MD-03607	DESCRIPTION	View southeast. View of approximate release extent. View of subsurface line, vegetation present	5
	SITE NAME	Tiger 11 Federal 001H	9/10/2024

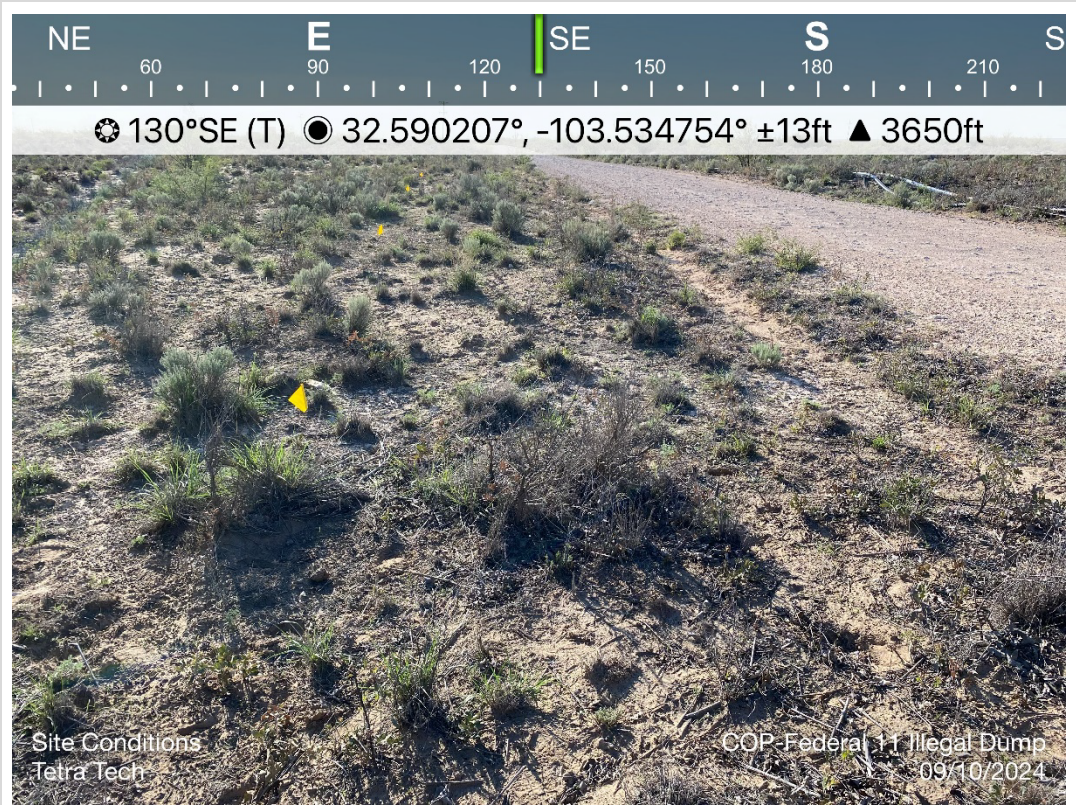
TETRA TECH, INC. PROJECT NO. 212C-MD-03607	DESCRIPTION	View southeast. View of approximate release extent. View of subsurface line, vegetation present	6
	SITE NAME	Tiger 11 Federal 001H	9/10/2024

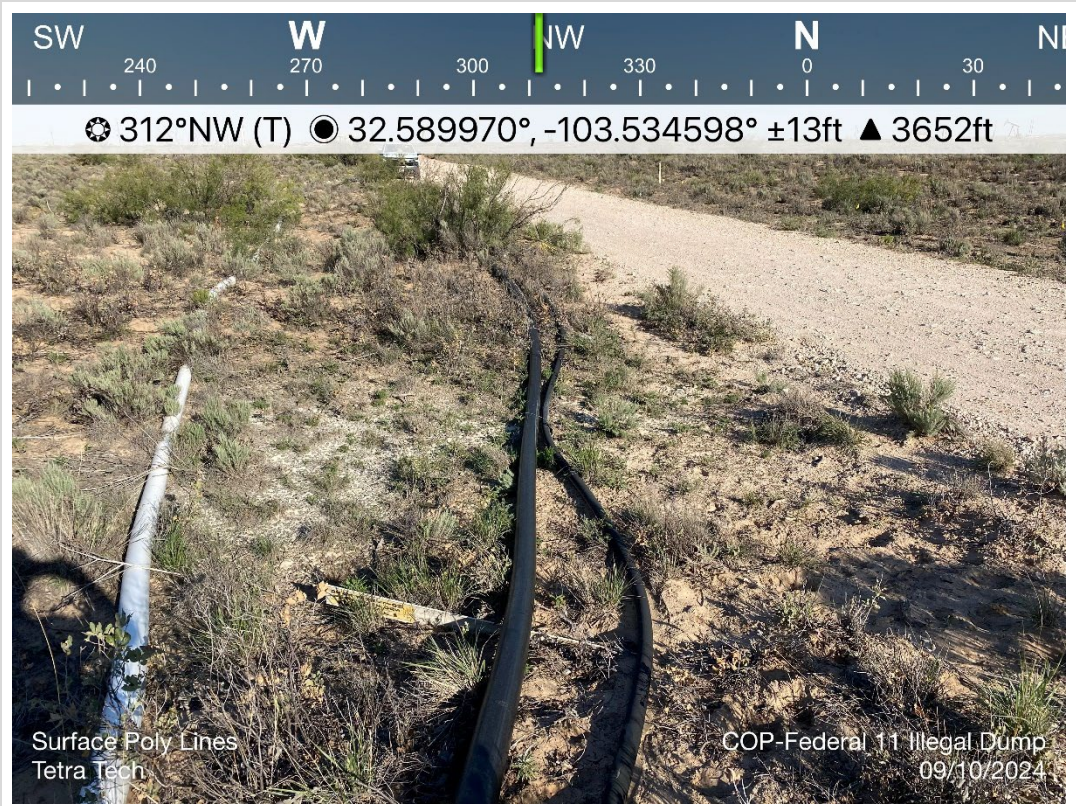
TETRA TECH, INC. PROJECT NO. 212C-MD-02832	DESCRIPTION	View northwest. View of approximate release extent. View of surface lines, vegetation present	7
	SITE NAME	Tiger 11 Federal 001H	9/10/2024

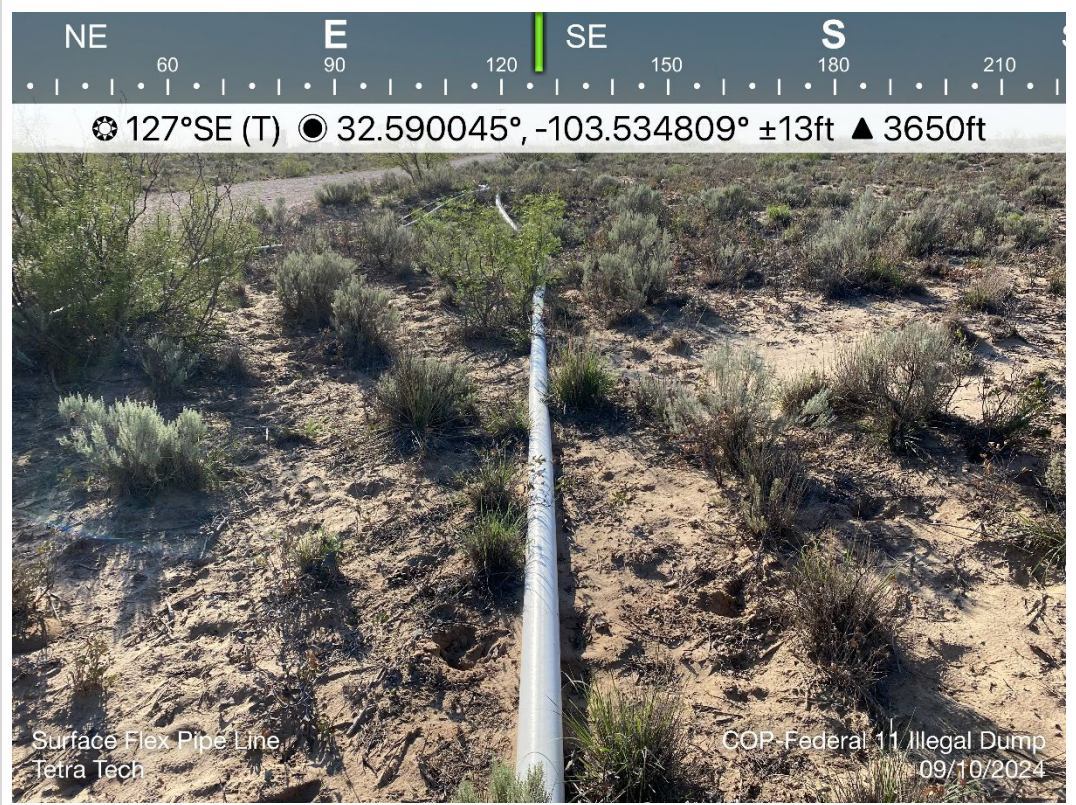
TETRA TECH, INC. PROJECT NO. 212C-MD-02832	DESCRIPTION	View southeast. View of approximate release extent. View of surface lines, vegetation present	8
	SITE NAME	Tiger 11 Federal 001H	9/10/2024

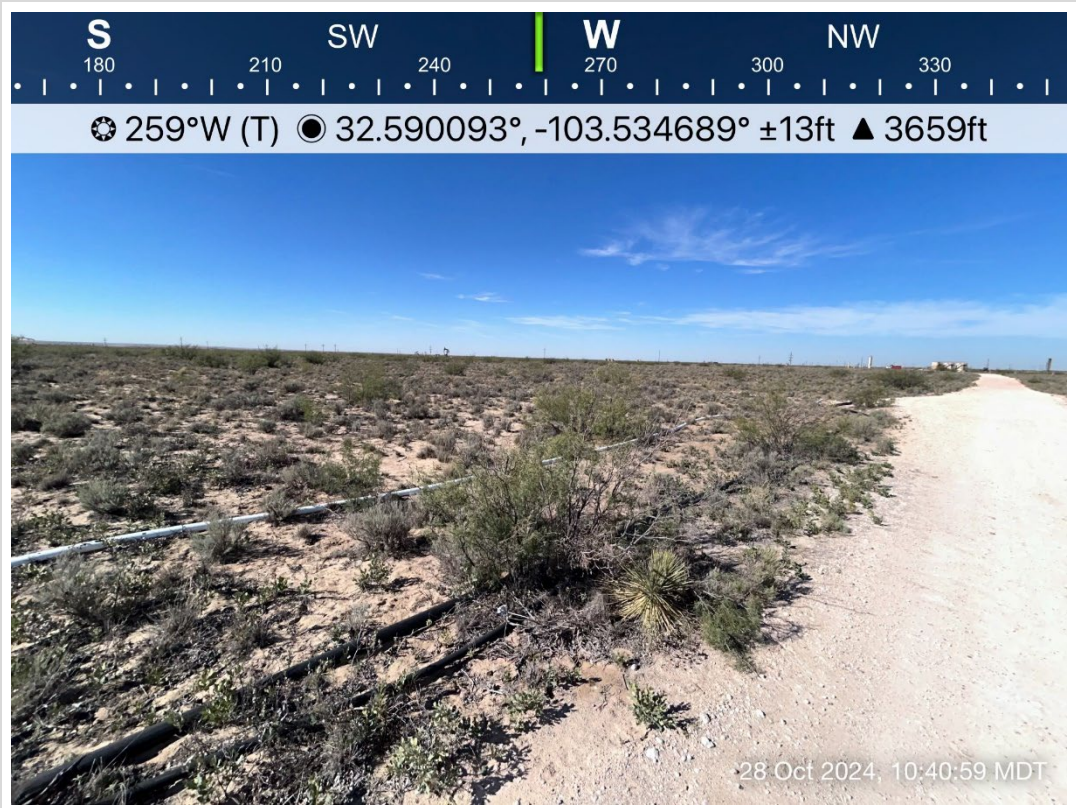
TETRA TECH, INC. PROJECT NO. 212C-MD-03607	DESCRIPTION	View west. View of release area following surface scrape. Vegetation present.	9
	SITE NAME	Tiger 11 Federal 001H	10/28/2024

The analytical data from the assessment was well below reclamation requirements of 600 mg/kg for chlorides and 100 mg/kg for TPH. ConocoPhillips elected to conduct a scrape of the impacted area to remove any surficial discoloration. During the surface scrape, personnel were cautious around existing vegetation as the release had not impacted the established vegetation. Therefore, based on 19.15.29.13 NMAC, areas disturbed by the remediation have been reclaimed, as the responsible party has restored the impacted surface areas to the condition that existed prior to the release.

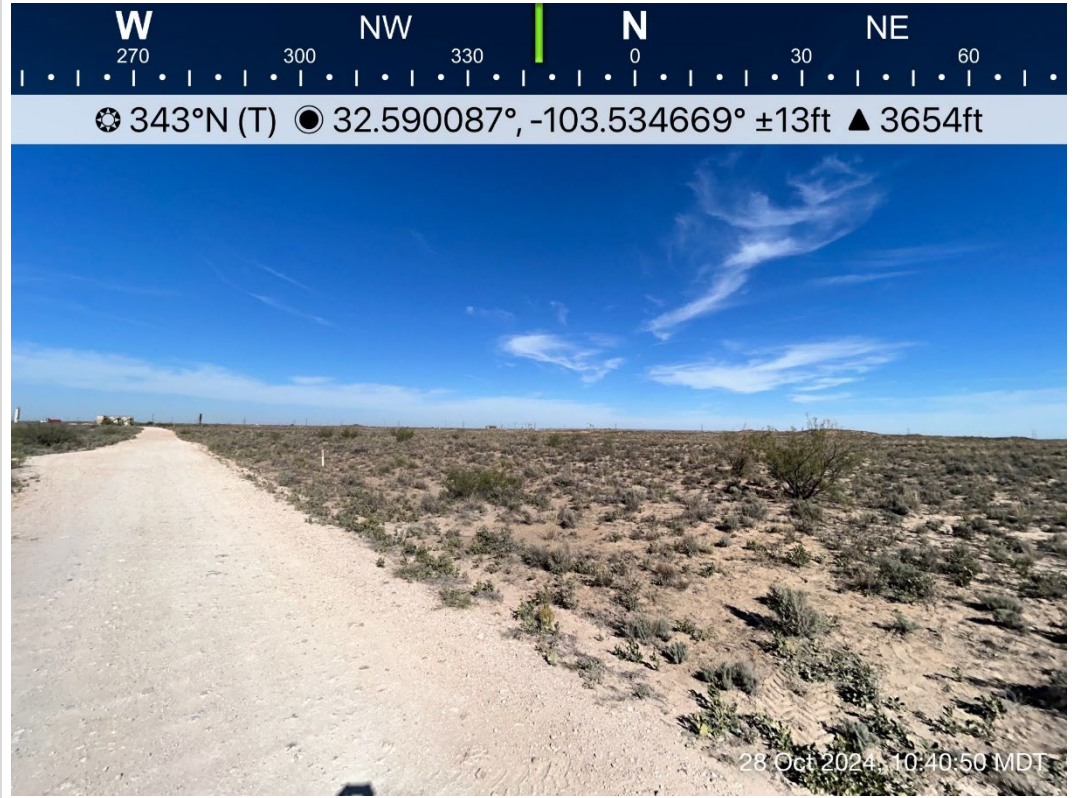
TETRA TECH, INC. PROJECT NO. 212C-MD-03607	DESCRIPTION	View north. View of release area following surface scrape. Vegetation present.	10
	SITE NAME	Tiger 11 Federal 001H	10/28/2024

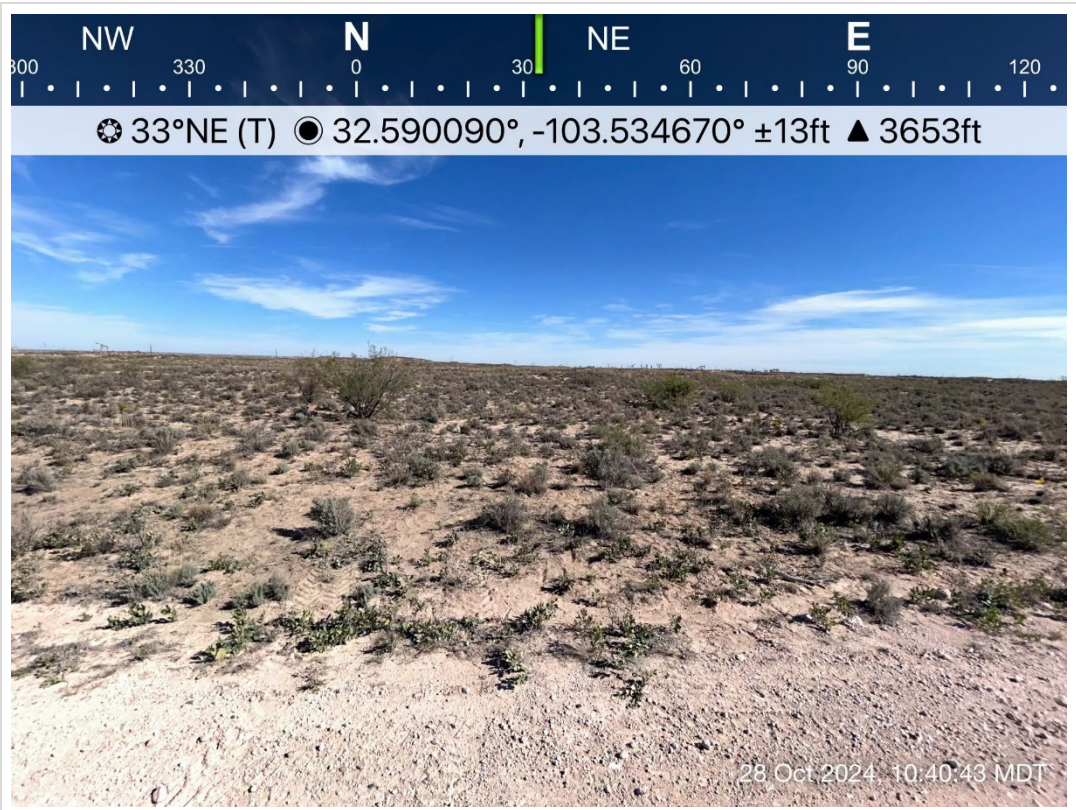
TETRA TECH, INC. PROJECT NO. 212C-MD-03607	DESCRIPTION	View northeast. View of release area following surface scrape. Vegetation present.	11
	SITE NAME	Tiger 11 Federal 001H	10/28/2024

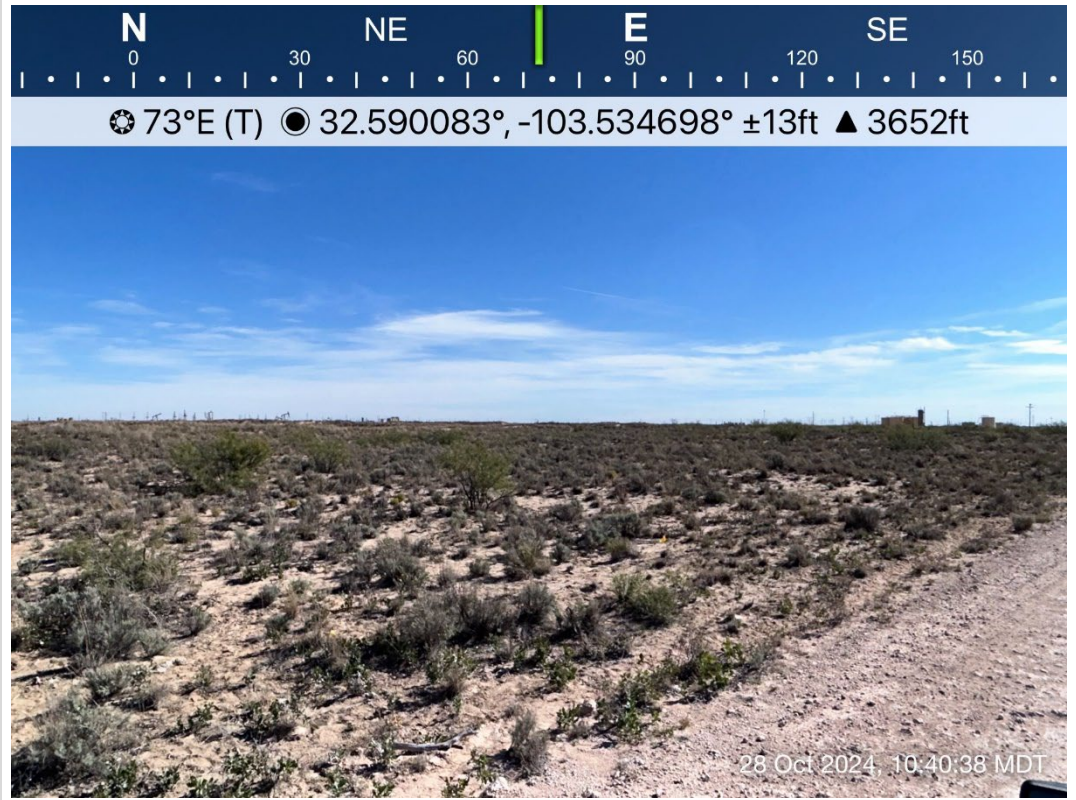
TETRA TECH, INC. PROJECT NO. 212C-MD-03607	DESCRIPTION	View east. View of release area following surface scrape. Vegetation present.	12
	SITE NAME	Tiger 11 Federal 001H	10/28/2024
