Snapping 2 State 6H

Closure Report

Section 2, Township 26S, Range 21E  
Eddy County, New Mexico

2RP-2686 – nAB1435732150

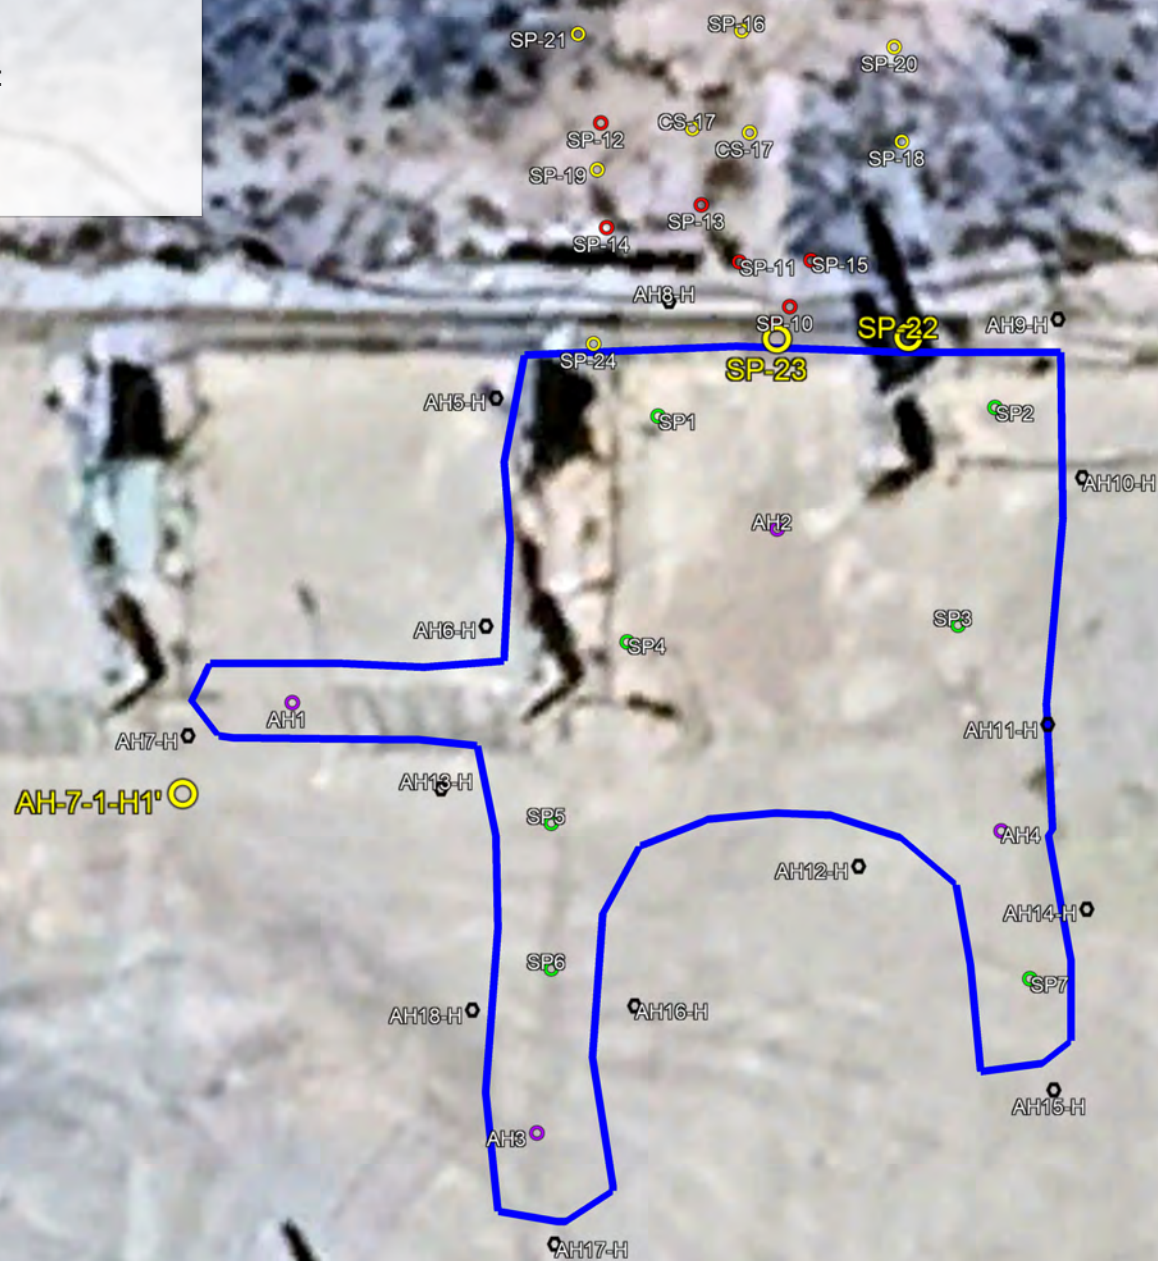
Confirmation Sampling:  
AH-7-1-H1'  
SP-22  
SP-23
