Devon Energy

Snapping 2 State 6H

Closure Report

2RP-4193 – nAB1712152502

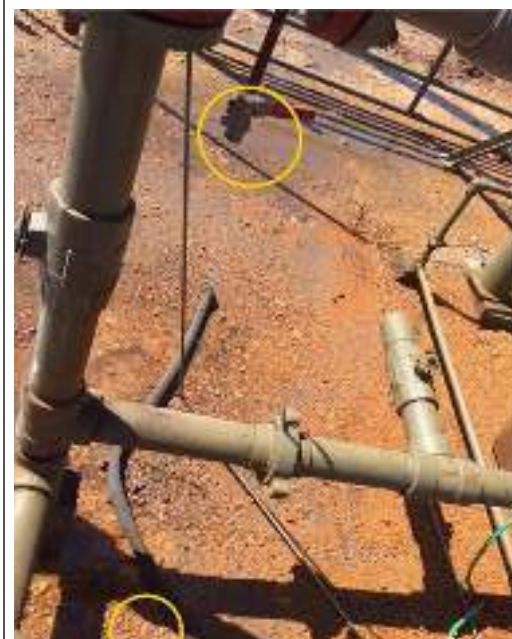
According to the subsequent C-141 incident dated April 16, 2017: the cause of release was an open drain on the heater treater. The plug was displaced and was discovered laying on the ground, causing a release of approximately 10 bbl. of produced water. All fluid remained on location. The spill impacted an area approximately 50' long and 10' wide. The NMOCD issued a permit number of 2RP-4193.

Release Point

Heater treater drain on dump was open and the plug was on the ground. The sample port on the dump was immediately closed to stop the release. The plug has been replaced and the heater treater is back in service.
