**Re: REVISED Release Characterization and Closure Request Addendum
BTA Oil Producers, LLC
Rojo 22-25 CTB @ 0 Release
Unit Letter N, Section 22, Township 25 South, Range 33 East
Lea County, New Mexico
Incident ID# nAPP2430254795**

Revised Release Characterization and Closure Request Addendum
March 19, 2025

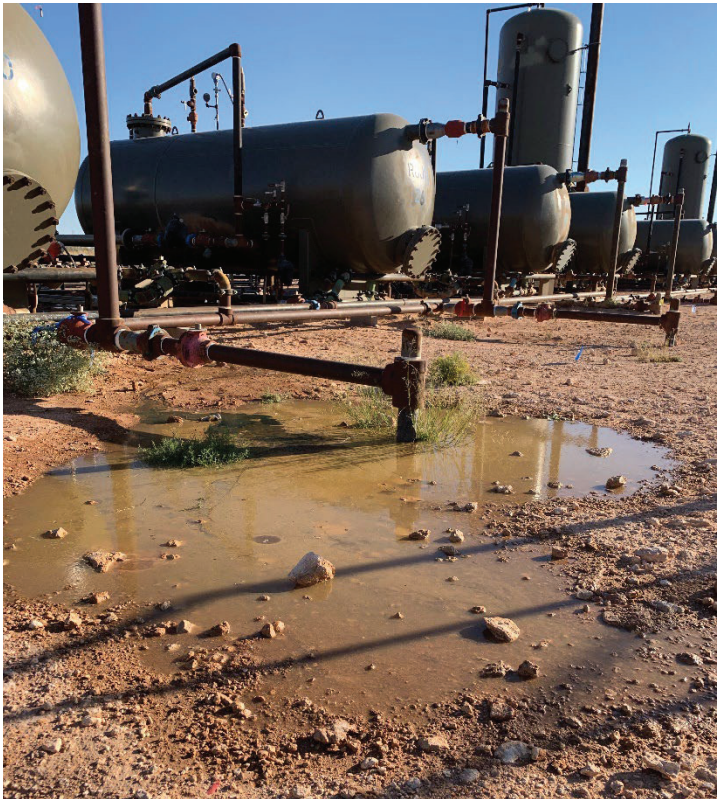
TETRA TECH, INC. PROJECT NO. 212C-MD-03684	DESCRIPTION	View of approximate release extent.	2
	SITE NAME	Rojo 22-25 CTB @ 0 Release	N/A

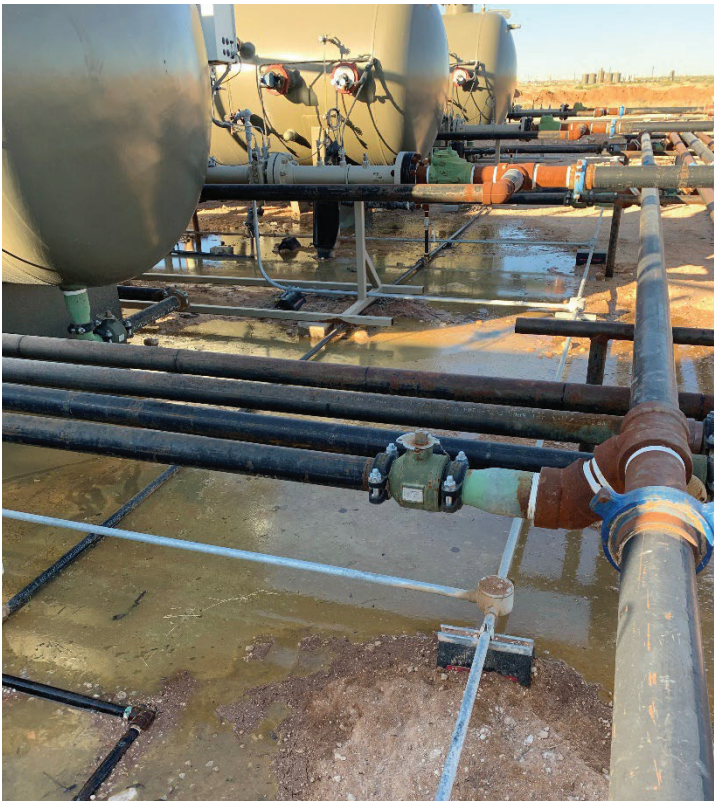
TETRA TECH, INC. PROJECT NO. 212C-MD-03684	DESCRIPTION	View of approximate release extent. Mass of flowlines.	3
	SITE NAME	Rojo 22-25 CTB @ 0 Release	N/A

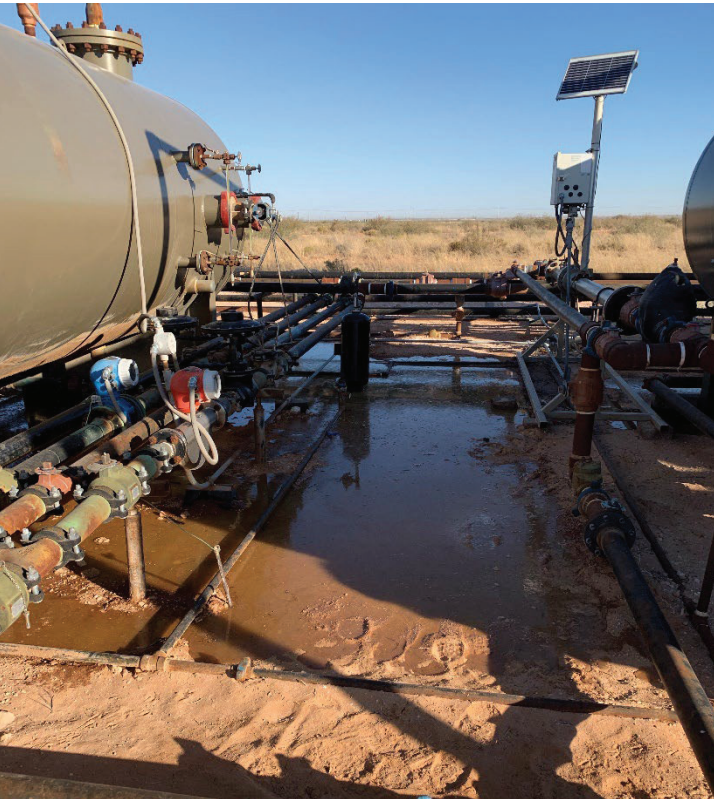
TETRA TECH, INC. PROJECT NO. 212C-MD-03684	DESCRIPTION	View of approximate release extent. Mass of flowlines.	4
	SITE NAME	Rojo 22-25 CTB @ 0 Release	N/A

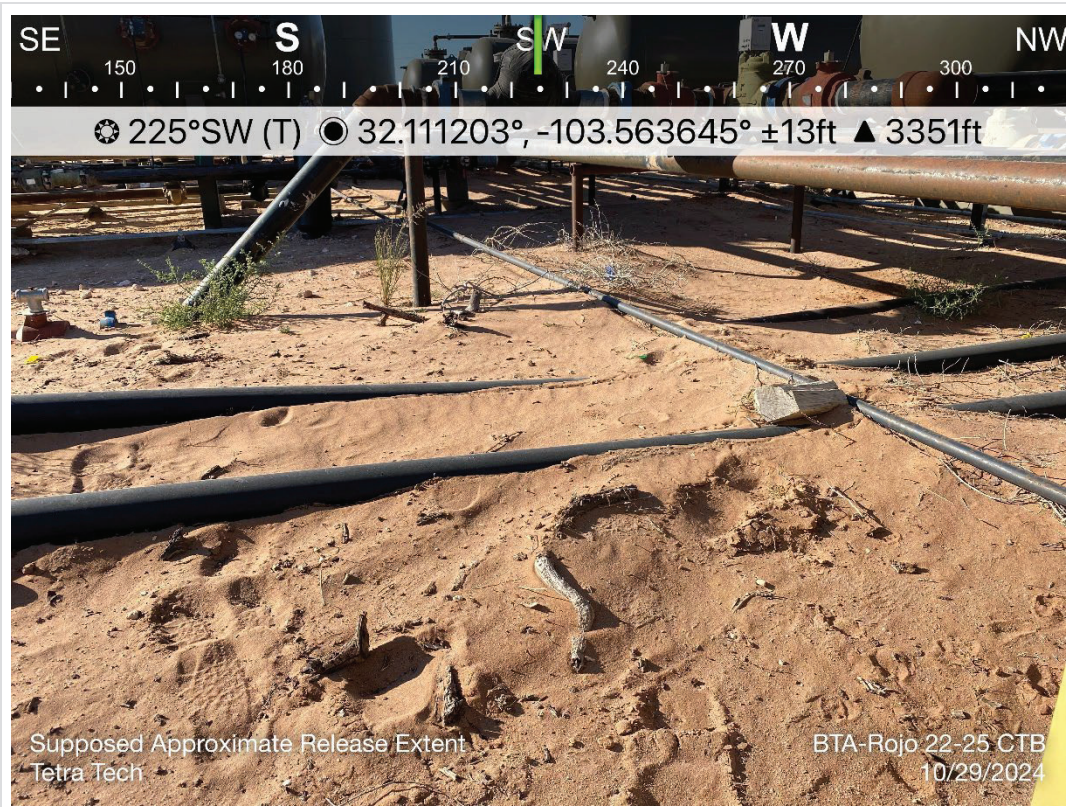
TETRA TECH, INC. PROJECT NO. 212C-MD-03684	DESCRIPTION	View southwest of site infrastructure. View of the approximate release area.	8
	SITE NAME	Rojo 22-25 CTB @ 0 Release	10/29/2024

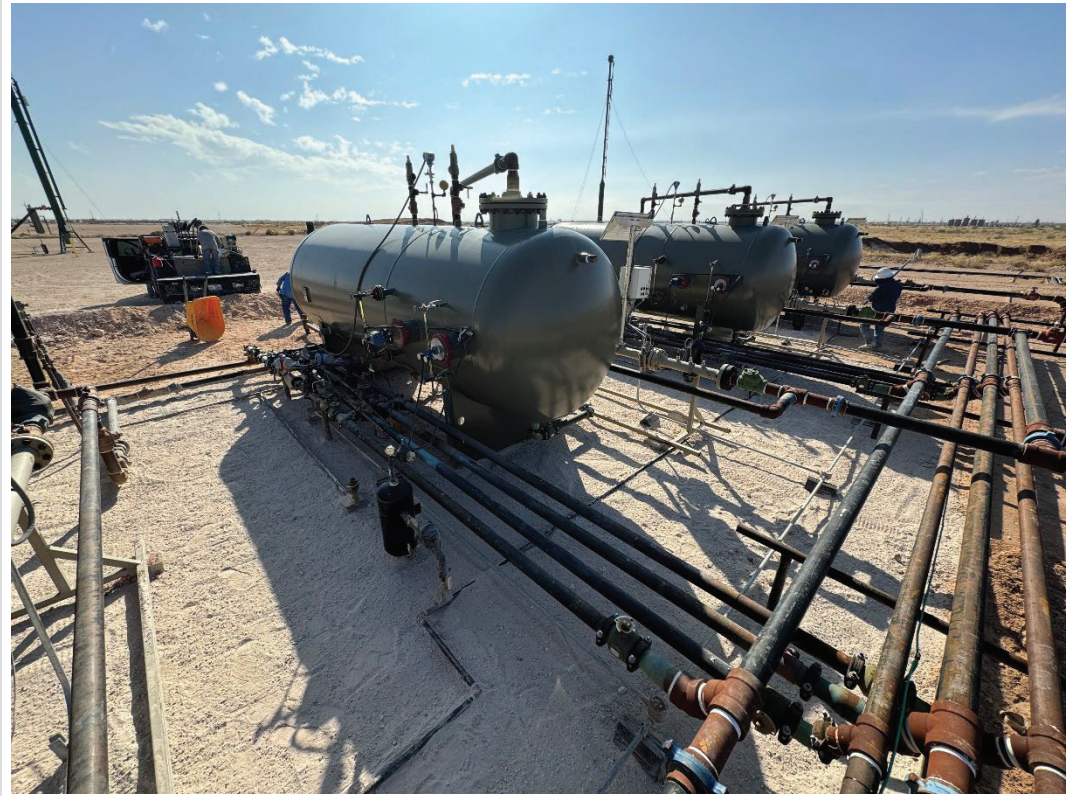
TETRA TECH, INC. PROJECT NO. 212C-MD-03684	DESCRIPTION	View of approximate release area post initial response activities.	10
	SITE NAME	Rojo 22-25 CTB @ 0 Release	N/A

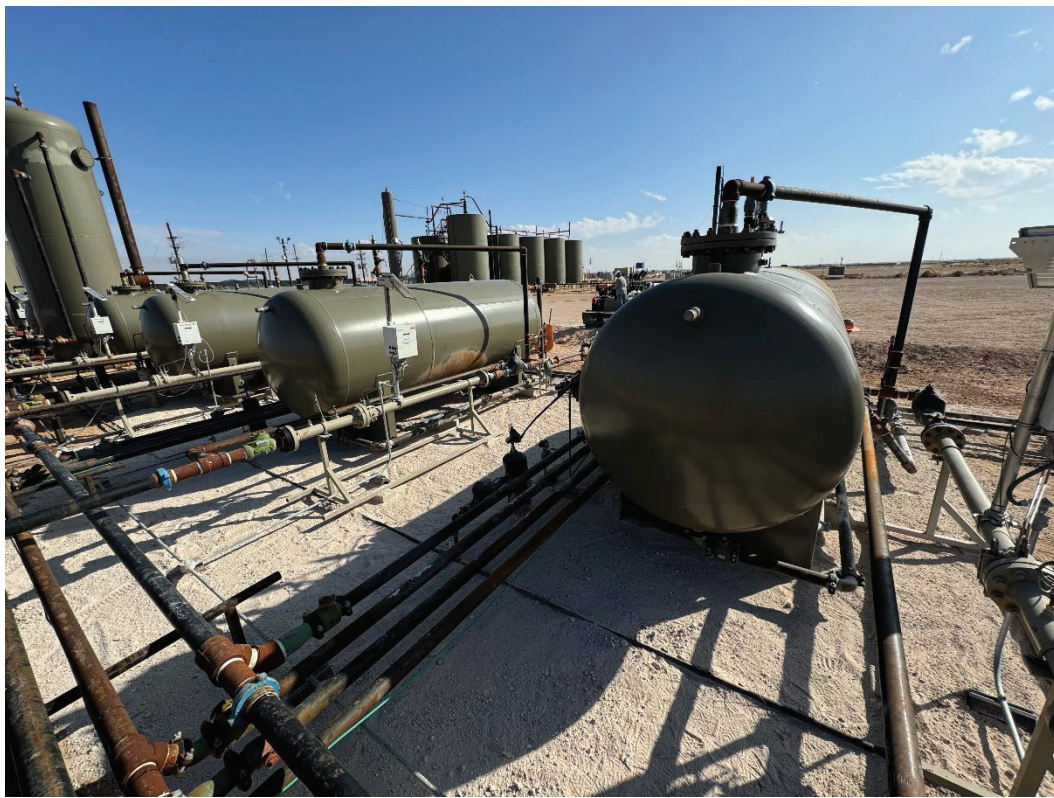
TETRA TECH, INC. PROJECT NO. 212C-MD-03684	DESCRIPTION	View of approximate release area post initial response activities.	11
	SITE NAME	Rojo 22-25 CTB @ 0 Release	N/A

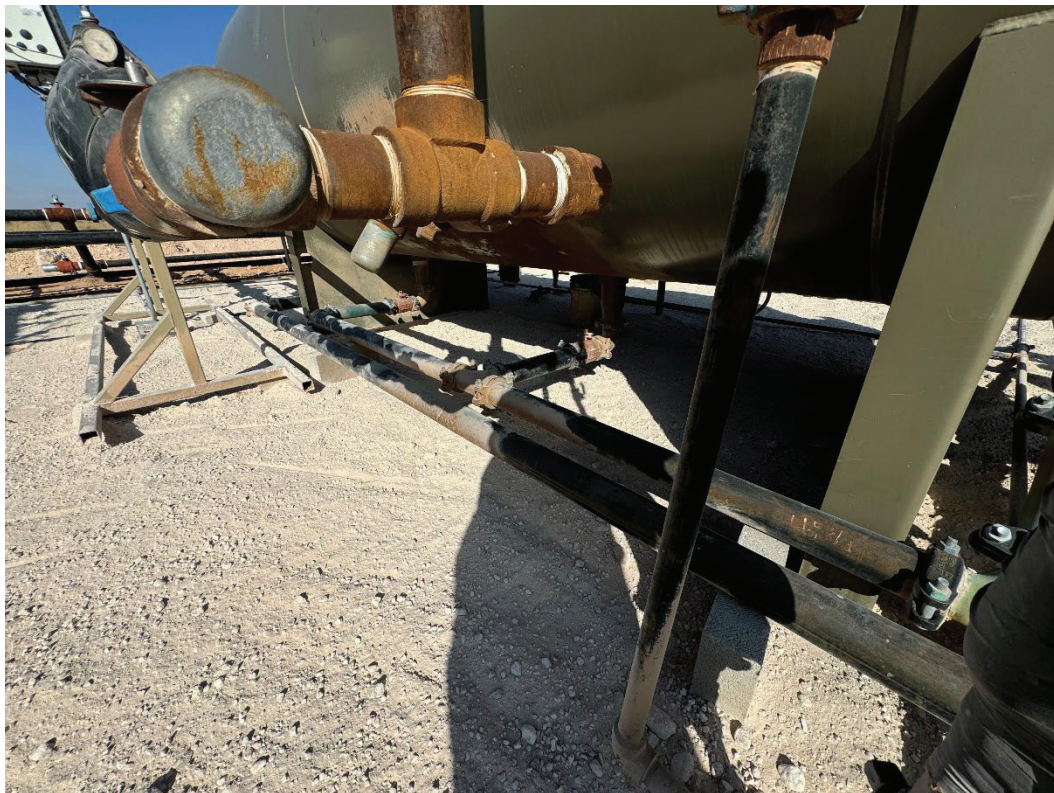
TETRA TECH, INC. PROJECT NO. 212C-MD-03684	DESCRIPTION	View of approximate release area post initial response activities.	12
	SITE NAME	Rojo 22-25 CTB @ 0 Release	N/A

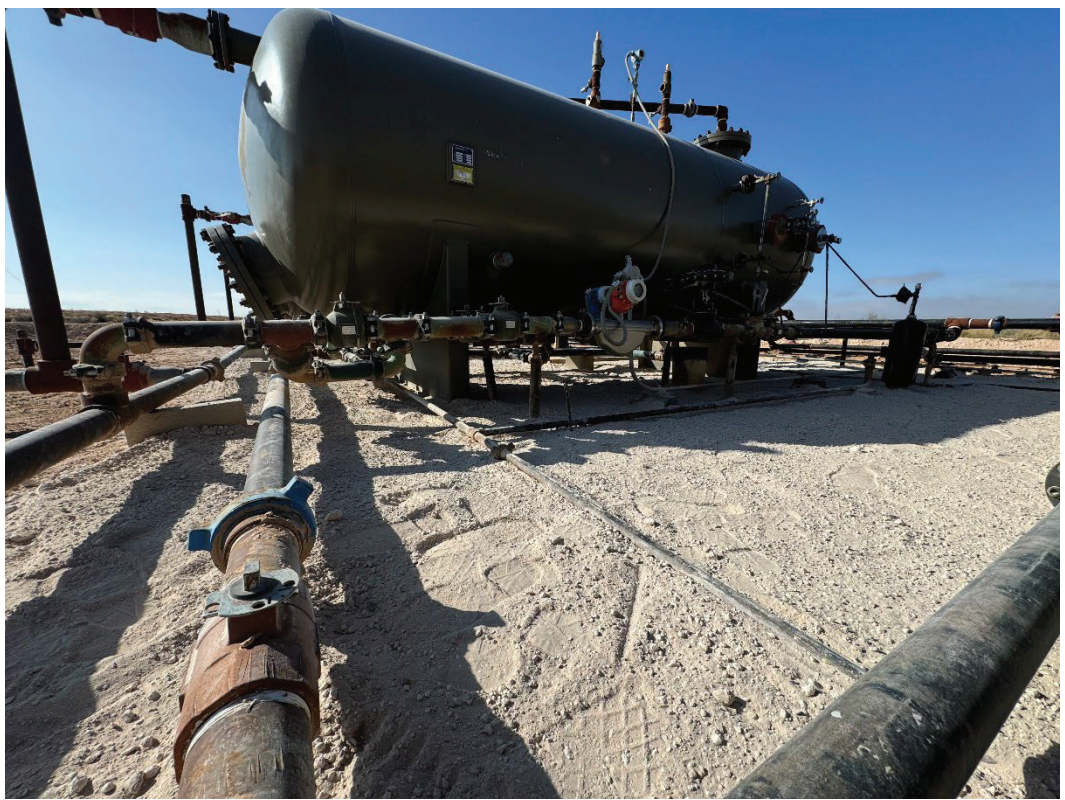
TETRA TECH, INC. PROJECT NO. 212C-MD-03684	DESCRIPTION	View of approximate release area post initial response activities.	13
	SITE NAME	Rojo 22-25 CTB @ 0 Release	N/A
