**Re: Closure Request  
PLU 28 BS West Battery  
Incident Number nAPP2435358022  
Eddy County, New Mexico**

Ensolum, LLC (Ensolum), on behalf of XTO Energy, Inc. (XTO), has prepared this *Closure Request* to document assessment, surface scraping, and soil sampling activities at the PLU 28 BS West Battery (Site). The purpose of the assessment and sampling activities was to assess for the presence or absence of impacts to soil following a flare fire resulting in crude oil overspray at the Site. Based on field observations, field screening activities, and soil sample laboratory analytical results, XTO is submitting this *Closure Request*, describing assessment surface scraping, and soil sampling activities that have occurred and requesting no further action for Incident Number nAPP2435358022.

XTO Energy, Inc  
Closure Request  
PLU 28 BS West Battery

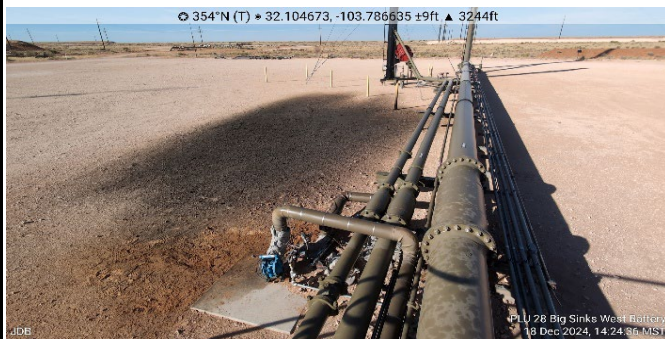
Photograph: 1 Date: 12/18/2024  
 Description: Initial assessment activities  
 View: North

On December 18, 2024, Ensolum personnel visited the Site to evaluate the overspray extent and soil staining from the fire based on information provided on the C-141 and visual observations. No soil samples were collected during the Site visit. The area of scorched soil was mapped utilizing a handheld Global Positioning System (GPS) unit and is depicted on Figure 2. Photographic documentation was collected during the Site assessment and Photographic Log is included in Appendix B.

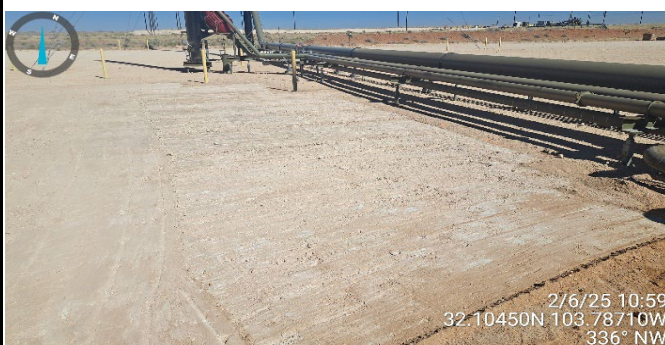
Photograph: 3 Date: 02/06/2025  
 Description: Surface scrape activities  
 View: Northwest

On January 8, 2025, Ensolum personnel returned to the Site to oversee surface scraping activities. An area of approximately 722 square feet of scorched pad soil was surface scraped with heavy equipment to the maximum extent possible. Following surface scraping activities, four 5-point composite confirmation soil samples, CS01 through CS04, were collected within the scraped area. The 5-point composite soil samples were collected by placing five equivalent aliquots of soil into a 1-gallon, resealable plastic bag and homogenizing the samples by thoroughly mixing. On March 5, 2025, Ensolum returned to the Site to collect lateral delineation soil samples. Three delineation samples SS01 through SS03 were collected at a depth of 0.5 feet bgs to assess the lateral extent of the release. All soil samples were field screened for volatile organic compounds (VOCs) utilizing a calibrated photoionization detector (PID) and chloride utilizing Hach® chloride QuanTab® test strips. The surface scrape extent and soil sample locations are depicted on Figure 2. Photographic documentation is included in Appendix B.
