Amended Remediation Summary & Soil Closure Request

Mewbourne Oil Company Rio Grande 2-1 #521H

Eddy County, New Mexico
Unit Letter "D", Section 2, Township 19 South, Range 28 East
Latitude 32.69156 North, Longitude 104.15495 West
NMOCD Reference No. nAPP2418546373

Etech Environmental & Safety Solutions, Inc.
6309 Indiana Ave, Ste. D
Lubbock, Texas 79413

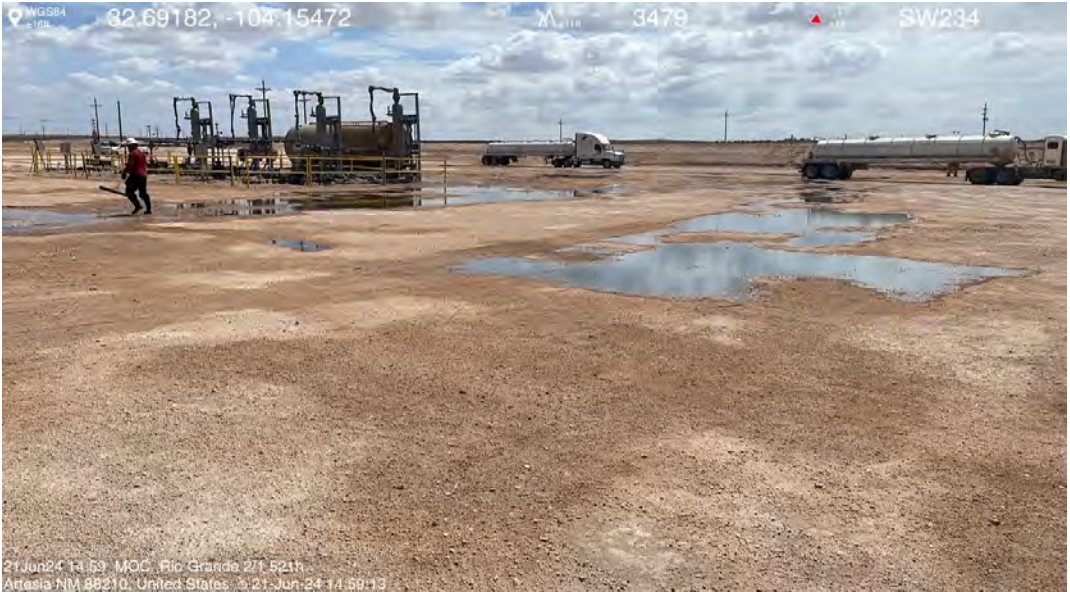
Photo Number: 3

<p>21 Jun 24 14:59 MOC, Rio Grande 211 52th Artesia NM 88210, United States © 21 Jun 24 14:59:19</p>
Photo Direction: Southwest	
Photo Description: View of the affected area.

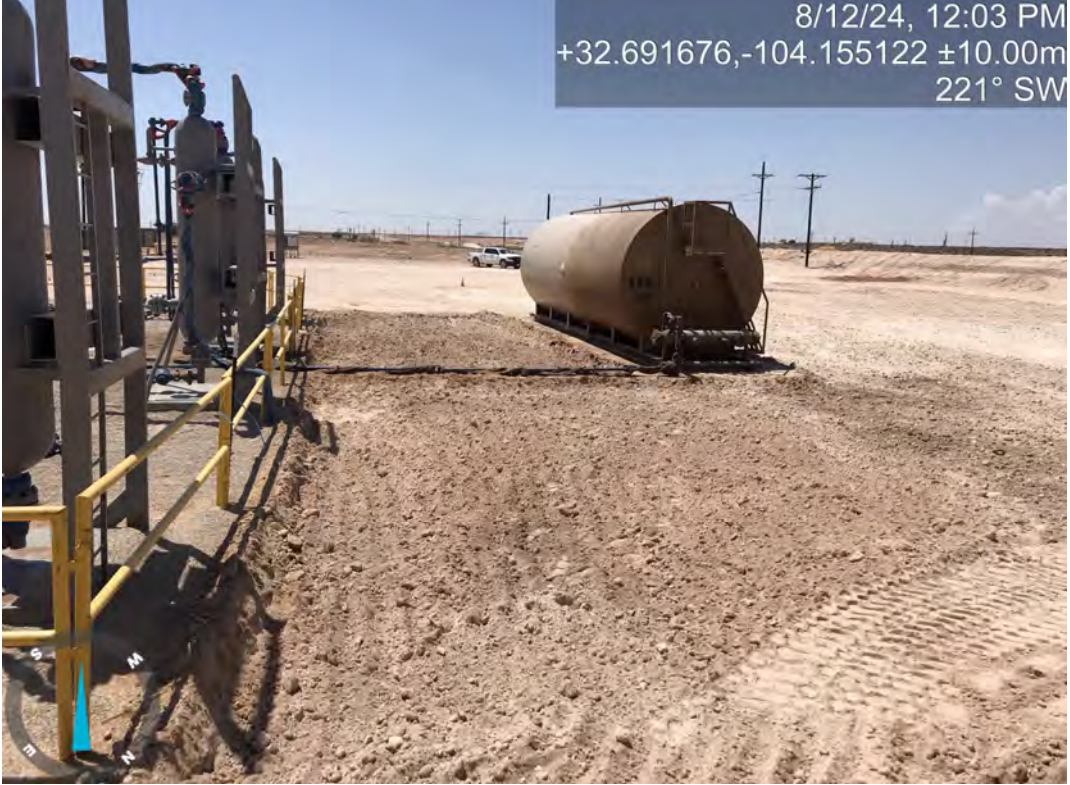
Photo Number: 7

<p>8/12/24, 12:03 PM +32.691676,-104.155122 ±10.00m 221° SW</p>
Photo Direction: Southwest	
Photo Description: View of the excavated area.

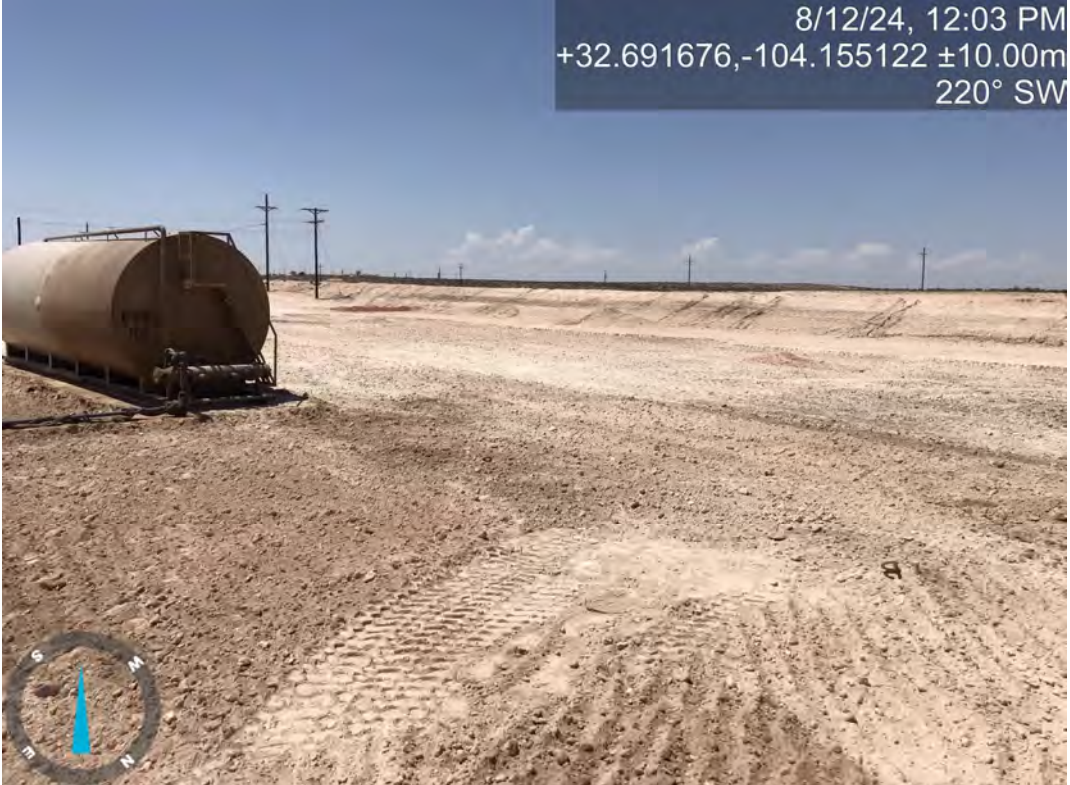
Photo Number: 8

<p>8/12/24, 12:03 PM +32.691676,-104.155122 ±10.00m 220° SW</p>
Photo Direction: Southwest	
Photo Description: View of the excavated area.

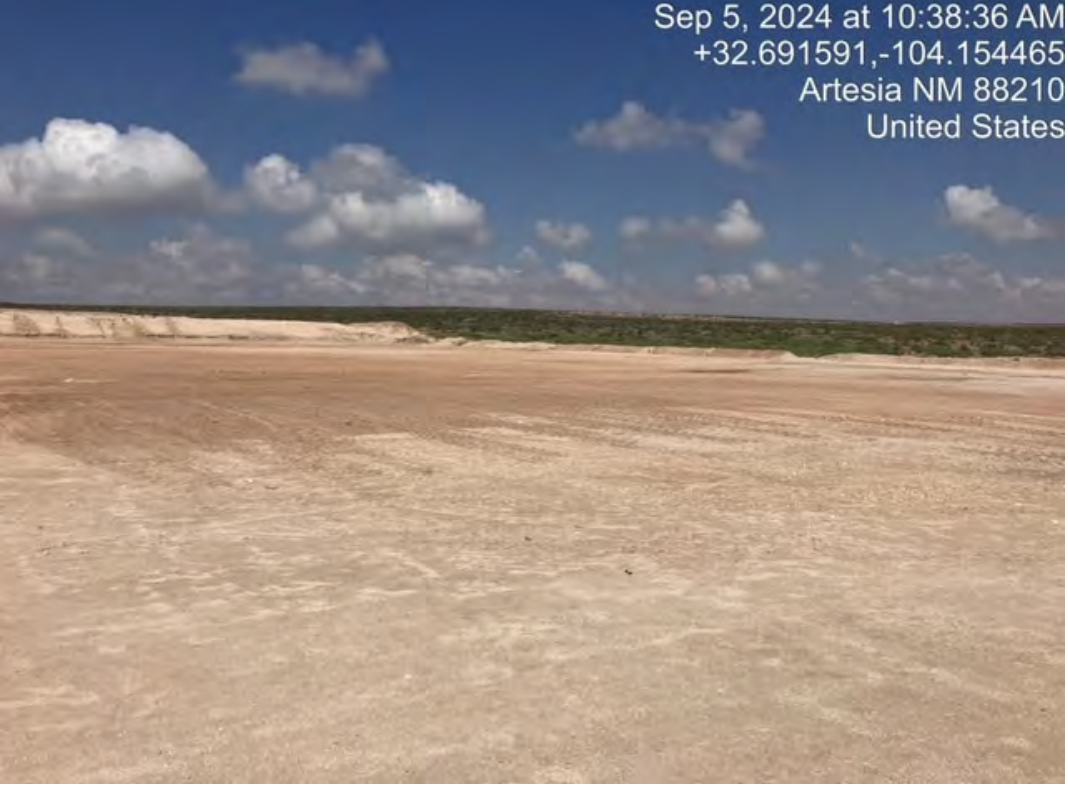
Photo Number: 13

<p>Sep 5, 2024 at 10:38:36 AM +32.691591,-104.154465 Artesia NM 88210 United States</p>
Photo Direction: Northwest	
Photo Description: View of the remediated area following backfilling and regrading.

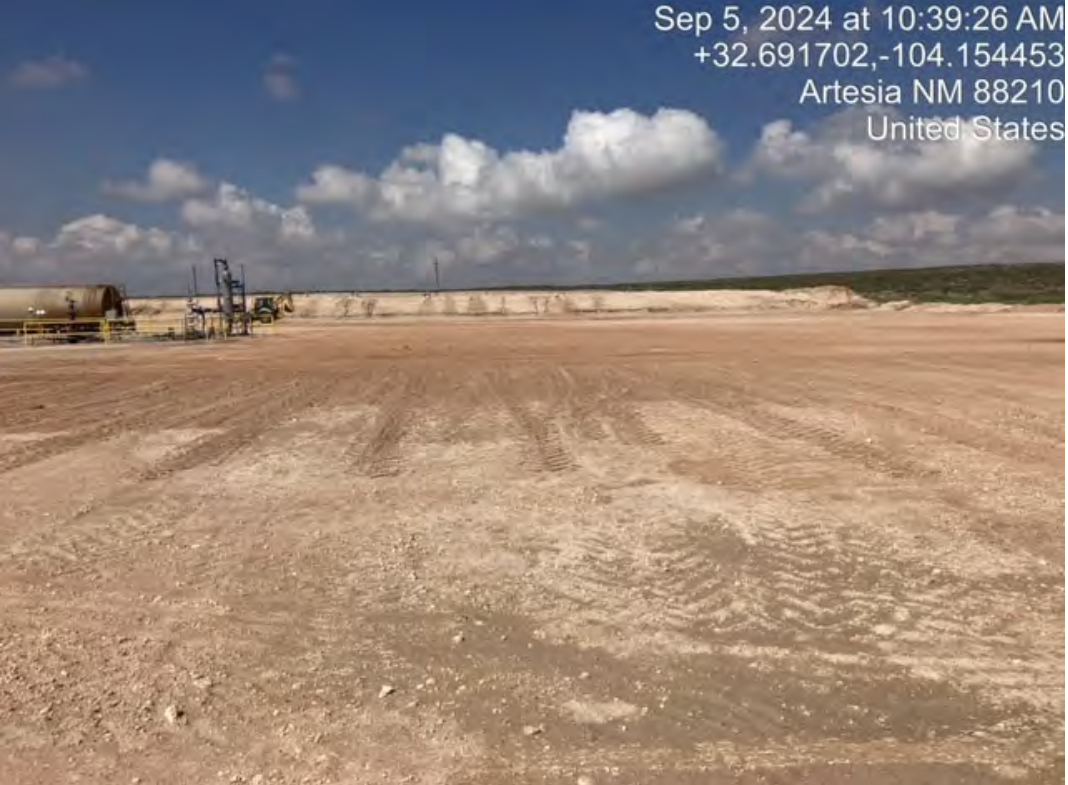
Photo Number: 14

<p>Sep 5, 2024 at 10:39:26 AM +32.691702,-104.154453 Artesia NM 88210 United States</p>
Photo Direction: West	
Photo Description: View of the remediated area following backfilling and regrading.

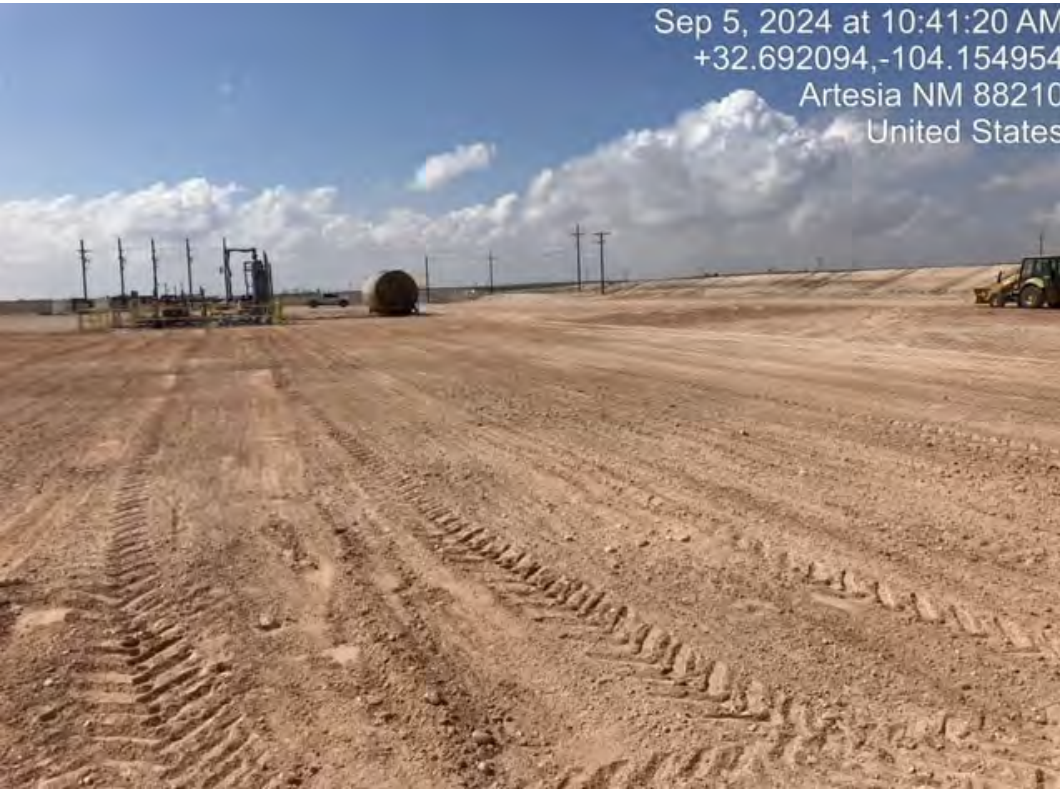
Photo Number: 15

<p>Sep 5, 2024 at 10:41:20 AM +32.692094,-104.154954 Artesia NM 88210 United States</p>
Photo Direction: South-Southwest	
Photo Description: View of the remediated area following backfilling and regrading.

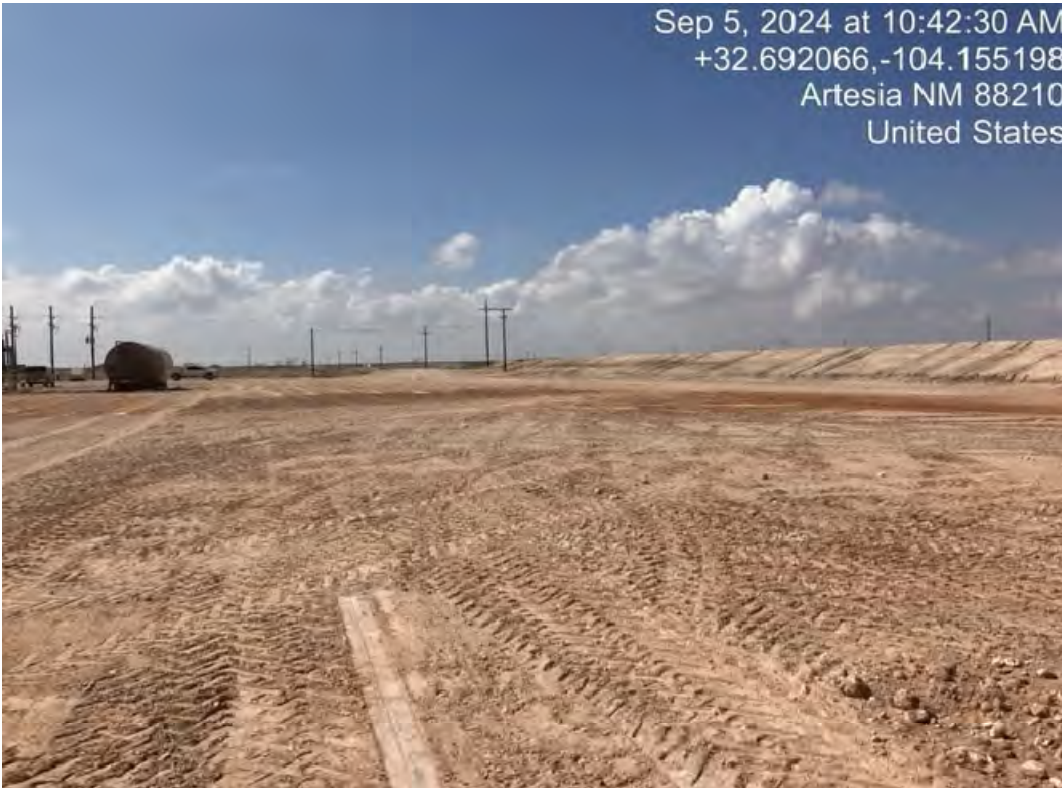
Photo Number: 17

<p>Sep 5, 2024 at 10:42:30 AM +32.692066,-104.155198 Artesia NM 88210 United States</p>
Photo Direction: South	
Photo Description: View of the remediated area following backfilling and regrading.

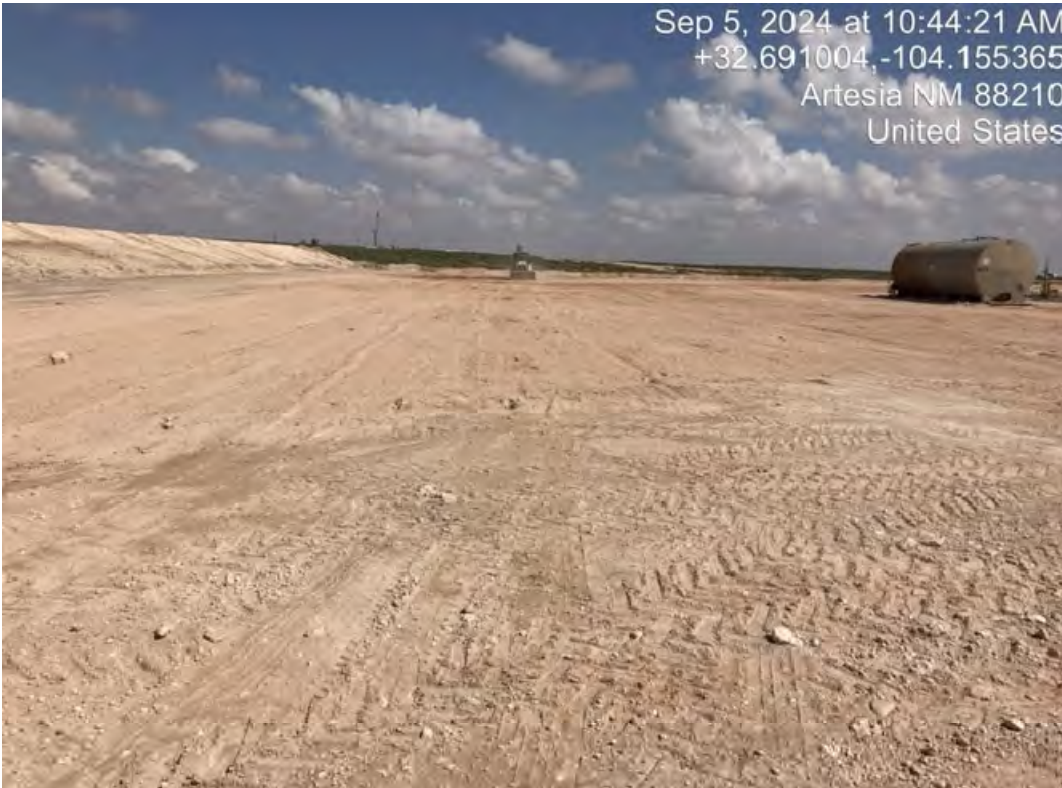
Photo Number: 18

<p>Sep 5, 2024 at 10:44:21 AM +32.691004,-104.155365 Artesia NM 88210 United States</p>
Photo Direction: South	
Photo Description: View of the remediated area following backfilling and regrading.

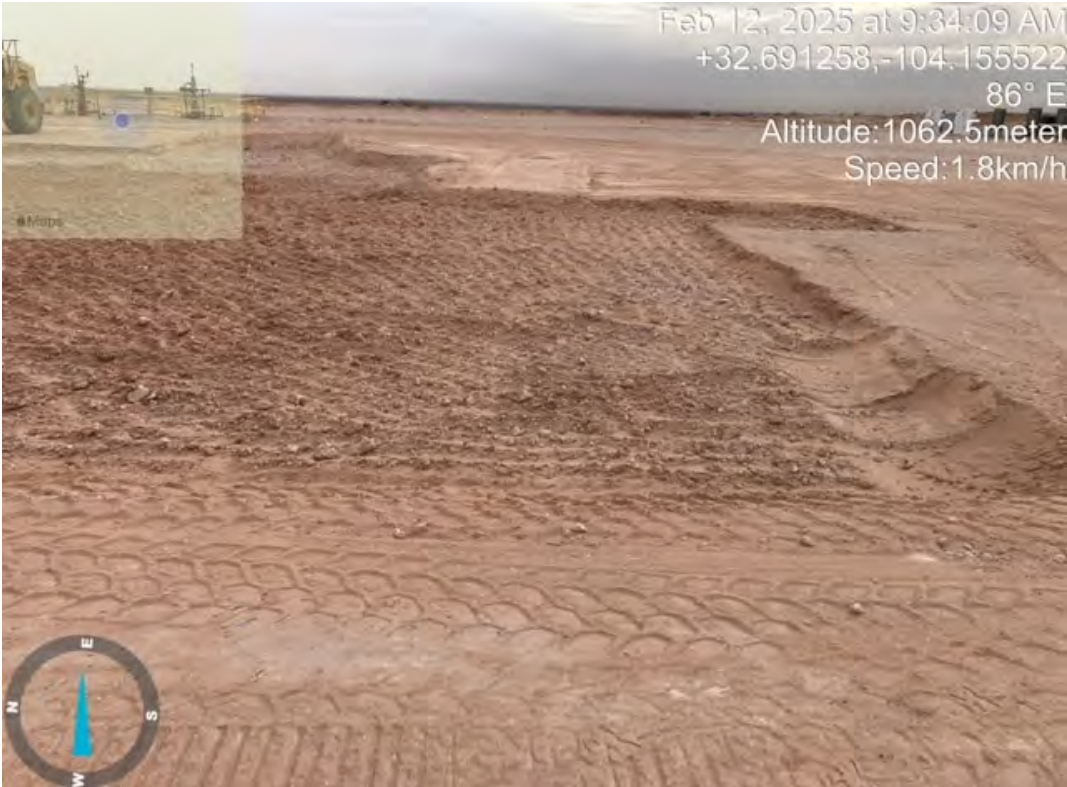
Photo Number: 20	<div><div>Feb 12, 2025 at 9:34:09 AM +32.691258,-104.155522 86° E Altitude:1062.5meter Speed:1.8km/h</div>

</div>
Photo Direction: East	
Photo Description: View of the reexcavated area.

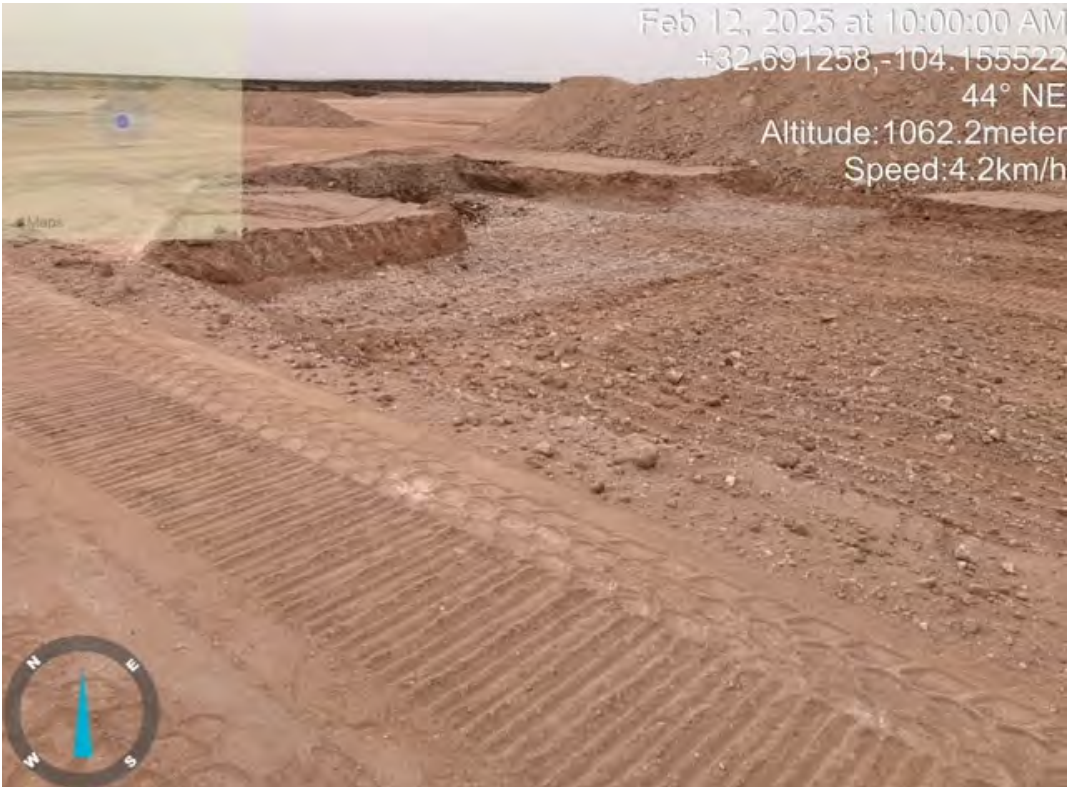
Photo Number: 22

Photo Direction: Northeast	
Photo Description: View of the reexcavated area.

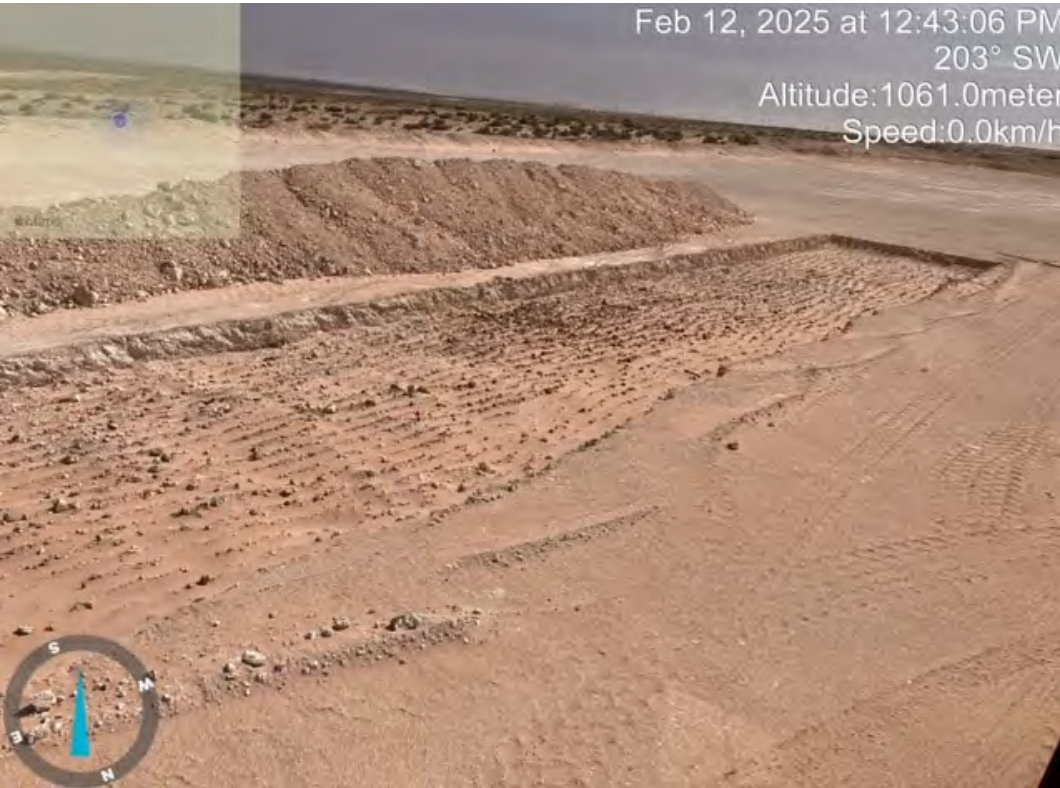
Photo Number: 25	<div>Feb 12, 2025 at 12:43:06 PM 203° SW Altitude:1061.0meter Speed:0.0km/h</div>

Photo Direction: South-Southwest	
Photo Description: View of the reexcavated area.

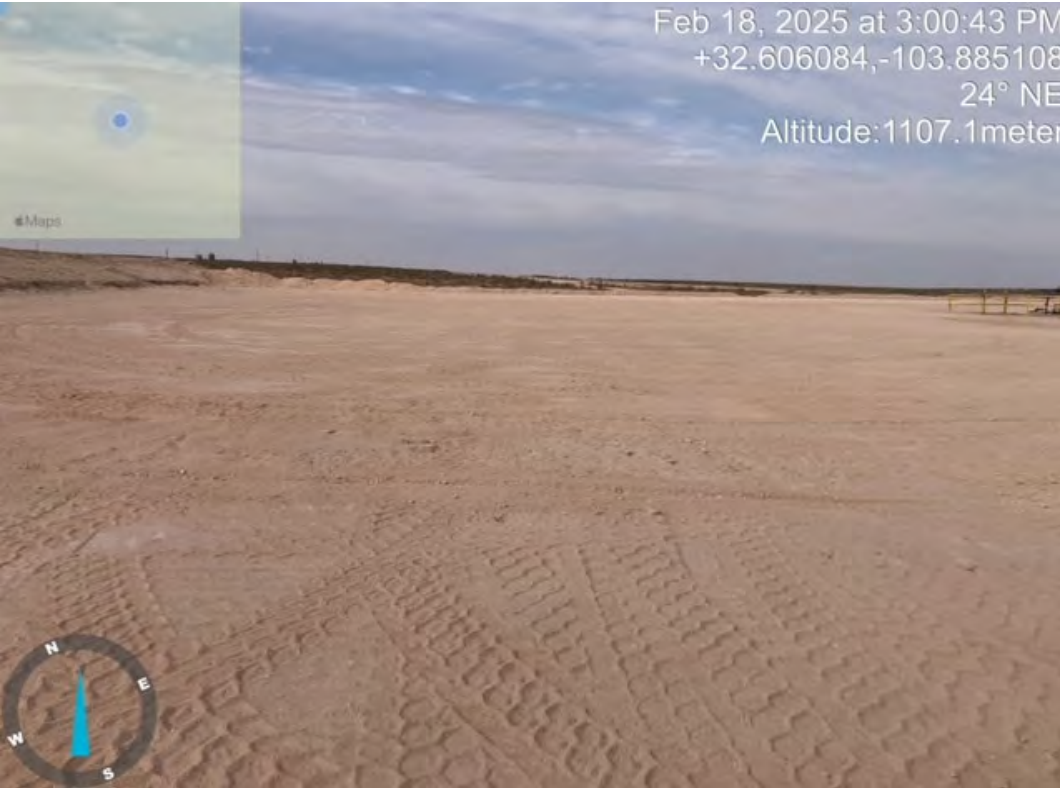
Photo Number: 26	<div>Feb 18, 2025 at 3:00:43 PM +32.606084, -103.885108 24° NE Altitude:1107.1meter</div>

Photo Direction: North-Northeast	
Photo Description: View of the remediated area following backfilling and regrading.

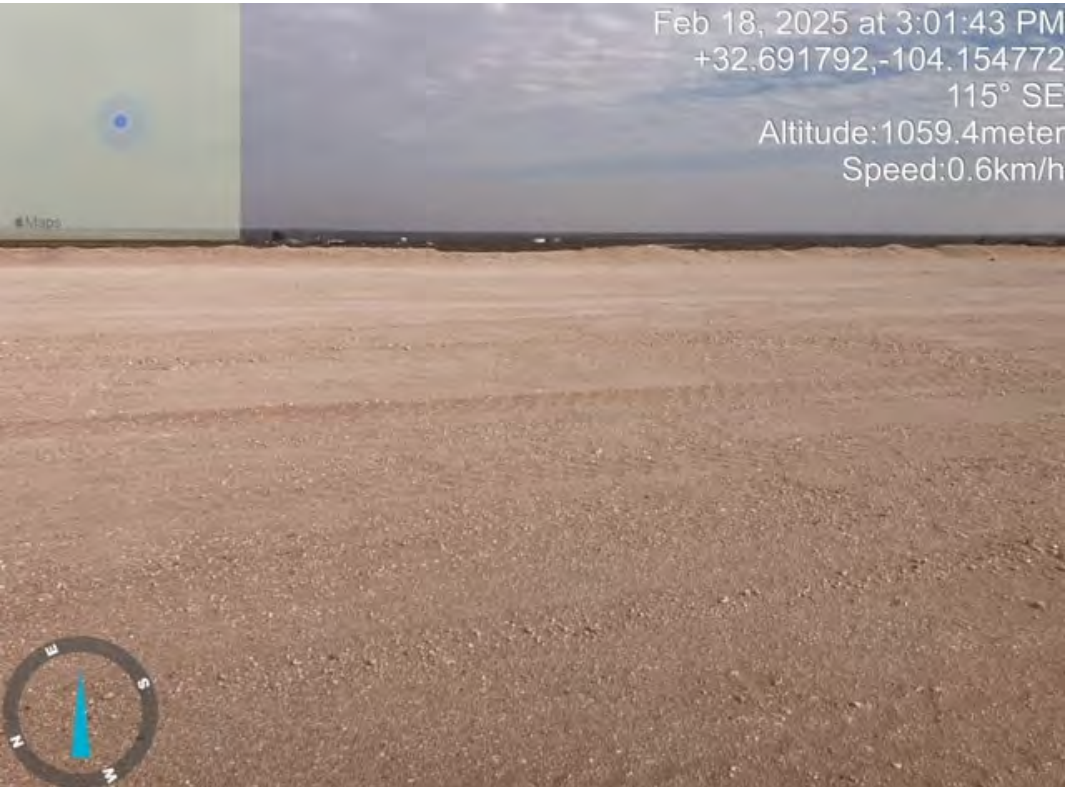
Photo Number: 28

Photo Direction: East-Southeast	
Photo Description: View of the remediated area following backfilling and regrading.
