# SITE ASSESSMENT AND REMEDIATION WORK PLAN

PREPARED FOR:  
DEVON ENERGY PRODUCTION, LP.

**LOCATION:** Rattlesnake 16 SWD #001

**NMOCD REF. NO.** NAB1913345254

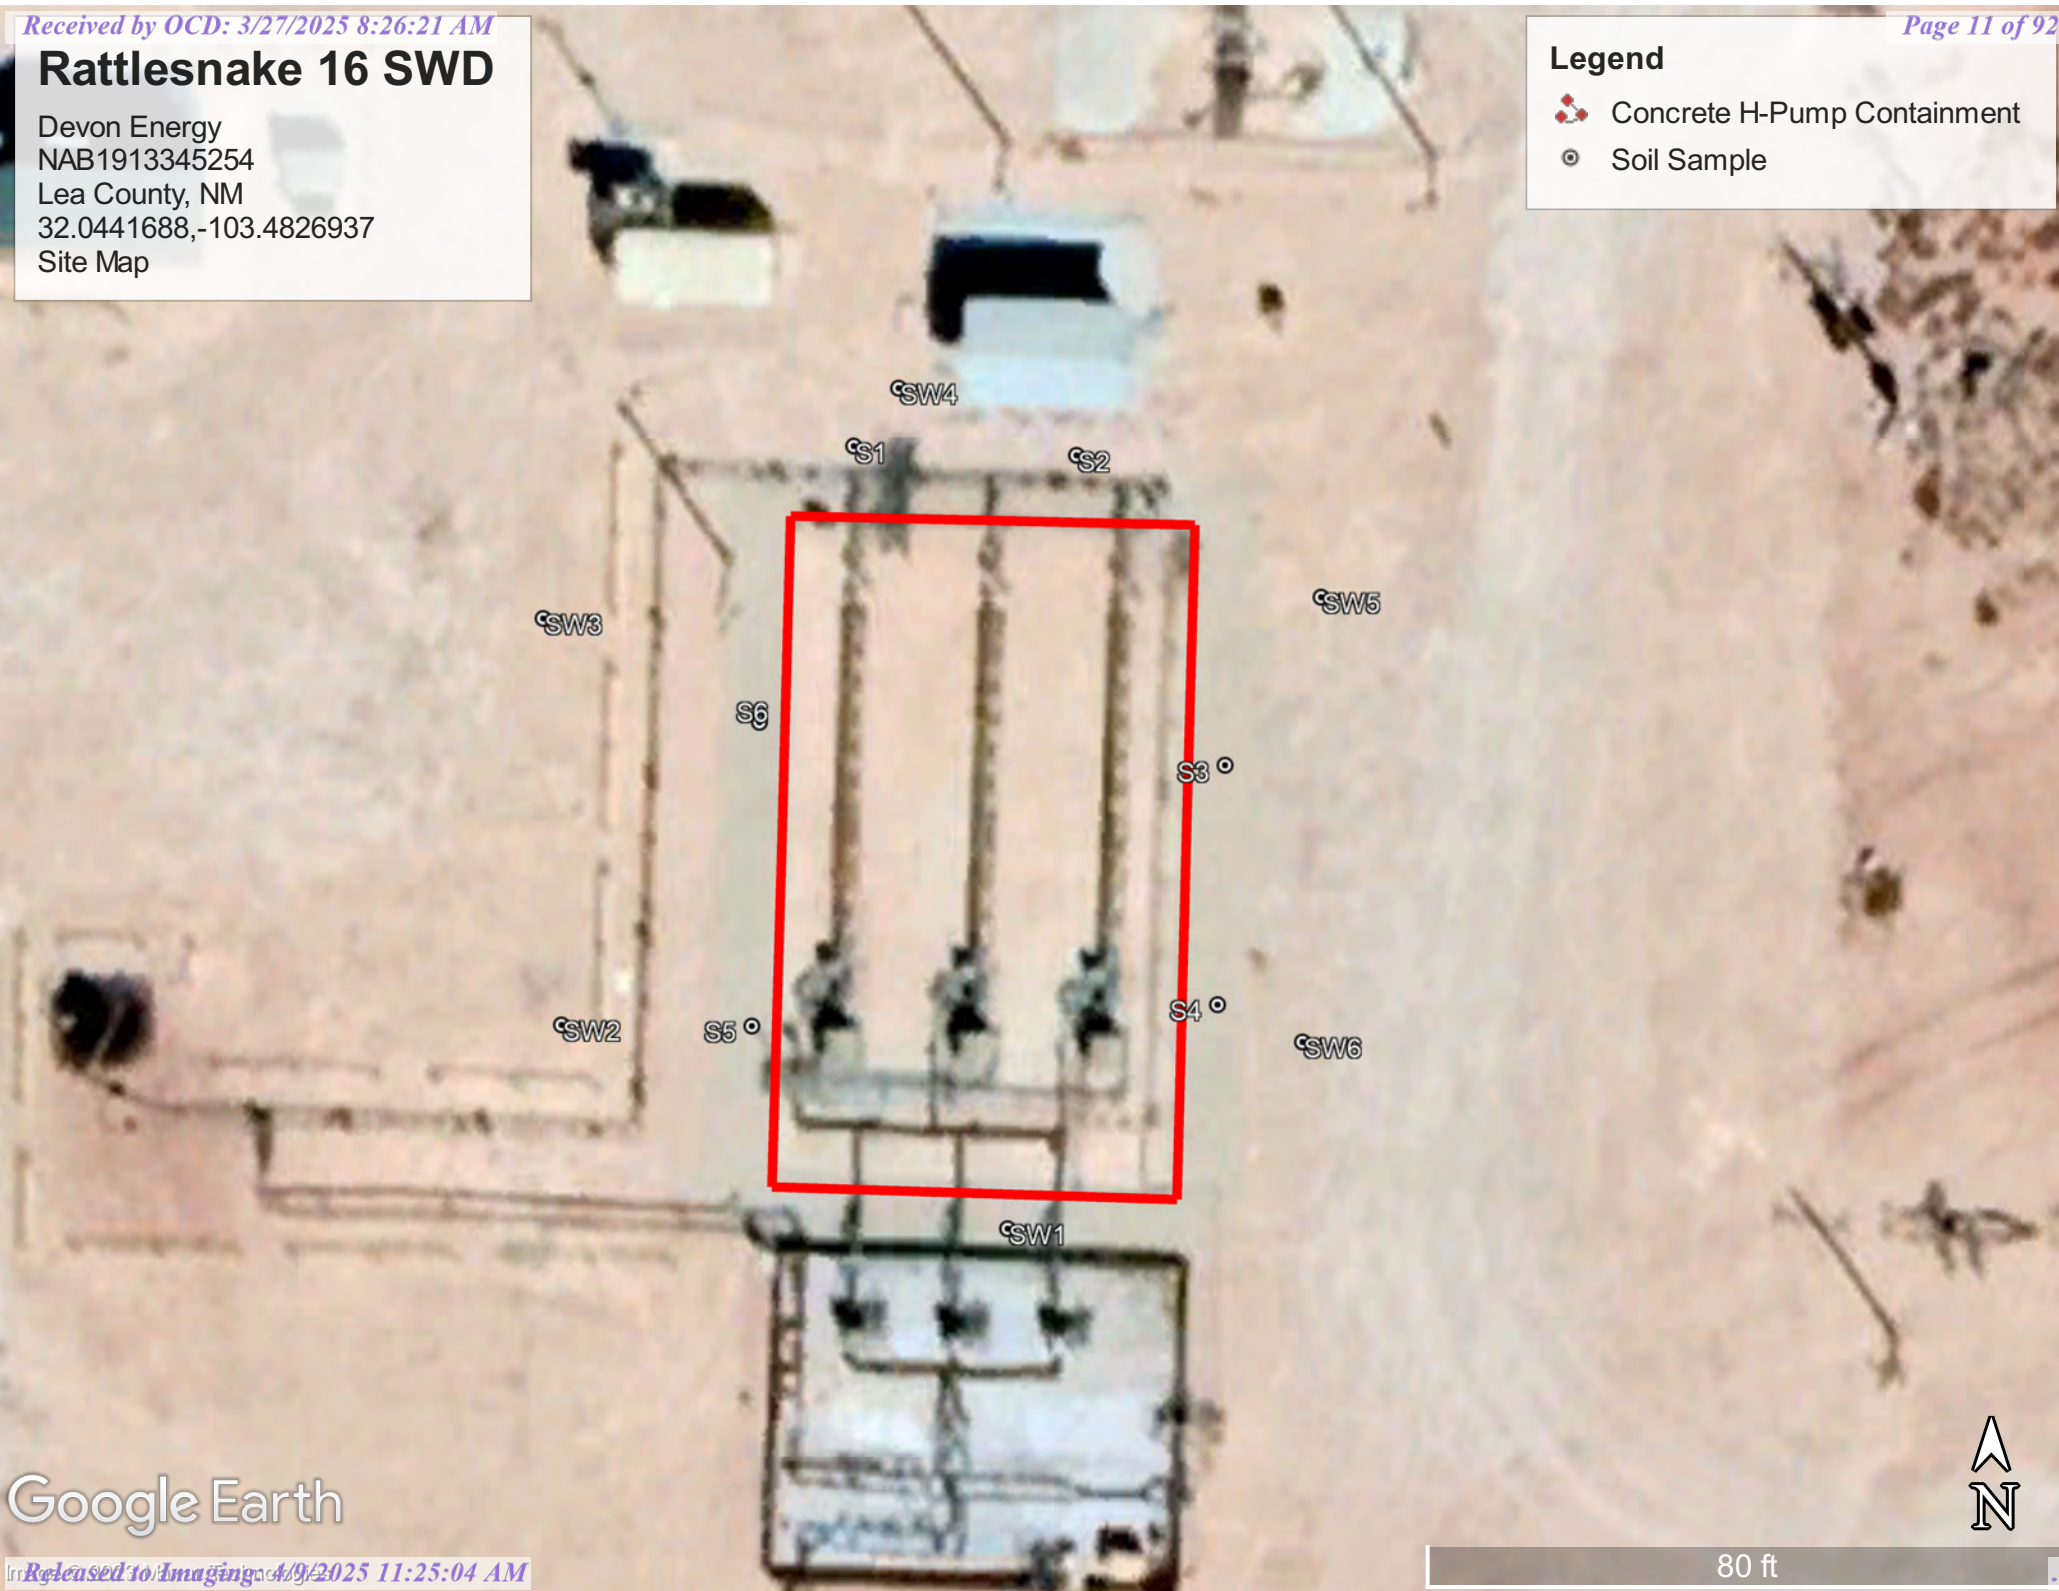
# Rattlesnake 16 SWD

**After conducting the site assessment, Pima determined that the release dimensions reported on the initial C-141 were incorrect and/or did not provide enough information to ensure entire release area was captured. Pima extended the release area to surround the entire H-Pump containment to verify contamination was not present.**

Devon Energy  
NAB1913345254  
Lea County, NM  
32.0441688,-103.4826937  
Site Map

- Concrete H-Pump Containment
- Soil Sample

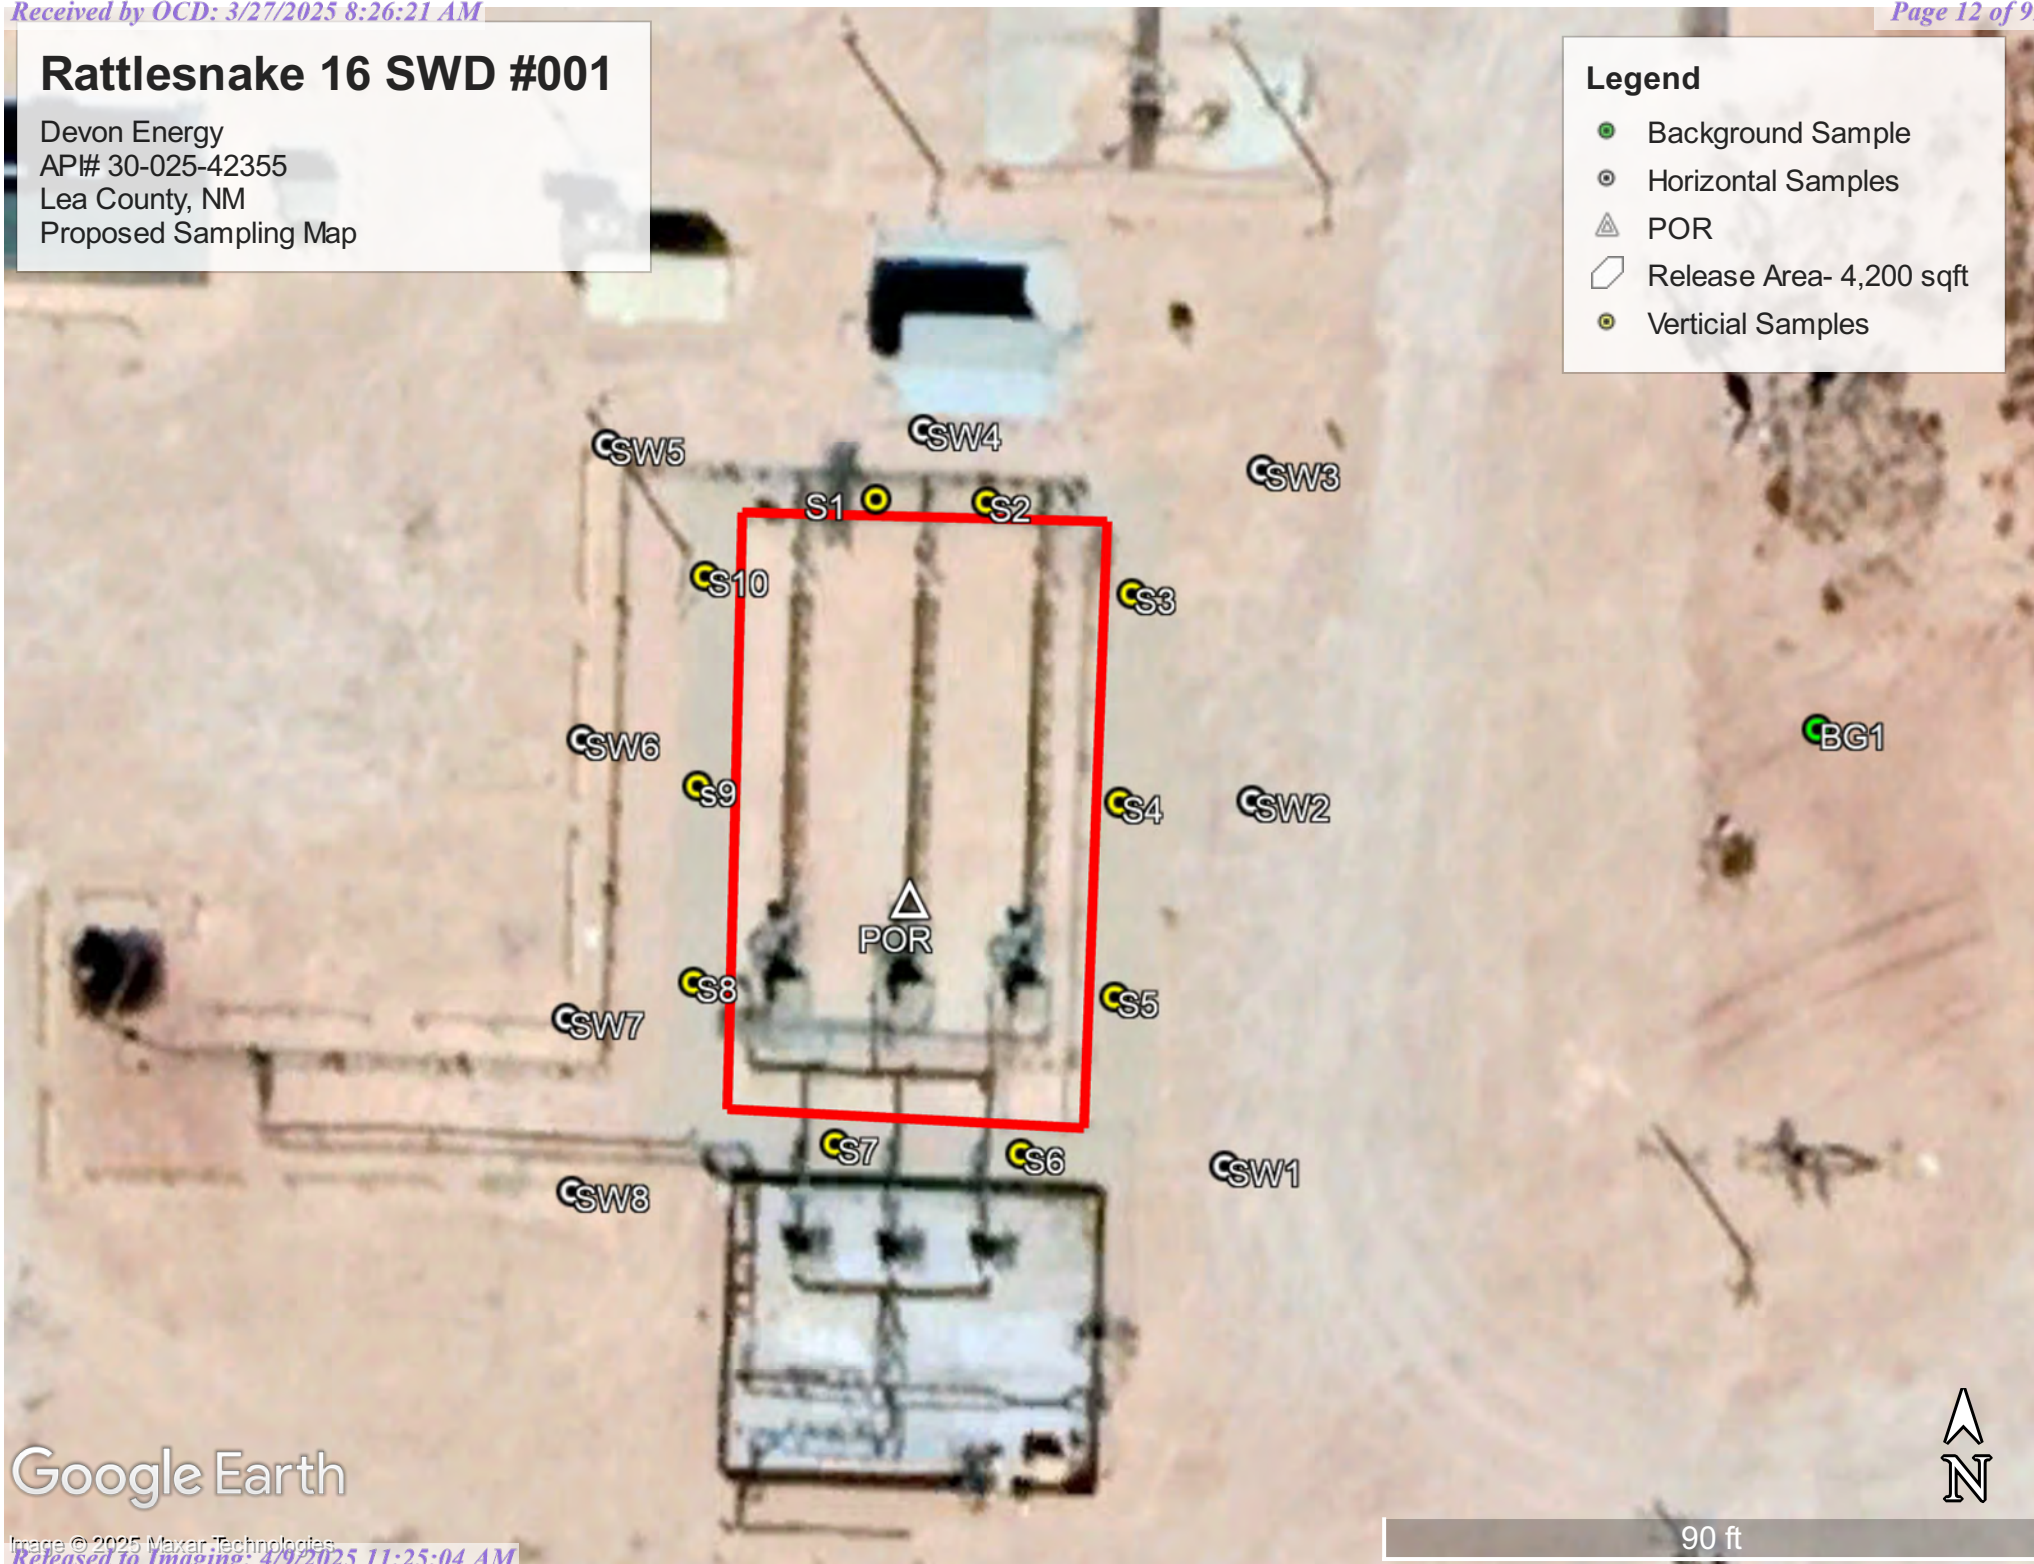
# Rattlesnake 16 SWD #001

1. Included in this Remediation Work Plan is a Proposed Sampling Map (Figure 6) showing ten (10) vertical samples, and eight (8) horizontal samples to be collected as delineation/exploration samples. Pima is requesting a variance that these samples be collected representing a surface area of no more than 400 ft<sup>2</sup> and will be collected from surface, 1', 2', 3', and 4' bgs. One (1) background sample will be collected from the pasture at a depth of 1' bgs.

Devon Energy  
API# 30-025-42355  
Lea County, NM  
Proposed Sampling Map

- Background Sample
- Horizontal Samples
- △ POR
- Release Area- 4,200 sqft
- Vertical Samples

2. In the event that impact is encountered and samples come back over the regulatory limits, Devon Energy proposes to dig and haul contaminated soil to remediate/reclaim the site. After remediation, Devon will submit a 48-hour sampling notification before collecting 5-point confirmation samples representing a surface area of no more than 200 ft<sup>2</sup>.

3. If the samples come back under regulatory limits, Devon Energy is requesting a variance to use delineation samples as closure confirmation samples. Devon Energy will submit the required 48-hour sampling notification before collecting the delineation/exploration samples.

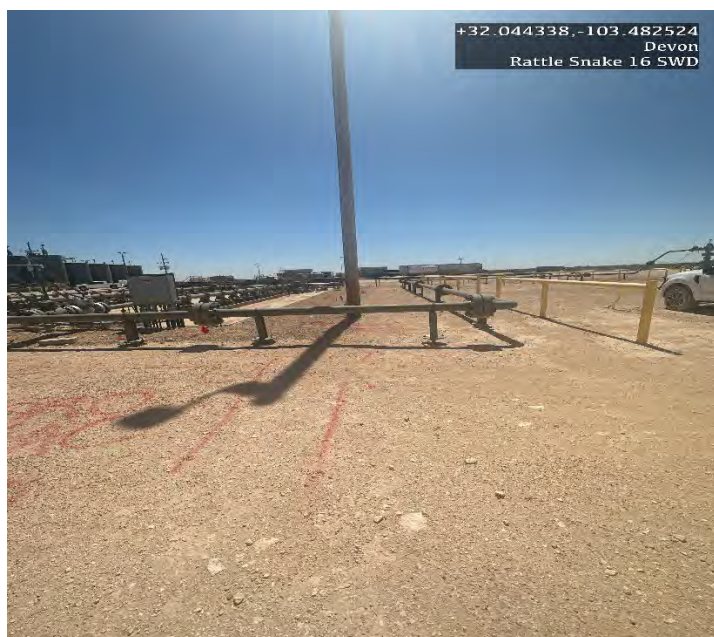
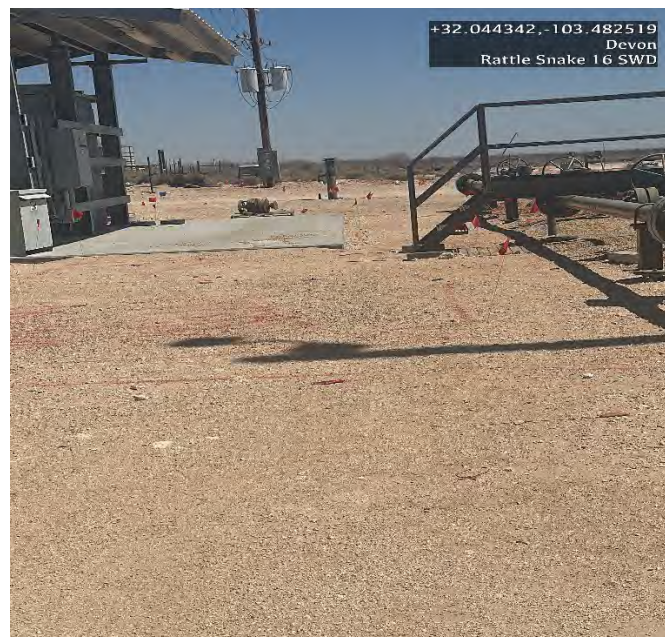
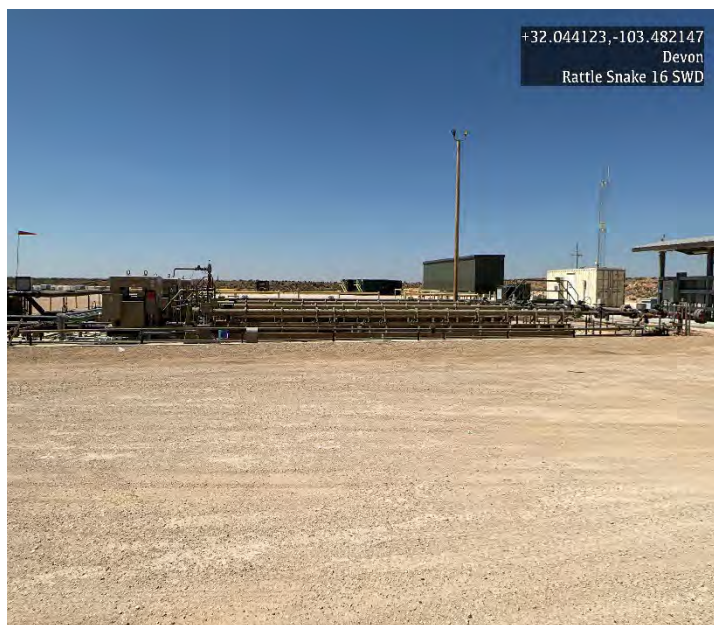
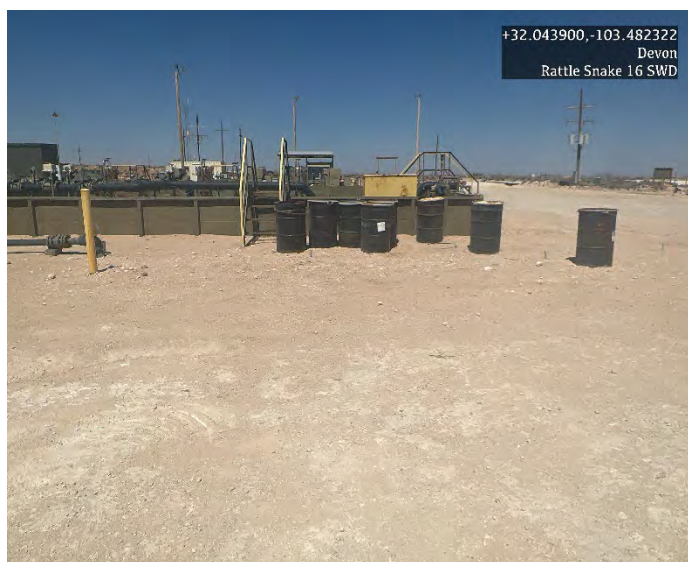
**SITE PHOTOGRAPHS  
DEVON ENERGY  
RATTLESNAKE 16 SWD 1**

**Site Assessment**
