Re: **Remediation Completion Report and Closure Request**

Lambe 2C
San Juan County, New Mexico
Hilcorp Energy Company
NMOCD Incident Number: NVF1836050592

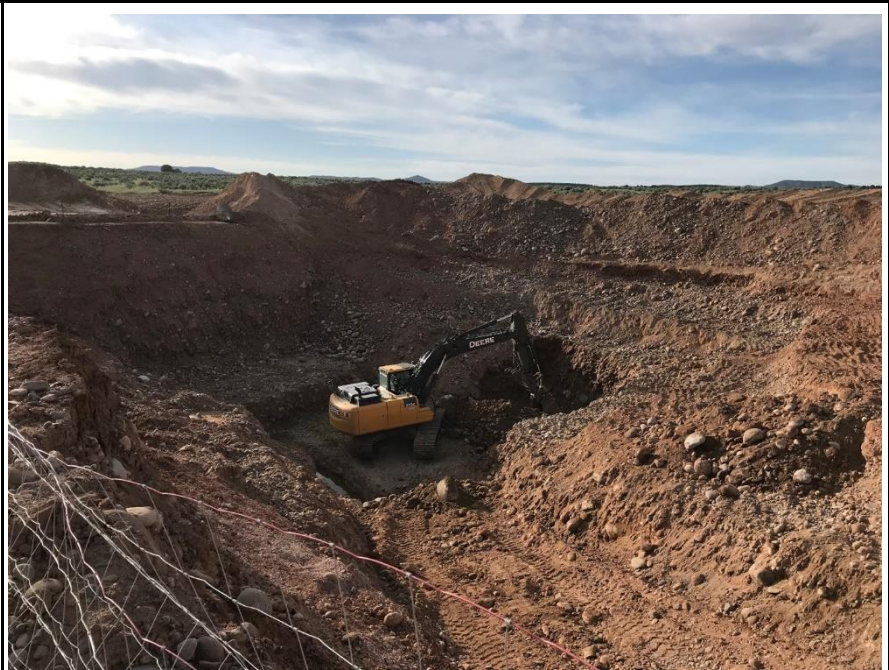
Photograph 1

Final excavation extent from
initial remediation efforts, view
looking southeast.
Date: May 6, 2019

Hilcorp responded to the release by conducting several delineation investigations to determine the extent of subsurface hydrocarbon impact. In January of 2019, soil samples were collected from soil borings via hand auger and a CME-55 hollow-stem auger drill rig. Borings were advanced until refusal in cobbles at depths ranging from 9 feet to 12 feet below ground surface (bgs). Upon encountering refusal with the hollow-stem drill rig due to cobbles at a relatively shallow depth, Hilcorp initiated remediation activities via excavation between January and May 2019. An estimated 5,000 cubic yards of impacted soil was excavated and hauled for disposal. The excavation depth ranged from 23 feet to 29 feet bgs, which required significant sloping of the sidewalls. A photograph of the excavation extent is attached in Appendix A.

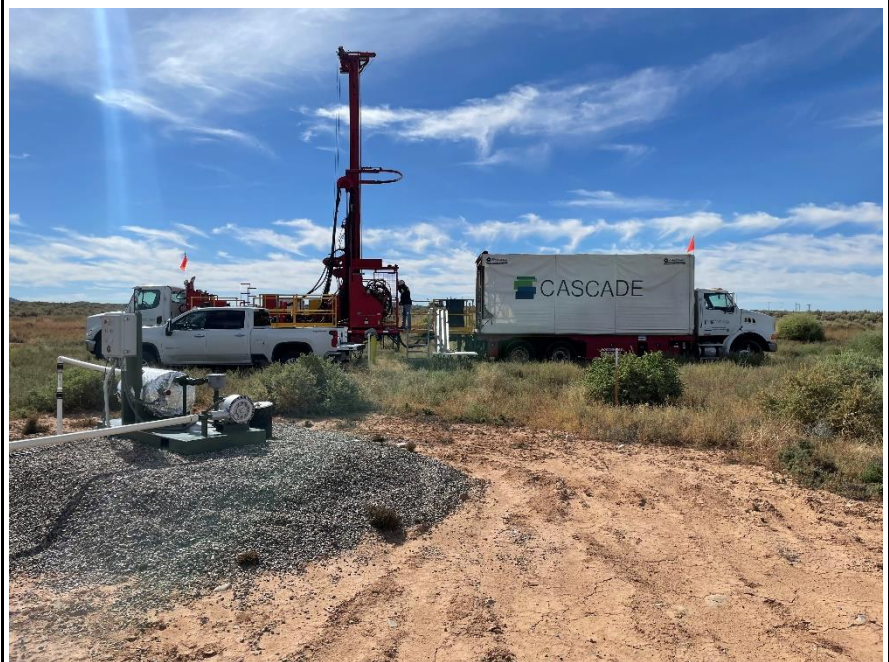
**Photograph 2**

Sonic drill rig at boring SB01,
view looking south.
Date: September 22, 2023

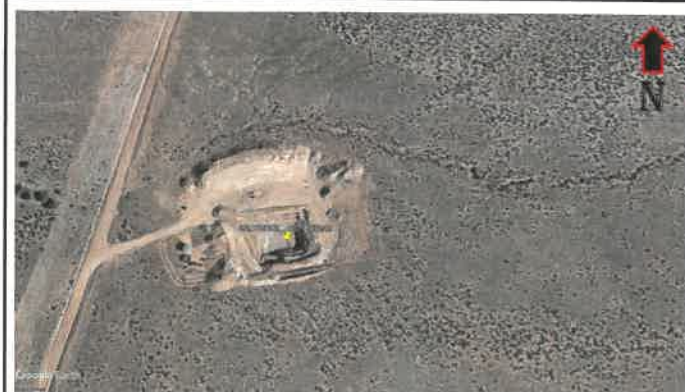
Penetration Resistance	Moisture Content	Vapor (ppm)	HC Staining?	Sample #	Depth (ft. bgs.)	Sample Run	Recovery	Soil/Rock Type	Lithology/Remarks	Well Completion
	Dry	0.6	NO		0			SP-SM	med. dense, red brown silty sand	
					1				Excavation backfill to ~20'	
					2					
					3					
					4					
	moist	1.6	NO		5					
					6					
					7					
					8					
					9					
	moist	4.7	NO		10					
					11					
					12					
					13					
					14					
	moist	6.3	NO		15

Boring/Well #	MW01	
										Project:	Lambe 2c	
										Project #	017818055	
										Date	7/24/19	
Penetration Resistance	Moisture Content	Vapor (ppm)	Staining	Sample #	Depth (ft. bgs.)	Sample Run	Recovery	Soil/Rock Type	Lithology/Remarks	Well Completion		
					15				Excavation backfill ↓	X	X	
					16					X	X	
					17					X	X	
					18					X	X	
					19			SPSM		X	X	
	moist	10.6	NO		20							
					21			GP	Loose, lt brown, coarse sand and gravel cobbles > 8" diameter			
					22	5						
					23							
					24							
	Dry	14.3	NO		25							
					26			SC	Dense, dark brown/black silty sand, some clay < 25% small band of staining, strong odor			
					27	6						
					28							
					29							
	moist	> 5,000	YES small band ~1.5"		30							
					31							
					32							
					33	7						
					34							
					35			SM	Dense, lt brown, silty sand trace clay < 10% NO stain			
	moist	18.6 18.6	NO		36							
					37

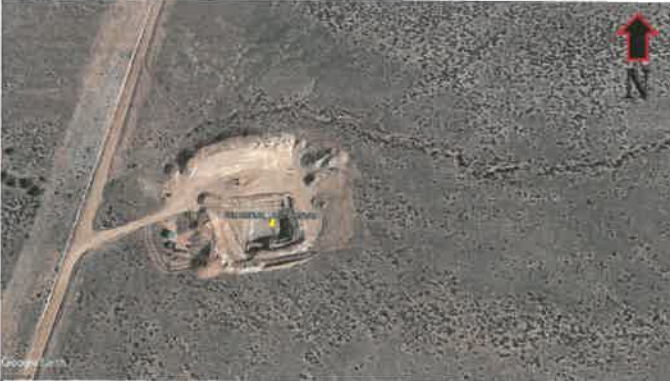
Advancing Opportunity										
		848 E. 2nd Ave Durango, Colorado 81301										
		BORING LOG/MONITORING WELL COMPLETION DIAGRAM										
		Boring/Well Number: <u>MW03</u>	Project: <u>Lambe 2C</u>									
Date: <u>7/23/19</u>		Project Number: <u>017818055</u>										
Logged By: <u>E. Carroll</u>		Drilled By: <u>CASCADE</u>										
Elevation: _____ Detector: <u>PID</u>		Drilling Method: <u>sonic</u>										
Gravel Pack: <u>10-20 Silica Sand</u>		Seal: <u>Bentonite</u>										
Casing Type: <u>Schedule 40 PVC</u>		Grout: <u>Bentonite</u>										
Screen Type: <u>Schedule 40 PVC</u> Slot: <u>0.010"</u>		Diameter: <u>2"</u> Length: <u>26'</u>	Hole Diameter: <u>6"</u> Depth to Liquid: <u>NA</u>									
Screen Type: <u>Schedule 40 PVC</u> Slot: <u>0.010"</u>		Diameter: <u>2"</u> Length: <u>15'</u>	Total Depth: <u>35'</u> Depth to Water: <u>27'</u>									
Penetration Resistance	Moisture Content	Vapor (ppm)	HC Staining?	Sample #	Depth (ft. bgs.)	Sample Run	Recovery	Soil/Rock Type	Lithology/Remarks	Well Completion

Dry	0.0	NO		0			SP-SM	Dry med. dense, reddish brown Silty sand (backfill) no stain/odor			
					1						X	X
					2						X	X
					3	7					X	X
					4					X	X	
	Dry	1.1	NO		5			SP-SM	SAA	X	X	
					6					X	X	
					7					X	X	
					8					X	X	
					9	2				X	X	
	Dry	1.4	NO		10			SP-SM	SAA	X	X	
					11					X	X	
					12					X	X	
					13	3				X	X	
					14					X	X	
	Dry	0.6	NO		15			SP-SM	SAA	X	X

Boring/Well #	MW03	
										Project:	Lambe 2c	
										Project #	017818055	
										Date	7/23/19	
Penetration Resistance	Moisture Content	Vapor (ppm)	Staining	Sample #	Depth (ft. bgs.)	Sample Run	Recovery	Soil/Rock Type	Lithology/Remarks	Well Completion		
					15			SP-SM	SAA no stain/odor	X	X	
					16					X	X	
					17	4				X	X	
					18					X	X	
	Dry	4.4	NO		19			GP	Loose, lt brown, sand and gravel Cobbles > 8" no stain/odor		X	
					20							
					21							
					22							
					23	5						
	Dry	7.5	NO		24			GP	SAA no stain/odor			
					25							
	Wet	3.0	NO		26			GP GW	Loose, dark red brown, coarse sand and gravel, wet no stain/odor			
					27							
					28							
					29	6		SM	dense, med silty sand, trace clay < 10% no stain/odor			
	moist	3.3	NO		30							
					31							
	moist	5.0	NO		32			SC	compact, dark brown/black, silty sand some clay < 25% no stain/odor			
					33	7						
					34			SM	Dense, lt brown silty sand, trace clay < 10% no stain/odor

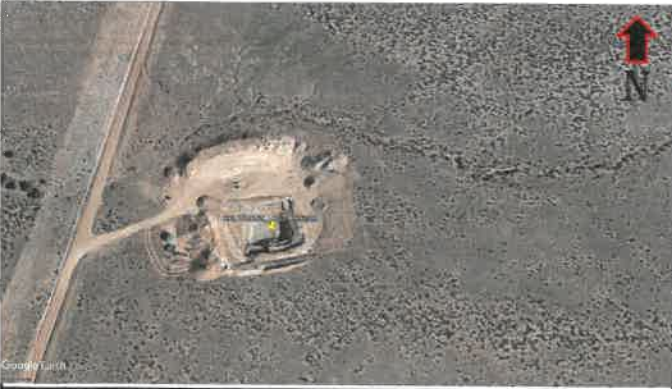
Advancing Opportunity 848 E. 2nd Ave Durango, Colorado 81301								
		BORING LOG/MONITORING WELL COMPLETION DIAGRAM								
		Boring/Well Number: MW04	Project: Lambe 2C							
		Date: 7/24/19	Project Number: 017818055							
Elevation:		Detector: PID	Logged By: E. Carroll	Drilled By: CASCADE						
Gravel Pack: 10-20 Silica Sand		Drilling Method: Sonic	Sampling Method: Continuous							
Casing Type: Schedule 40 PVC		Seal: Bentonite	Grout: Bentonite							
Screen Type: Schedule 40 PVC		Diameter: 2"	Length: 25'	Hole Diameter: 6"						
Slot: 0.010"		Diameter: 2"	Length: 15'	Total Depth: 35'						
				Depth to Liquid: NA						
				Depth to Water: 27'						
Penetration Resistance	Moisture Content	Vapor (ppm)	HC Staining?	Sample #	Depth (ft. bgs.)	Sample Run	Recovery	Soil/Rock Type	Lithology/Remarks	Well Completion
	Dry	0.0	no		0			SP-SM	Dry, lt. reddish brown, silty sand	
					1					X
					2					X

3	1				X
					4					X
	Dry	1.3	no		5			SP-SM	SAA no stain/odor	X
					6					X
					7					X
					8	2				X
					9					X
	Dry	1.1	no		10			SP-SM	SAA no stain/odor	X
					11					X
					12					X
					13	3				X
					14					X
	Dry	2.0	no		15			GP	Loose, lt. brown coarse sand and gravel cobbles > 8" diameter no stain/odor	X
										X

Boring/Well #	MW04	
										Project:	Lambert 2C	
										Project #	C17818055	
										Date	7/24/14	
Penetration Resistance	Moisture Content	Vapor (ppm)	Staining	Sample #	Depth (ft. bgs.)	Sample Run	Recovery	Soil/Rock Type	Lithology/Remarks	Well Completion		
					15							
					16					X	X	
					17	4				X	X	
					18					X	X	
	Dry	3.8	NO		19			GP	Loose, lt brown, Sand and gravel, cobbles > 8" diameter	X	X	
					20				no stain/odor			
					21							
					22							
					23	5						
	Dry	6.6	NO		24			GP	SAA, no stain/odor			
					25							
					26							
	Wet	6.5	NO		27			GW	Loose, Saturated, coarse Sand			
					28	6		GP	And gravel, no stain/odor			
					29			SM	Dense, lt. brown silty sand, trace clay < 10% NO stain/odor			
	moist	5.2	NO		30							
					31							
					32	7						
					33							
					34			SM	SAA no stain/odor			
	moist	2.2	NO		35							
					36				TD = 35'			
					37

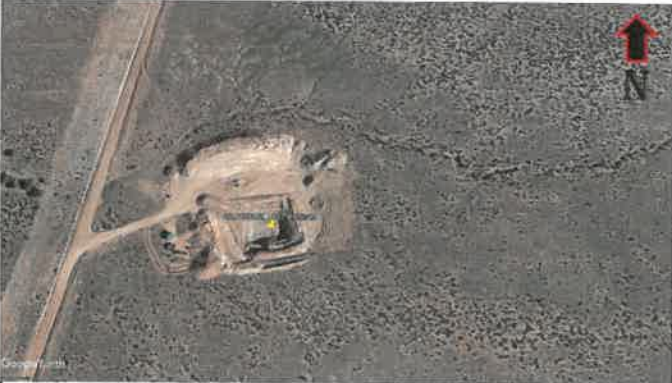
Advancing Opportunity								
		848 E. 2nd Ave Durango, Colorado 81301								
		BORING LOG/MONITORING WELL COMPLETION DIAGRAM								
		Boring/Well Number: MW05	Project: Lambe 2C							
Date: 7/24/19		Project Number: 017818055								
Logged By: E. Carroll		Drilled By: CASCADE								
Elevation: 		Detector: PID								
Drilling Method: sonic		Sampling Method: continuous								
Gravel Pack: 10-20 Silica Sand		Seal: Bentonite								
Grout: Bentonite										
Casing Type: Schedule 40 PVC		Diameter: 2"	Length: 25'							
Screen Type: Schedule 40 PVC		Slot: 0.010"	Diameter: 2"							
		Length: 15'	Hole Diameter: 6"							
		Total Depth: 35'	Depth to Liquid: NA							
		Depth to Water: 26'								
Penetration Resistance	Moisture Content	Vapor (ppm)	HC Staining?	Sample #	Depth (ft. bgs.)	Sample Run	Recovery	Soil/Rock Type	Lithology/Remarks	Well Completion
	Wet	0.8	NO		0			SP-SM	Wet, dark reddish brown, silty sand no stain/odor

1					
					2					
					3	1				
					4					
	Dry	1.1	NO		5			SP-SM	SAA no stain/odor	
					6					
					7					
					8	2				
					9					
	Dry	1.3	NO		10			SP-SM	SAA no stain/odor	
					11					
					12					
					13	3				
					14					
	Dry	1.2	NO		15			GP	Loose, lt. brown, sand and gravel cobbles > 8" diameter no stain/odor

Boring/Well #	MW05
										Project:	Lambe 7C
										Project #	
										Date	7/24/19
Penetration Resistance	Moisture Content	Vapor (ppm)	Staining	Sample #	Depth (ft. bgs.)	Sample Run	Recovery	Soil/Rock Type	Lithology/Remarks	Well Completion	
					15						
					16						
					17	4					
					18						
					19						
	Dry	19.9	NO	MW05 15'-20' 940	20			GP	SAA no stain/odor		
					21						
					22						
					23	5		GP	SAA no stain/odor		
					24						
	Dry	13.4	NO		25						
					26			GW			
					27						
	Wet	6.3	NO		28			SM	Dense, lt. brown, Silty Sand trace Clay < 10% NO stain/odor		
					29	6					
	moist	7.8	NO		30			SC	Dense, dark brown black Silty Sand Some Clay < 25% NO stain/odor		
					31						
					32						
					33						
					34			SM	Dense, lb brown, Silty Sand, trace Clay < 10% NO stain/odor		
	moist	7.2	NO	MW05 30'-35' 1100	35						
					36						
					37
