Re: First Quarter 2025 – SVE System Update

Sullivan GC D #1E
San Juan County, New Mexico
Hilcorp Energy Company
NMOCD Incident Number: NCS1518952648

Hilcorp Energy Company
First Quarter 2025 – SVE System Update
Sullivan GC D#1E

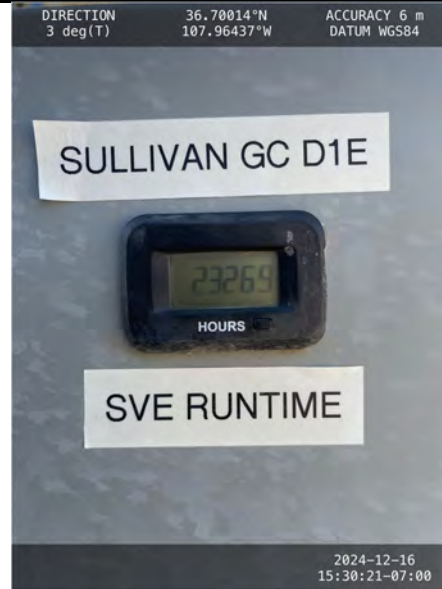
(1) Hour meter found to be in need of replacement on 12/2/2024. A replacement was installed in a separate location on 12/3/2024 and photos of the old hour meter were taken on 12/16/2024 and 1/3/2025.

<p>Photograph 1</p> <p>Runtime meter taken on December 16, 2024 at 3:30 PM Hours = 23,269</p>

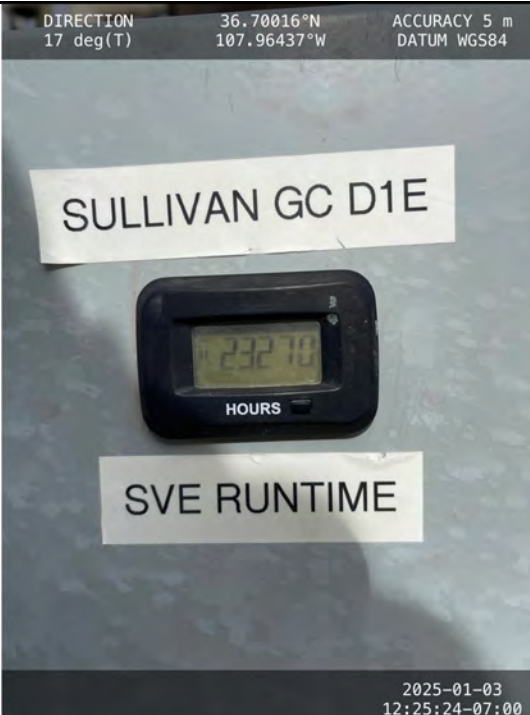
the broken meter. The broken meter was left in place temporarily and a photo of the old meter was inadvertently collected on December 16, 2024 and January 3, 2025, prior to discovery of the error while drafting the *Fourth Quarter 2024 – SVE System Update* report. Following identification of the error, photo documentation of the new hour meter began on January 20, 2025, and continued throughout the remainder of first quarter of 2025. An accurate runtime percentage cannot be calculated between December 16, 2024 and January 20, 2025. No alarms were noted on the system telemetry throughout the quarter and the system was in operation during Site visits conducted twice per month during the first quarter of 2025. Based on this information, we believe the system was fully operational between December 16, 2024 and January 20, 2025, and runtime was likely greater than 90%. Between January 20 and March 31, 2025, the SVE system operated for 1,534 hours, with a runtime efficiency of 100 percent (%). Appendix B presents photographs of the runtime meter for calculating the runtime efficiency. Table 1 presents the SVE system operational hours and percent runtime based on the field notes collected during the quarter.

<p>DIRECTION 36.70014°N ACCURACY 6 m 3 deg(T) 107.96437°W DATUM WGS84</p> <p>SULLIVAN GC D1E</p> <p>23269 HOURS</p> <p>SVE RUNTIME</p> <p>2024-12-16 15:30:21-07:00</p>
<p>Photograph 2</p> <p>Runtime meter taken on January 3, 2025 at 12:25 PM Hours = 23,270</p>

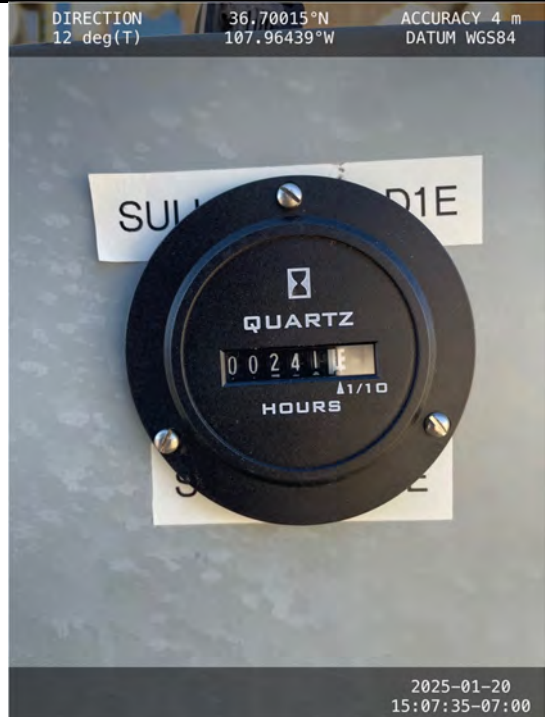
(2) New hour meter readings began on 1/20/2025.

Photograph 3 Runtime meter taken on January 20, 2025 at 3:07 PM Hours = 241.1

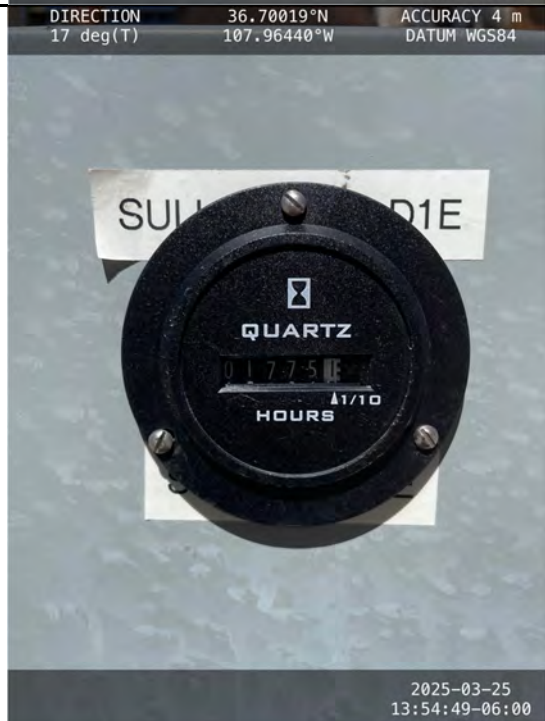
Date	Total Operational Hours	Delta Hours	Days	% Runtime
12/16/2024 ⁽¹⁾	23,269	--	--	--
1/20/2025 ⁽²⁾	241	--	--	--
3/25/2025	1,775	1,534	64	100%

<p>Photograph 3 shows a black circular quartz runtime meter mounted on a metal surface. The meter has a digital display showing '00241.1' and 'HOURS'. Above the meter is a white label with 'SULLIVAN GC D #1E'. The meter is secured with four screws. The background is a light-colored metal plate. The image includes a data overlay at the top: 'DIRECTION 12 deg(T)', '36.70015°N', '107.96439°W', 'ACCURACY 4 m', and 'DATUM WGS84'. At the bottom right, the date and time are '2025-01-20 15:07:35-07:00'.</p>
Photograph 4 Runtime meter taken on March 25, 2025 at 1:54 PM Hours = 1,775.1
