Red Lake 32 State #002H Battery

Incident ID NRM2034247342

Site Assessment, Remediation, and Closure Report

RE: Site Assessment, Remediation, and Closure Report
Red Lake 32 State #002H Battery
API No. 30-015-44948
GPS: Latitude 32.784483 Longitude -104.292631
UL- P, Section 32, Township 17S, Range 27E
NMOCD Reference No. NRM2034247342

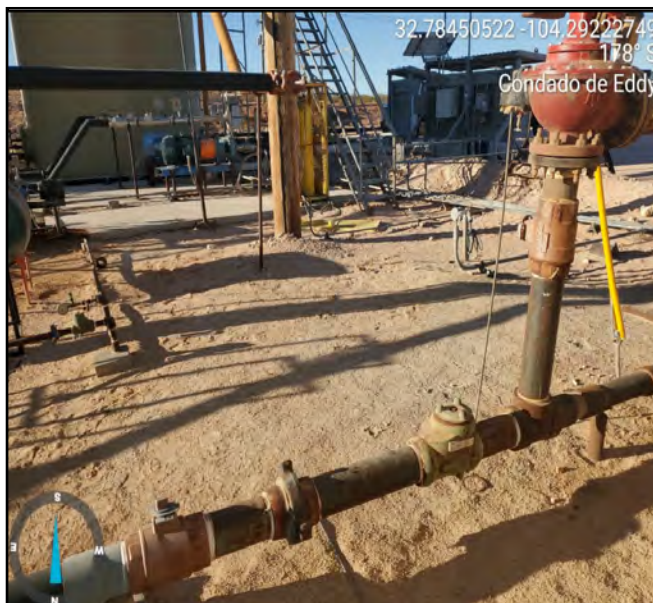
Photograph taken before excavation facing south.

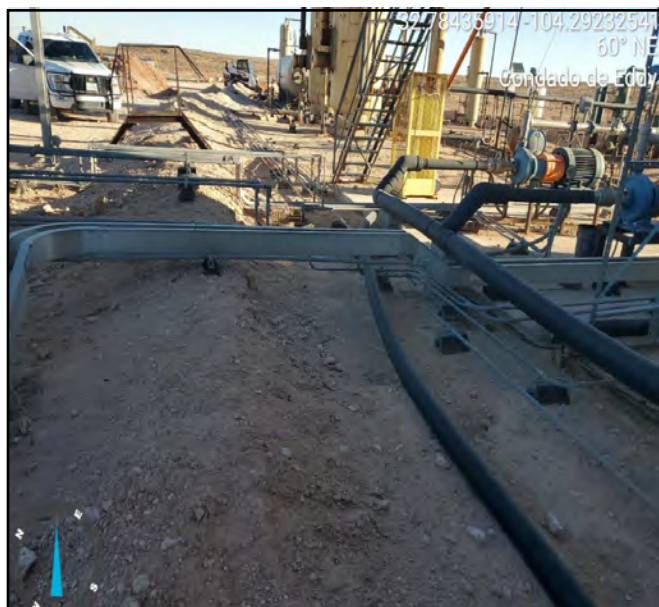
Photograph taken before excavation facing northeast.

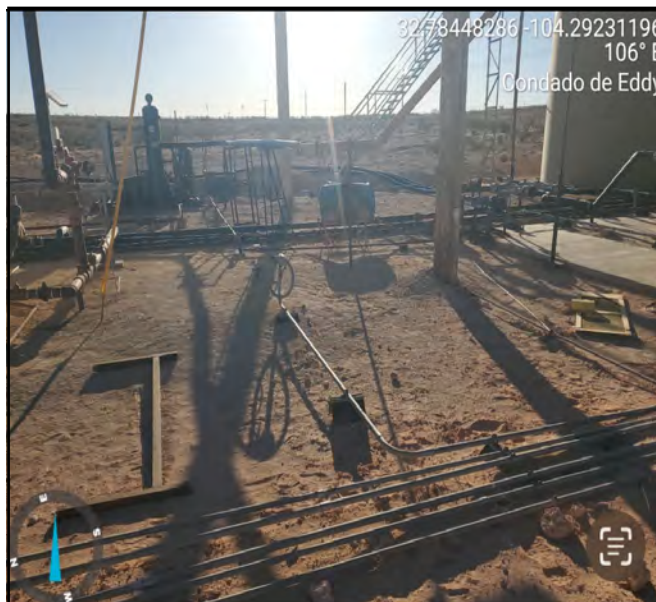
Photograph taken before excavation facing east.

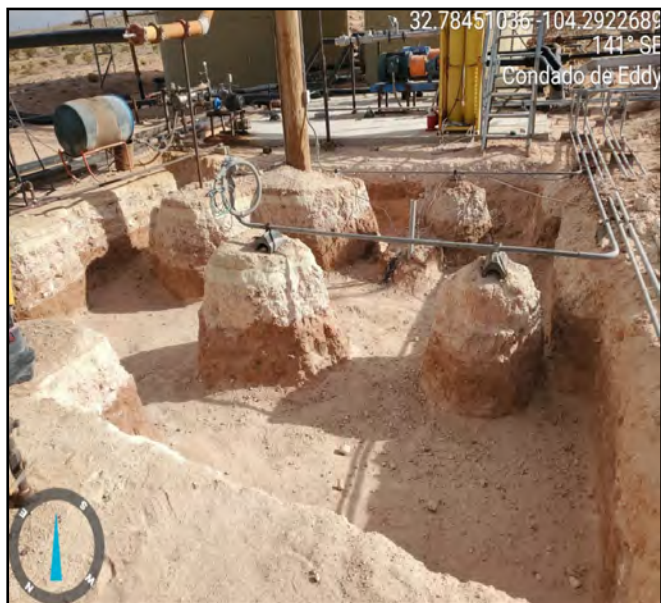
Photograph taken during the excavation process, facing southeast.

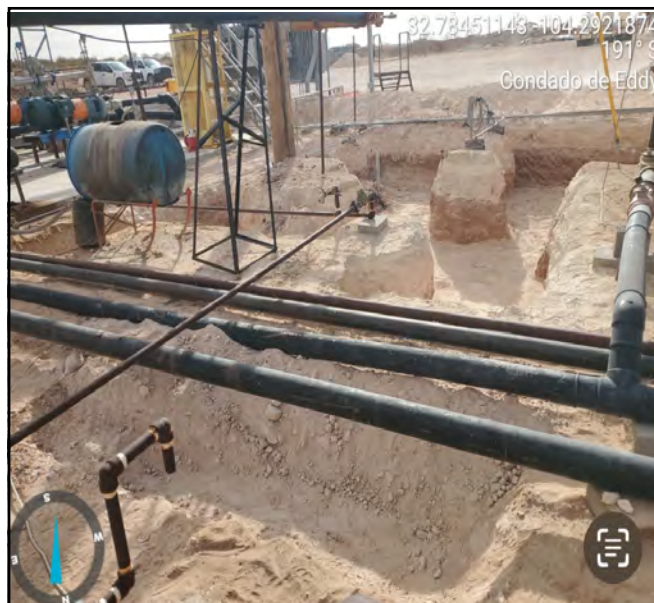
Photograph taken during the excavation process, facing south.

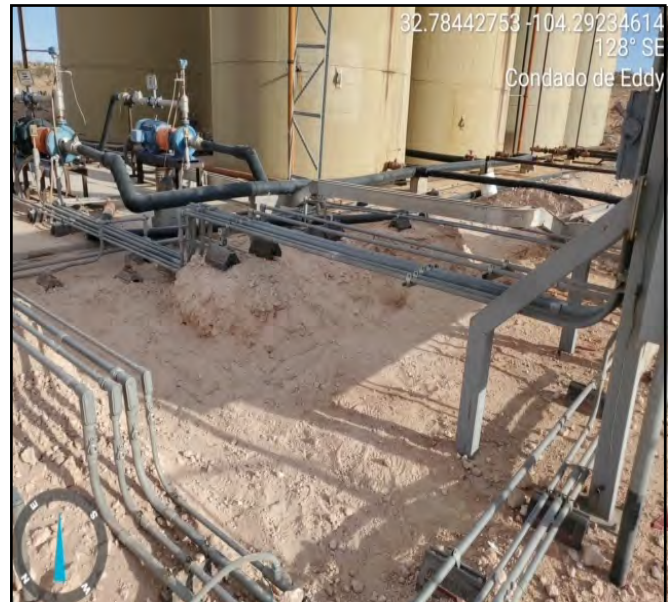
Photograph taken during the excavation process, facing southeast.

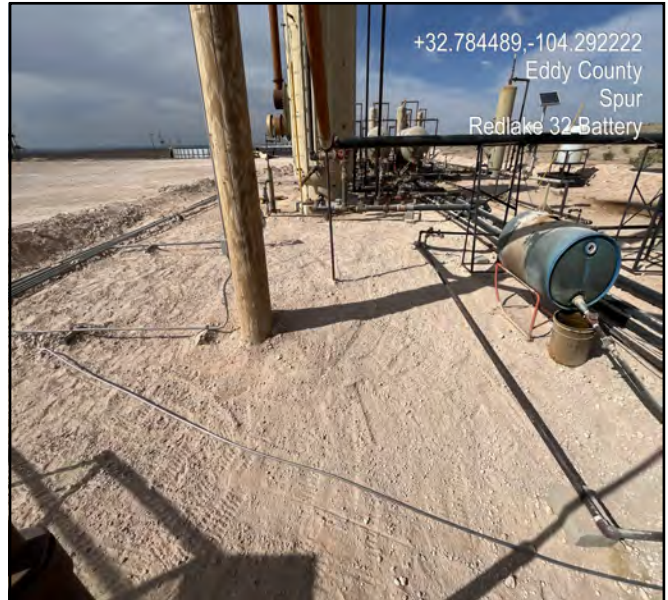
Photograph taken post excavation.

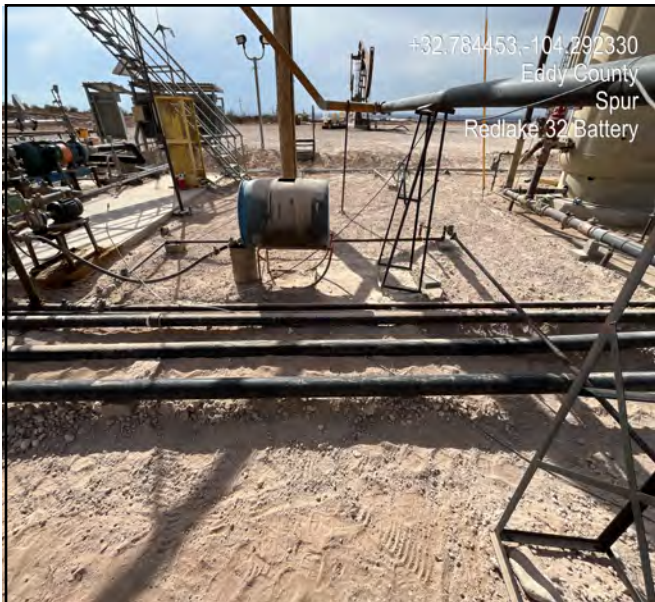
Photograph taken post excavation.

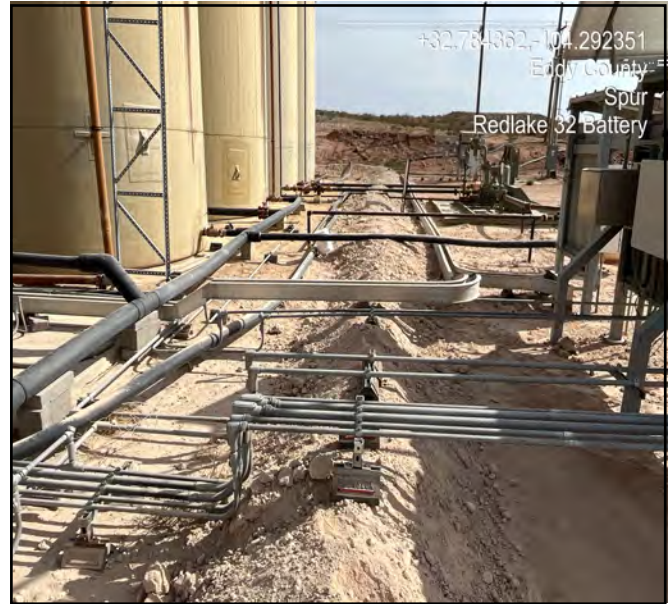
Photograph taken during the excavation process.
