Incident Number: nAPP2500254282

Incident Closure

Brushy Draw 30 – 31 Federal Battery

Incident Closure
April 2025

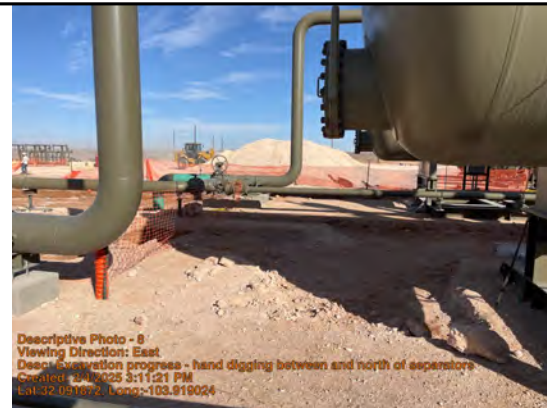
Excavation progress - hand digging between and north of separators

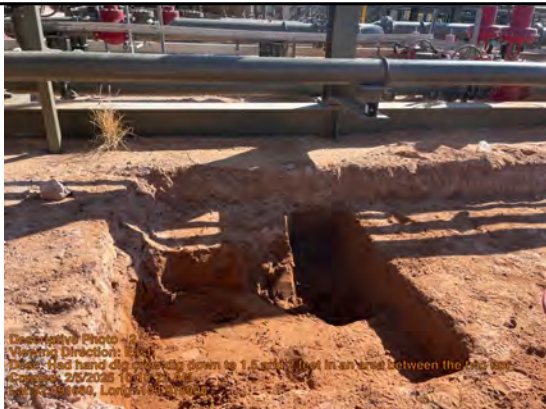
Had hand dig crew dig down to 1.5 and 2 feet in an area between the two north large separators to gauge how deep they need to advance the area down.

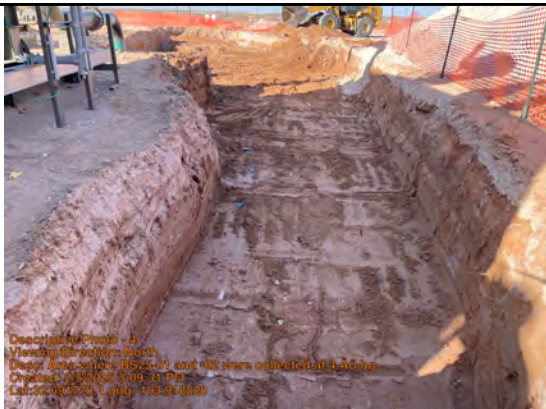
Area where BS25-01 and -02 were collected at 4' bgs.

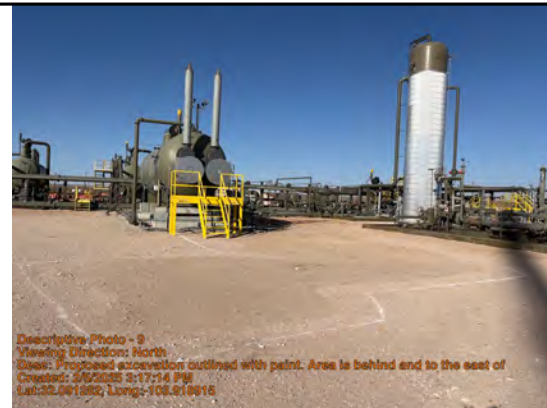
Proposed excavation outlined with paint. Area is behind and to the east of the southern large separator.

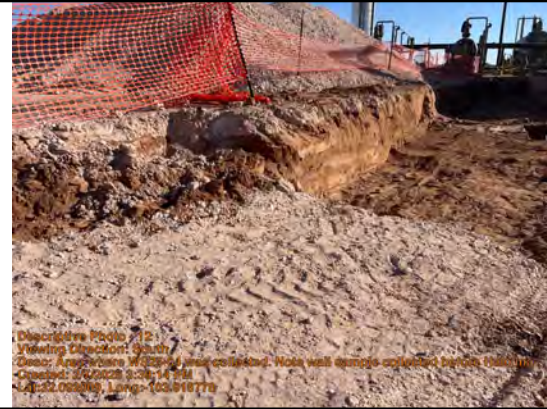
Area where WS25-04 was collected. Note wall sample collected before Halo made ramp for Hydrovac truck

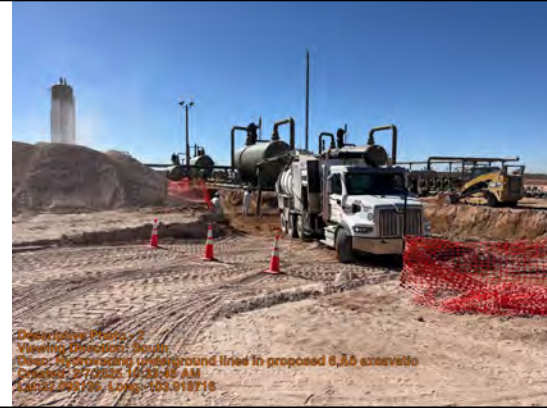
Halo sent out Hydrovac crew to hydrovac around underground lines in proposed 6' excavation.

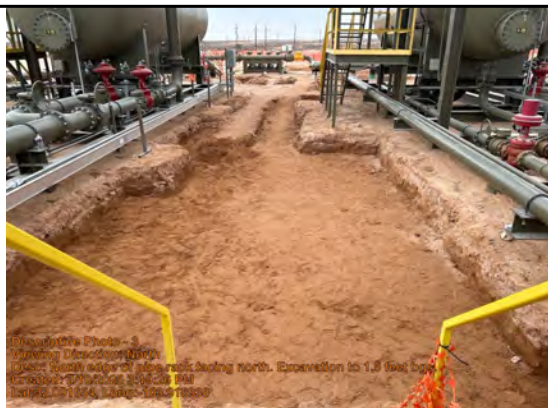
North edge of pipe rack facing north. Excavation to 1.5 feet bgs.

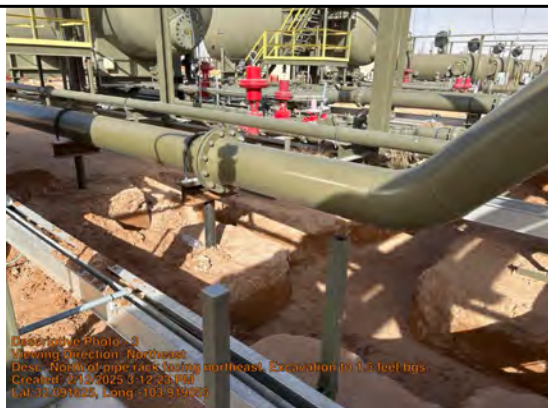
North of pipe rack facing northeast. Excavation to 1.5 feet bgs.

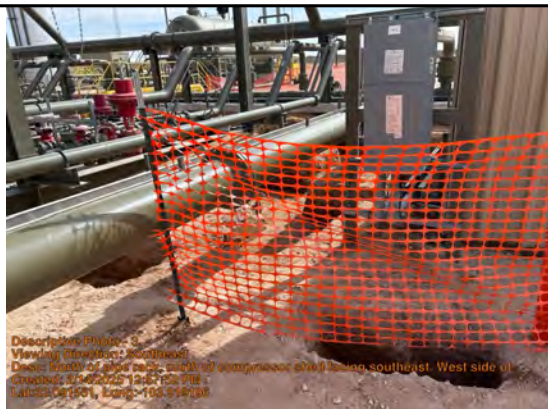
North of pipe rack, north of compressor shed facing southeast. West side of excavation to 1.5 feet bgs completed north of pipe rack.

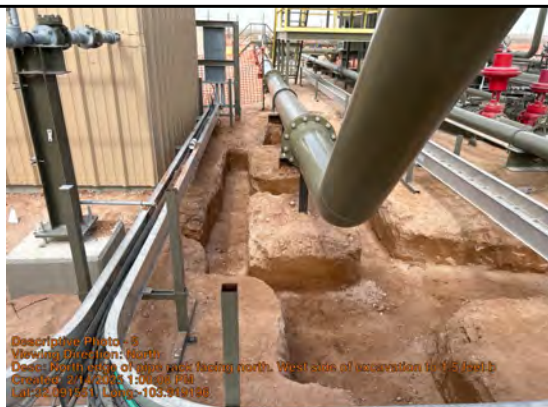
North edge of pipe rack facing north. West side of excavation to 1.5 feet bgs completed north of pipe rack.

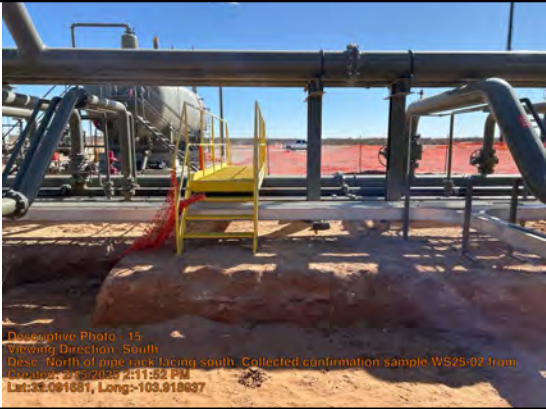
<p><small>Descriptive Photo - 15 Viewing Direction: South Desc: North of pipe rack facing south. Collected confirmation sample WS25-02 from south edge excavation to 1.5 feet bgs against pipe rack and equipment. Created: 2/16/2025 2:11:52 PM Lat:32.091681, Long:-103.918937</small></p>	<p>Viewing Direction: North</p>

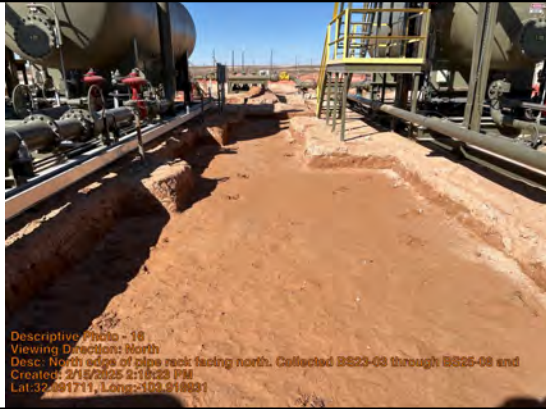
<p><small>Descriptive Photo - 16 Viewing Direction: North Desc: North edge of pipe rack facing north. Collected BS23-03 through BS25-08 and WS25-03 through WS25-05 from excavation to 1.5 feet bgs. Created: 2/16/2025 2:16:23 PM Lat:32.091711, Long:-103.918931</small></p>
<p>North of pipe rack facing south. Collected confirmation sample WS25-02 from south edge excavation to 1.5 feet bgs against pipe rack and equipment.</p>	<p>North edge of pipe rack facing north. Collected BS23-03 through BS25-08 and WS25-03 through WS25-05 from excavation to 1.5 feet bgs.</p>

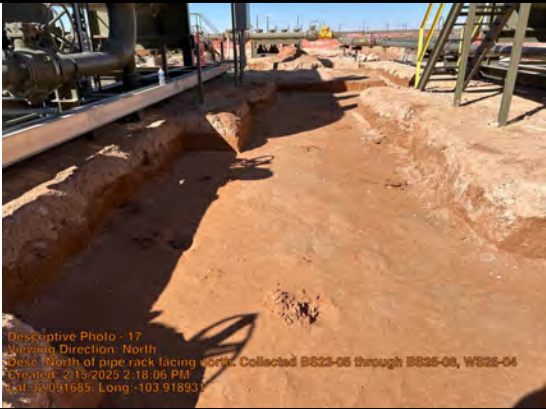
<p><small>Descriptive Photo - 17 Viewing Direction: North Desc: North of pipe rack facing north. Collected BS23-05 through BS25-08, WS25-04, and WS25-05 from excavation to 1.5 feet bgs. Created: 2/16/2025 2:18:06 PM Lat:32.091685, Long:-103.918931</small></p>	<p>Viewing Direction: Northeast</p>

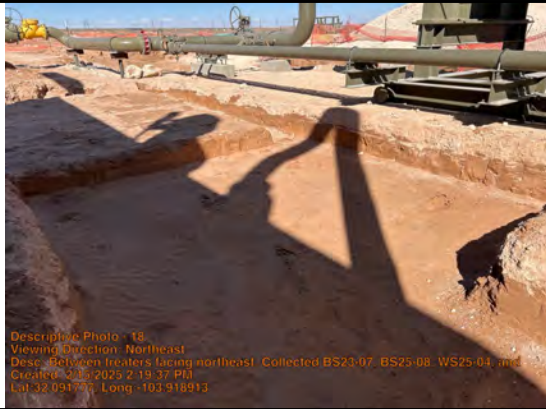
<p><small>Descriptive Photo - 18 Viewing Direction: Northeast Desc: Between treaters facing northeast. Collected BS23-07, BS25-08, WS25-04, WS25-05, and WS25-06 from excavation to 1.5 feet bgs. Created: 2/16/2025 2:19:37 PM Lat:32.091685, Long:-103.918931</small></p>
<p>North of pipe rack facing north. Collected BS23-05 through BS25-08, WS25-04, and WS25-05 from excavation to 1.5 feet bgs.</p>	<p>Between treaters facing northeast. Collected BS23-07, BS25-08, WS25-04, WS25-05, and WS25-06 from excavation to 1.5 feet bgs.</p>

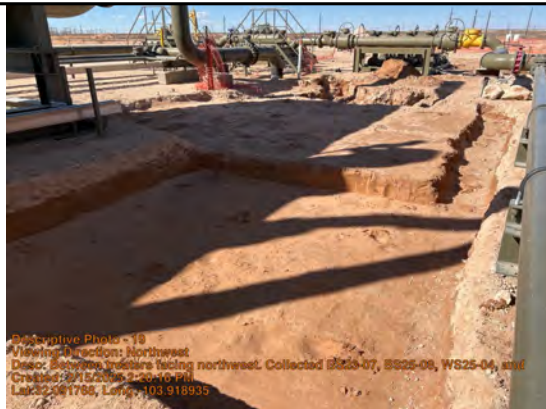
Between treaters facing northwest. Collected BS23-07, BS25-08, WS25-04, WS25-05, and WS25-06 from excavation to 1.5 feet bgs.

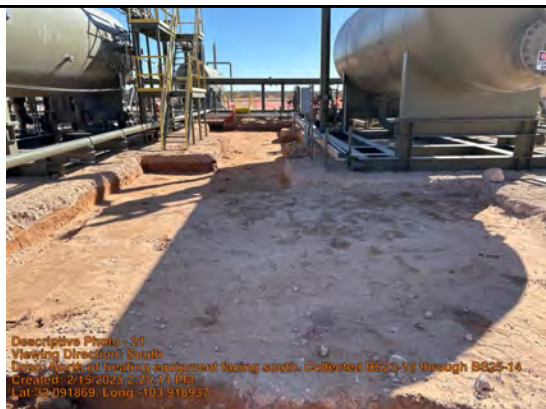
North of treating equipment facing south. Collected BS23-12 through BS25-14 and WS25-07 from excavation to 1 feet bgs.

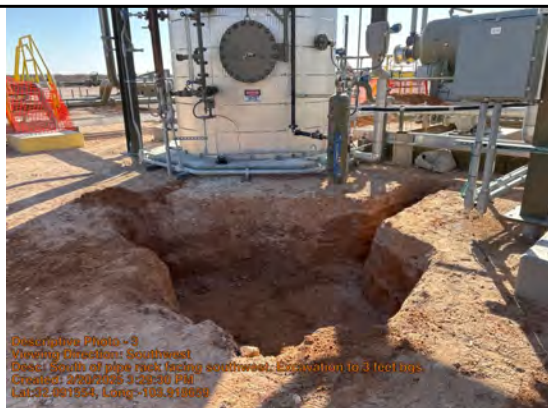
South of pipe rack facing southwest.
Excavation to 3 feet bgs.

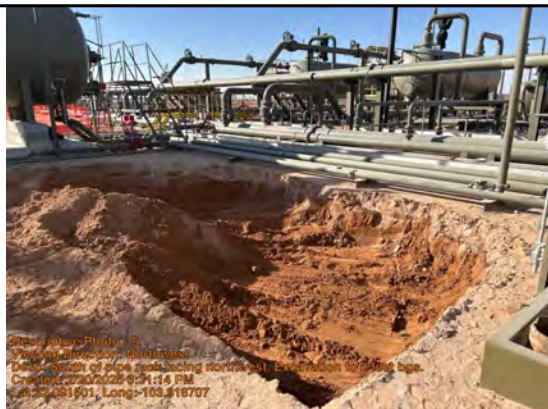
South of pipe rack facing northwest.
Excavation to 2 feet bgs.

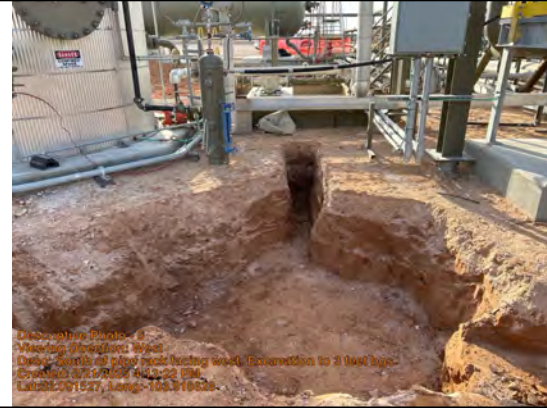
South of pipe rack facing west. Excavation to 3 feet bgs.

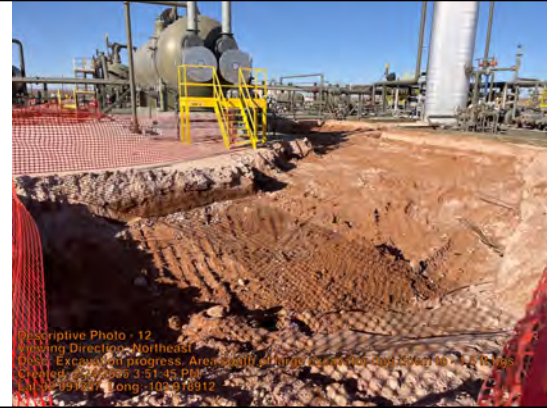
Excavation progress. Area south of large separator was dug down to ~1.5 ft bgs using mini-excavator

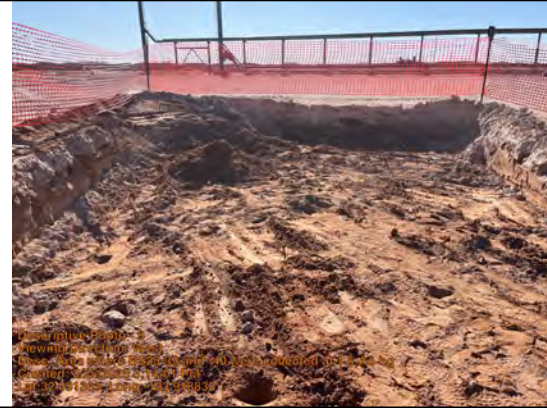
Area where BS25-39 and -40 were collected at 1.5' bgs.

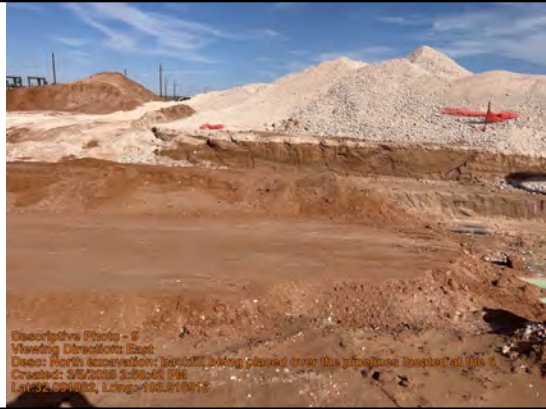
Descriptive Photo - 5
Viewing Direction: East
Desc: North excavation: backfill being placed over the pipelines located at the 6 ft
Created: 3/5/2025 2:09:45 PM
Lat: 33.000000, Long: -103.810000

North excavation (24E-04918, nAPP2431846528): backfilling (topsoil) being placed over the pipelines located at the 6ft excavation.

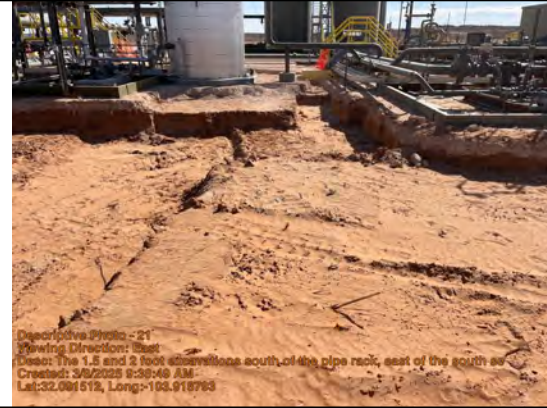
The 1.5 and 2 foot excavations south of the pipe rack, east of the south separator.

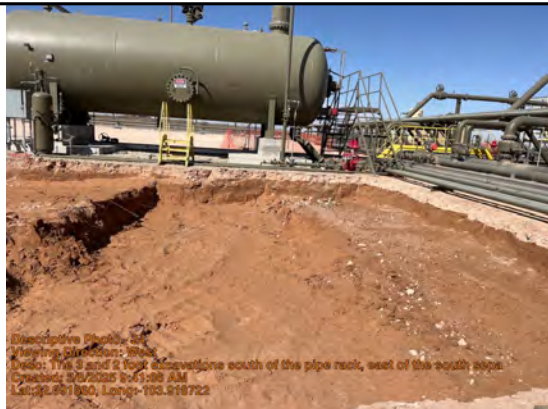
The 3 and 2 foot excavations south of the pipe rack, east of the south separator.

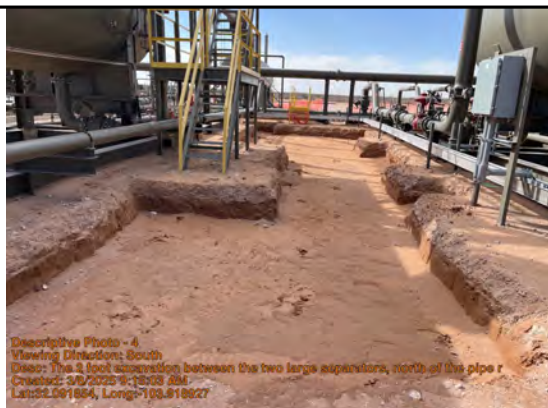
Descriptive Photo - 4
Viewing Direction: South
Desc: The 1.5 foot excavation between the two large separators, north of the pipe rack
Created: 3/8/2025 9:15:03 AM
Lat:32.091584, Long:-103.816527

The 1.5 foot excavation between the two large separators, north of the pipe rack)
