Re: Site Characterization and Remediation Deferral Request
Devon Energy Production Corporation
Red Bull 29 CTB 2
Unit N, Section 29, Township 23S, Range 35E
Site Coordinates: 32.26943, -103.39078
Lea County, New Mexico
Incident ID: nAPP2425341702 & nAPP2426476658

On behalf of Devon Energy Production Corporation (Devon), New Tech Global Environmental, LLC (NTGE) has prepared this Site Characterization and Remediation Deferral Request for submittal to the New Mexico Oil Conservation Division (NMOCD) District 2 Office in Artesia, New Mexico to document site assessment, remedial action activities, and sample analysis results for release numbers: nAPP2425341702 & nAPP2426476658– Red Bull 29 CTB 2 (Site). The Site is in Unit Letter N, Section 29, of Township 23 South and Range 35 East in Lea County, New Mexico. The GPS coordinates for the release site are 32.26943° N latitude and 103.39078° W longitude. The site location with respect to the nearest town is shown on Figure 1 and the topography of the area is shown on Figure 2.

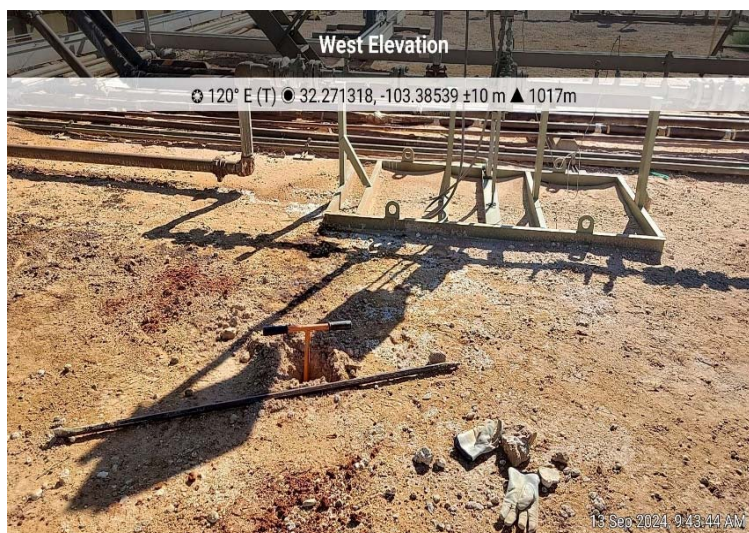
Photograph No. 4**Facility:** Red Bull 29 CTB 2**County:** Lea County, New Mexico**Description:**

Area of Concern (nAPP2425341702)

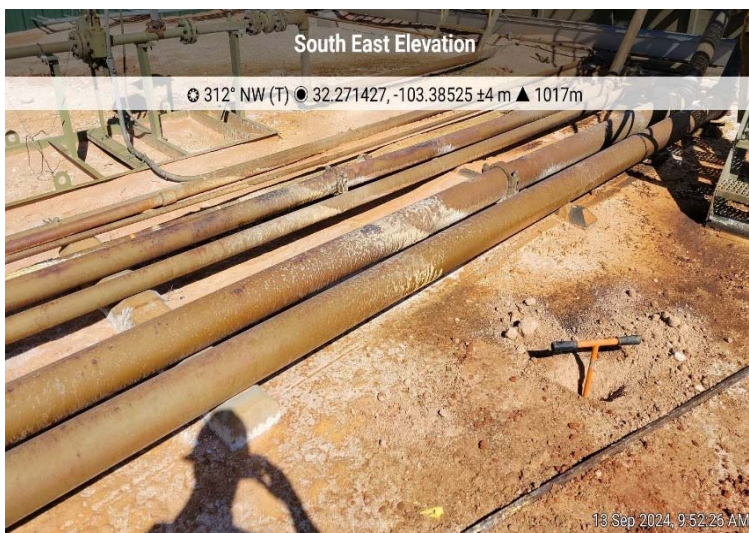
**Photograph No. 5****Facility:** Red Bull 29 CTB 2**County:** Lea County, New Mexico**Description:**

Area of Concern (nAPP2425341702)

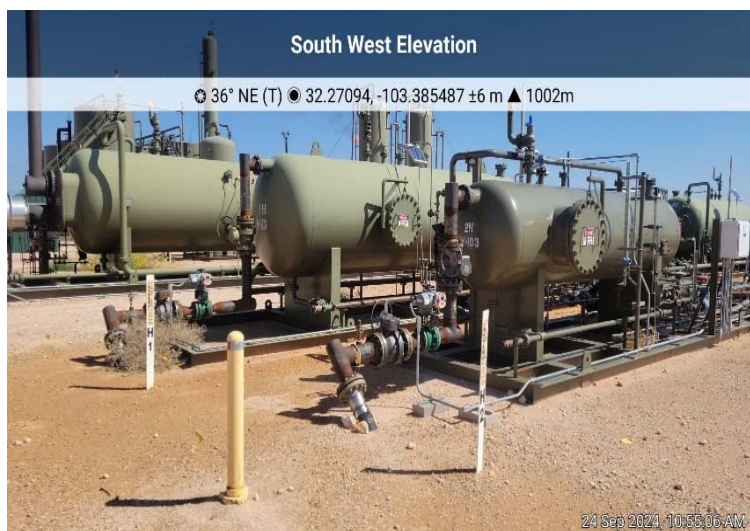
Photograph No. 7

Description:
Area of Concern (nAPP2426476658)

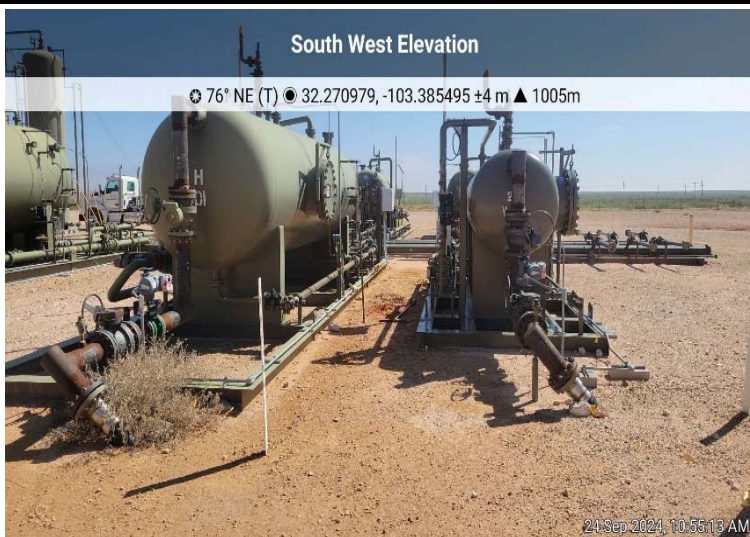
**Photograph No. 8**

Description:
Area of Concern (nAPP2426476658)

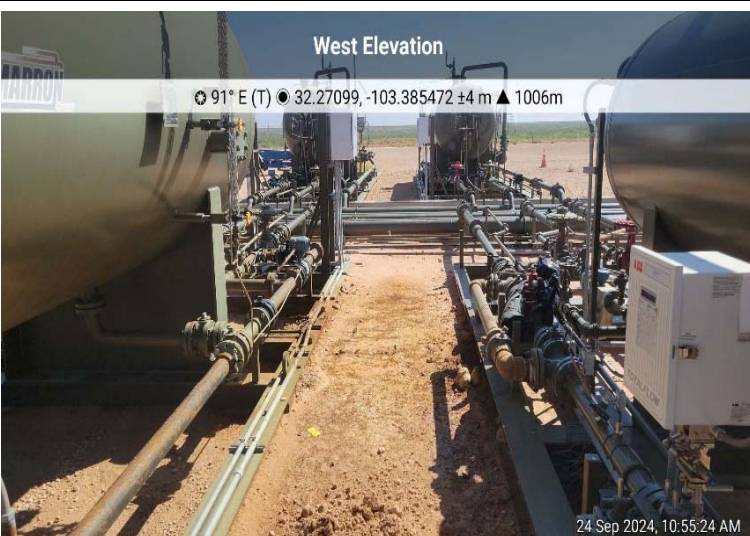
**Photograph No. 9**

Description:
Area of Concern (nAPP2426476658)

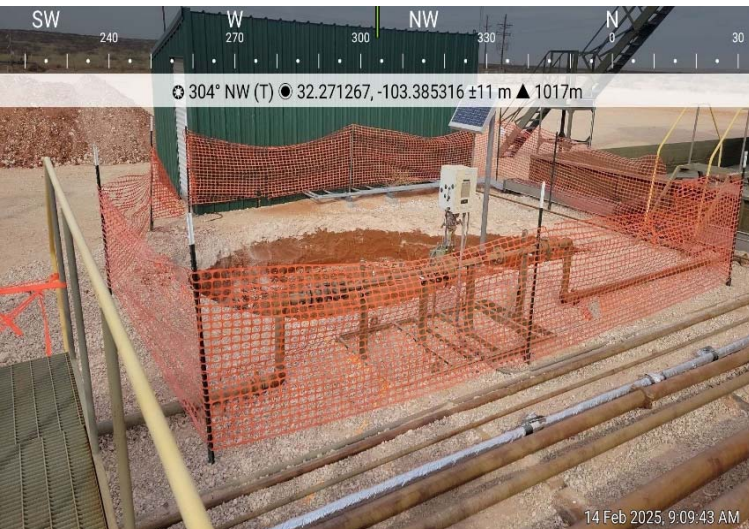
**Photograph No. 12**

View of Excavation (nAPP2425341702)
