EAST VACUUM (GSA) UNIT #002

PREPARED BY SAPEC-ECO, LLC.  
PREPARED FOR MAVERICK PERMIAN, LLC.

## **Proposed Sampling and Remediation Work Plan**

Re: Proposed Sampling and Remediation Work Plan  
 NMOCD Incident Number: **nOY1815237113**  
 East Vacuum (GSA) Unit #002 API No. 30-025-26225  
 Unit M, Section 28, Township 17S, Range 35E 1140 FSL 1310 FWL Lea County, NM  
 GPS Coordinates: Latitude 32.8018303 Longitude -103.467041 NAD83

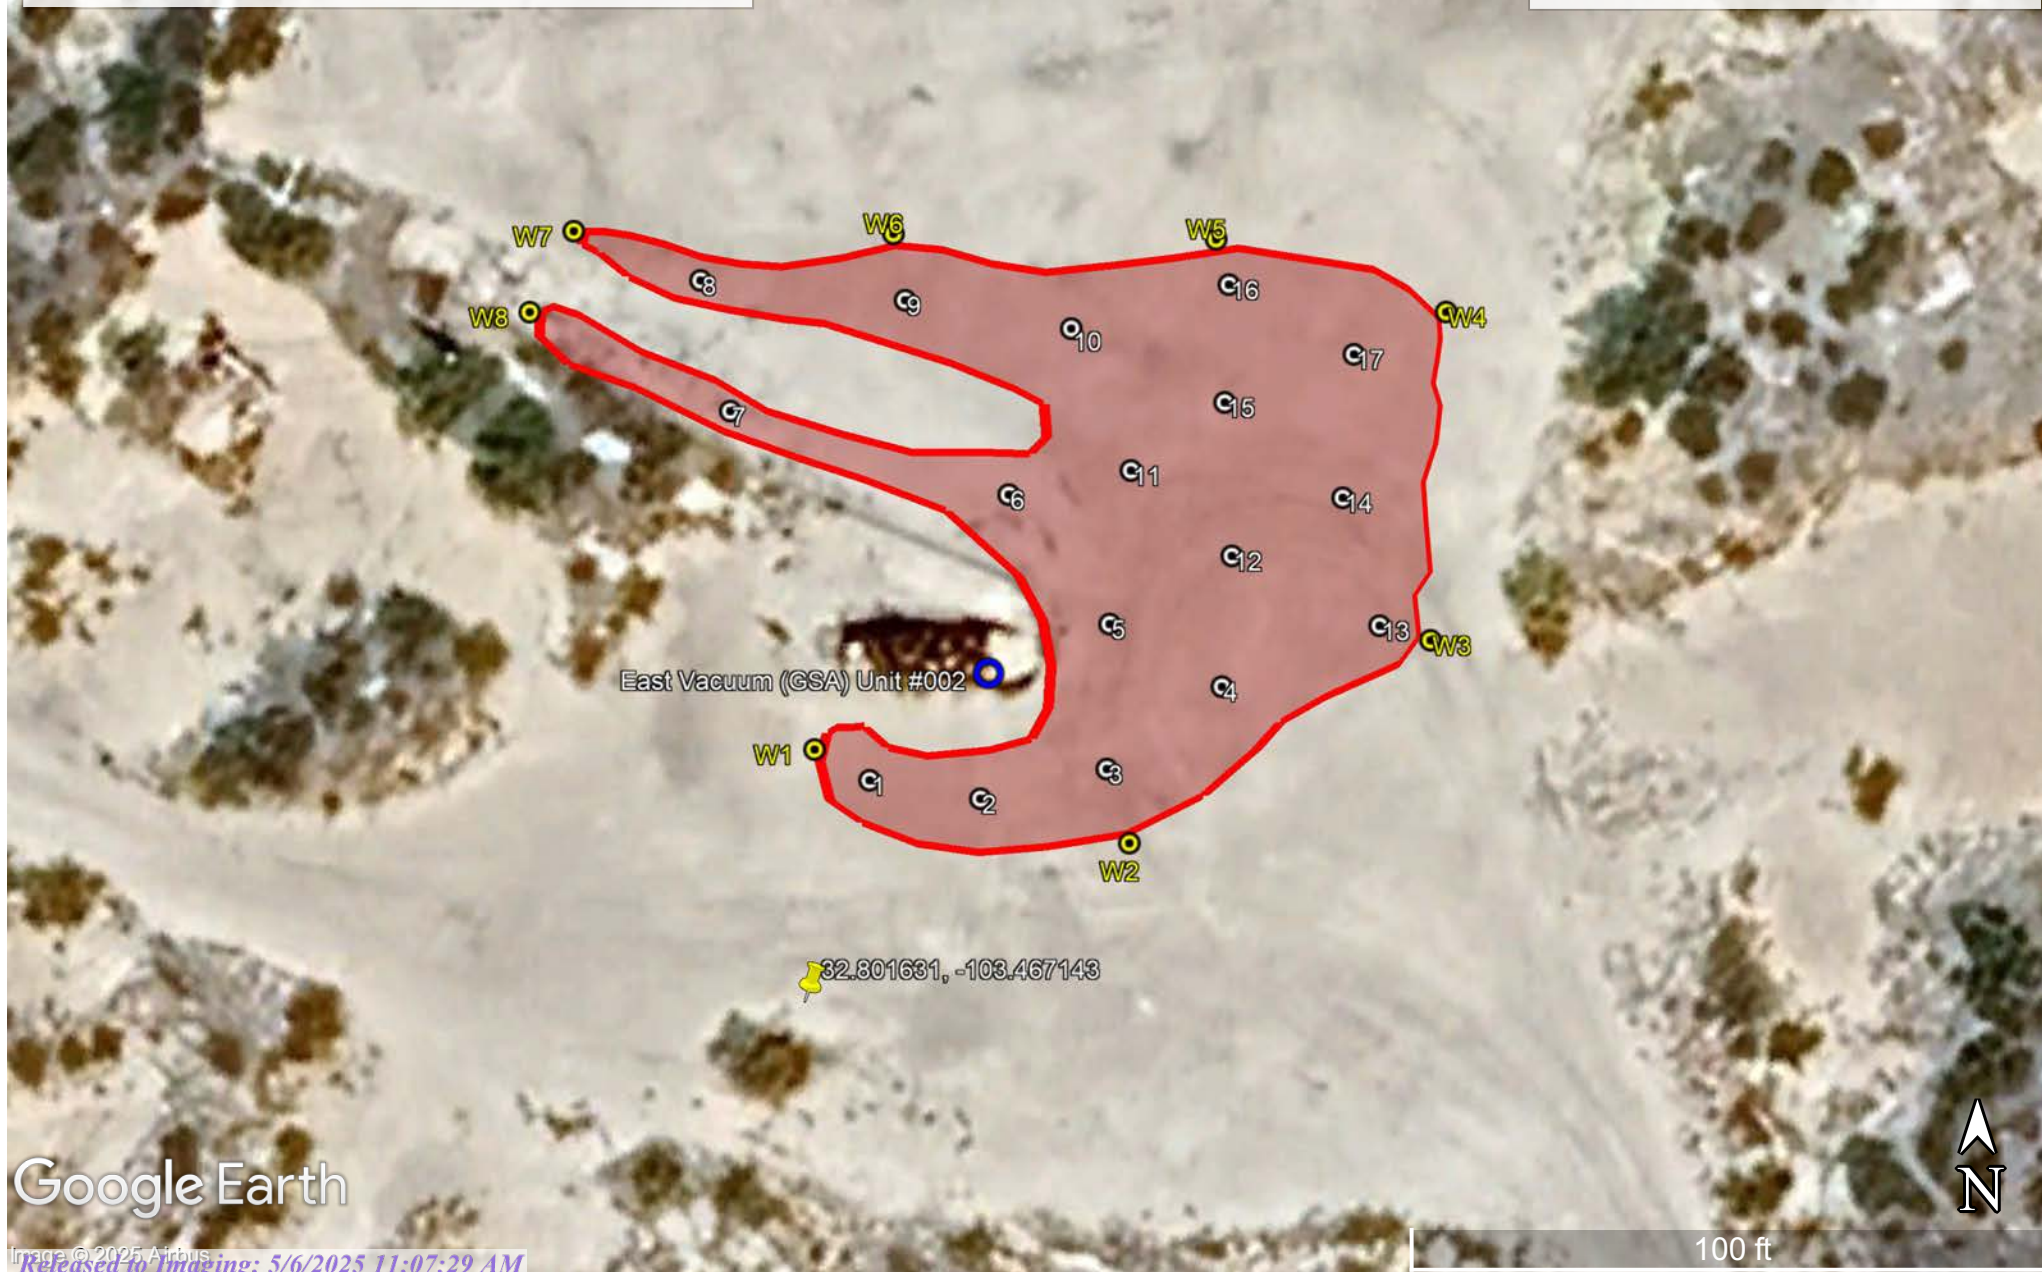
- East Vacuum (GSA) Unit #002
- Proposed horizontal samples
- Proposed vertical samples
- Release area - 6568 sqft

- A 48-hour sampling notification will be issued to the NMOCD for these sampling events. A variance request is included below for permission to use the delineation samples as confirmation samples depending on the sample results of the soil. A Proposed Sample Map can be found in Figure 1.

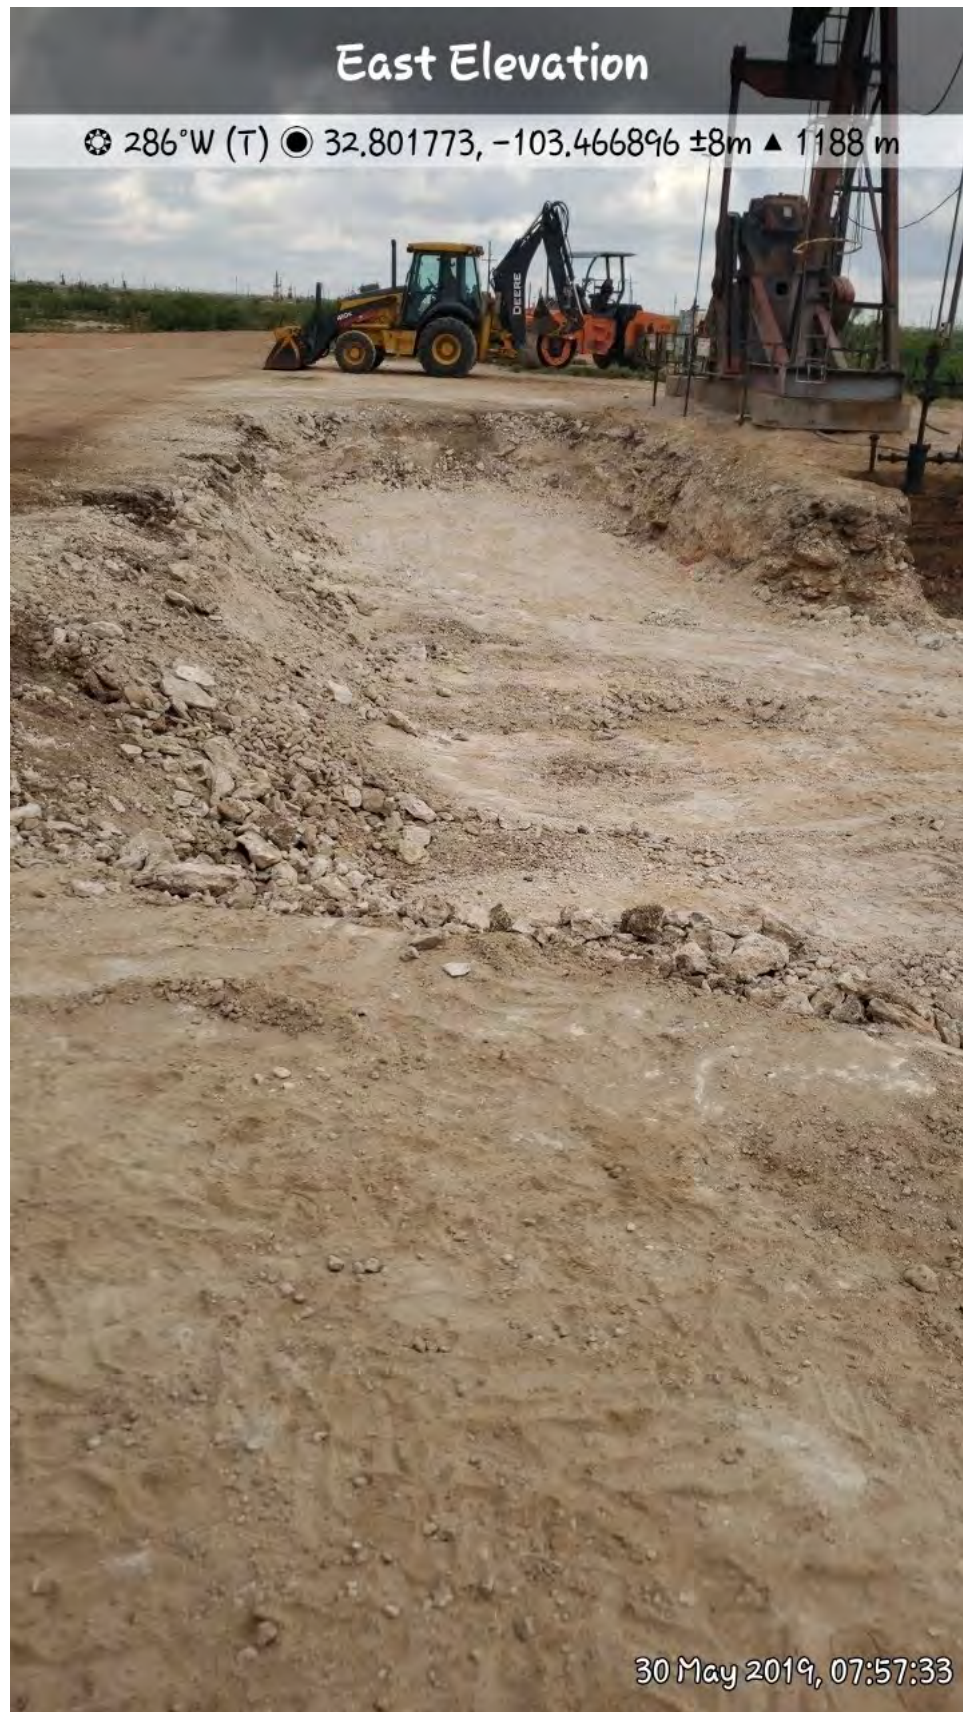
TETRA TECH, INC. PROJECT NO. 212C-MD-02152	DESCRIPTION	View facing west of excavation on well pad.	1
	SITE NAME	EVGSAU 2801-002 Stuffing Box Release	5/30/2019

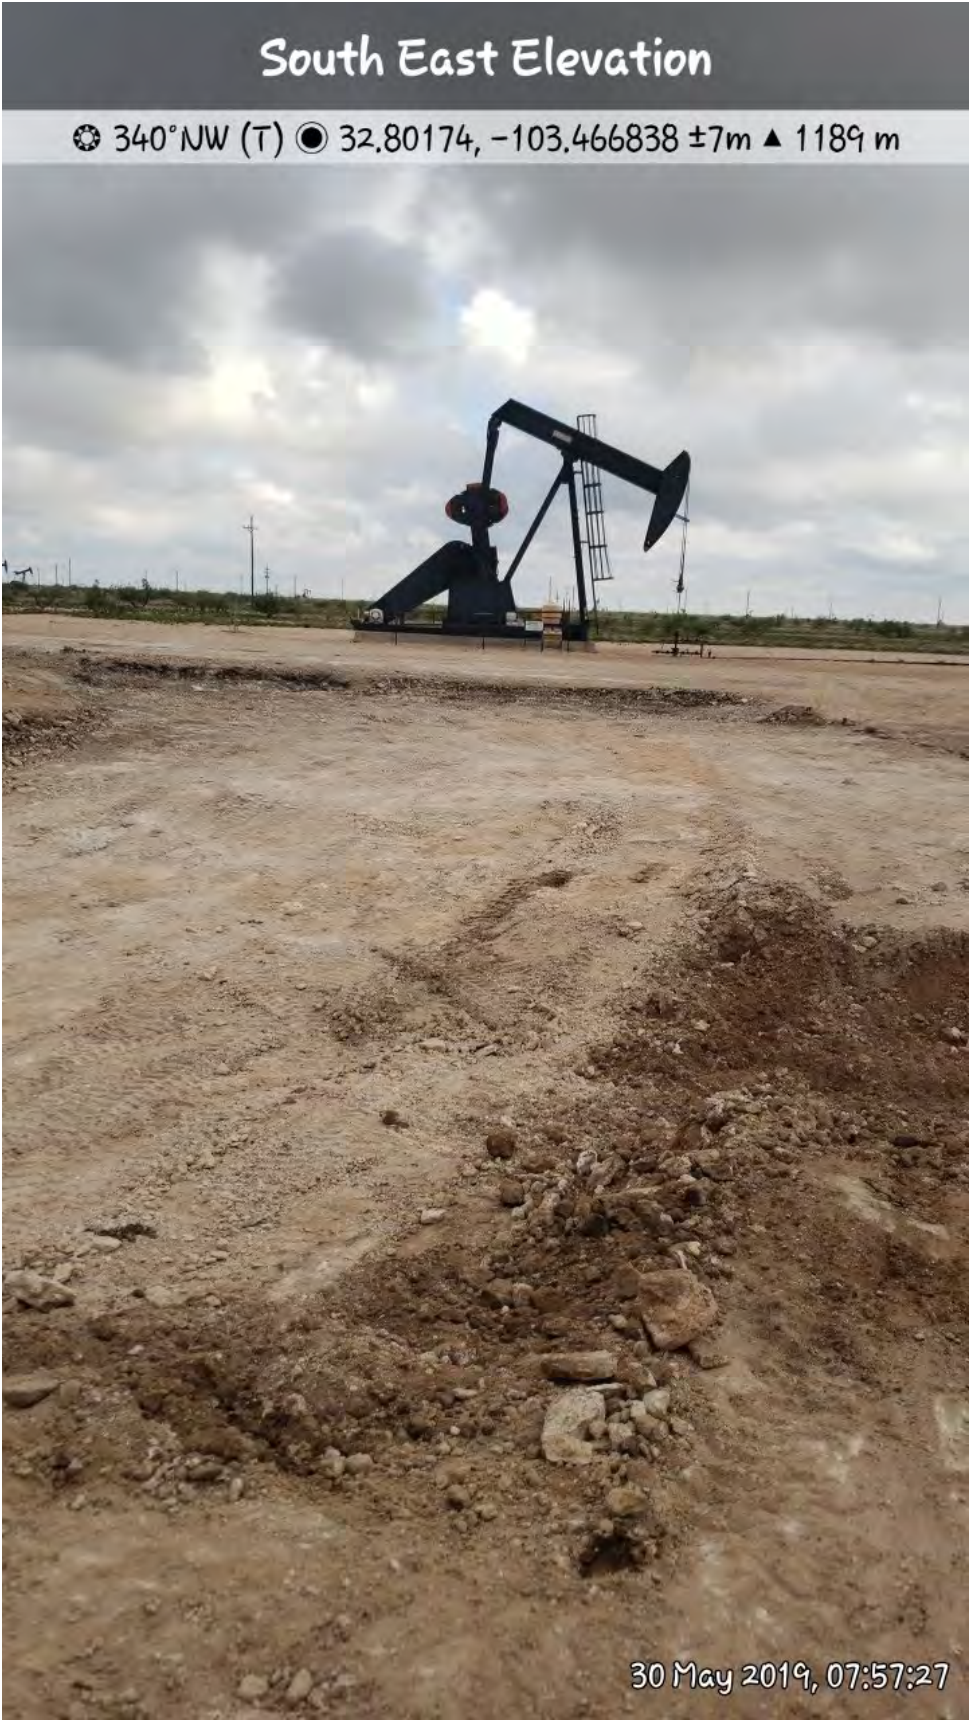
TETRA TECH, INC. PROJECT NO. 212C-MD-02152	DESCRIPTION	View facing northwest of excavation on well pad.	2
	SITE NAME	EVGSAU 2801-002 Stuffing Box Release	5/30/2019

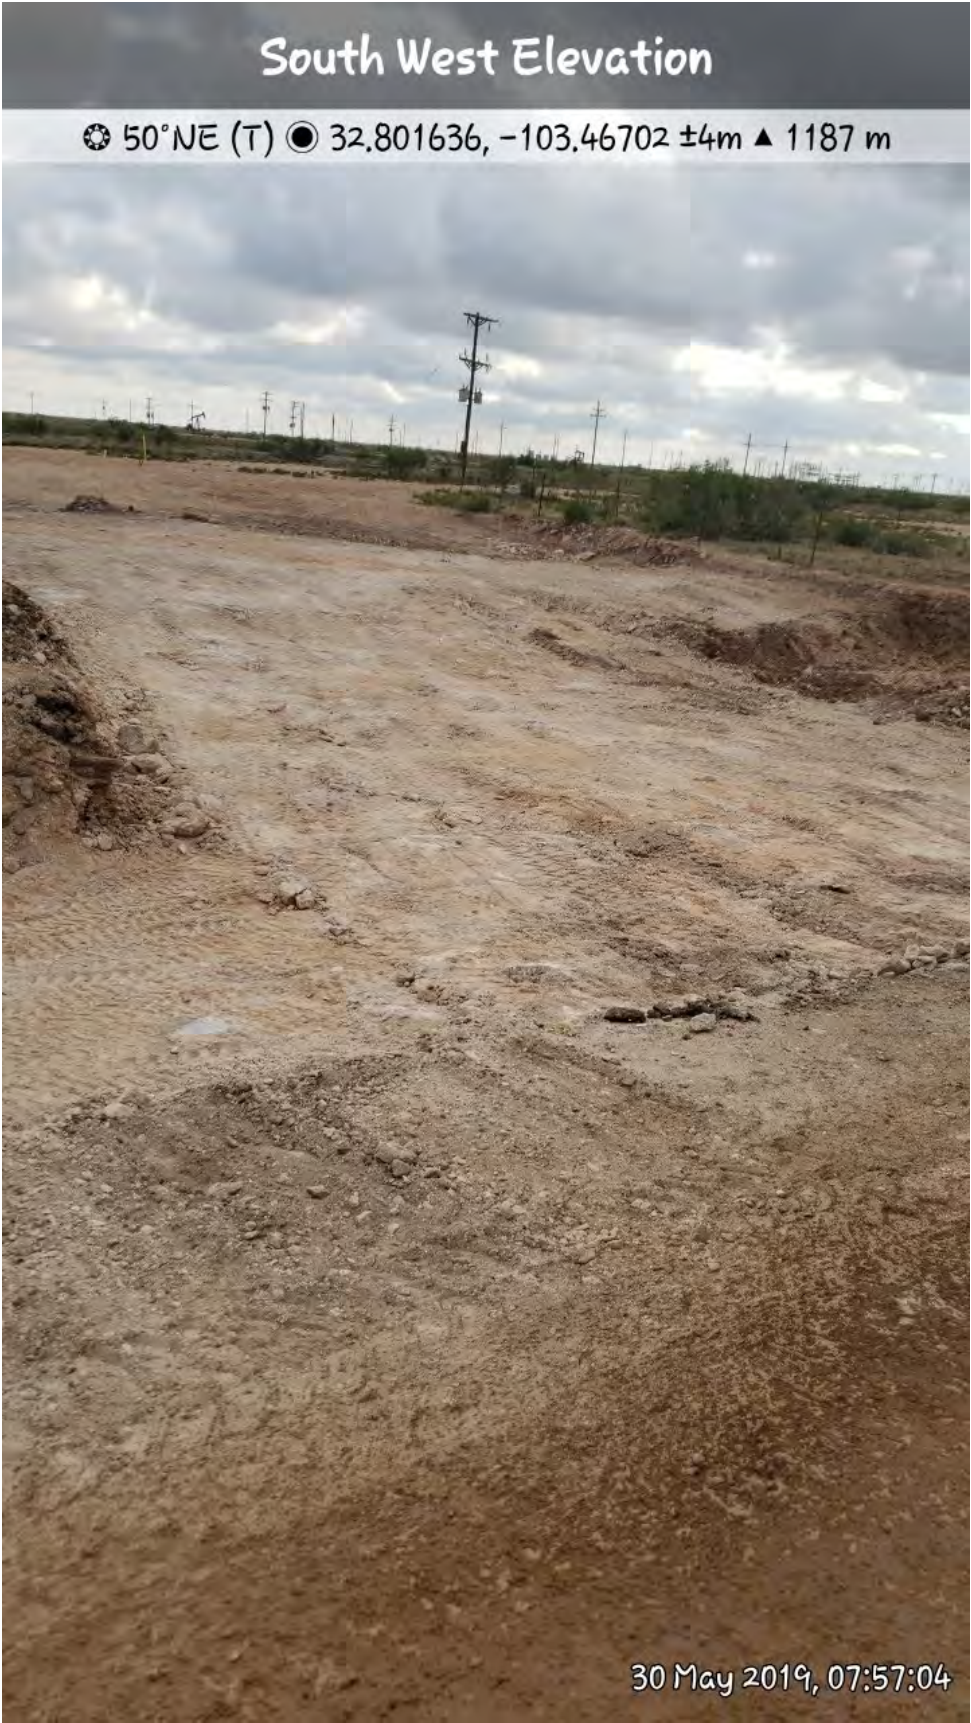
TETRA TECH, INC. PROJECT NO. 212C-MD-02152	DESCRIPTION	View facing northeast of excavation on well pad.	3
	SITE NAME	EVGSAU 2801-002 Stuffing Box Release	5/30/2019

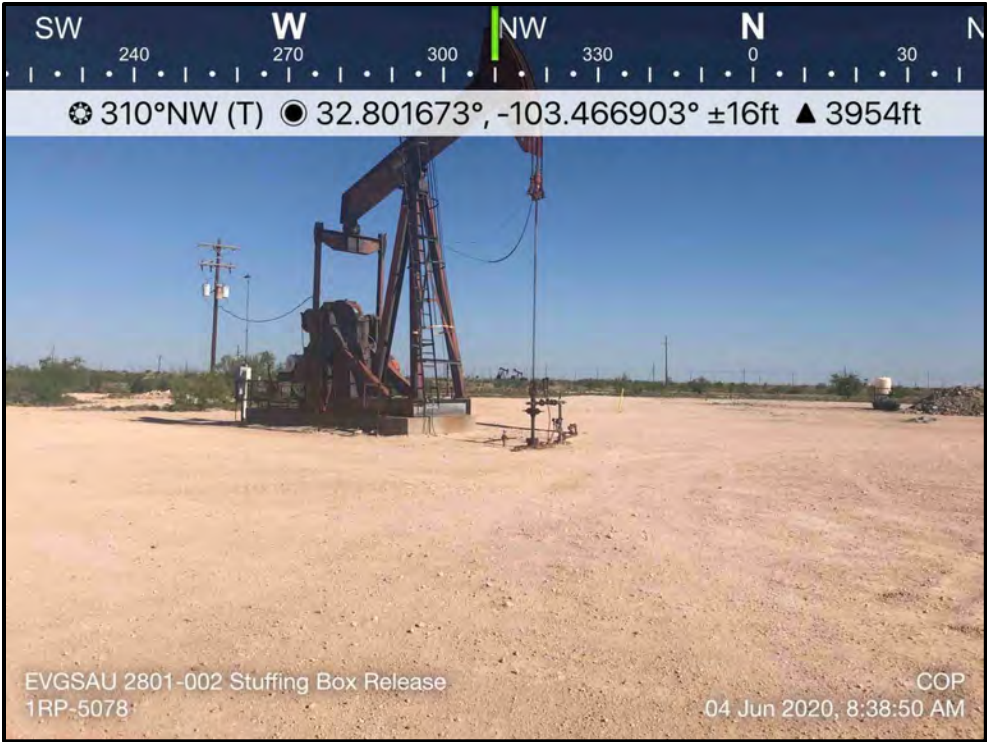
TETRA TECH, INC. PROJECT NO. 212C-MD-02152	DESCRIPTION	View facing northwest of well pad.	4
	SITE NAME	EVGSAU 2801-002 Stuffing Box Release	6/4/2020

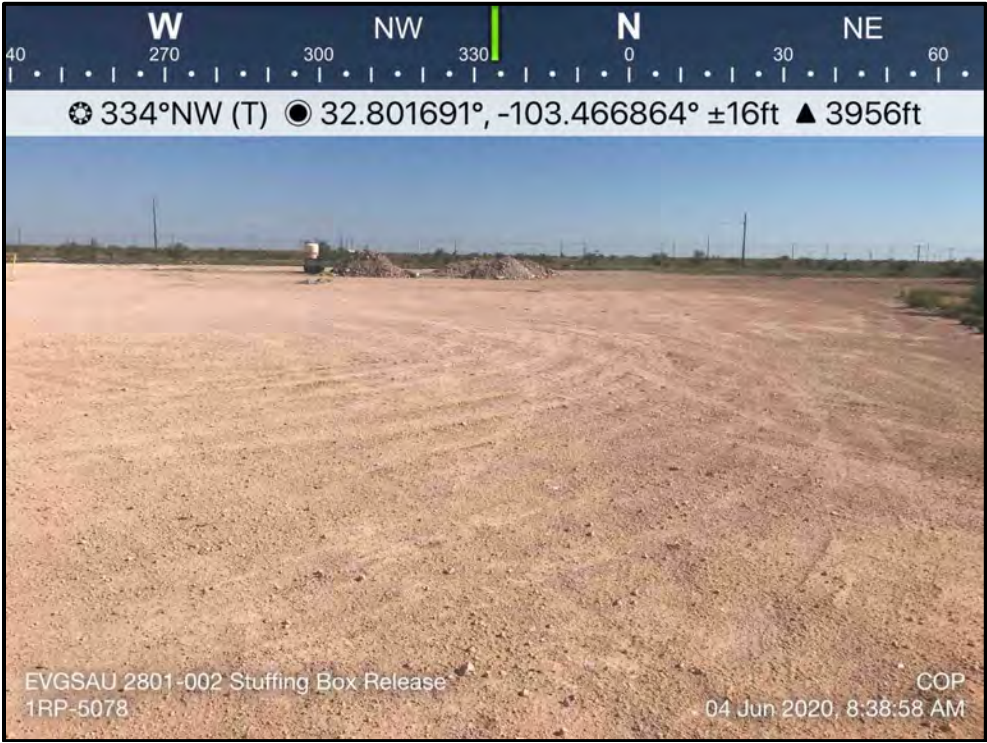
TETRA TECH, INC. PROJECT NO. 212C-MD-02152	DESCRIPTION	View facing northwest of well pad.	5
	SITE NAME	EVGSAU 2801-002 Stuffing Box Release	6/4/2020

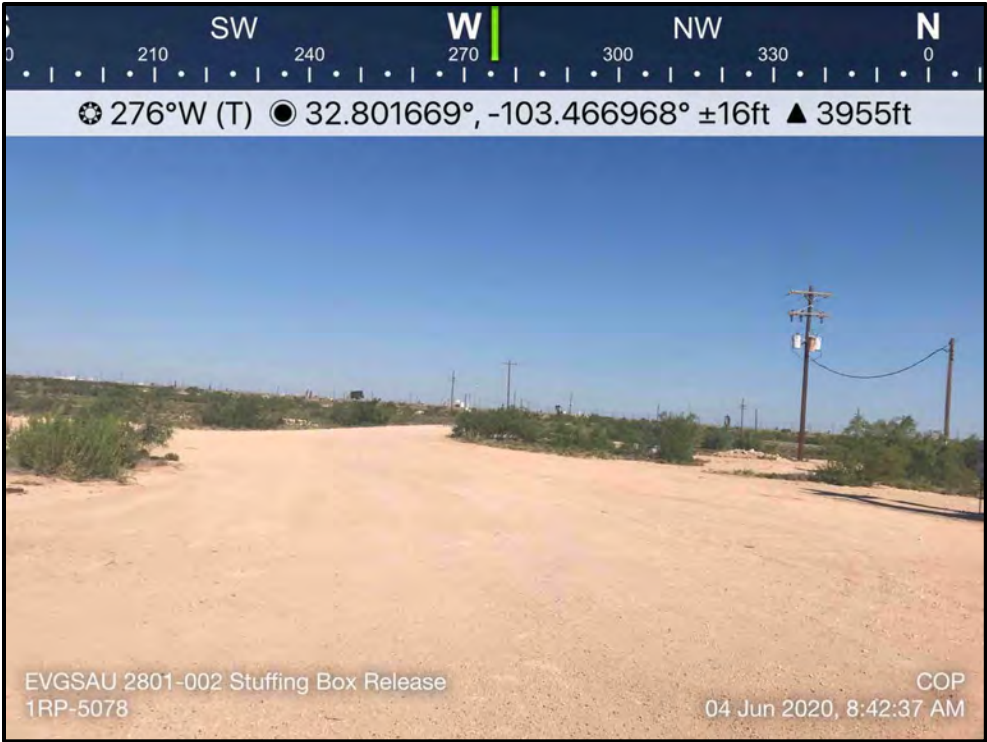
TETRA TECH, INC. PROJECT NO. 212C-MD-02152	DESCRIPTION	View facing west of lease road adjacent to well pad.	6
	SITE NAME	EVGSAU 2801-002 Stuffing Box Release	6/4/2020
