EAST VACUUM (GSA) UNIT #006
nGRL1013255165

PREPARED BY SAPEC-ECO, LLC.
PREPARED FOR MAVERICK PERMIAN, LLC.

Proposed Sampling and Remediation Work Plan

April 25, 2025

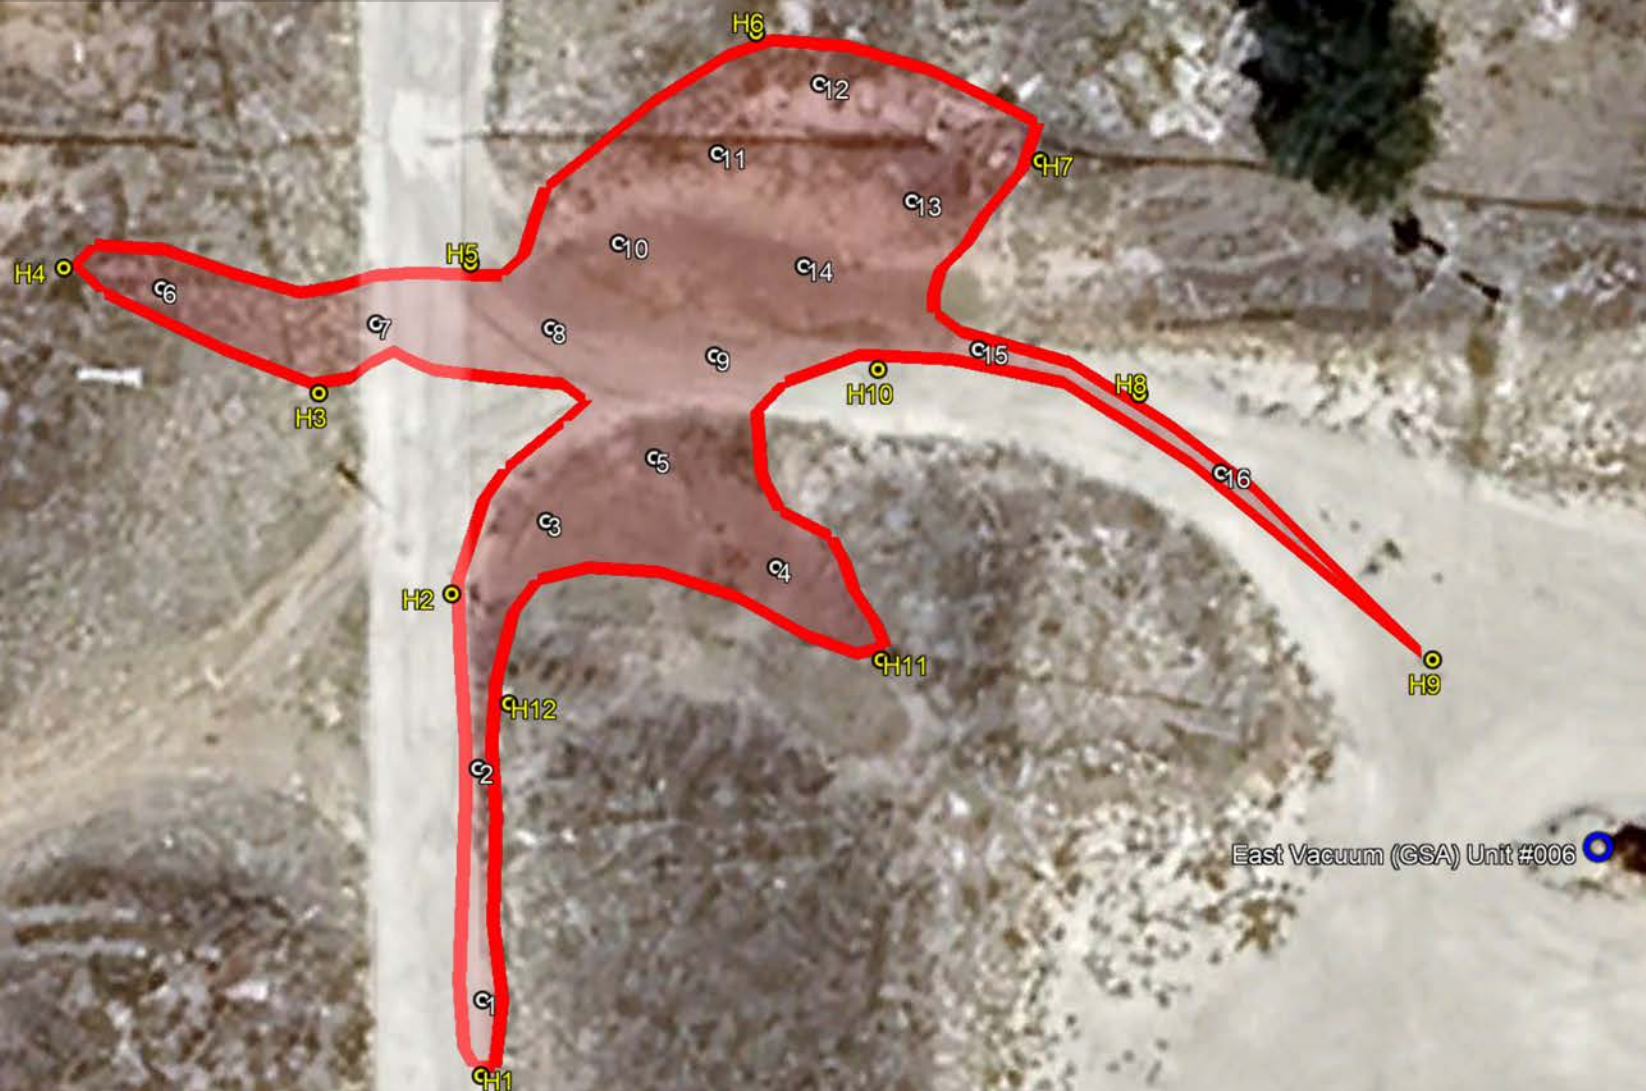
- Proposed horizontal samples
- Proposed vertical samples
- Release area - 8,894 sqft

- A 48-hour sampling notification will be issued to the NMOCD for these sampling events. A variance request is included below for permission to use the delineation samples as confirmations samples depending on the sample results of the soil. A Proposed Sample Map referencing the release area and the previously remediated area can be found in Figure 1.

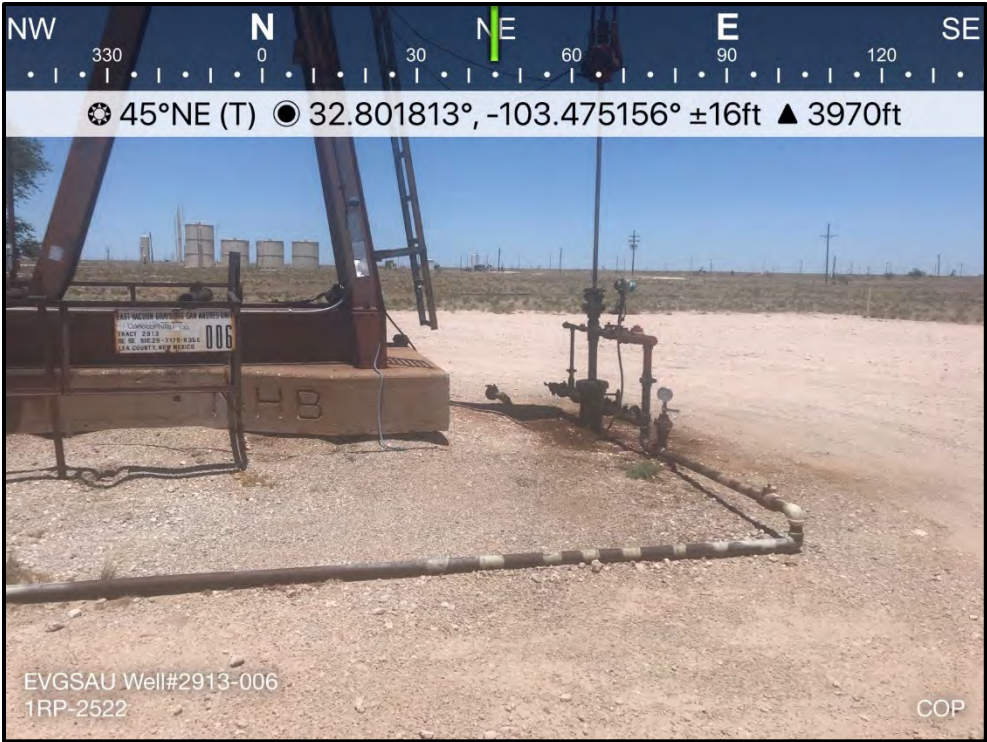
TETRA TECH, INC. PROJECT NO. 212C-MD-02152	DESCRIPTION	View facing northeast of well head.	1
	SITE NAME	EVGSAU Well #2913-006 Flowline Release	6/8/2020

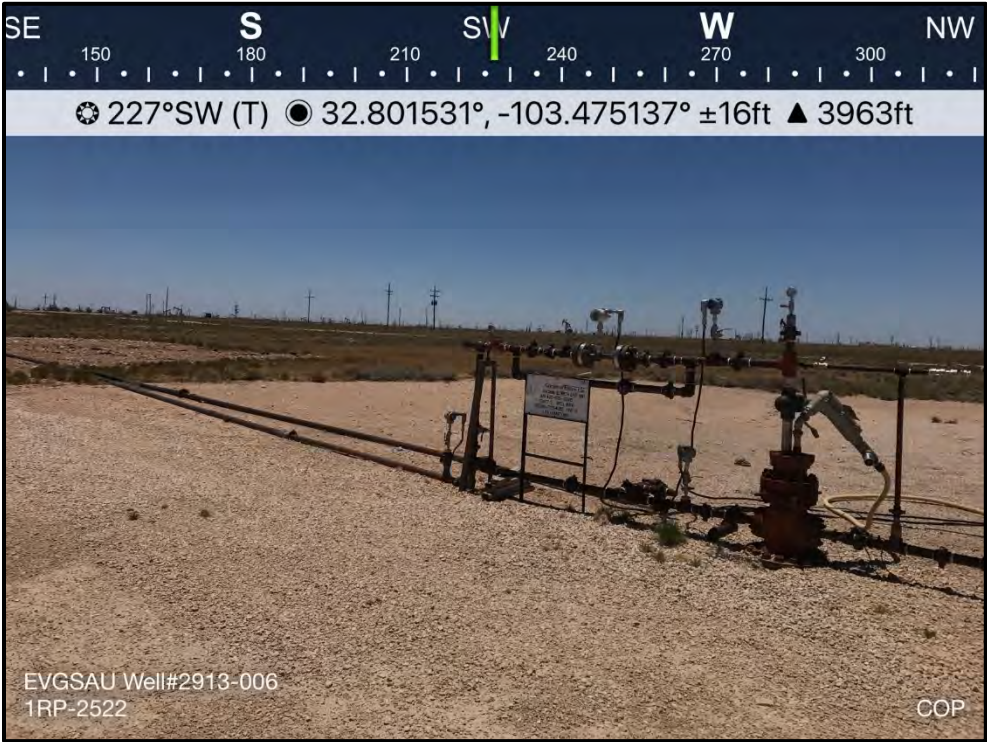
TETRA TECH, INC. PROJECT NO. 212C-MD-02152	DESCRIPTION	View facing southwest of release area.	2
	SITE NAME	EVGSAU Well #2913-006 Flowline Release	6/8/2020

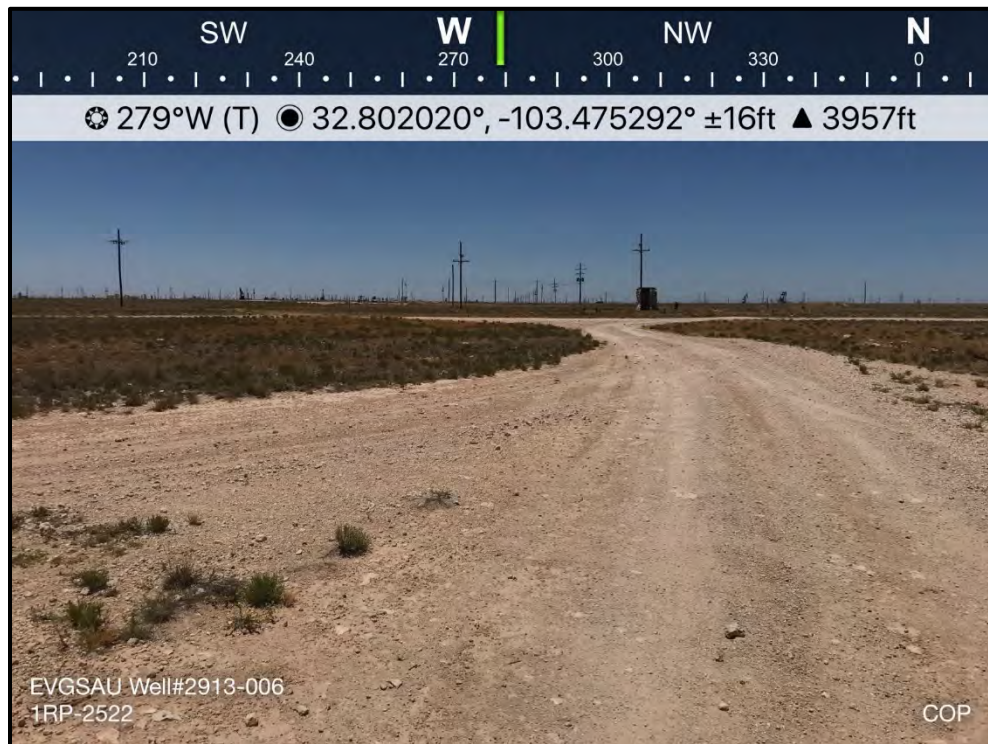
TETRA TECH, INC. PROJECT NO. 212C-MD-02152	DESCRIPTION	View facing west of release area.	3
	SITE NAME	EVGSAU Well #2913-006 Flowline Release	6/8/2020

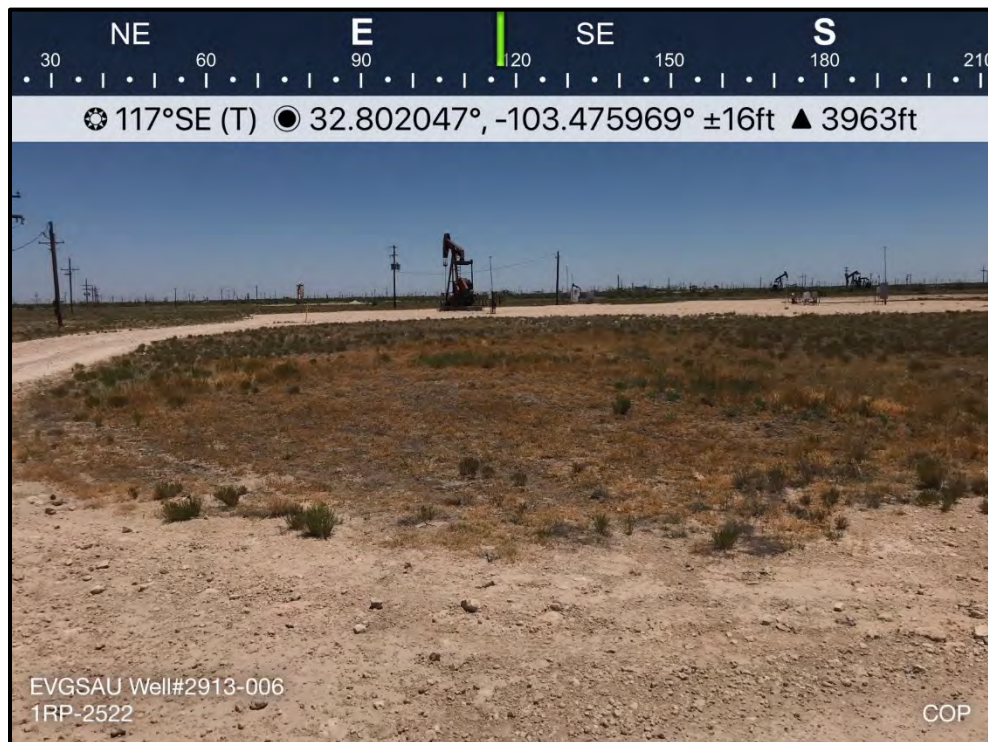
TETRA TECH, INC. PROJECT NO. 212C-MD-02152	DESCRIPTION	View facing southeast of release area.	4
	SITE NAME	EVGSAU Well #2913-006 Flowline Release	6/8/2020

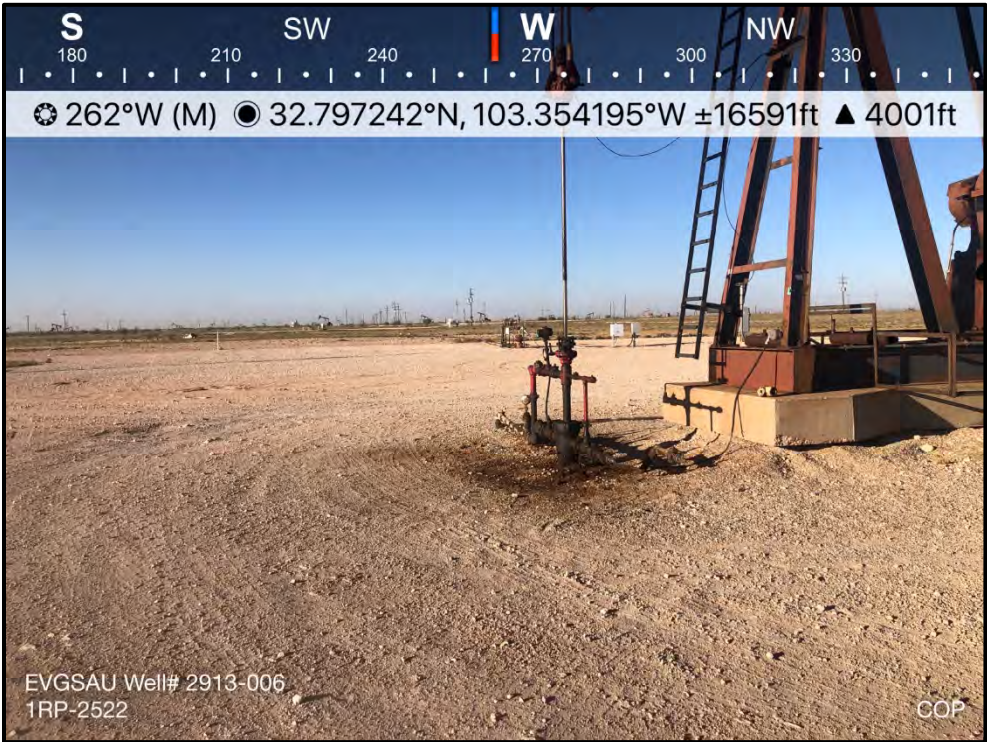
TETRA TECH, INC. PROJECT NO. 212C-MD-02152	DESCRIPTION	View facing west of well head.	5
	SITE NAME	EVGSAU Well #2913-006 Flowline Release	6/8/2020

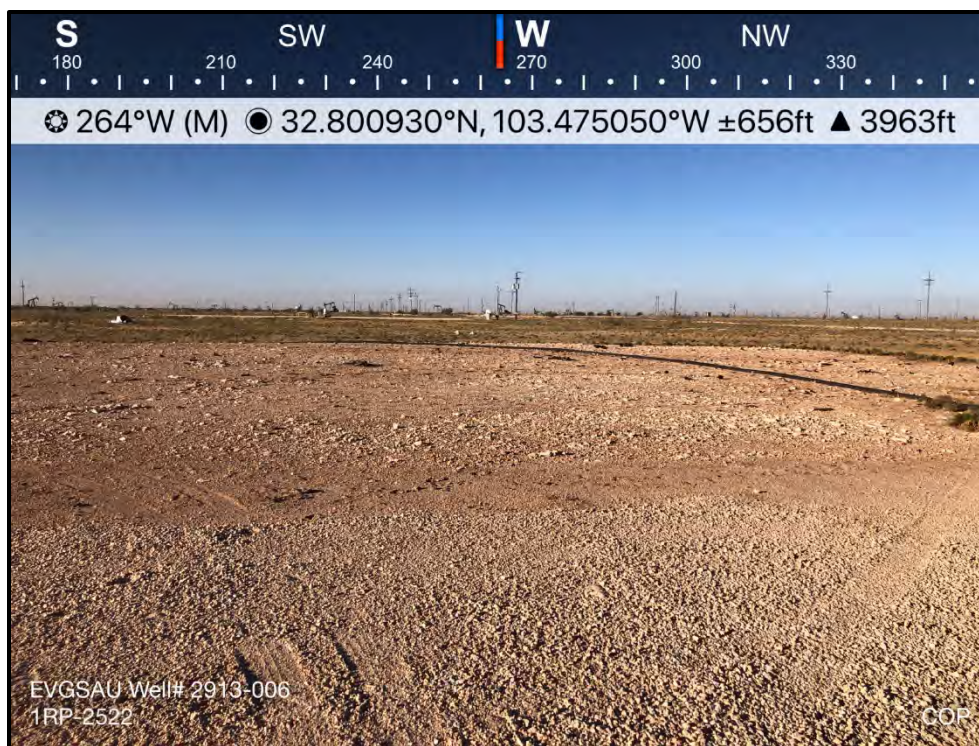
TETRA TECH, INC. PROJECT NO. 212C-MD-02152	DESCRIPTION	View facing west of well pad area.	7
	SITE NAME	EVGSAU Well #2913-006 Flowline Release	6/8/2020
