EAST VACUUM (GSA) UNIT #006
nT01418156731

PREPARED BY SAPEC-ECO, LLC.
PREPARED FOR MAVERICK PERMIAN, LLC.

Proposed Sampling and Remediation Work Plan

April 25, 2025

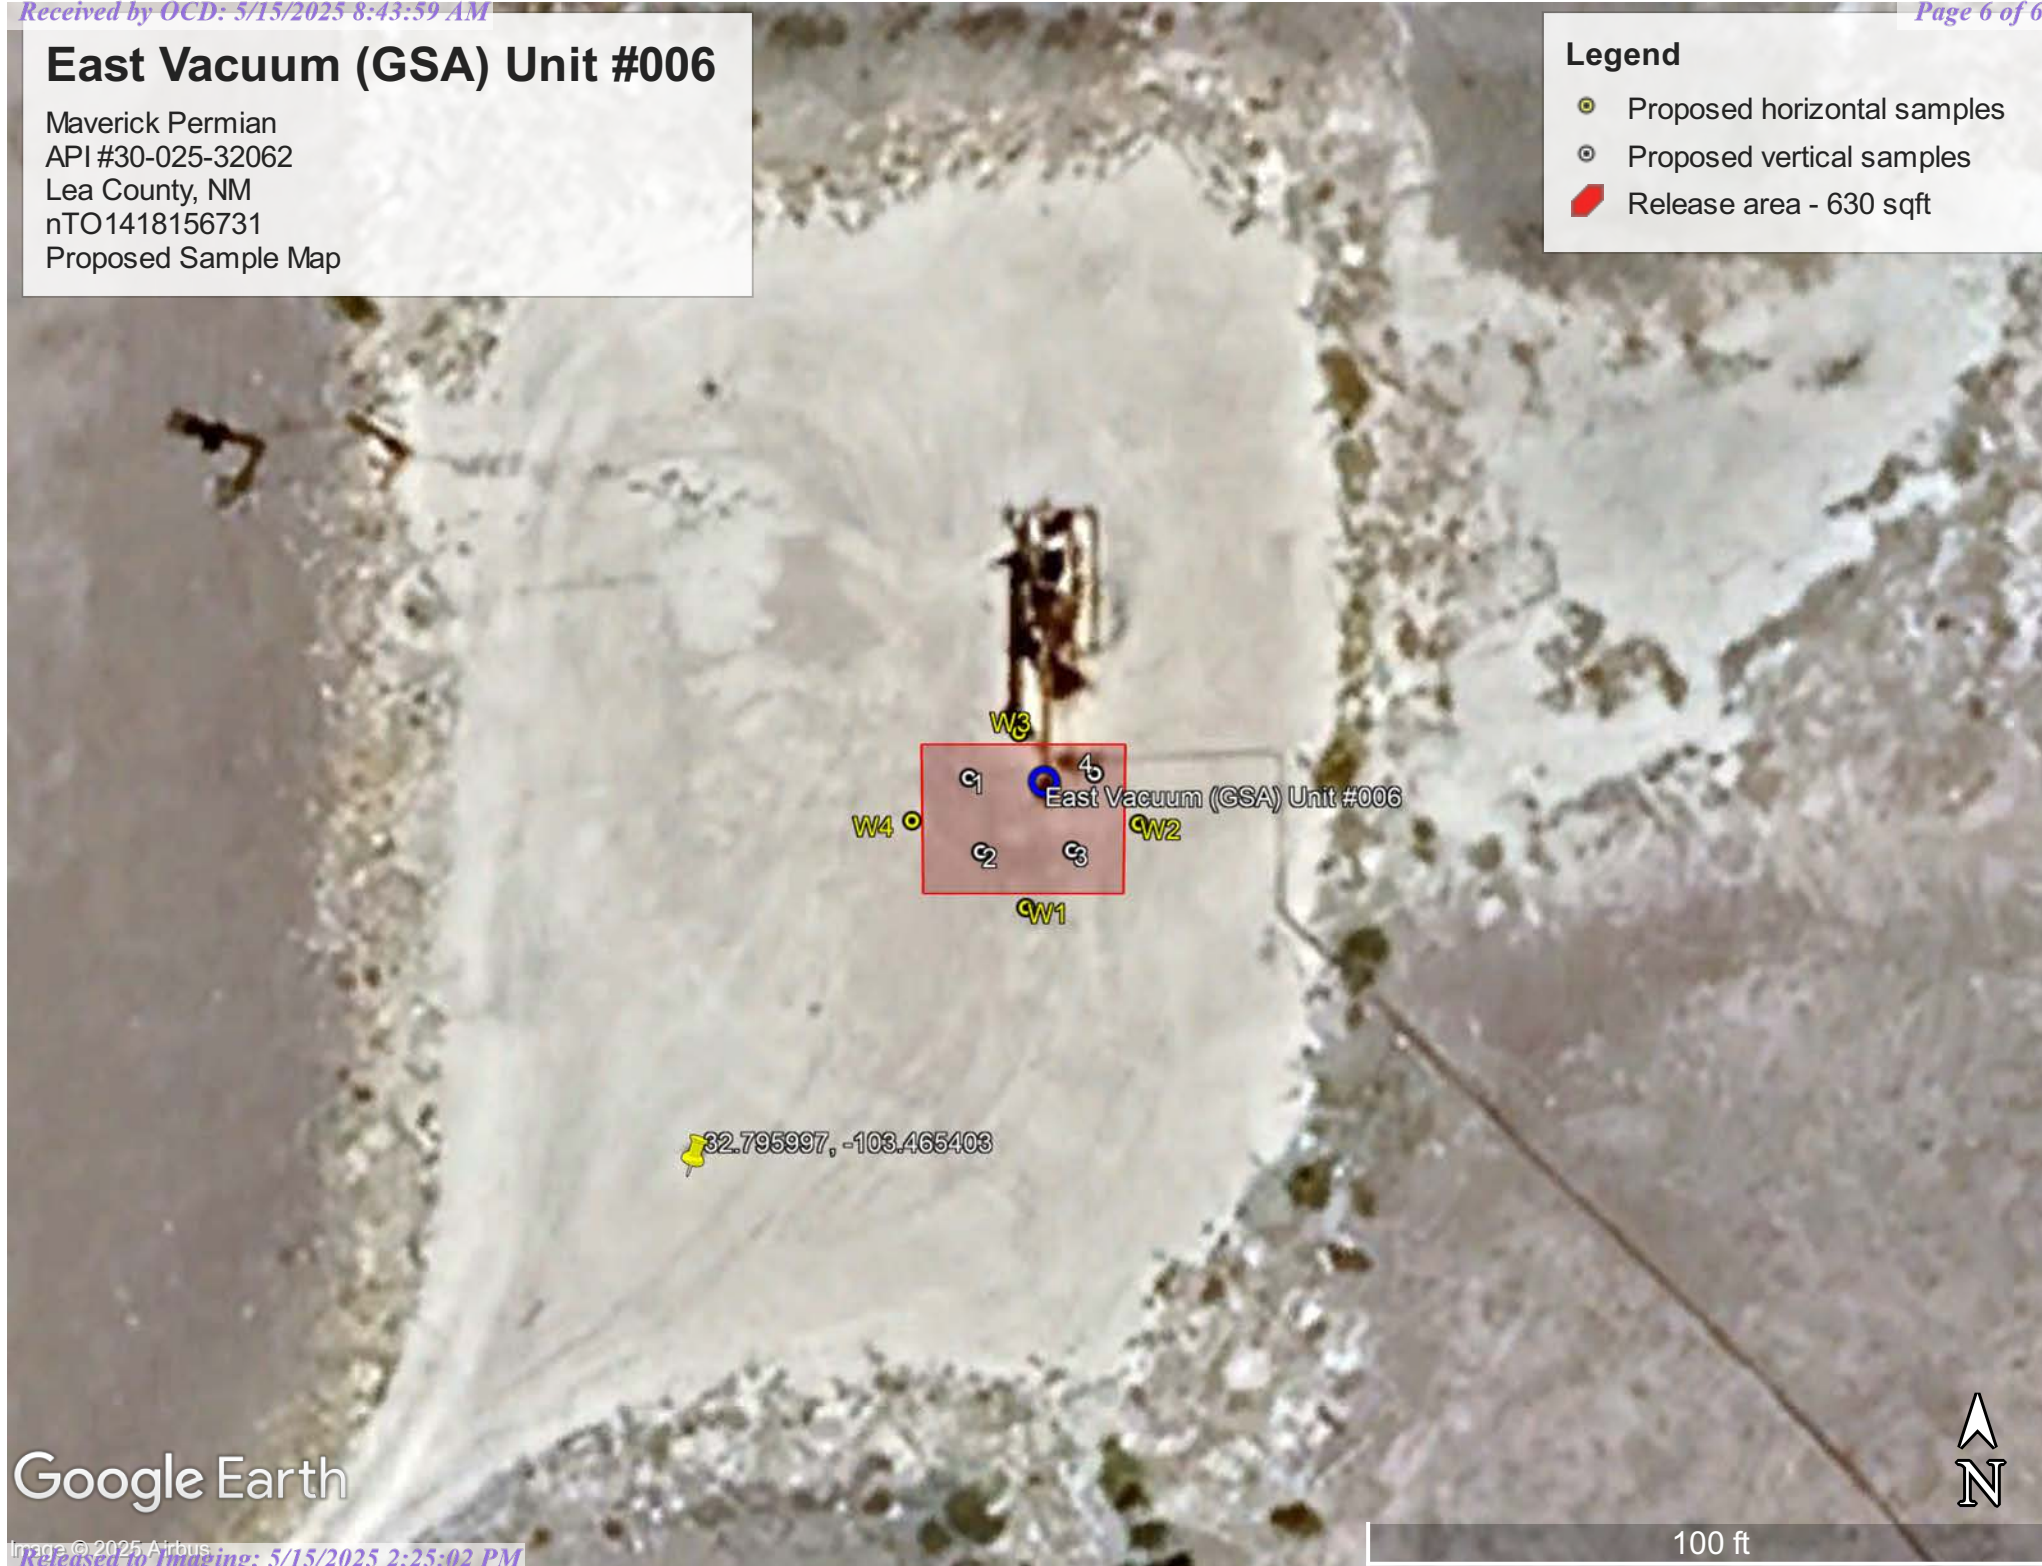
- The area of concern measures approximately 630 square feet and is entirely on the pad surface surrounding the wellhead.
- Collect discrete samples from within and around the edges of the release area to evaluate the presence of contaminants. Twenty (20) samples will be collected from 4 different sample points within the release area from depths of surface, 1', 2', 3', and 4' bgs. Twenty (20) samples will be collected from 4 different sample points around the edges of the release area from depths of surface, 1', 2', 3', and 4' bgs.

- A 48-hour sampling notification will be issued to the NMOCD for these sampling events. A variance request is included below for permission to use the delineation samples as confirmation samples depending on the sample results of the soil. A Proposed Sample Map referencing the release area and the previously remediated area can be found in Figure 1.

- Proposed horizontal samples
- Proposed vertical samples
- Release area - 630 sqft

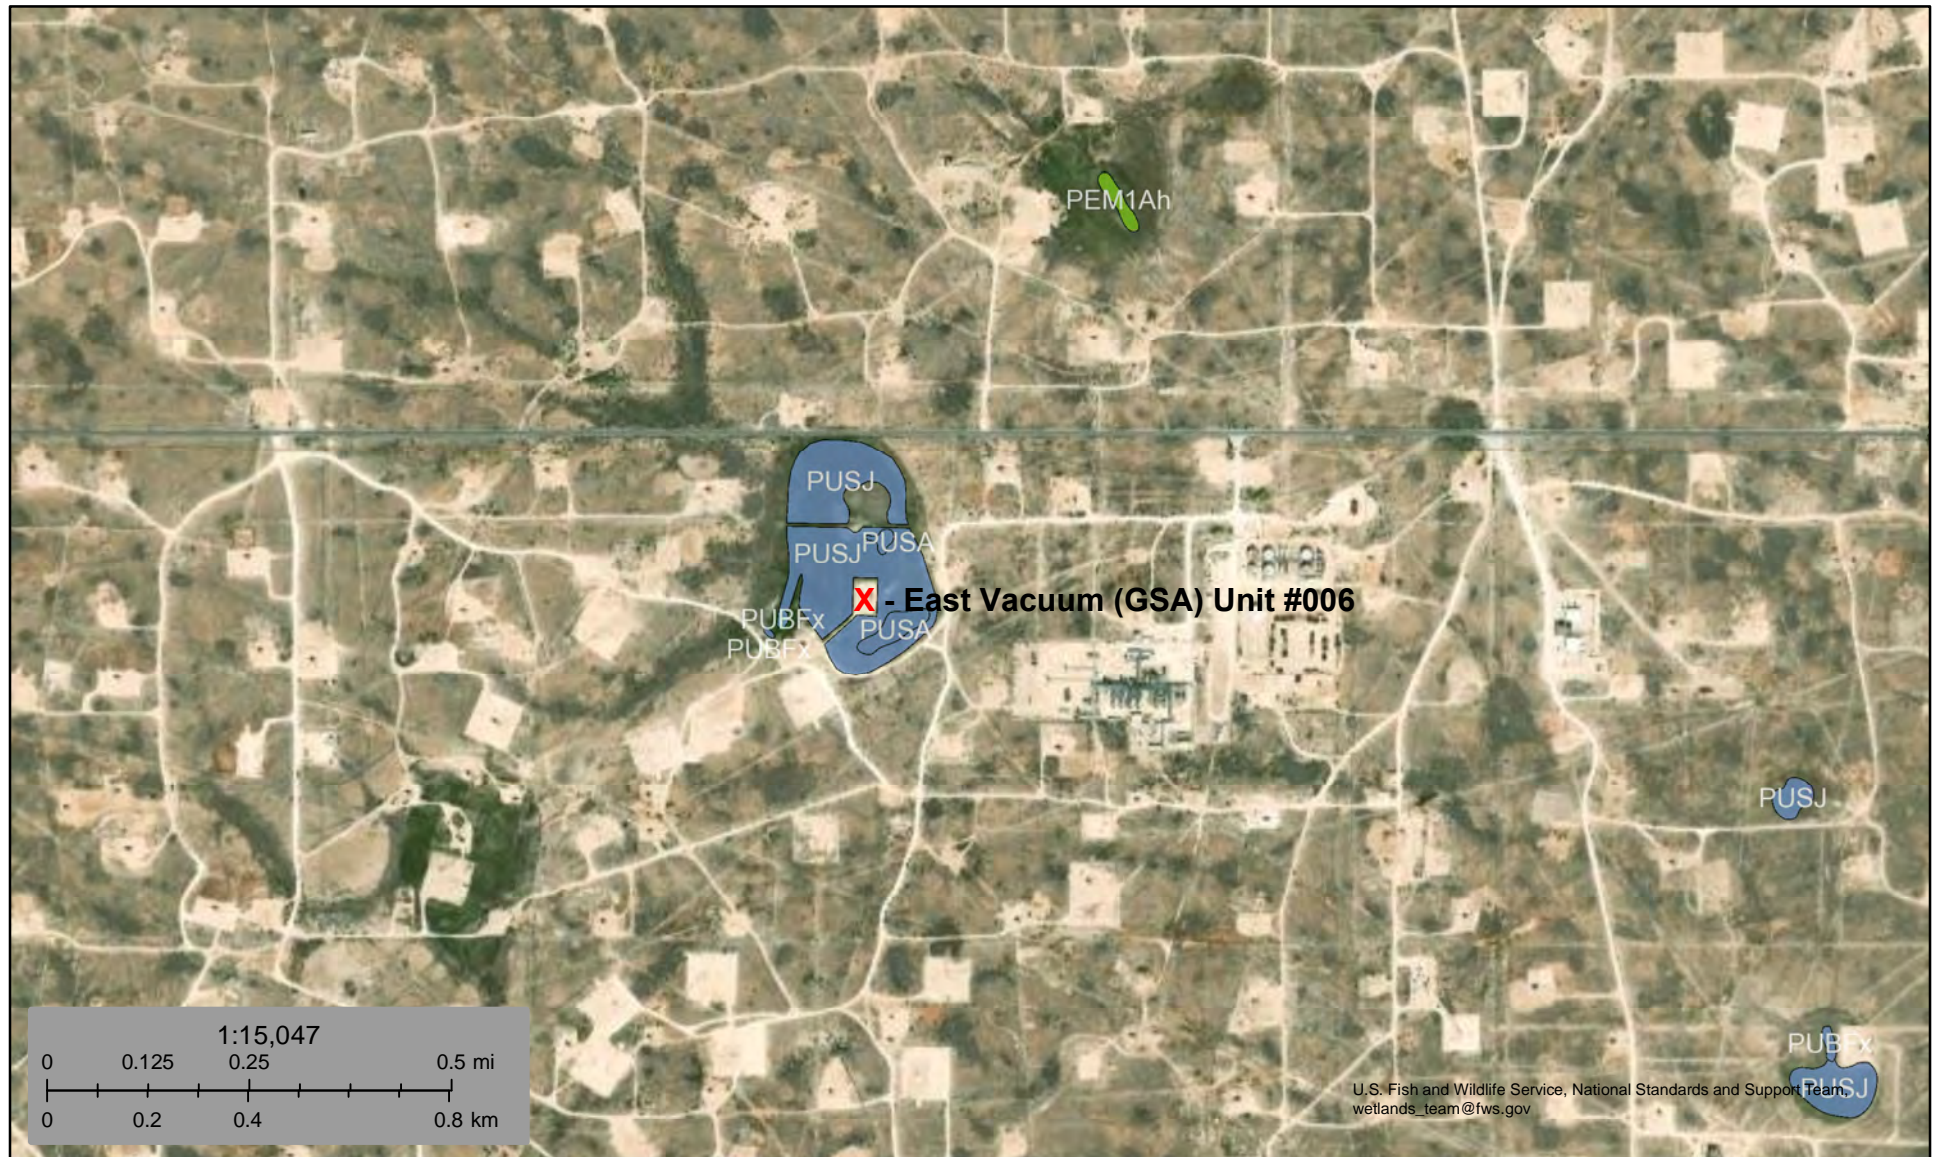
Wetlands Map

Wetlands

The nearest surface water feature is an Unnamed Pond, and it is located approximately 2.43 miles to the northwest. The U.S. Fish and Wildlife Service National Wetlands Inventory shows the Site to be surrounded on all sides by a Freshwater Pond. According to Fema's National Flood Hazard Layer search, the Site is situated in Zone D - Area of Undetermined Flood Hazard and is greater than 5 miles away from the nearest flood hazard zone. See Appendix B for referenced Water Surveys and Water-Related Maps.

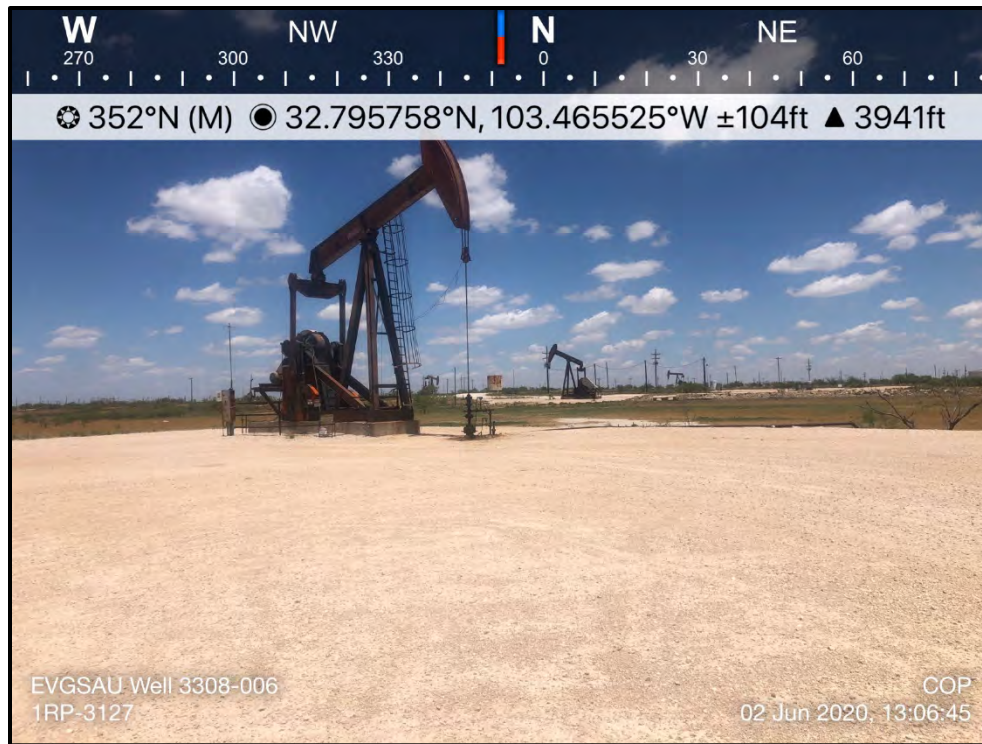
TETRA TECH, INC. PROJECT NO. 212C-MD-02152	DESCRIPTION	View facing north of well pad.	1
	SITE NAME	EVGSAU Well 3308-006 Wellhead Release	6/2/2020

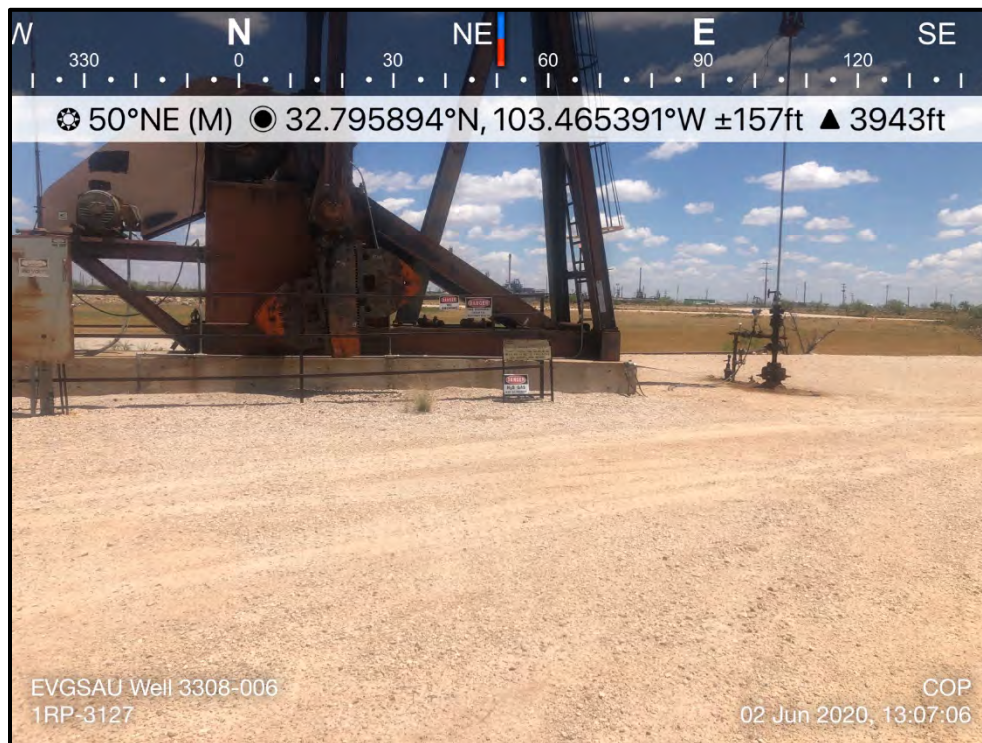
TETRA TECH, INC. PROJECT NO. 212C-MD-02152	DESCRIPTION	View facing northwest of wellhead and equipment.	2
	SITE NAME	EVGSAU Well 3308-006 Wellhead Release	6/2/2020

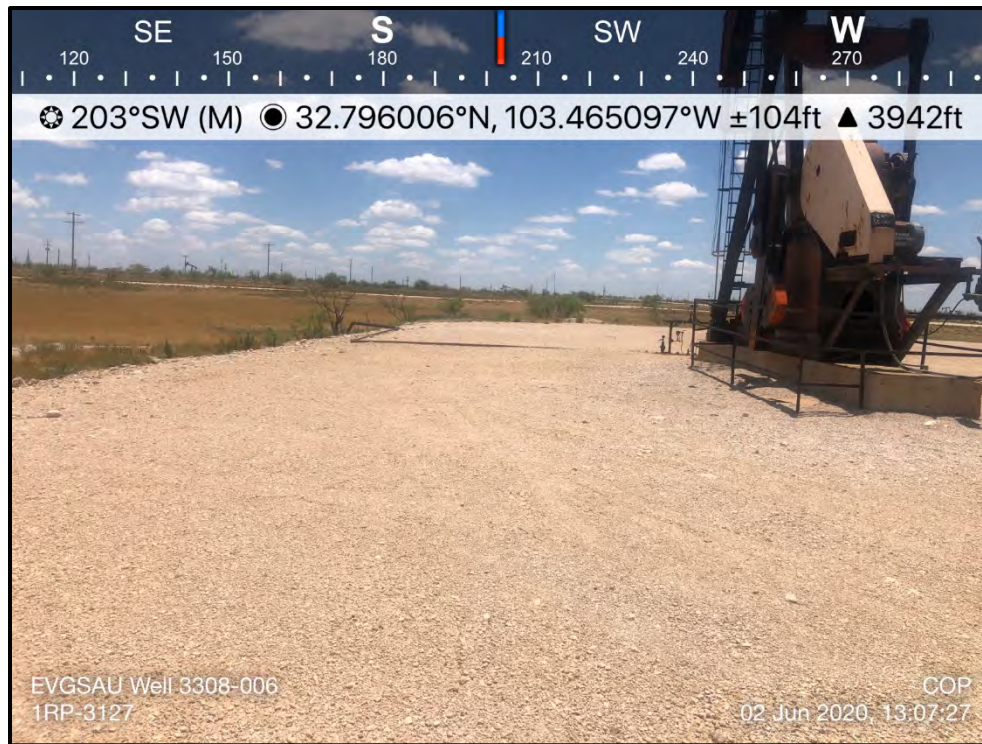
TETRA TECH, INC. PROJECT NO. 212C-MD-02152	DESCRIPTION	View facing south of well pad and pipeline from wellhead.	3
	SITE NAME	EVGSAU Well 3308-006 Wellhead Release	6/2/2020

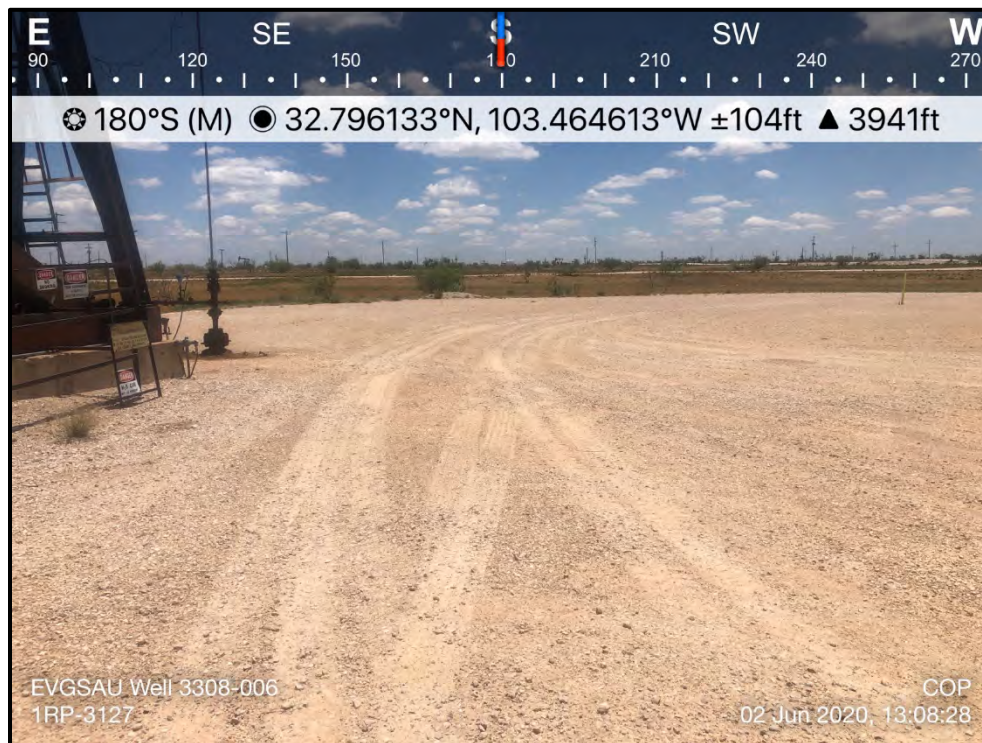
TETRA TECH, INC. PROJECT NO. 212C-MD-02152	DESCRIPTION	View facing south of well pad and wellhead.	4
	SITE NAME	EVGSAU Well 3308-006 Wellhead Release	6/2/2020
