May 13, 2025

**Re: Closure Request Addendum
James Ranch Unit #091
Incident Number NAB1515234386
Eddy County, New Mexico**

XTO Energy, Inc
Closure Request Addendum
James Ranch Unit #091

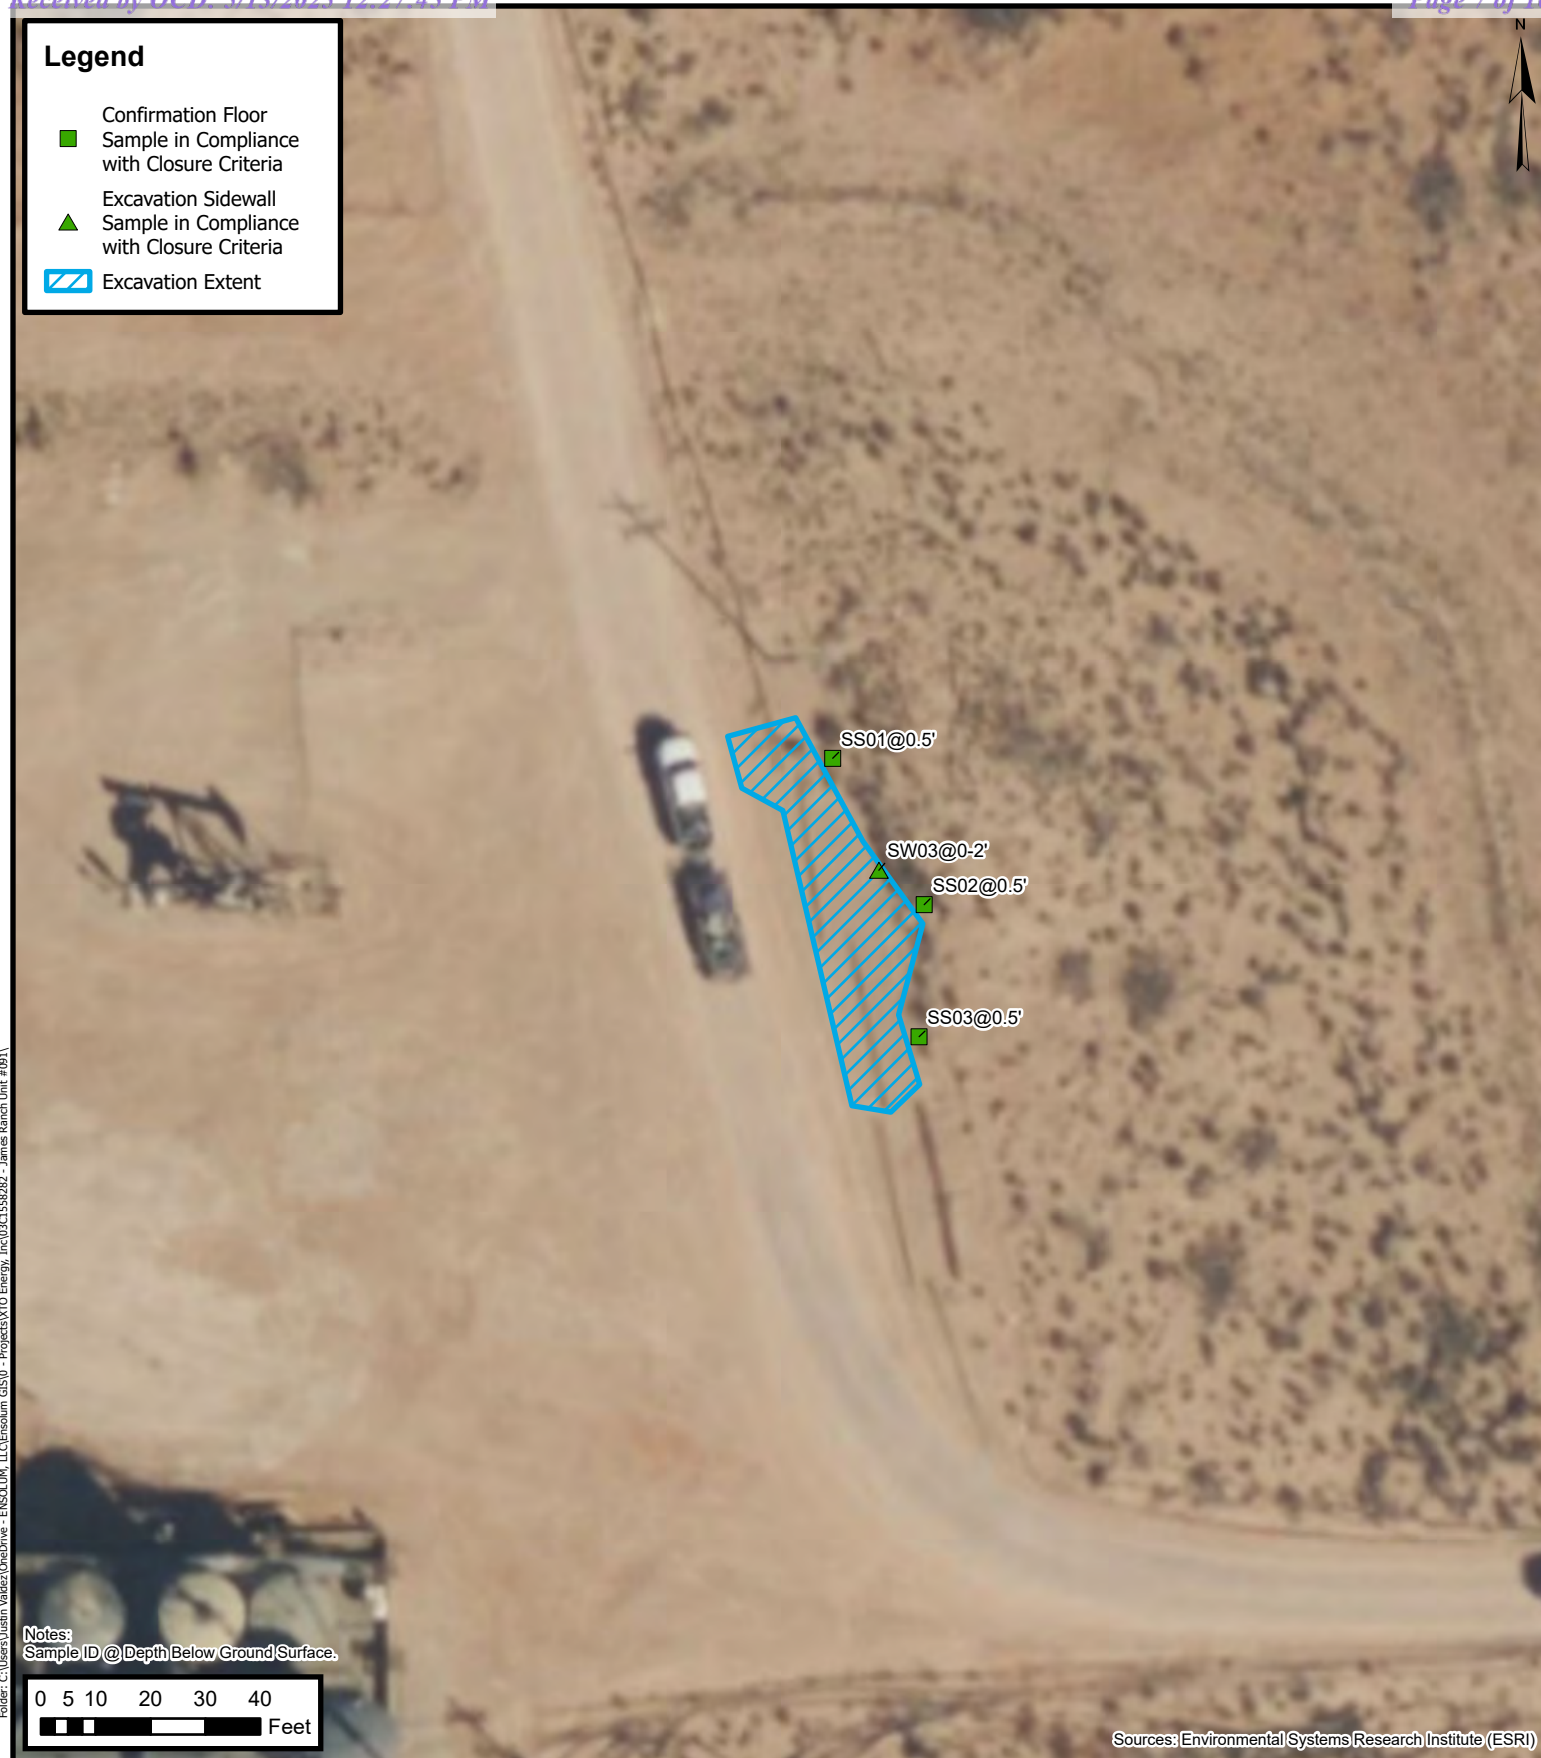
Confirmation Soil Sample Locations

As previously reported, the excavation area measured approximately 575 square feet. The impacted soil was transported and properly disposed of at the Lea Land landfill facility in Hobbs, New Mexico. A total of 40 cubic yards of impacted soil were removed from the Site. The excavation has been backfilled with material purchased locally and the Site has been recontoured to match pre-existing site conditions.

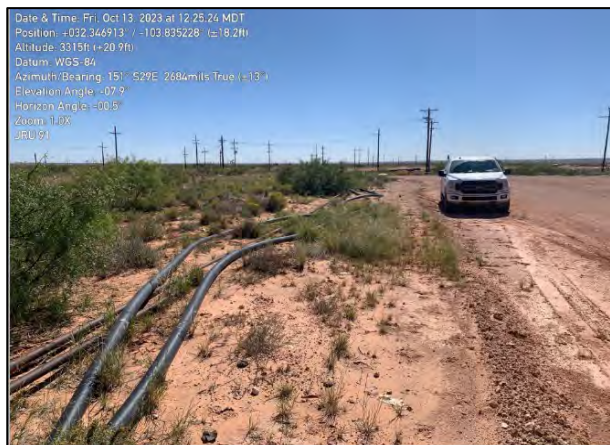
Photograph: 1 Date: 10/13/2023
Description: Site Assessment
View: South

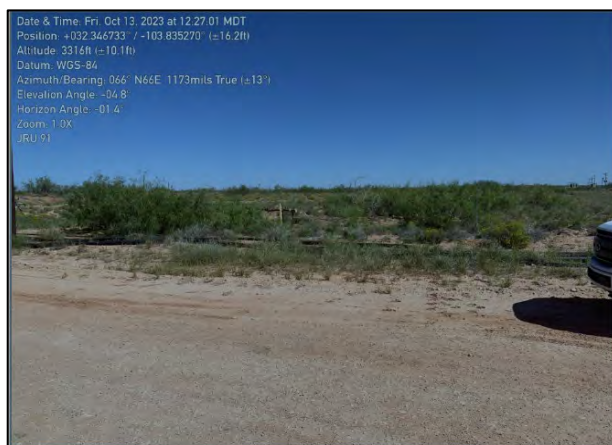
Photograph: 2 Date: 10/13/2023
Description: Site Assessment
View: East

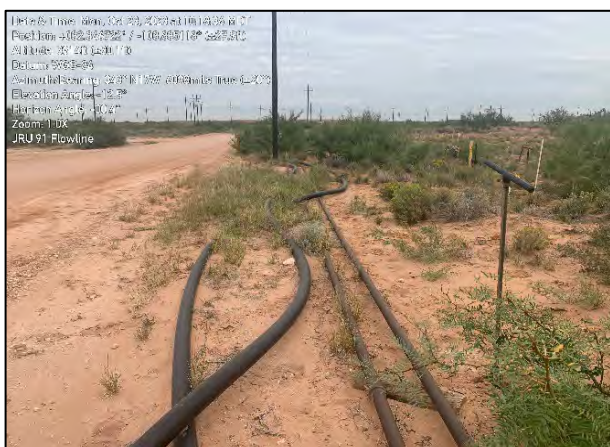
Photograph: 3 Date: 10/23/2023
Description: Sampling activities
View: North

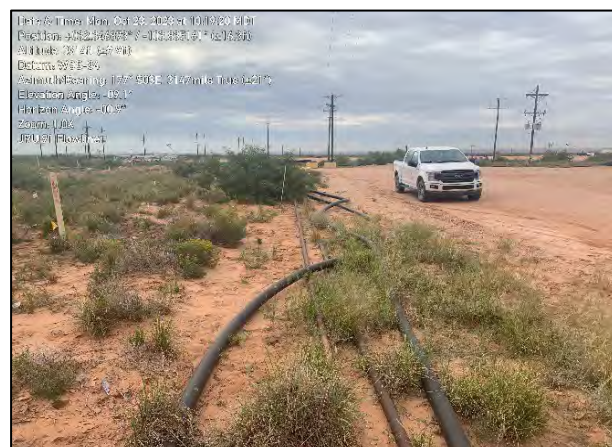
Photograph: 4 Date: 10/23/2023
Description: Sampling activities
View: South

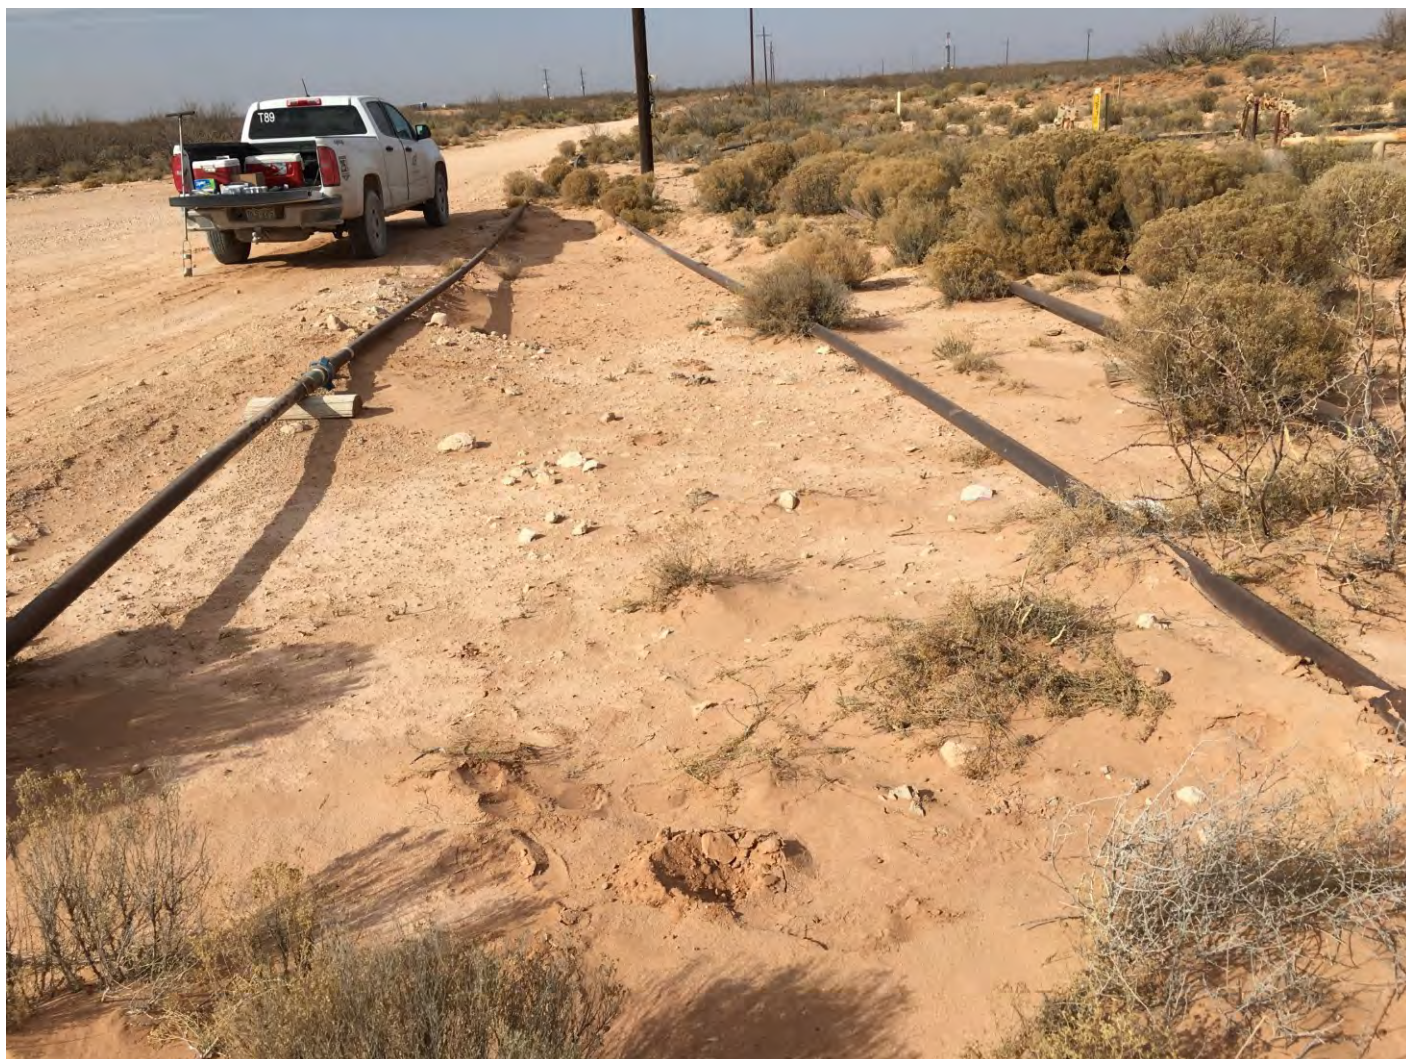
Northern view of the release area from the well pad during the site assessment.

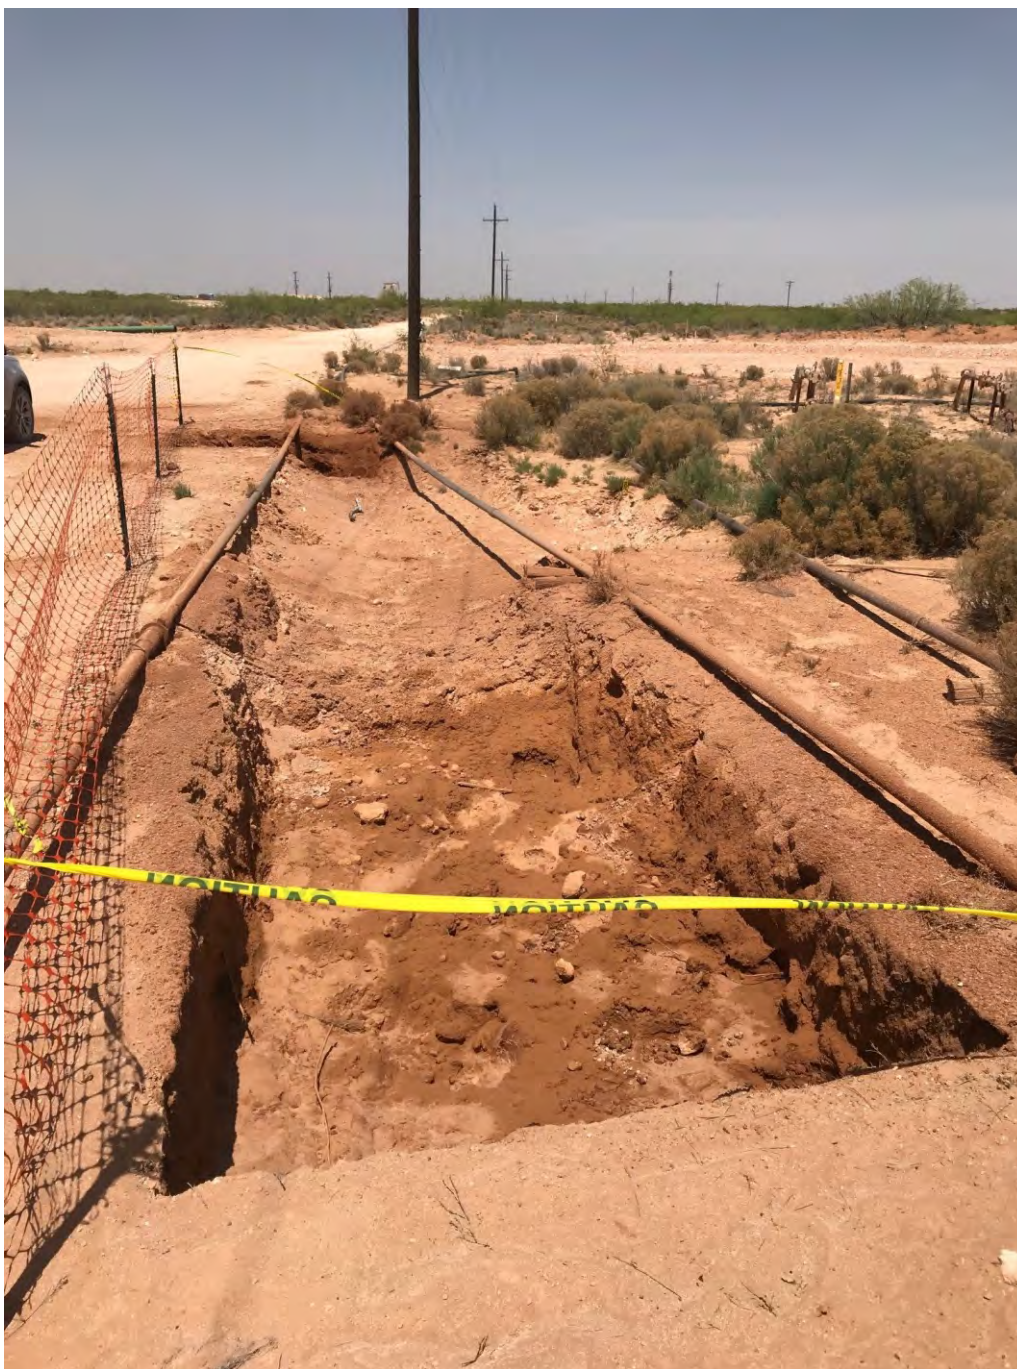
Northern view of the final excavation extent during confirmation sampling activities.
