Environmental Site Remediation Work Plan

NMOCD District:	District 2 - Artesia	Incident ID:	nJMW1231248032,nJMW1317034502, nAB1516753239
Landowner:	Bureau of Land Management	RP Reference:	2RP-1391, 2RP-1686, 2RP-3051
Client:	Devon Energy Production Company, LP	Site Location:	Todd 24 B Federal #002
Date:	July 4, 2023	Project #:	21E-02816-016
Client Contact:	Dale Woodall	Phone #:	405.318.4697
Vertex PM:	Kent Stallings	Phone #:	346.814.1413

The objective of the Environmental Site Remediation Work Plan is to identify areas of exceedance for constituents of concern delineated during spill assessment and site characterization activities, and propose appropriate remediation techniques to address the open release at Todd 24 B Federal #002 (hereafter referred to as "Todd 24"). This incident is composed of three separate incidents. The most recent occurred when a transfer pump failure resulted in the release of approximately 80 barrels (bbl) of produced water inside the unlined, earthen containment on the pad. Upon discovery, a hydrovac truck was dispatched to the site to recover free fluids. Approximately 75 bbl of oil were recovered and removed for disposal off-site. The second incident o

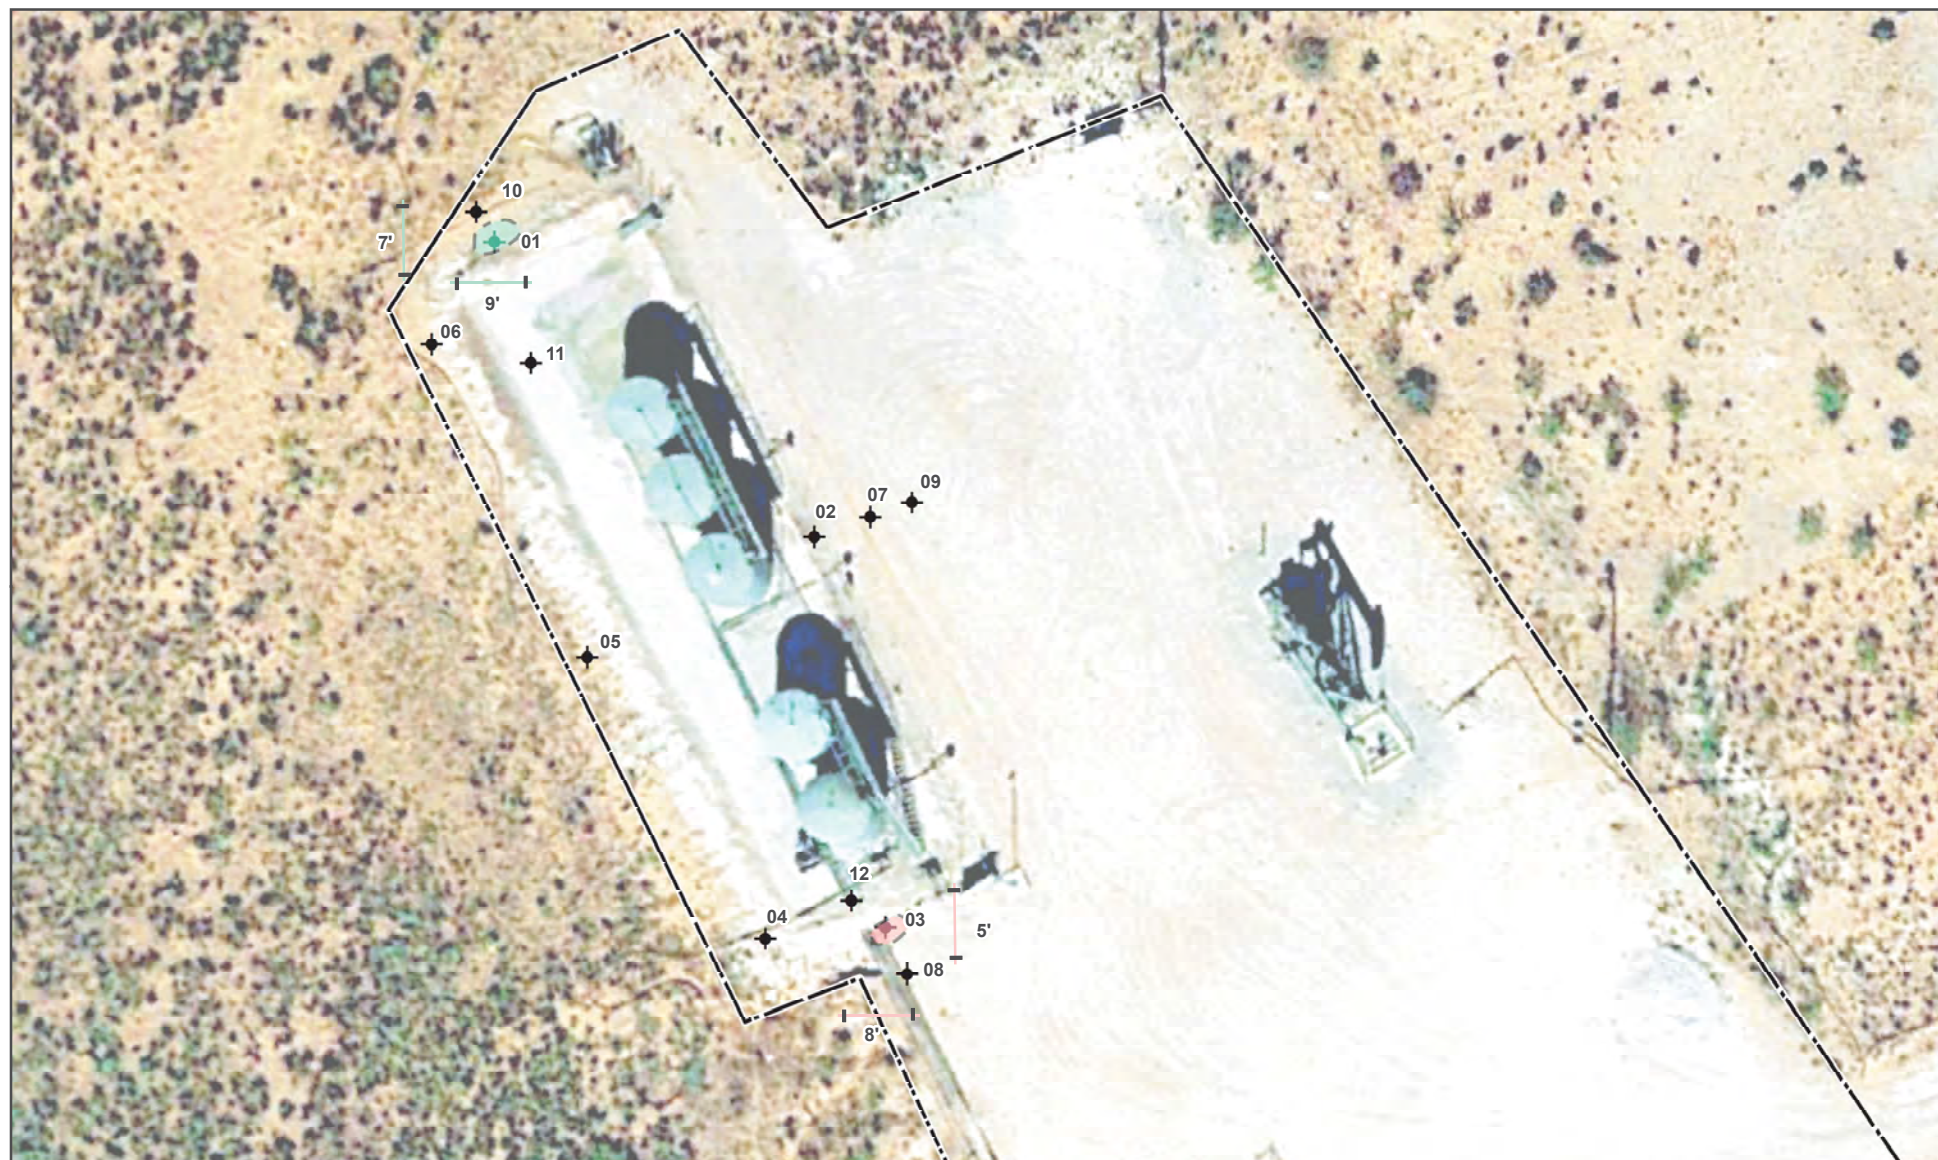
ATTACHMENT 1

◆ Borehole (Prefixed by "BH22-")
 [Dashed Line] Approximate Lease Boundary
 [Green Shaded Area] Remaining Area of Impact - North (~52 sq.ft)
 [Red Shaded Area] Remaining Area of Impact - South (~35 sq.ft.)

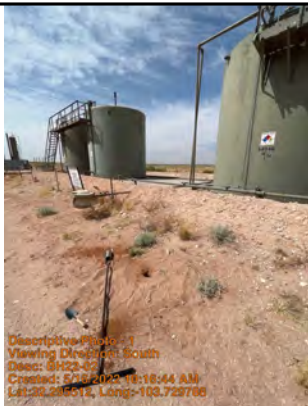
Viewing Direction: South

BH22-02

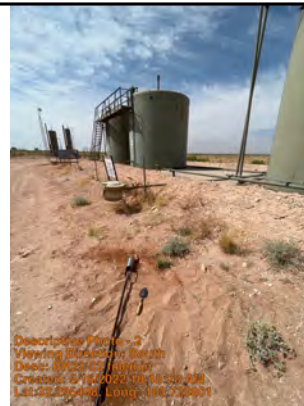
Viewing Direction: South

BH22-02 filled in

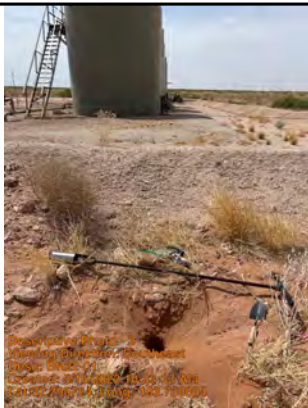
Viewing Direction: Southeast

BH22-01

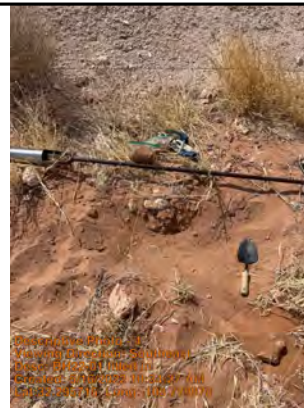
Viewing Direction: Southeast

BH22-01 filled in

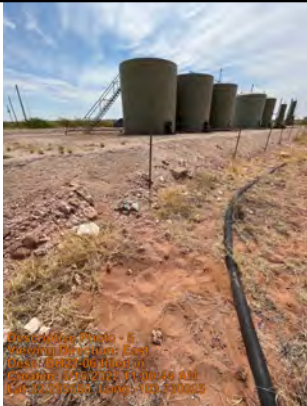
<p> <small> Description Photo - 5 Viewing Direction: East Date: 5/16/2022 Location: 33°19'25" N 103°00'44" W Lat: 33.323611, Long: -103.012500 </small> </p>	<p>Viewing Direction: Northeast</p>

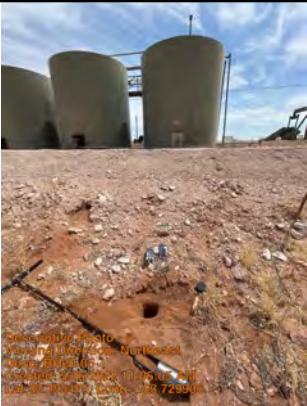
<p> <small> Description Photo - 6 Viewing Direction: Northeast Date: 5/16/2022 Location: 33°19'25" N 102°59'45" W Lat: 33.323611, Long: -102.995833 </small> </p>
BH22-06 filled in	BH22-05
<p>Viewing Direction: Northeast</p>

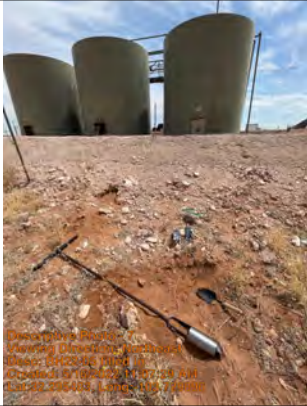
<p> <small> Description Photo - 7 Viewing Direction: Northeast Date: 5/16/2022 Location: 33°19'25" N 102°59'45" W Lat: 33.323611, Long: -102.995833 </small> </p>	<p>Viewing Direction: Northeast</p>

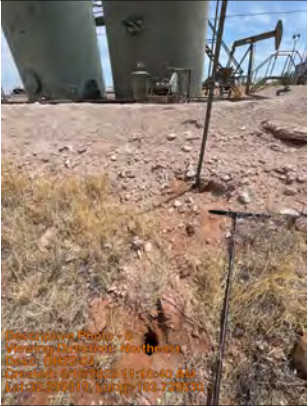
<p> <small> Description Photo - 8 Viewing Direction: Northeast Date: 5/16/2022 Location: 33°19'25" N 102°59'45" W Lat: 33.323611, Long: -102.995833 </small> </p>
BH22-05 filled in	BH22-04

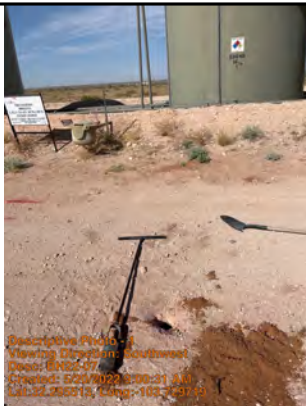
Descriptive Photo - 2
Viewing Direction: Southwest
Date: 5/12/22
Created: 5/22/2022 4:00:21 AM
Lat: 32.295226, Long: -103.728721

BH22-07, stepped out 10' from BH22-02

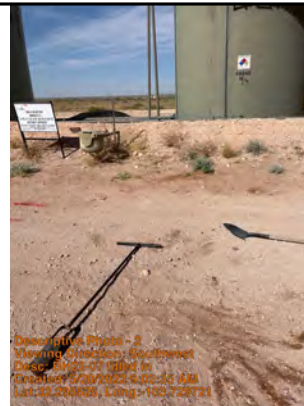
Descriptive Photo - 2
Viewing Direction: Southwest
Date: 5/12/22
Created: 5/22/2022 4:00:40 AM
Lat: 32.295226, Long: -103.728721

BH22-07 filled in

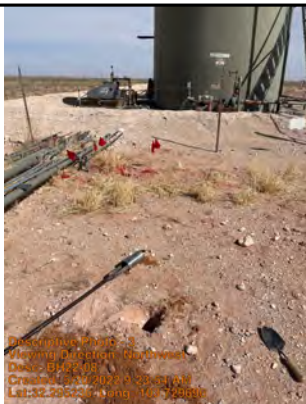
Descriptive Photo - 3
Viewing Direction: Northwest
Date: 5/12/22
Created: 5/22/2022 4:00:40 AM
Lat: 32.295226, Long: -103.728721

BH22-08

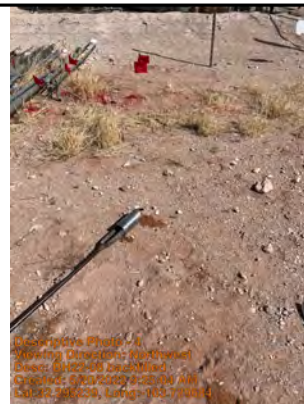
Descriptive Photo - 4
Viewing Direction: Northwest
Date: 5/12/22
Created: 5/22/2022 4:00:40 AM
Lat: 32.295226, Long: -103.728721

BH22-08 backfilled

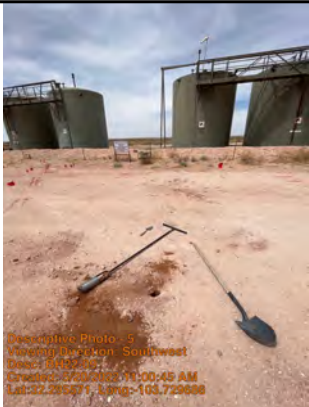
<p>Descriptive Photo #9 Viewing Direction: Southwest Date: 5/20/2022 Created: 5/20/2022 11:00:45 AM Lat: 32.295471, Long: -103.729688</p>

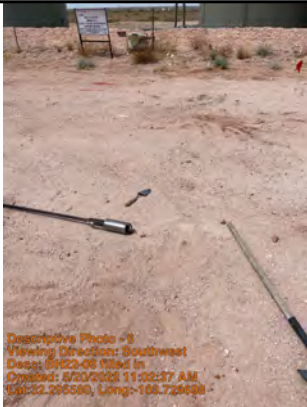
<p>Descriptive Photo #9 Viewing Direction: Southwest Date: 5/22/2022 Filled in Created: 5/20/2022 11:32:57 AM Lat: 32.295580, Long: -103.729688</p>
BH22-09	BH22-09 filled in

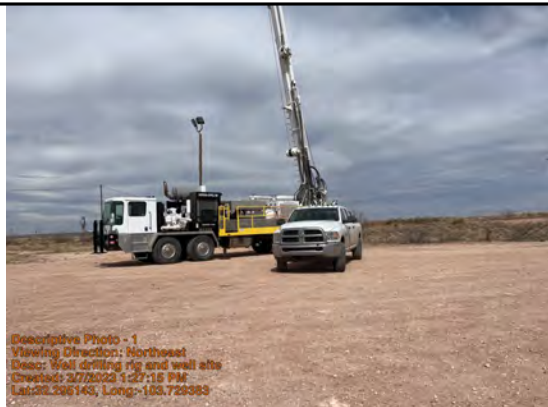
Well drilling rig and well site

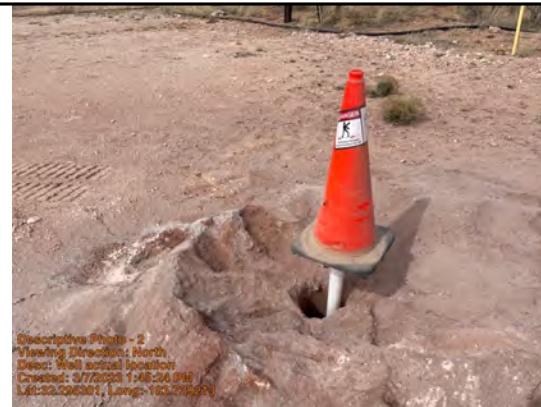
Well actual location

13:56 Well reading at 13:40 PM, 72 hours after drilling and initial measurement occurred, measured with Solinst model 122. Pipe height above ground is 3 foot. Well depth bottom reading at 60 ft and 6 inches with water detected at 59 ft. (Well is 57 ft and 6 inches total depth and 56 ft depth to meter observed ground water).
Coordinates of well location: (32.2953261, -103.7291990)
Well is approximately 36 ft SE of pump jack and 57 ft east of separators' fence at SE corner of pad.

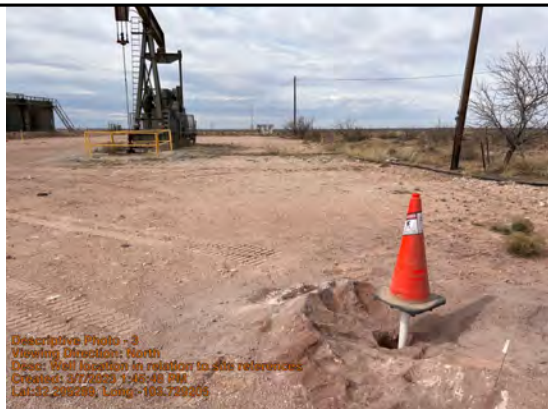
Well location in relation to site references

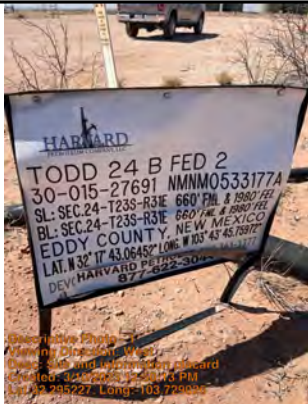
Site and information placard

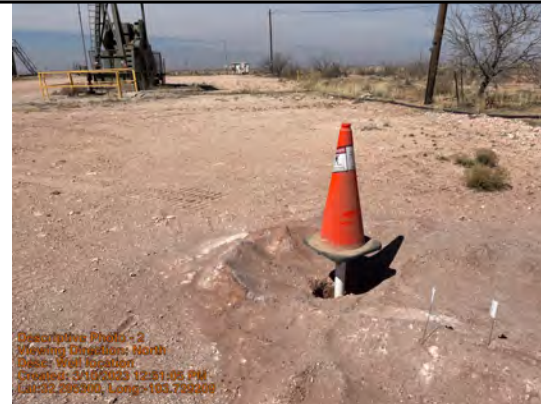
Well location

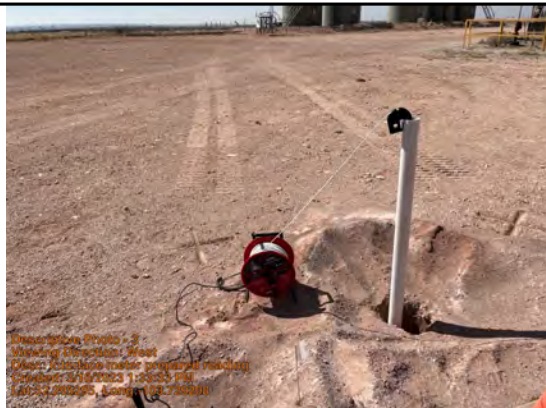
Interface meter prepared reading

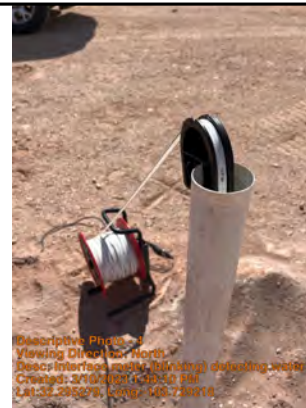
Interface meter (blinking) detecting water at measurement of 59 ft (with pipe)

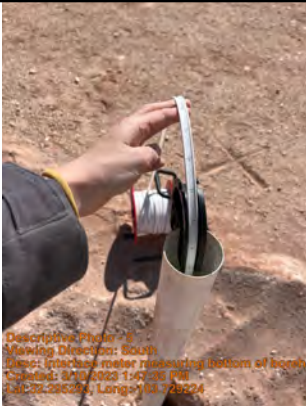
<p>Descriptive Photo #1 Viewing Direction: South Photo: Interface meter measuring bottom of borehole Created: 3/10/2023 1:57:26 PM Lat: 32.285274, Long: -101.726224</p>
Interface meter measuring bottom of borehole at 60.5 (apparently 60 FT and 6 inches)
