Environmental Site Remediation Work Plan

NMOCD District:	District 2 - Artesia	Incident ID:	nJMW1231248032,nJMW1317034502, nAB1516753239
Landowner:	Bureau of Land Management	RP Reference:	2RP-1391, 2RP-1686, 2RP-3051
Client:	Devon Energy Production Company, LP	Site Location:	Todd 24 B Federal #002
Date:	July 4, 2023	Project #:	21E-02816-016
Client Contact:	Dale Woodall	Phone #:	405.318.4697
Vertex PM:	Kent Stallings	Phone #:	346.814.1413

The objective of the Environmental Site Remediation Work Plan is to identify areas of exceedance for constituents of concern delineated during spill assessment and site characterization activities, and propose appropriate remediation techniques to address the open release at Todd 24 B Federal #002 (hereafter referred to as "Todd 24"). This incident is composed of three separate incidents. The most recent occurred when a transfer pump failure resulted in the release of approximately 80 barrels (bbl) of produced water inside the unlined, earthen containment on the pad. Upon discovery, a hydrovac truck was dispatched to the site to recover free fluids. Approximately 75 bbl of oil were recovered and removed for disposal off-site. The second incident o

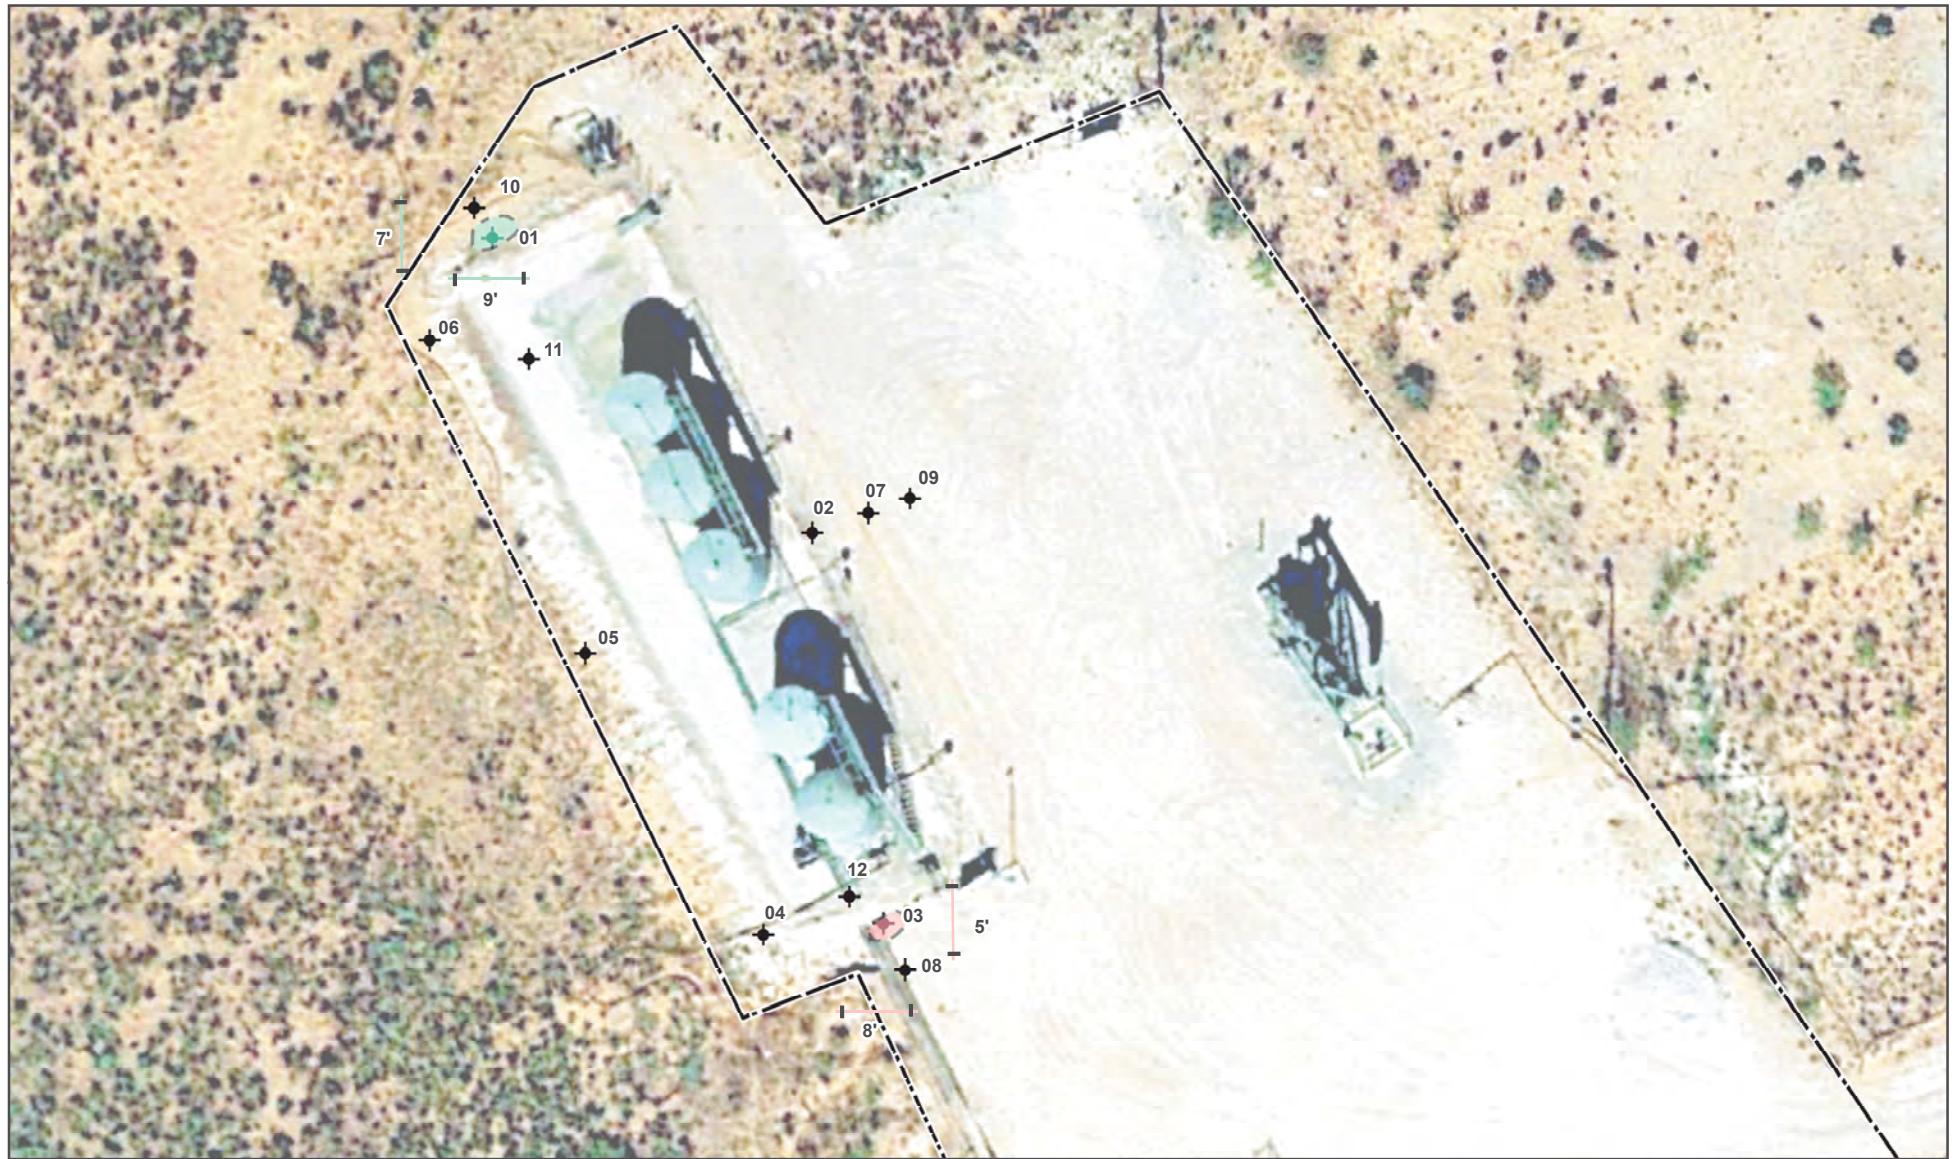
ATTACHMENT 1

◆ Borehole (Prefixed by "BH22-")
 [Dashed Line] Approximate Lease Boundary
 [Green Shaded Area] Remaining Area of Impact - North (~52 sq.ft)
 [Red Shaded Area] Remaining Area of Impact - South (~35 sq.ft.)

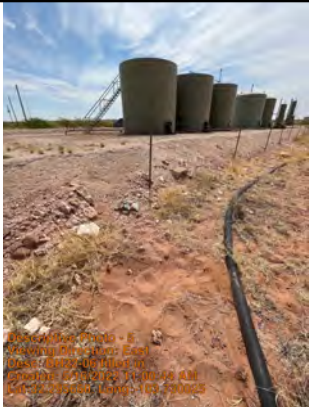
<p> <small> Description Photo - 5 Viewing Direction: East Date: 5/16/2022 11:00:44 AM Location: 33°12'52.71"N 103°00'44.40"W Lat: 33.2146416, Long: -103.0123333 </small> </p> <p>BH22-06 filled in</p>	<p>Viewing Direction: Northeast</p>

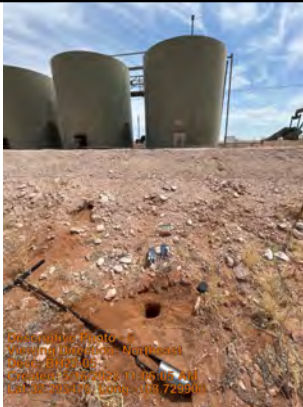
<p> <small> Description Photo - 5 Viewing Direction: Northeast Date: 5/16/2022 Location: 33°12'52.71"N 103°00'44.40"W Lat: 33.2146416, Long: -103.0123333 </small> </p> <p>BH22-05</p>
<p>Viewing Direction: Northeast</p>

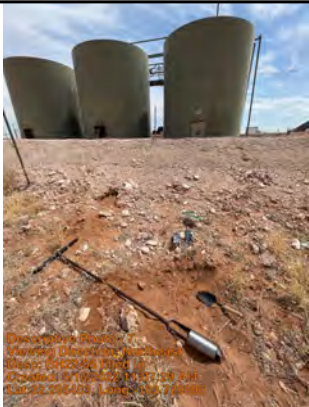
<p> <small> Description Photo - 5 Viewing Direction: Northeast Date: 5/16/2022 Location: 33°12'52.71"N 103°00'44.40"W Lat: 33.2146416, Long: -103.0123333 </small> </p> <p>BH22-05 filled in</p>	<p>Viewing Direction: Northeast</p>

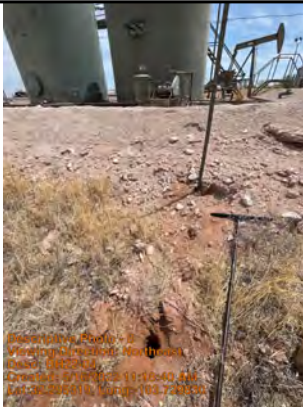
<p> <small> Description Photo - 5 Viewing Direction: Northeast Date: 5/16/2022 Location: 33°12'52.71"N 103°00'44.40"W Lat: 33.2146416, Long: -103.0123333 </small> </p> <p>BH22-04</p>

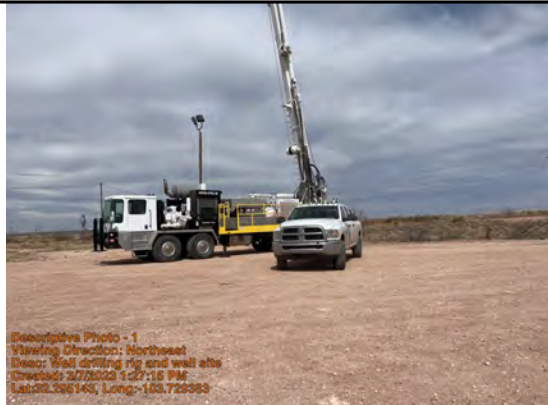
Well drilling rig and well site

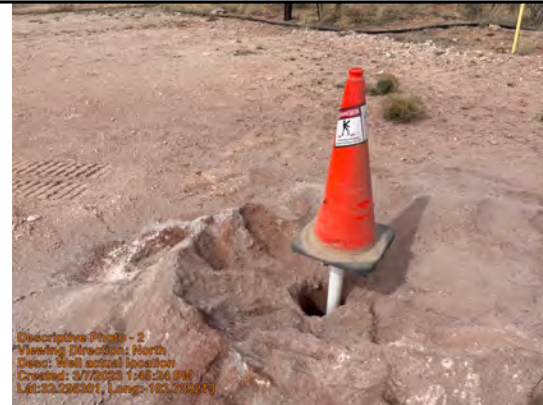
Well actual location

13:56 Well reading at 13:40 PM, 72 hours after drilling and initial measurement occurred, measured with Solinst model 122. Pipe height above ground is 3 foot. Well depth bottom reading at 60 ft and 6 inches with water detected at 59 ft. (Well is 57 ft and 6 inches total depth and 56 ft depth to meter observed ground water).
Coordinates of well location: (32.2953261, -103.7291990)
Well is approximately 36 ft SE of pump jack and 57 ft east of separators' fence at SE corner of pad.

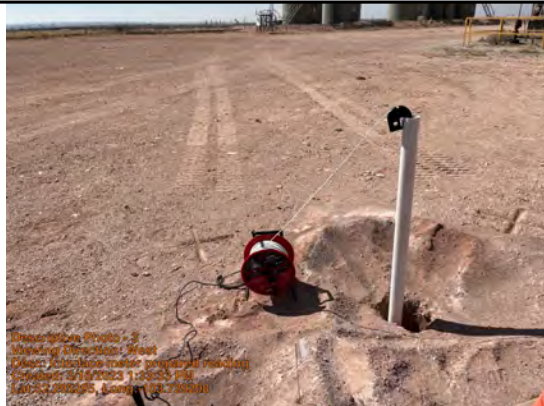
Interface meter prepared reading
