***** LIQUID SPILLS - VOLUME CALCULATIONS *****						
Location of spill:		NORTH VACUUM ABO UNIT #252 (32.83777, -103.52610)			Date of Spill: 2/9/2022	
Estimated Daily Production Loss:		2 BBL Oil 49 BBL Water			Site Soil Type: PS — Portales-Stegall loams	
Total Area Calculations						
Total Surface Area	width		length		wet soil depth	oil (%)
Rectangle Area #1	50.0 ft	X	165.0 ft	X	0.1 in	100%
Rectangle Area #2	ft	X	ft	X	in	0%
Rectangle Area #3	ft	X	ft	X	in	0%
Rectangle Area #4	ft	X	ft	X	in	0%
Rectangle Area #5	ft	X	ft	X	in	0%
Rectangle Area #6	ft	X	ft	X	in	0%
Rectangle Area #7	ft	X	ft	X	in	0%
Rectangle Area #8	ft	X	ft	X	in	0%
Porosity _____ 0.250 gal per gal						
Saturated Soil Volume Calculations:						
		<u>H2O</u>		<u>OIL</u>		
Area #1	8,250 sq. ft.	cu. ft.		34	cu. ft.	
Area #2	0 sq. ft.	cu. ft.			cu. ft.	
Area #3	0 sq. ft.	cu. ft.			cu. ft.	
Area #4	0 sq. ft.	cu. ft.			cu. ft.	
Area #5	0 sq. ft.	cu. ft.			cu. ft.

On 02/10/2022, Cross Timbers Energy, LLC reported a release at the North Vacuum Abo Unit #252. The release was caused when a 3” steel flowline vic clamp busted. Approximately 8,181 sqft. of the Pasture was found to be affected by the release.

Site Location Map
Cross Ti

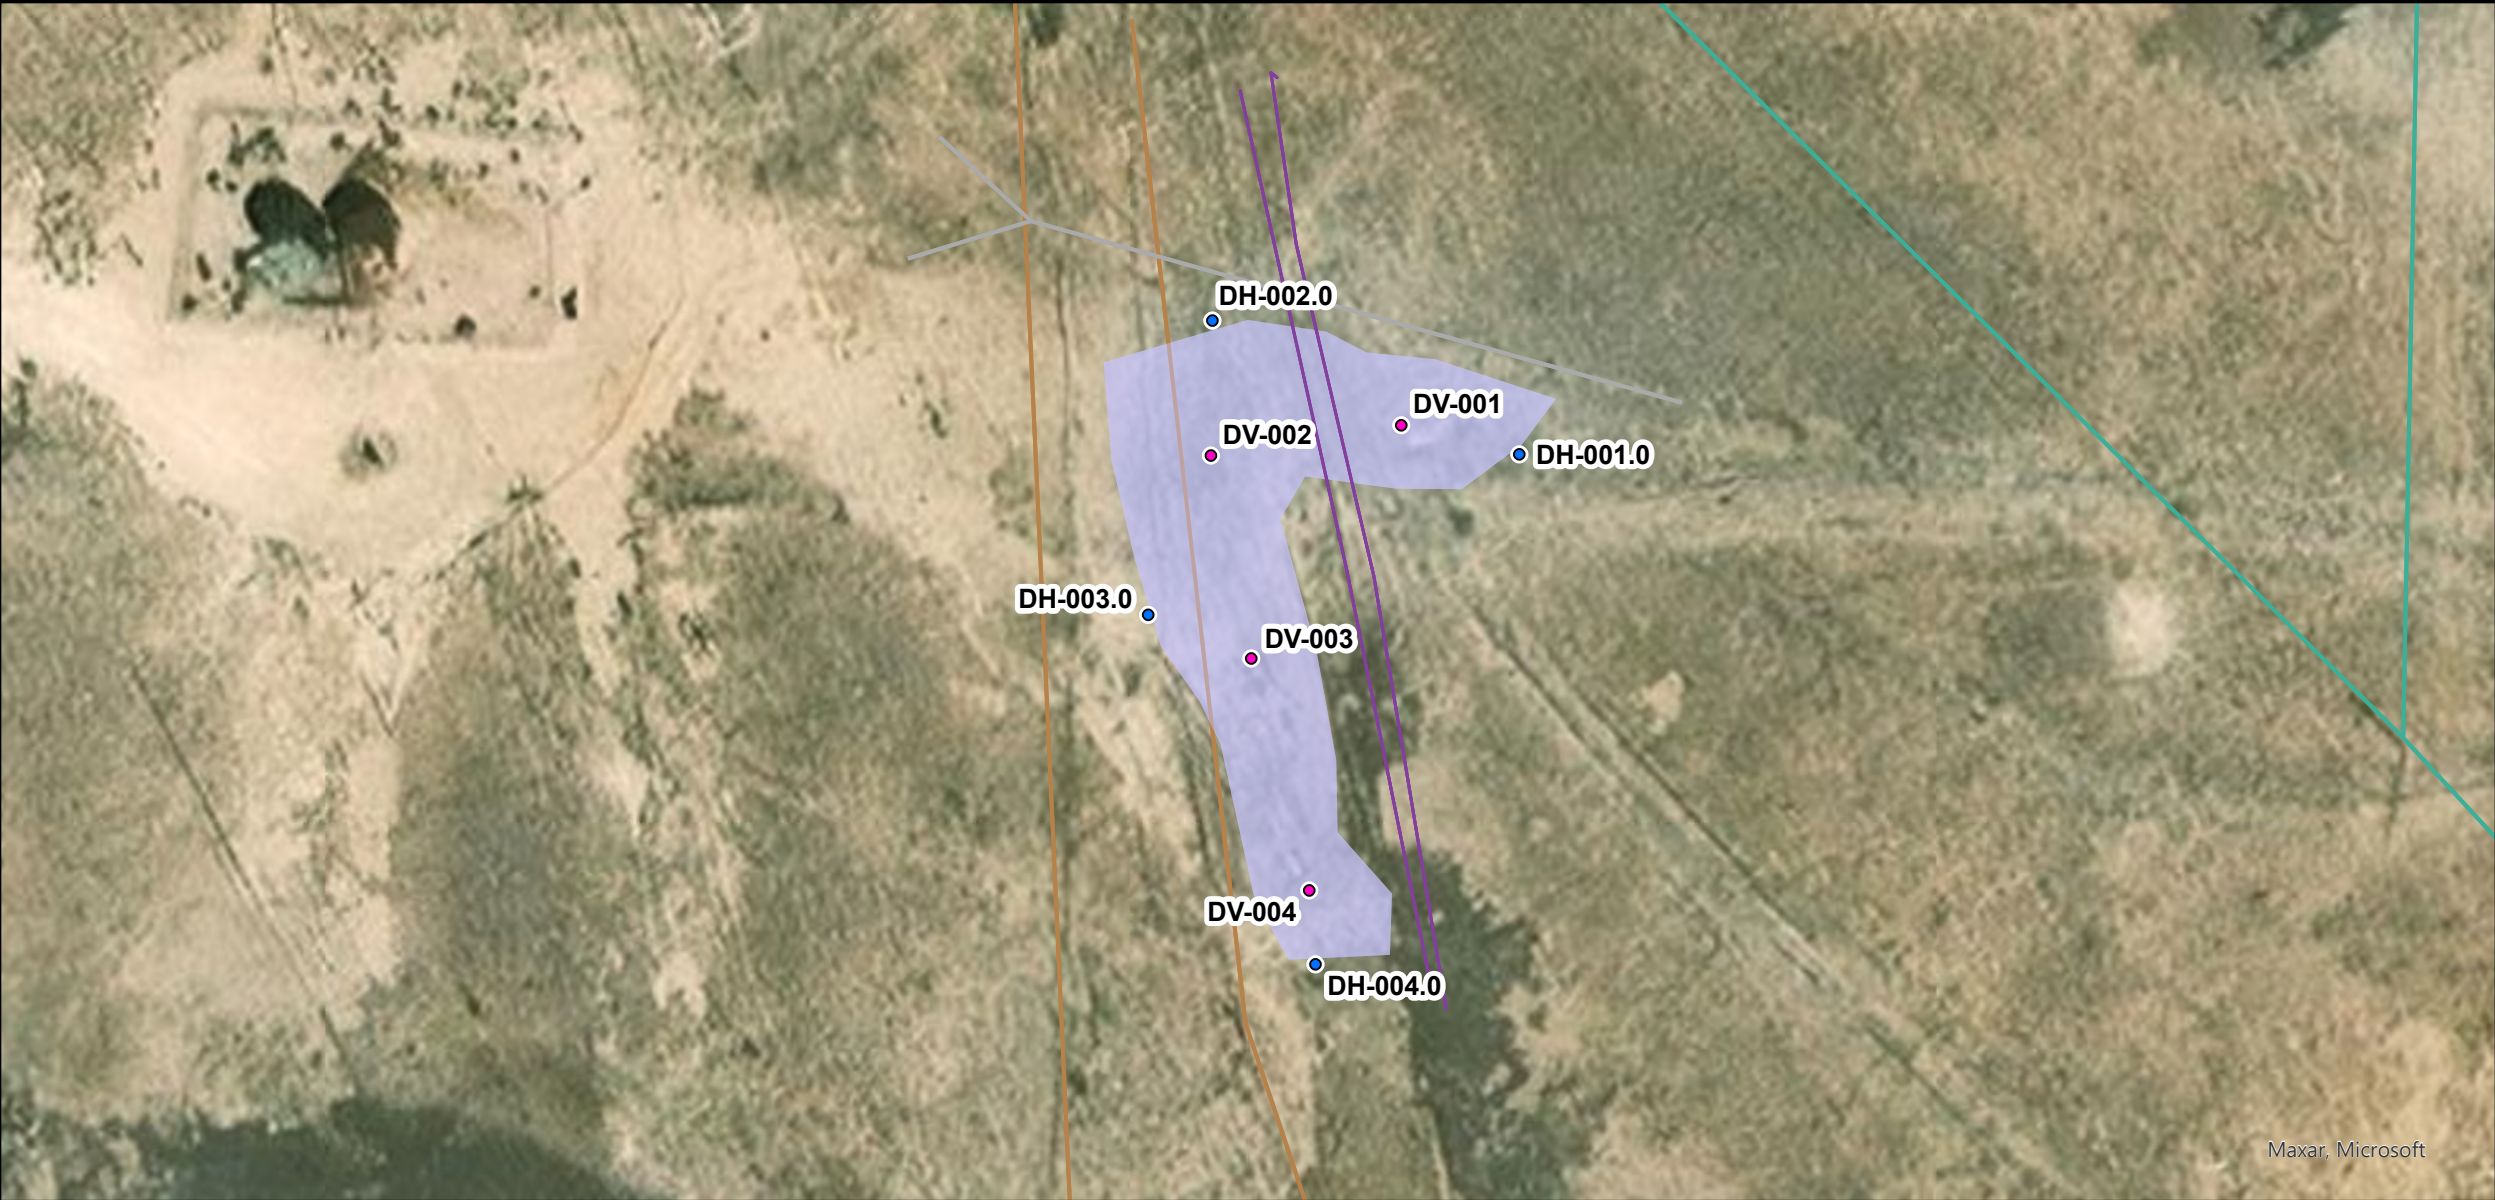
● Vertical Delineation	Above-Ground Lines
● Horizontal Delineation	— Poly
 Release Area	— Powerline
	— Other

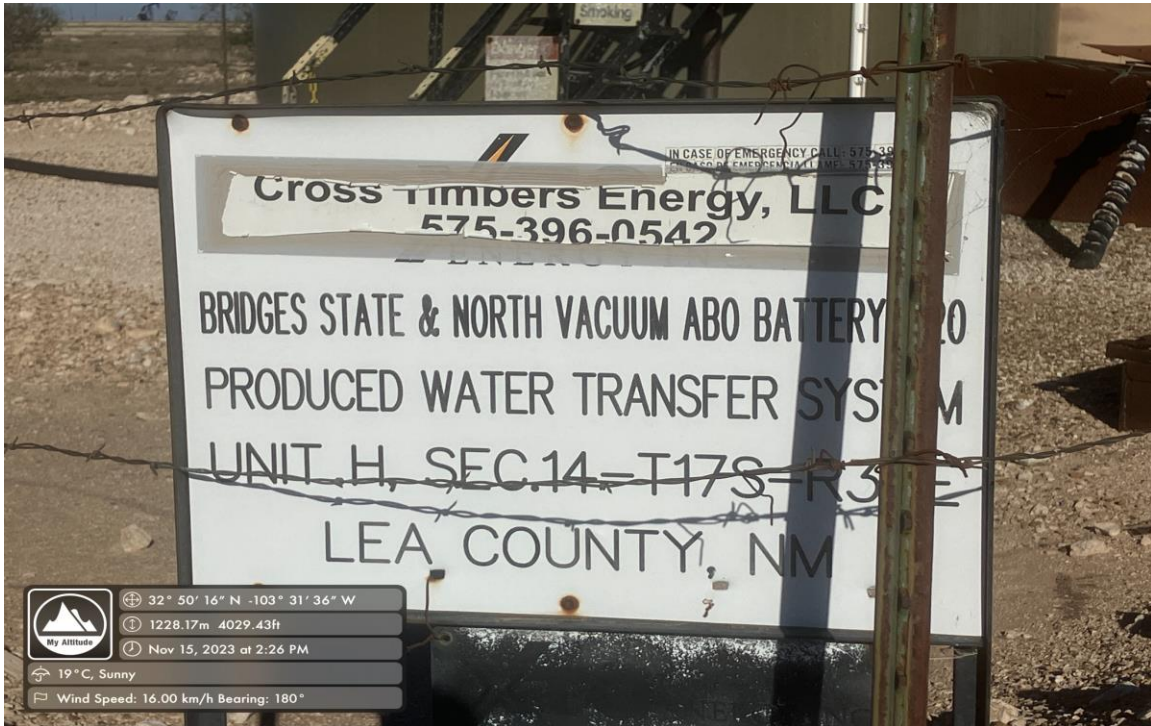
Photo 1: North Vacuum ABO 120 Battery Well Sign

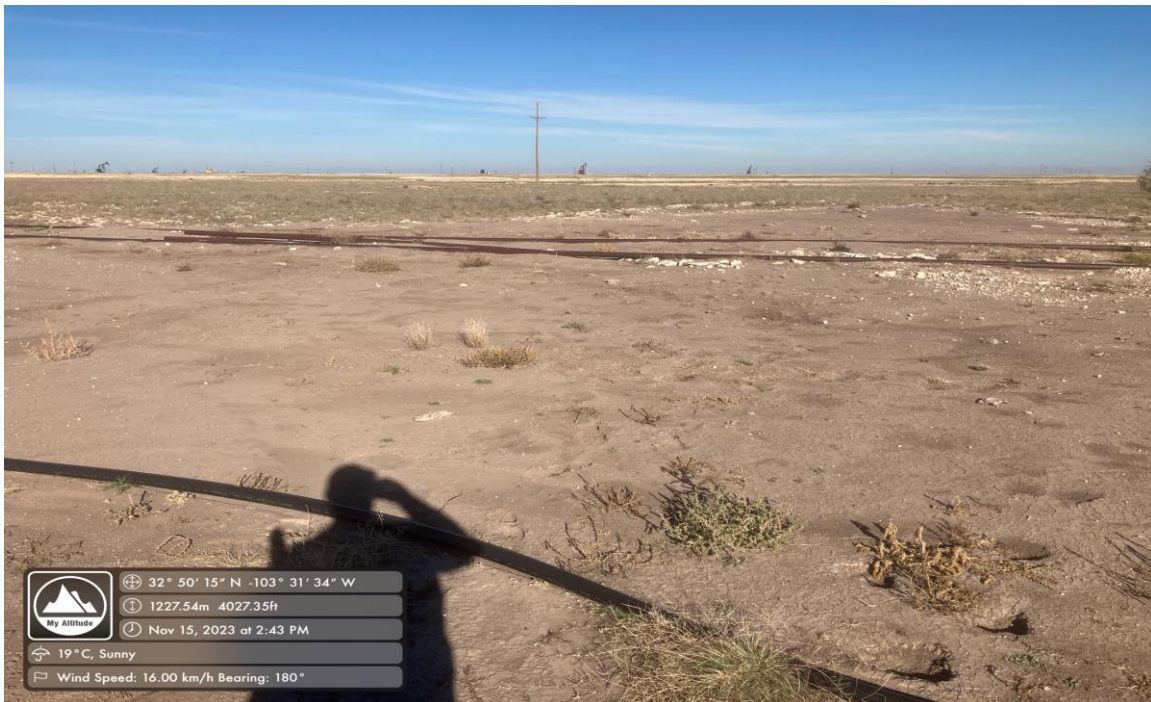
Photo 2: Sample Area 1

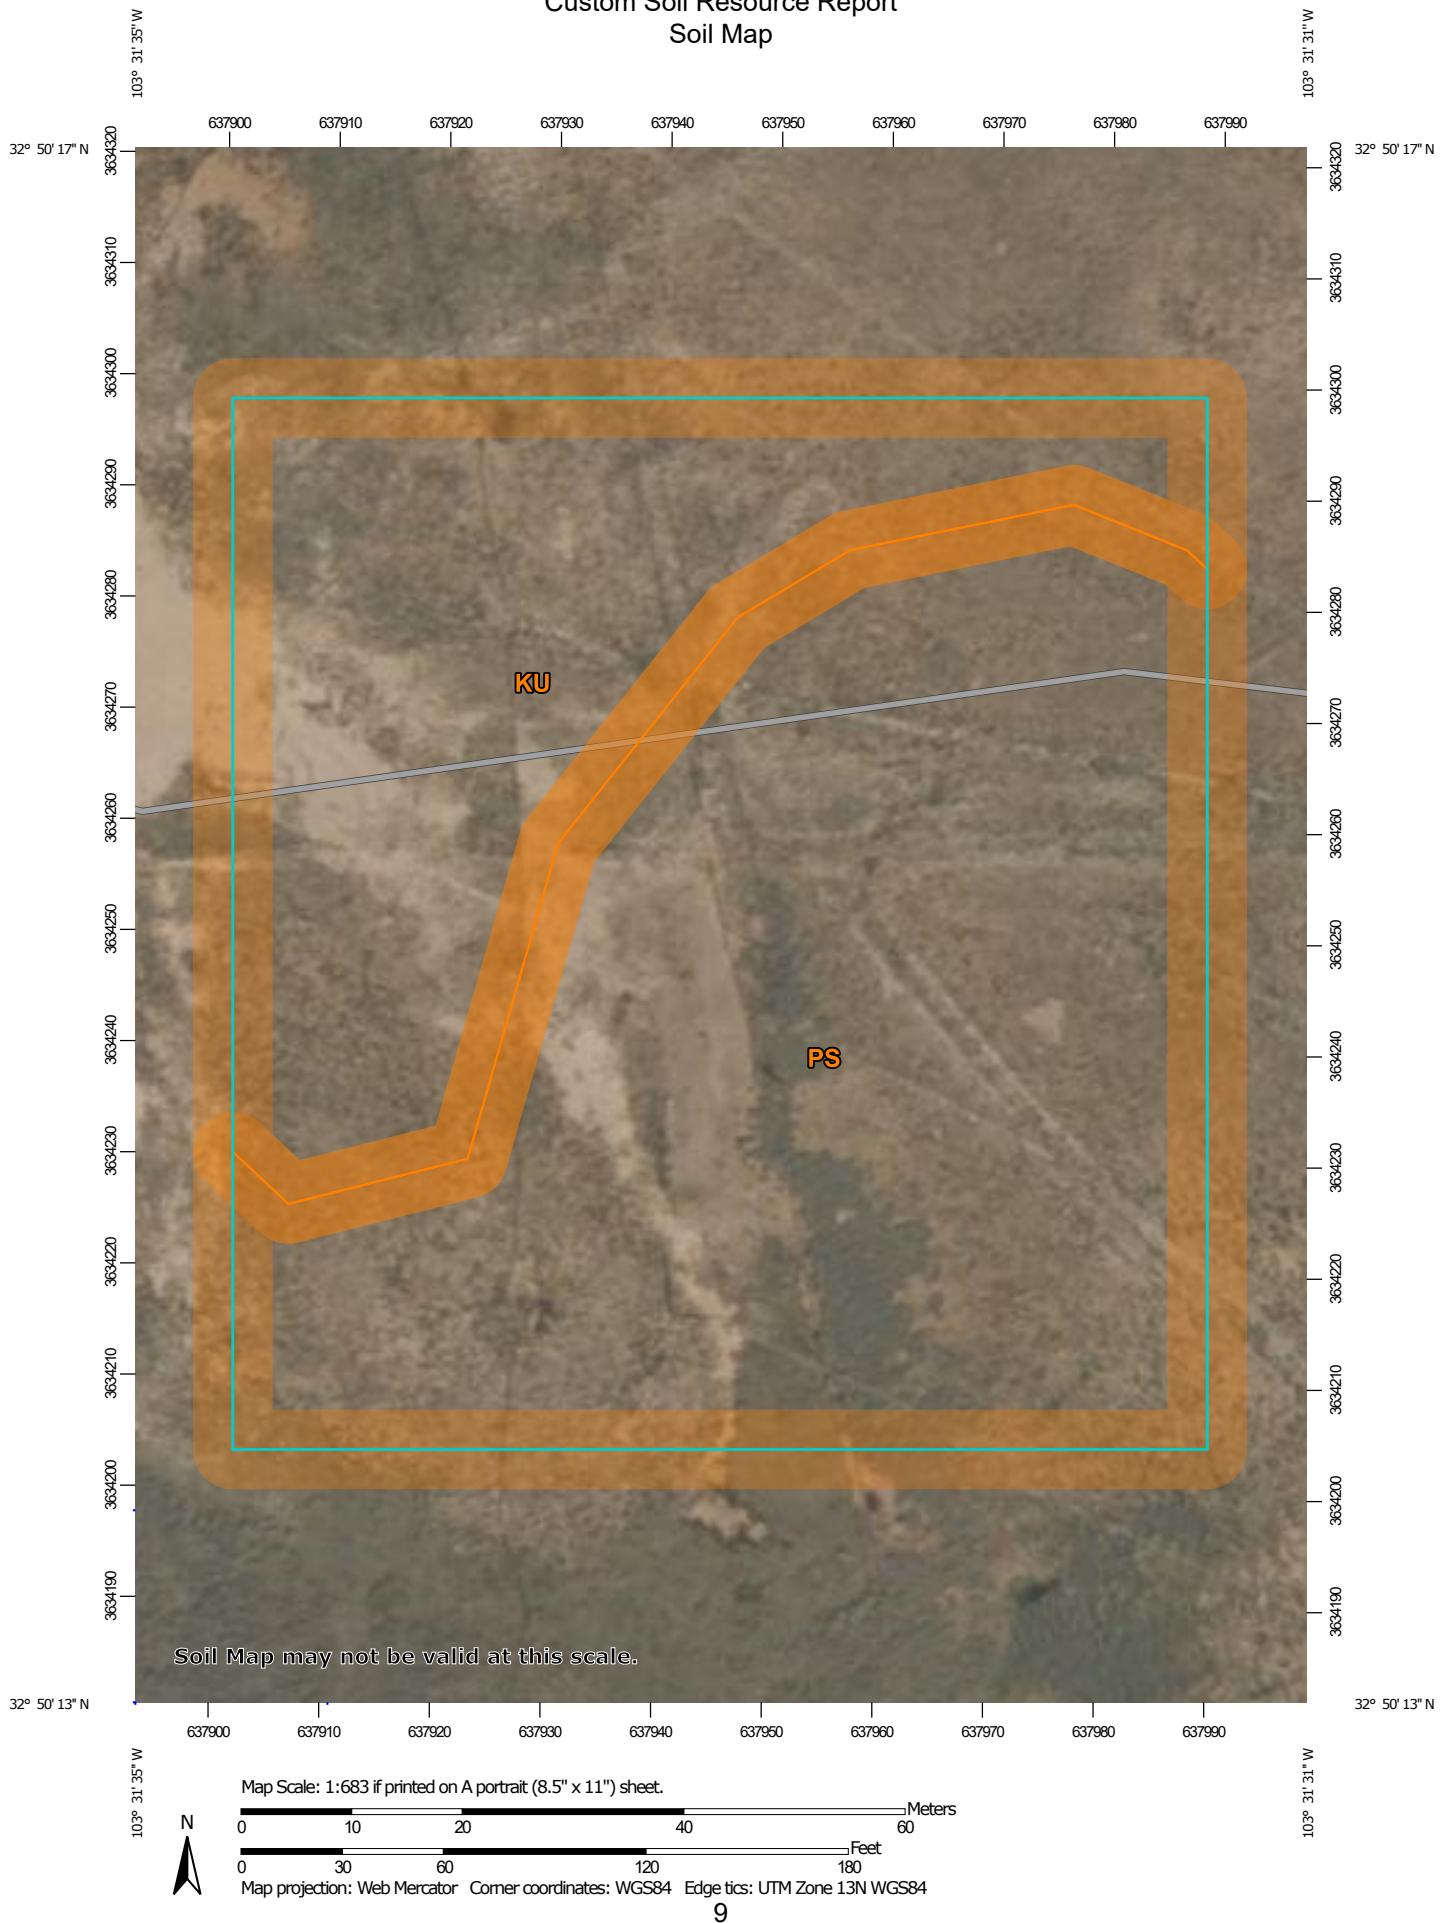
Custom Soil Resource Report Soil Map

The soil map section includes the soil map for the defined area of interest, a list of soil map units on the map and extent of each map unit, and cartographic symbols displayed on the map. Also presented are various metadata about data used to produce the map, and a description of each soil map unit.

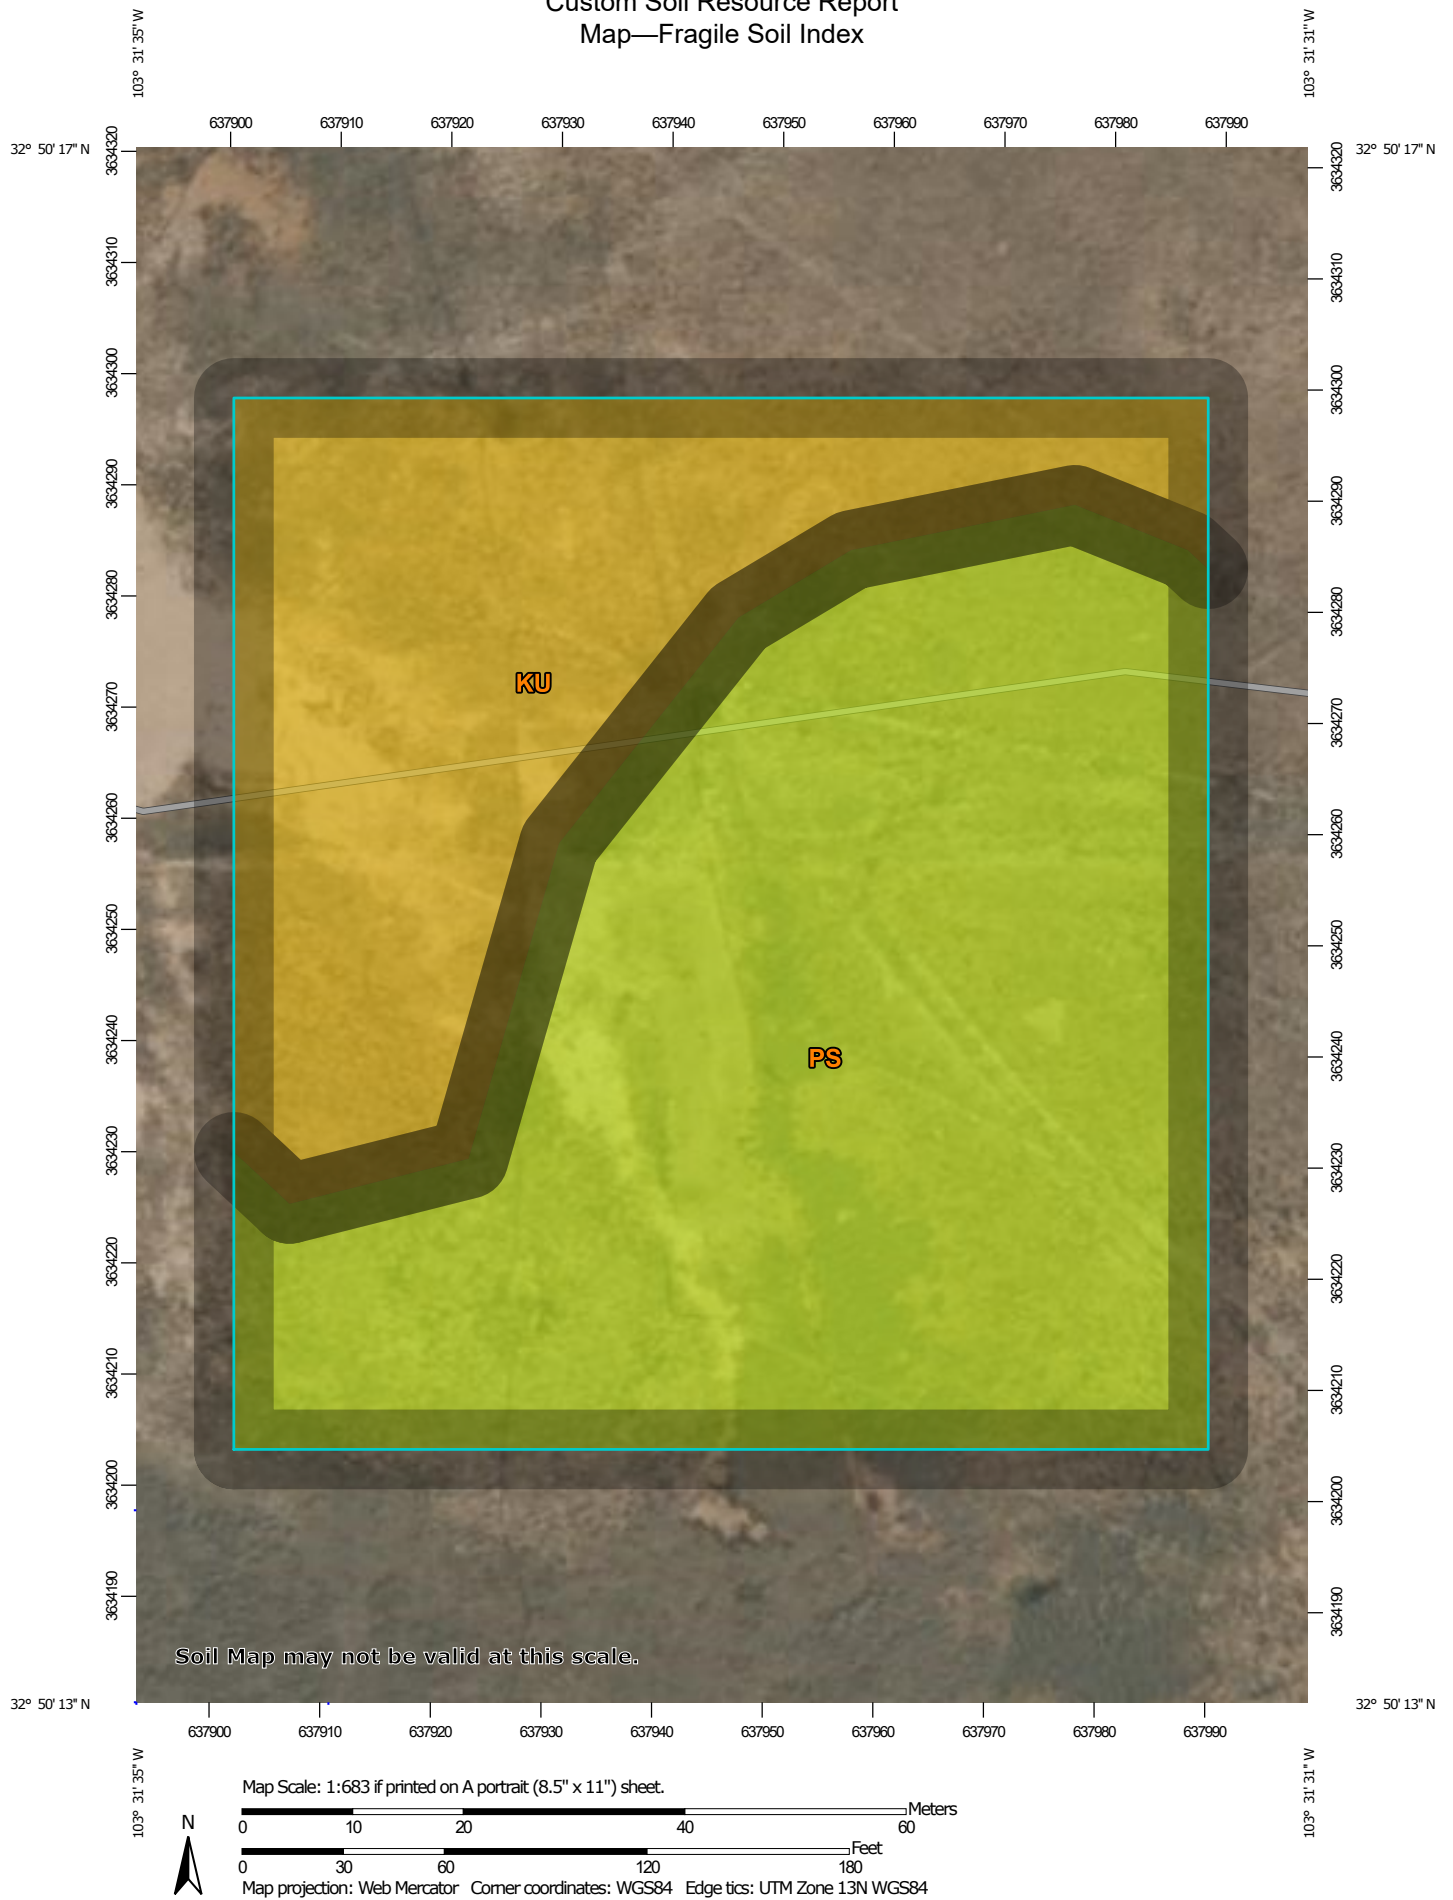
Custom Soil Resource Report
Map—Fragile Soil Index

Soils can be rated based on their susceptibility to degradation in the "Fragile Soil Index" interpretation. Fragile soils are those that are most vulnerable to degradation. In other words, they can be easily degraded they have a low resistance to degradation processes. They tend to be highly susceptible to erosion and can have a low capacity to recover after degradation has occurred (low resilience). Fragile soils are generally characterized by a low content of organic matter, low aggregate stability, and weak soil structure. They are generally located on sloping ground, have sparse plant cover, and tend to be in arid or semiarid regions. The index can be used for conservation and watershed planning to assist in identifying soils and areas highly vulnerable to degradation.

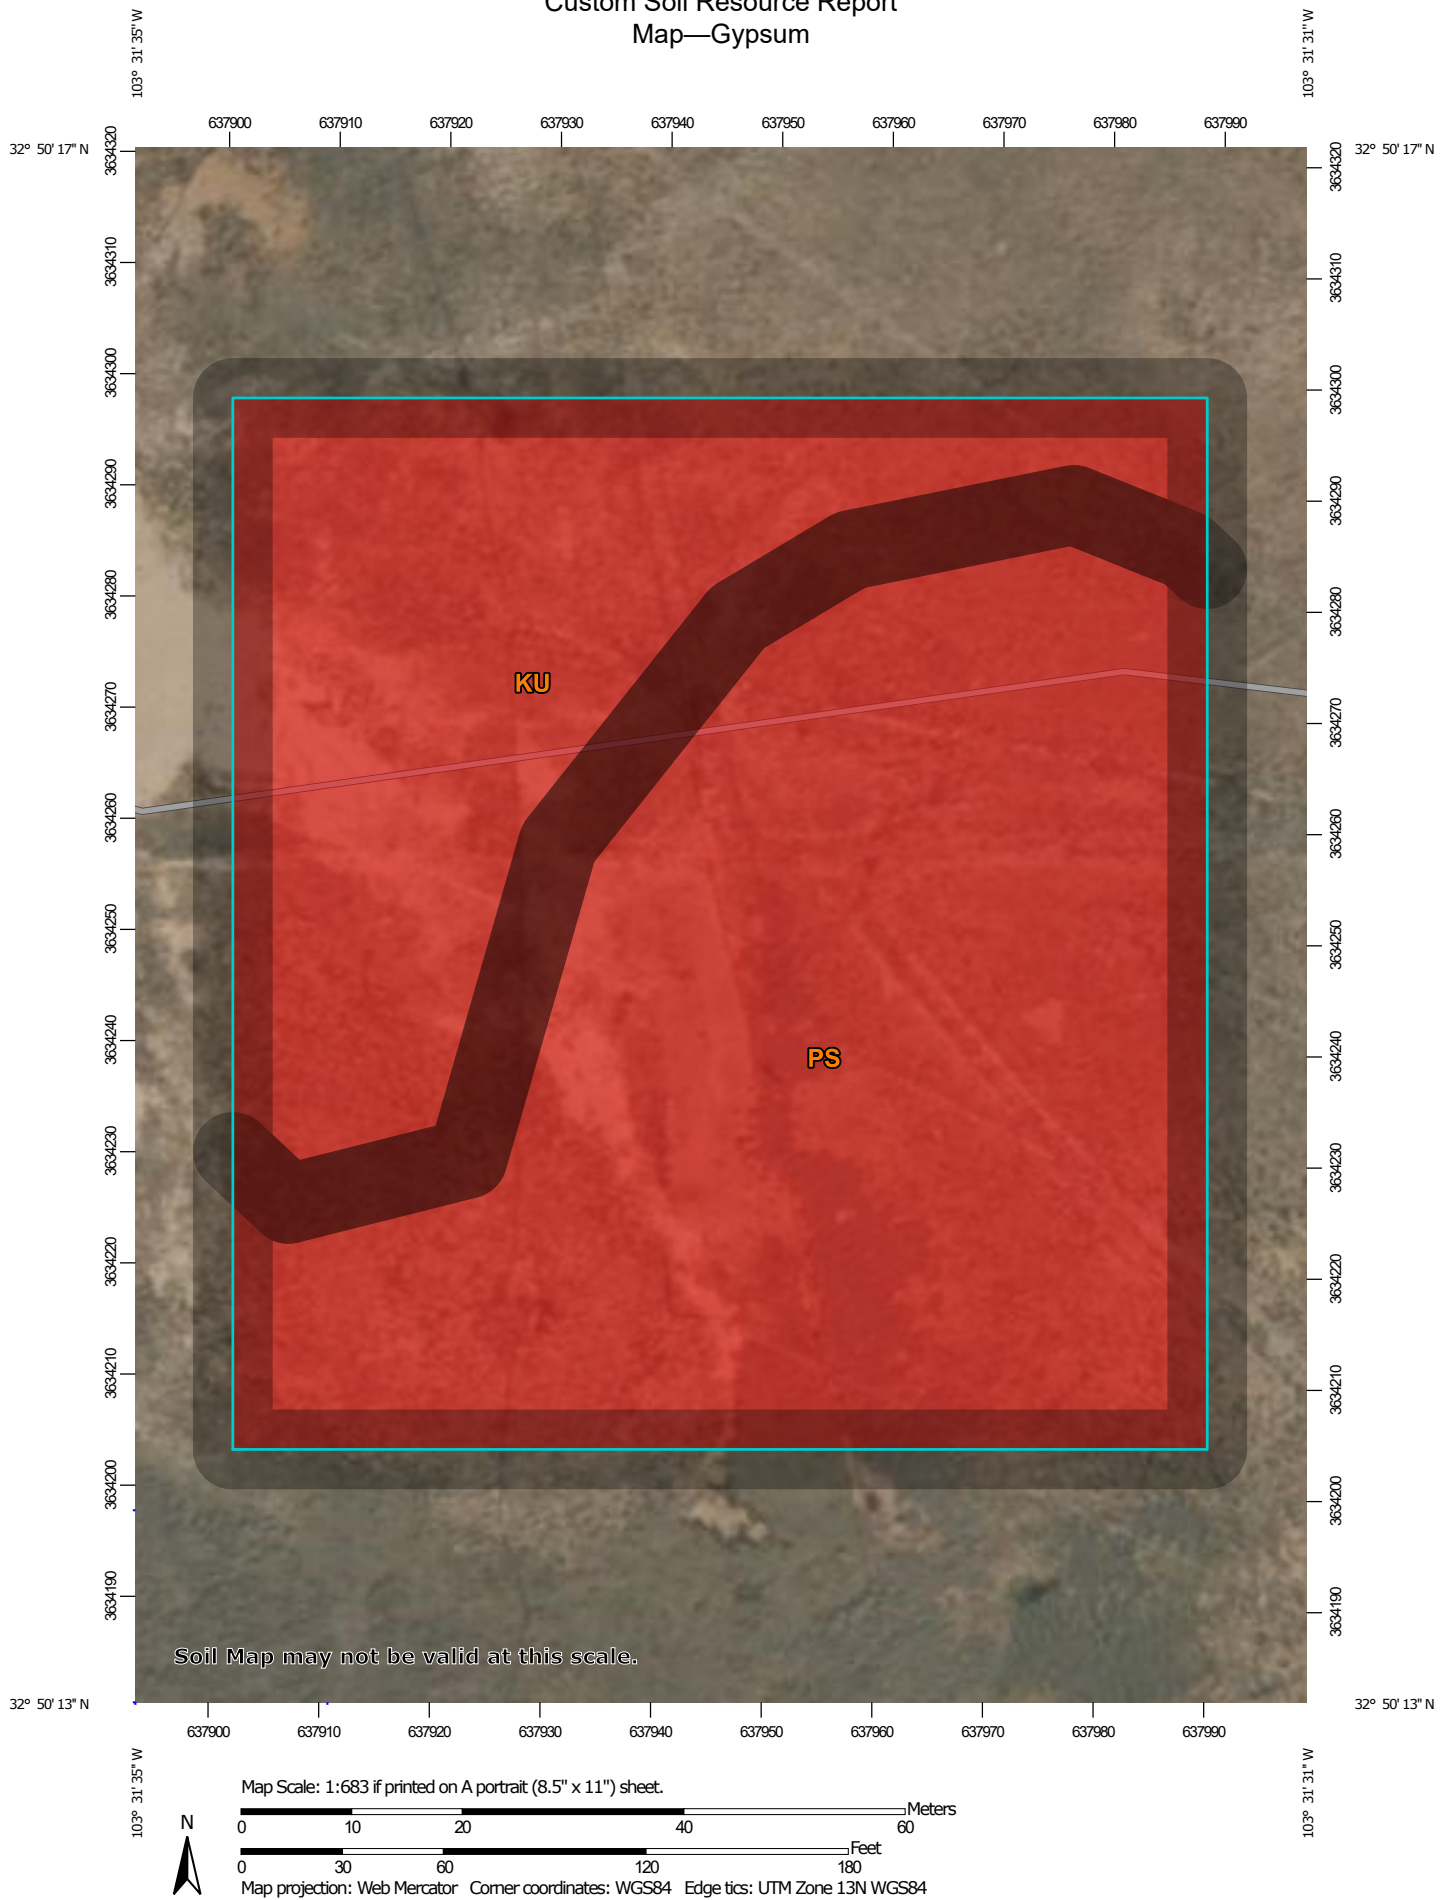
Custom Soil Resource Report
Map—Gypsum

The content of gypsum is the percent, by weight, of hydrated calcium sulfates in the fraction of the soil less than 20 millimeters in size. Gypsum is partially soluble in water. Soils high in content of gypsum, such as those with more than 10 percent gypsum, may collapse if the gypsum is removed by percolating water. Gypsum is corrosive to concrete.

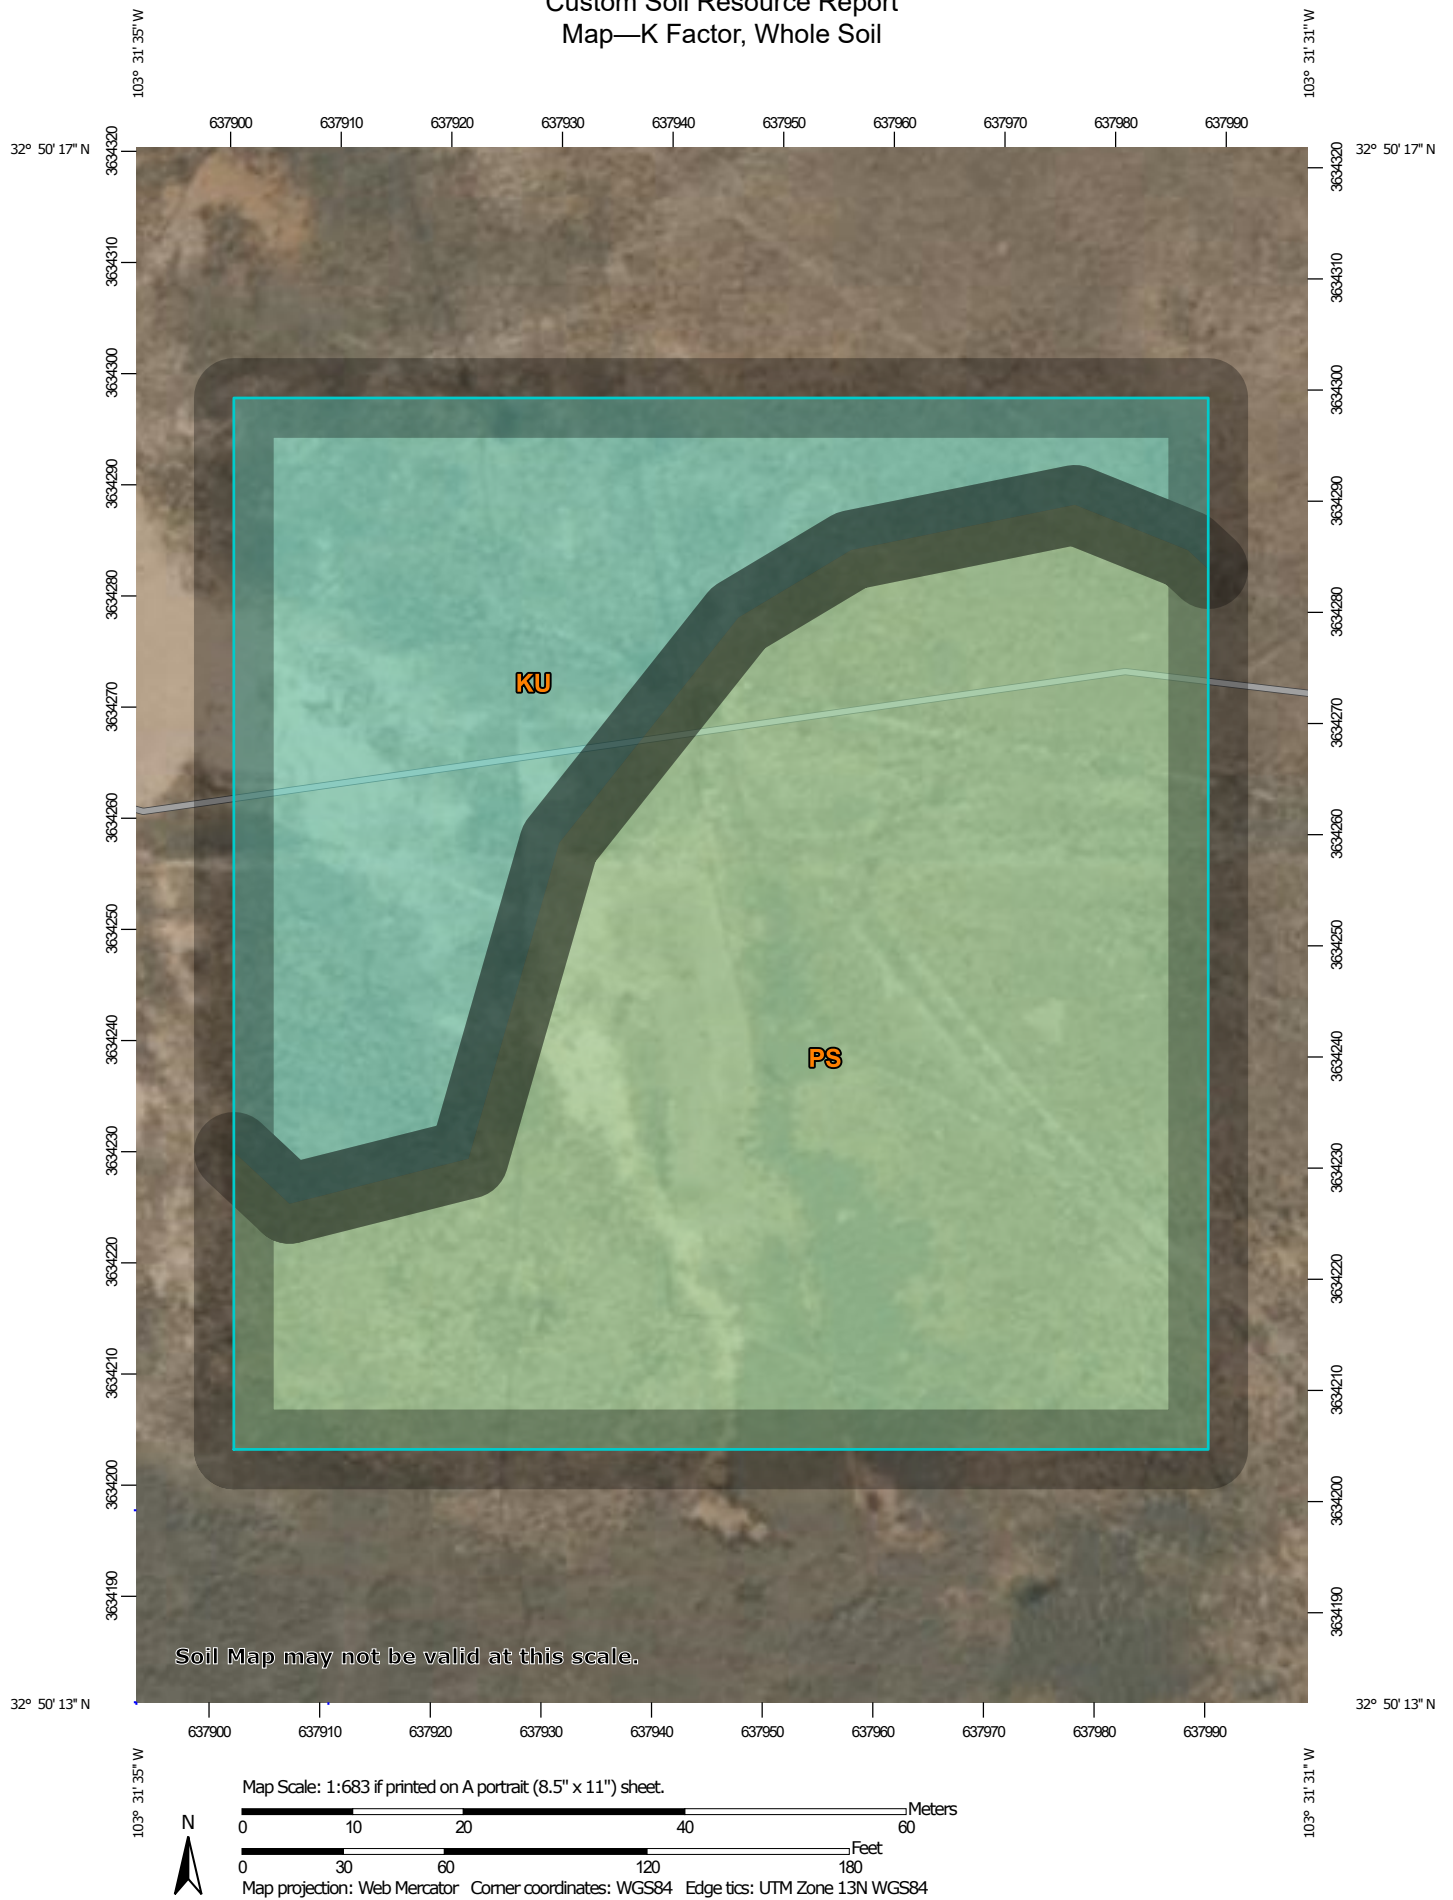
Custom Soil Resource Report
Map—K Factor, Whole Soil

Factor K does not apply to organic horizons and is not reported for those layers.

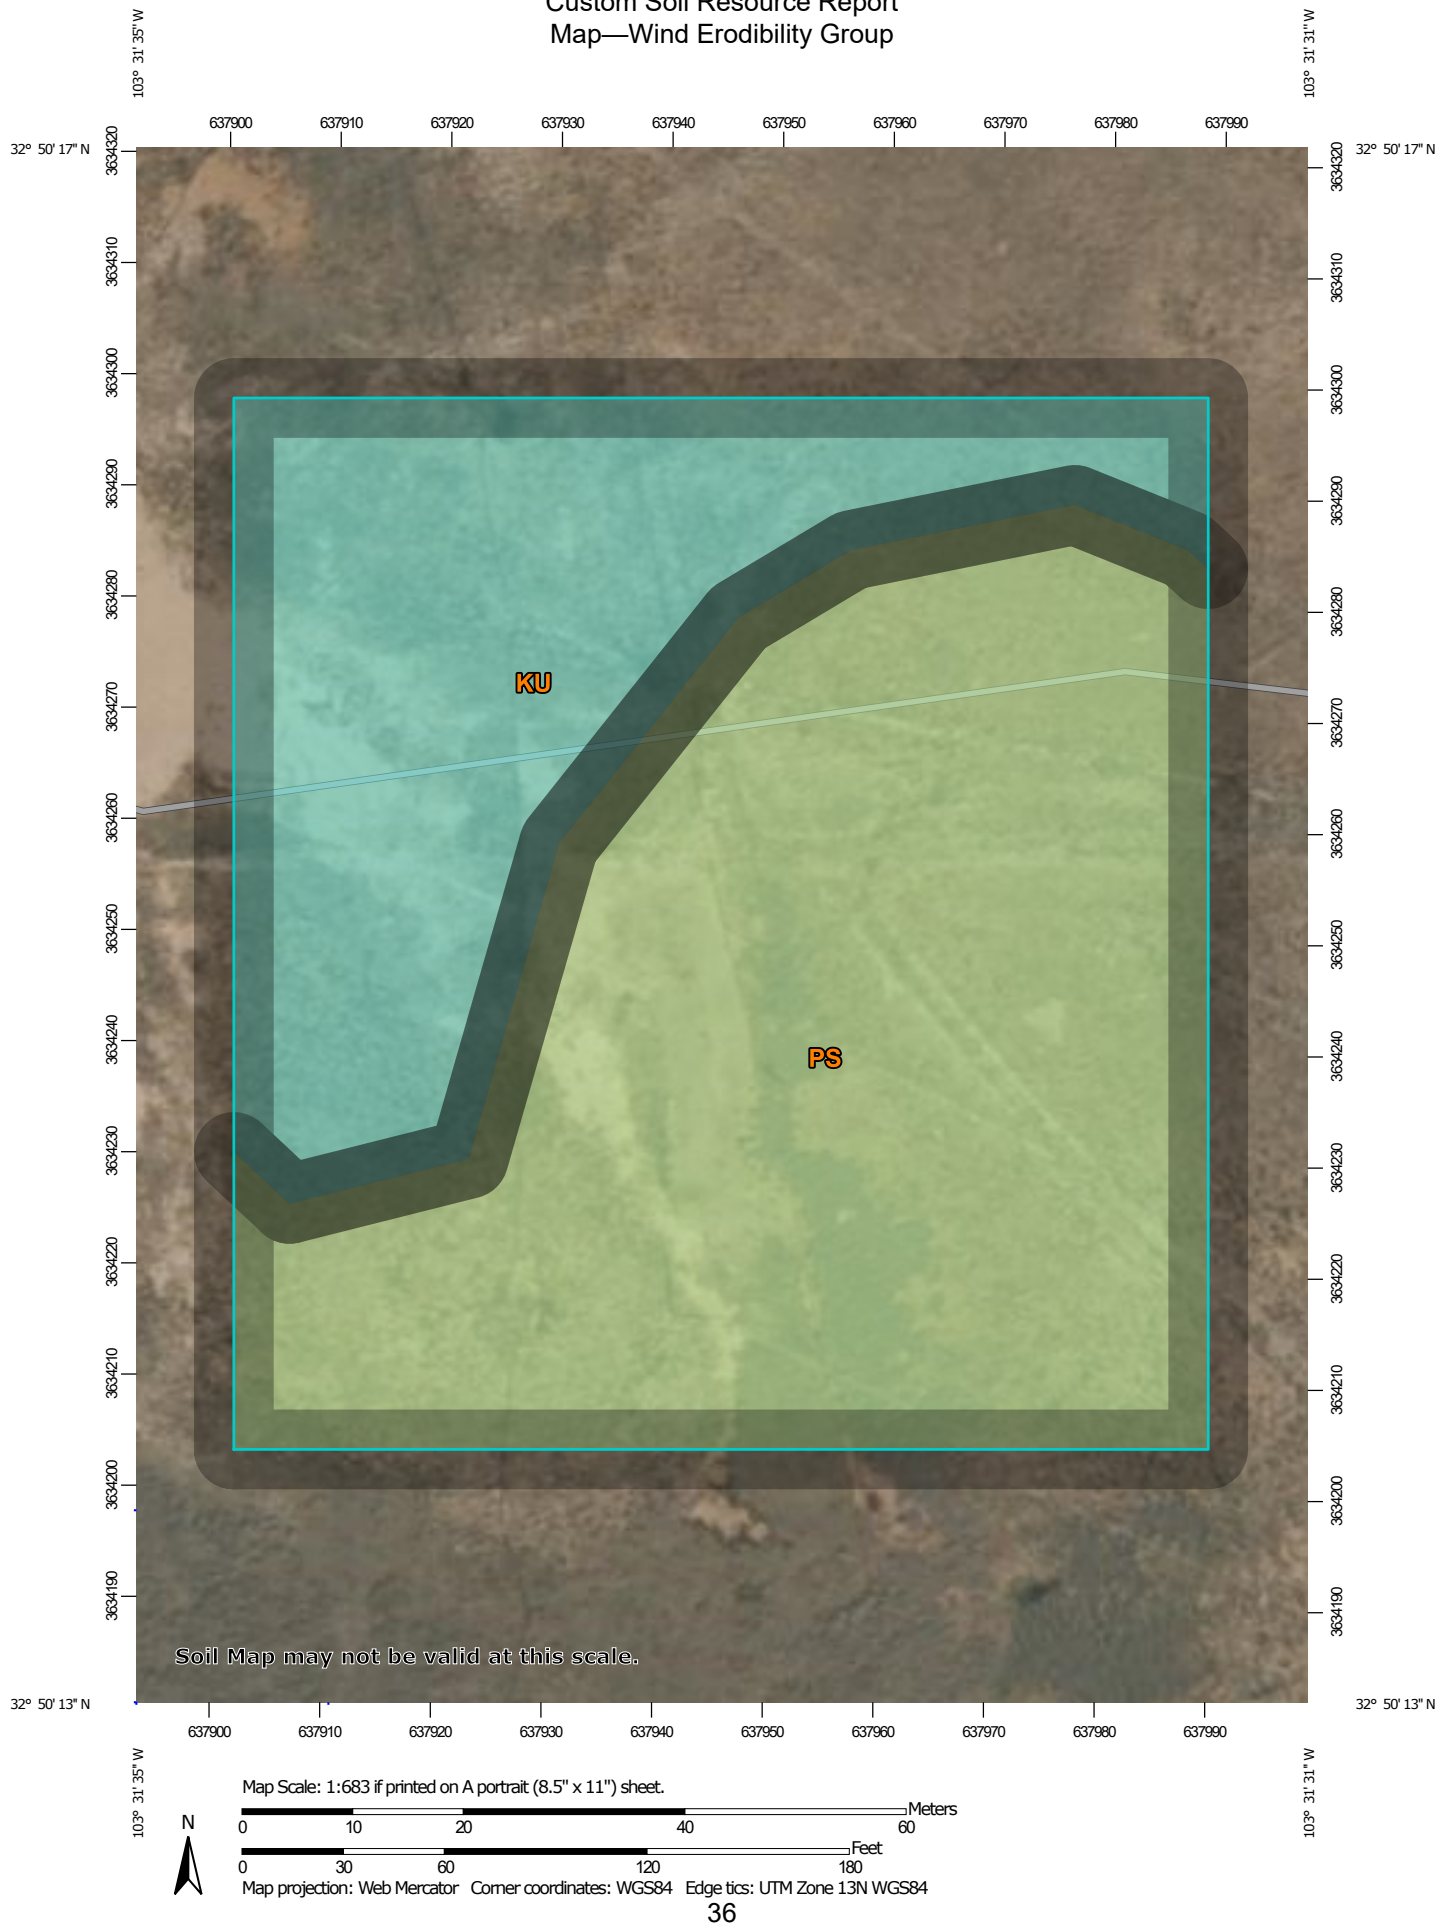
Custom Soil Resource Report
Map—Wind Erodibility Group

A wind erodibility group (WEG) consists of soils that have similar properties affecting their susceptibility to wind erosion in cultivated areas. The soils assigned to group 1 are the most susceptible to wind erosion, and those assigned to group 8 are the least susceptible.

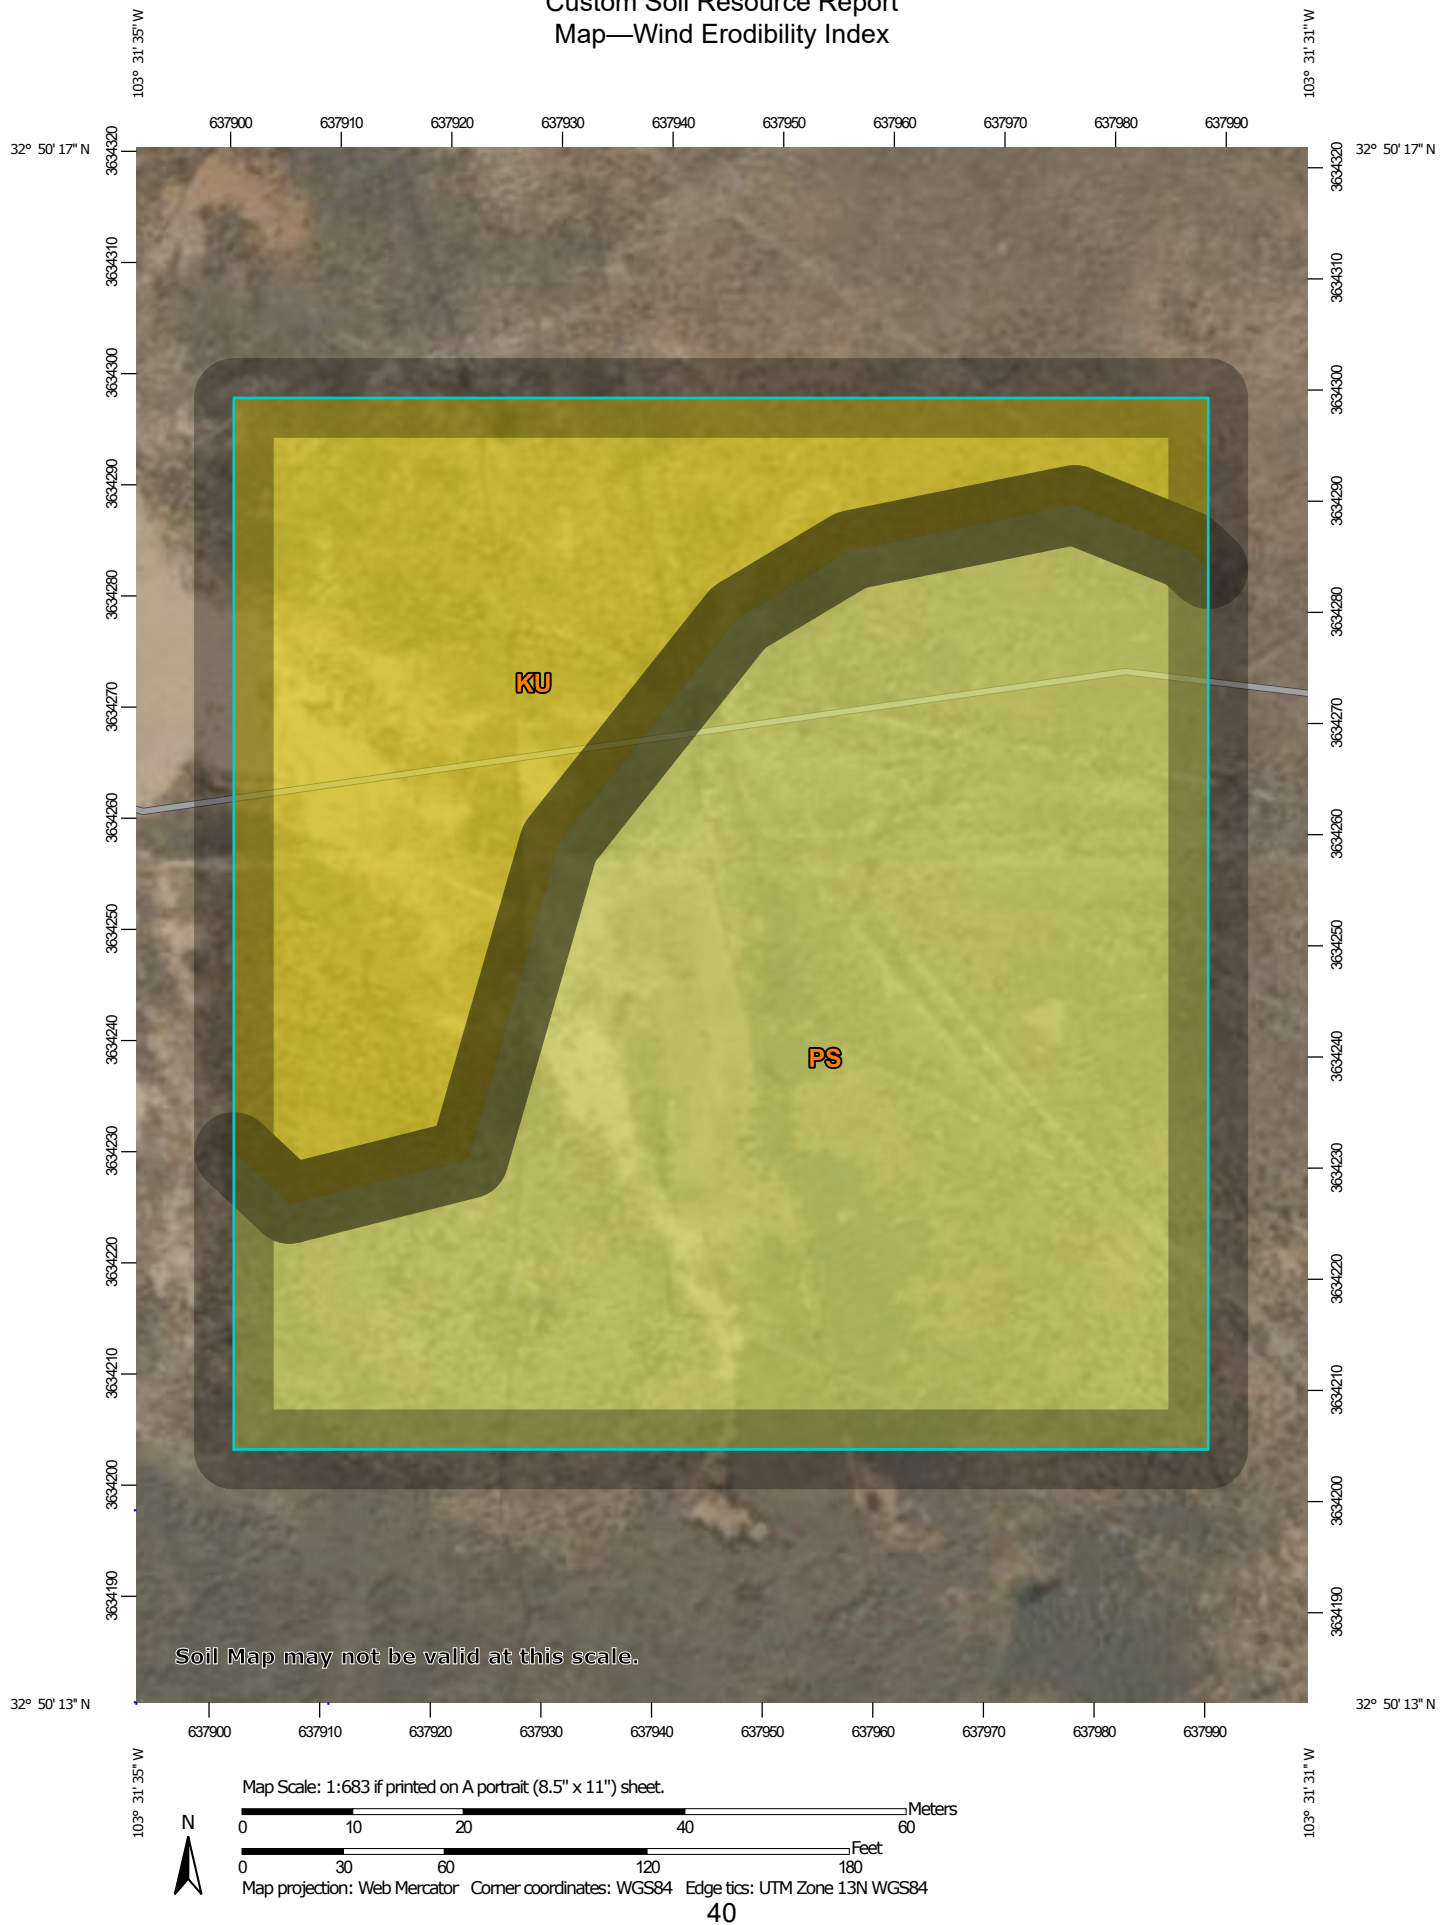
Custom Soil Resource Report
Map—Wind Erodibility Index

The wind erodibility index is a numerical value indicating the susceptibility of soil to wind erosion, or the tons per acre per year that can be expected to be lost to wind erosion. There is a close correlation between wind erosion and the texture of the surface layer, the size and durability of surface clods, rock fragments, organic matter, and a calcareous reaction. Soil moisture and frozen soil layers also influence wind erosion.
