***** LIQUID SPILLS - VOLUME CALCULATIONS *****						
Location of spill:		NORTH VACUUM ABO UNIT #252 (32.83777, -103.52610)			Date of Spill: 2/9/2022	
Estimated Daily Production Loss:		2 BBL Oil 49 BBL Water			Site Soil Type: PS — Portales-Stegall loams	
Total Area Calculations						
Total Surface Area	width		length		wet soil depth	oil (%)
Rectangle Area #1	50.0 ft	X	165.0 ft	X	0.1 in	100%
Rectangle Area #2	ft	X	ft	X	in	0%
Rectangle Area #3	ft	X	ft	X	in	0%
Rectangle Area #4	ft	X	ft	X	in	0%
Rectangle Area #5	ft	X	ft	X	in	0%
Rectangle Area #6	ft	X	ft	X	in	0%
Rectangle Area #7	ft	X	ft	X	in	0%
Rectangle Area #8	ft	X	ft	X	in	0%
Porosity _____ 0.250 gal per gal						
Saturated Soil Volume Calculations:						
		<u>H2O</u>		<u>OIL</u>		
Area #1	8,250 sq. ft.	cu. ft.		34	cu. ft.	
Area #2	0 sq. ft.	cu. ft.			cu. ft.	
Area #3	0 sq. ft.	cu. ft.			cu. ft.	
Area #4	0 sq. ft.	cu. ft.			cu. ft.	
Area #5	0 sq. ft.	cu. ft.			cu. ft.

On 02/10/2022, Cross Timbers Energy, LLC reported a release at the North Vacuum Abo Unit #252. The release was caused when a 3” steel flowline vic clamp busted. Approximately 8,181 sqft. of the Pasture was found to be affected by the release.

Site Location Map
Cross Ti

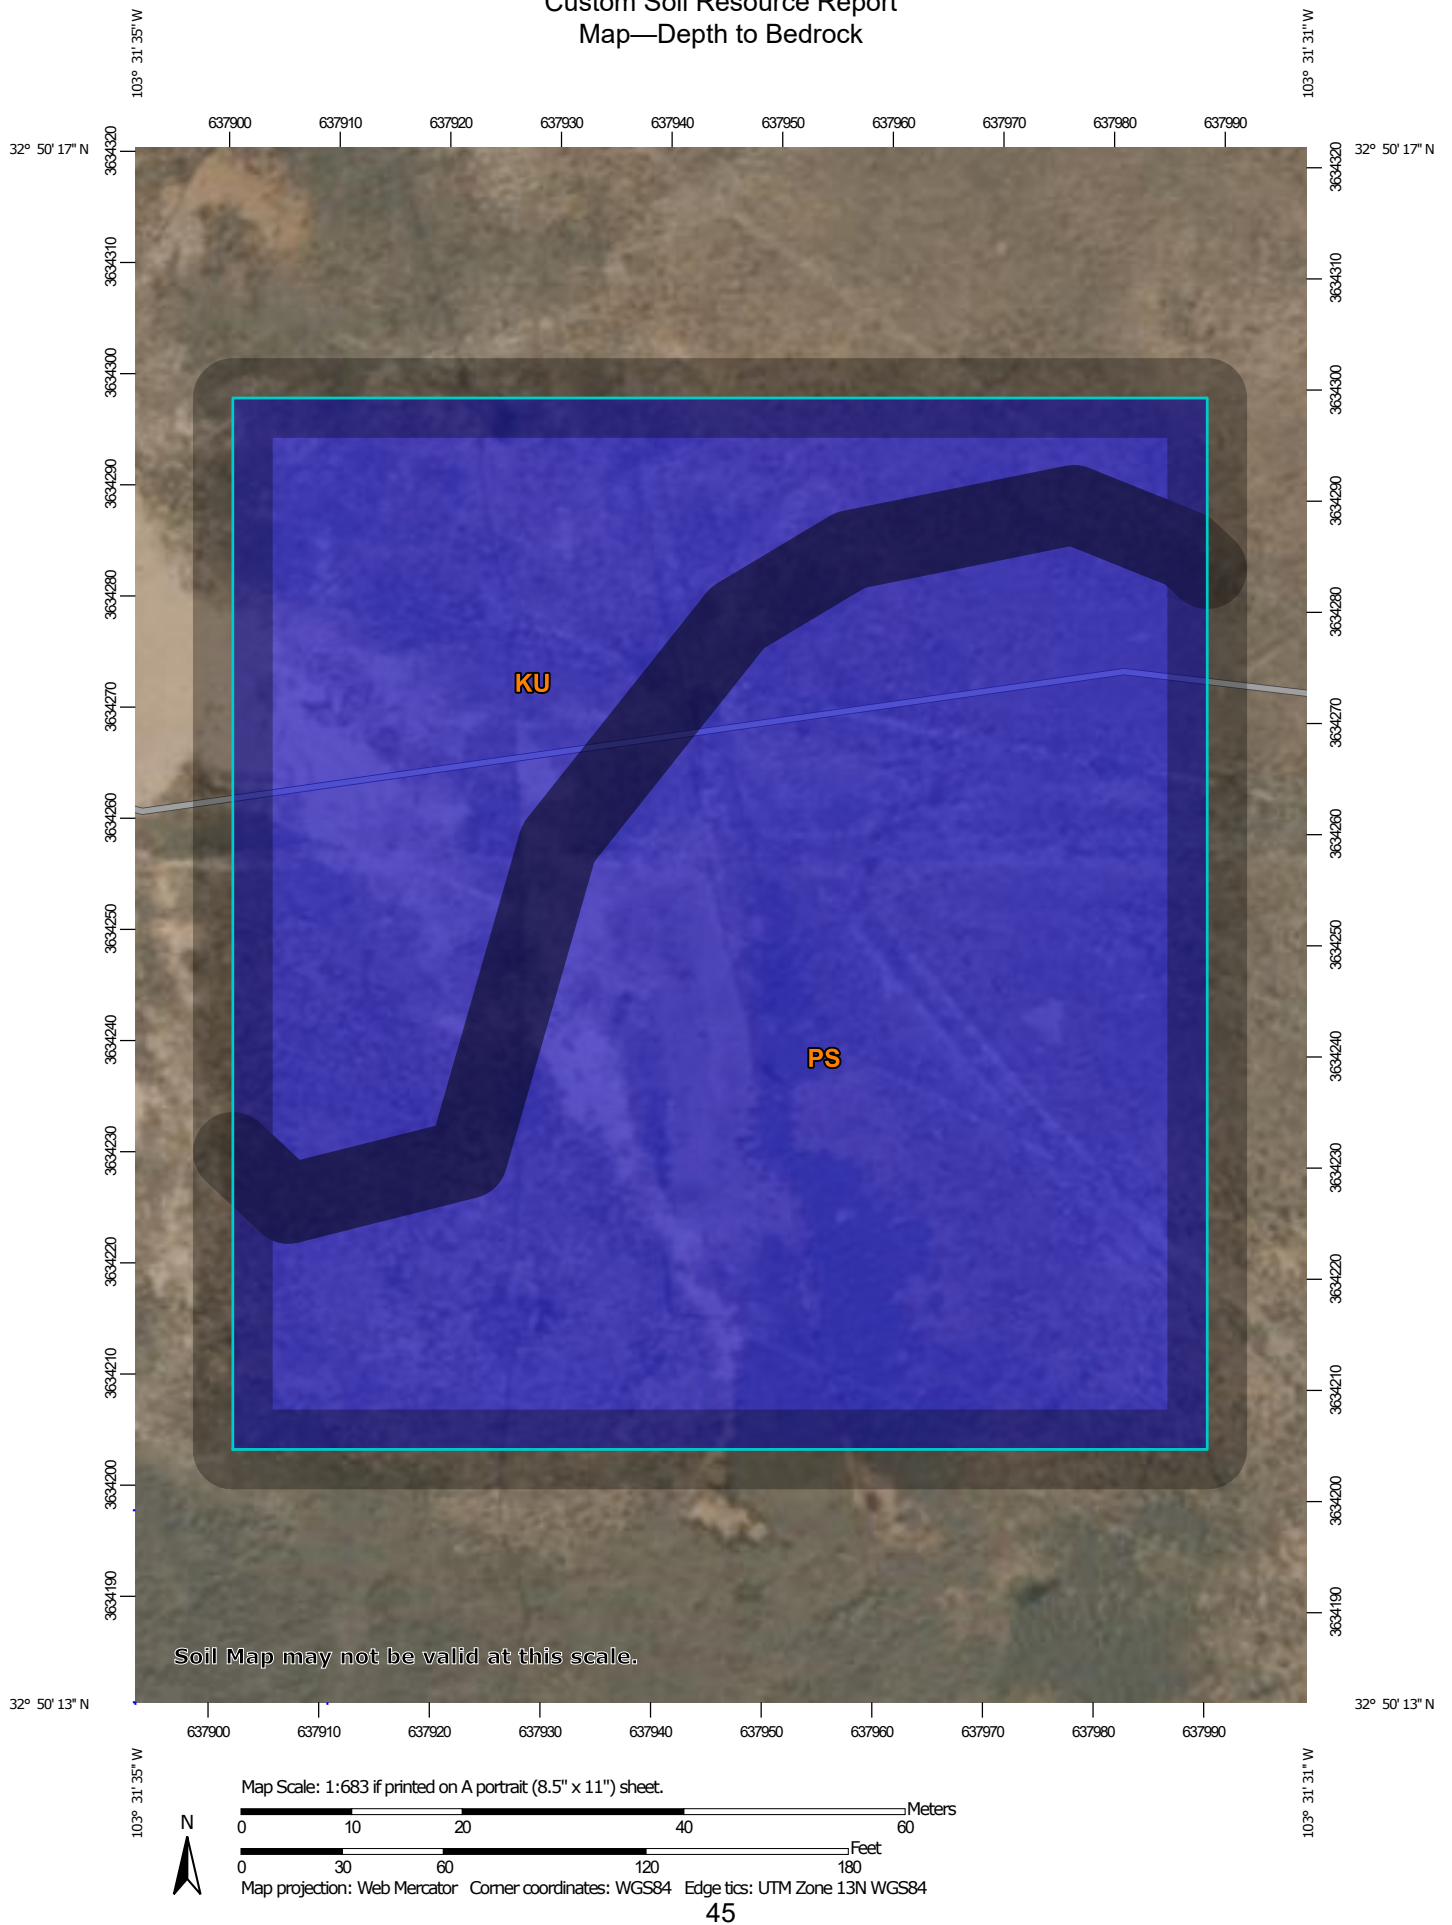
Custom Soil Resource Report
Map—Depth to Bedrock

Densic bedrock represents a unique kind of bedrock recognized within the soil survey. It is non-coherent and consolidated, dense root restrictive material, formed by pressure, heat, and dewatering of earth materials or sediments. Densic bedrock differs from densic materials, which formed under the compaction of glaciers, mudflows, and or human-caused compaction.

Depth to bedrock is actually recorded as three separate values in the database. A low value and a high value indicate the range of this attribute for the soil component. A "representative" value indicates the expected value of this attribute for the component. For this soil property, only the representative value is used.

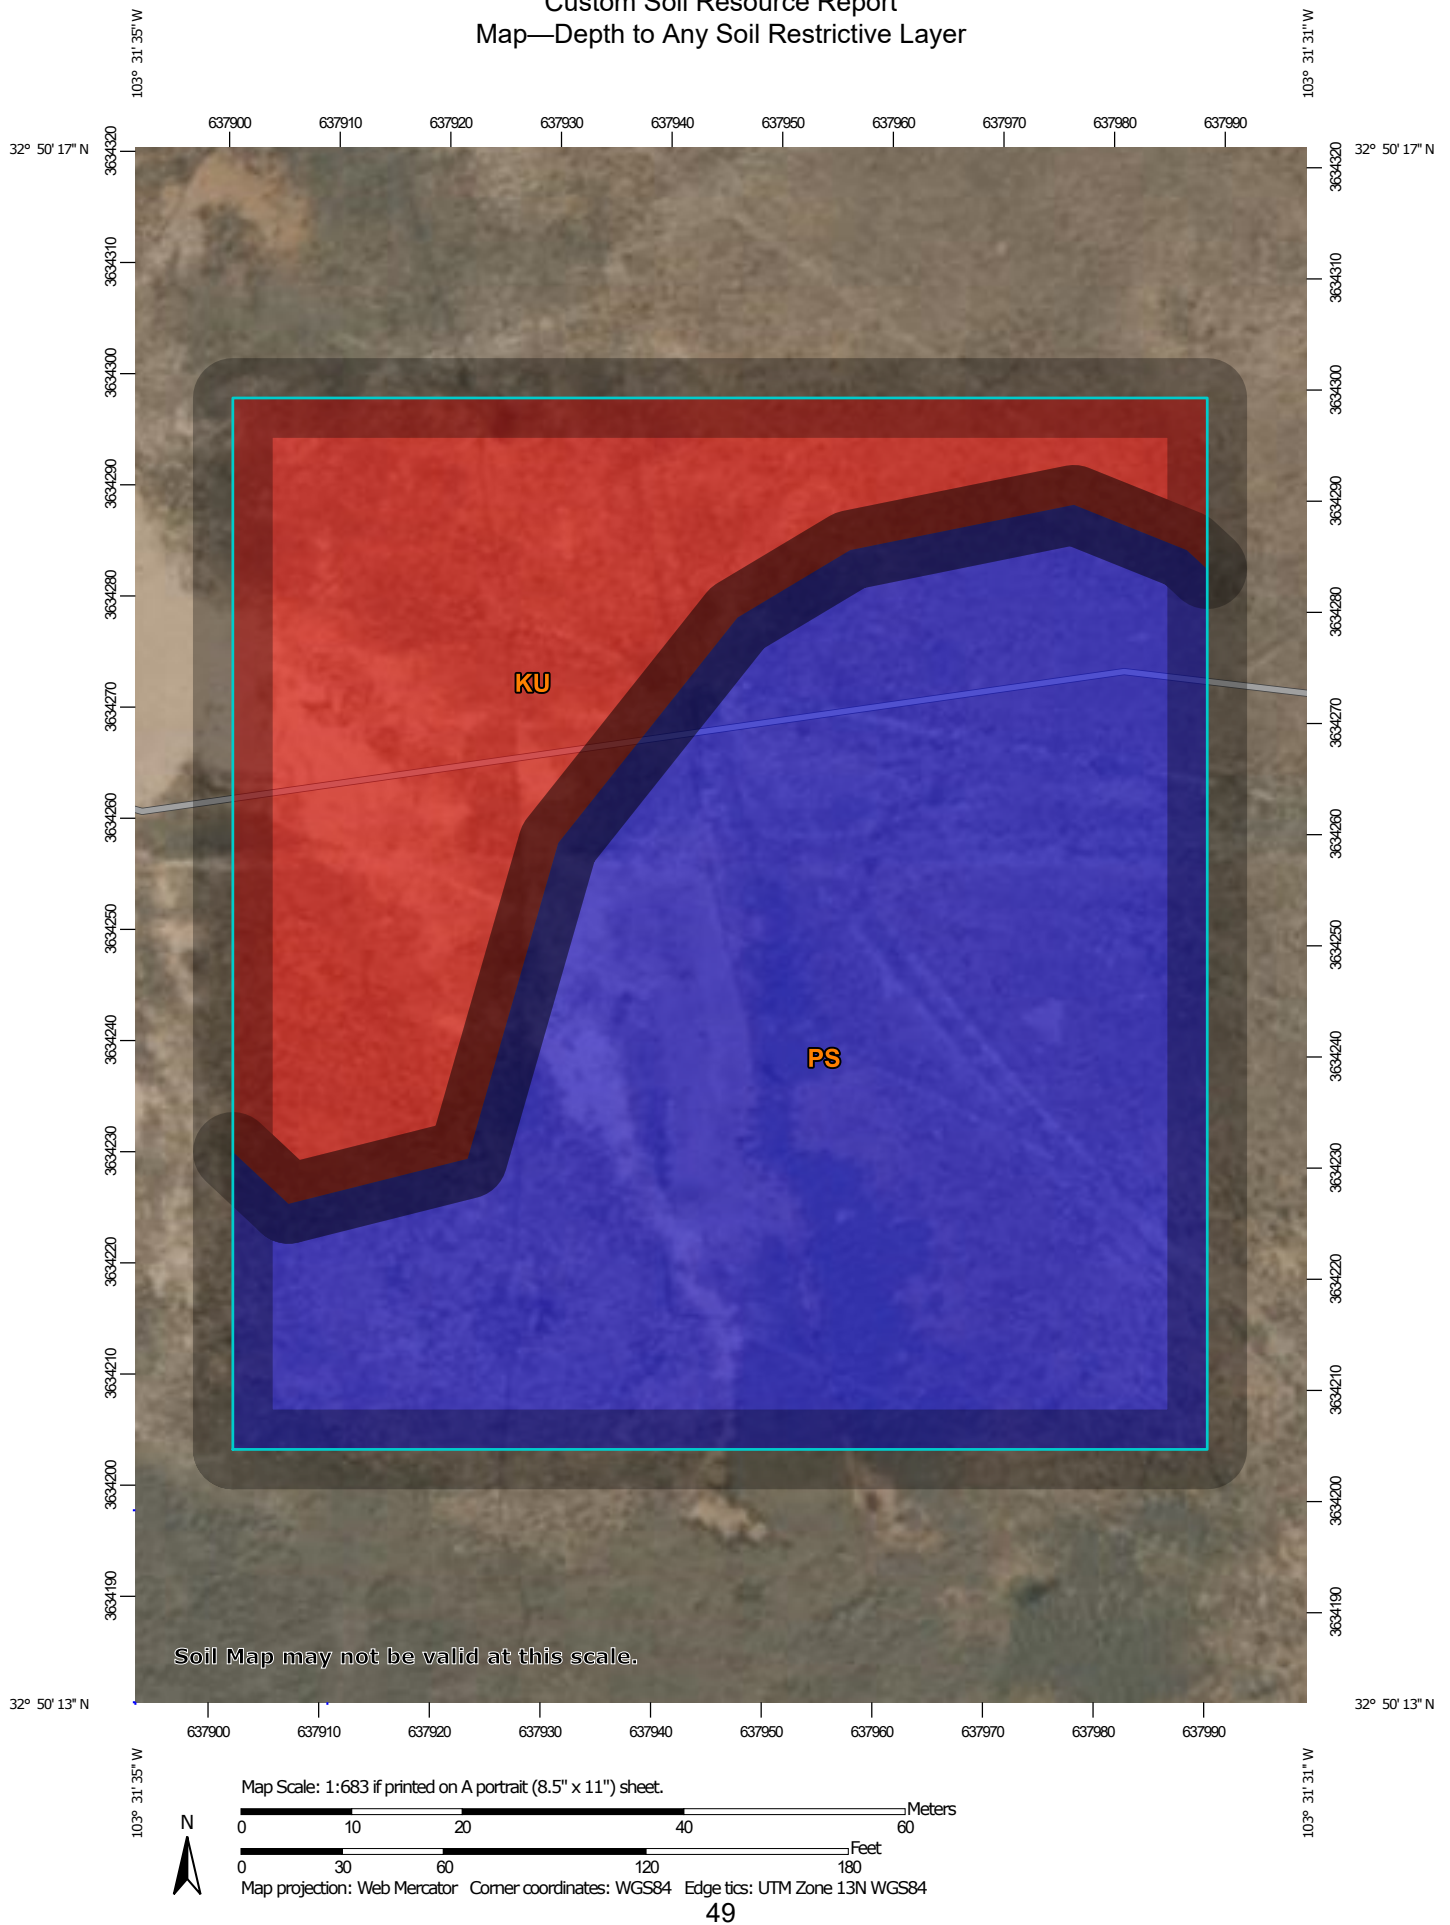
Custom Soil Resource Report
Map—Depth to Any Soil Restrictive Layer

This attribute is actually recorded as three separate values in the database. A low value and a high value indicate the range of this attribute for the soil component. A "representative" value indicates the expected value of this attribute for the component. For this soil property, only the representative value is used.

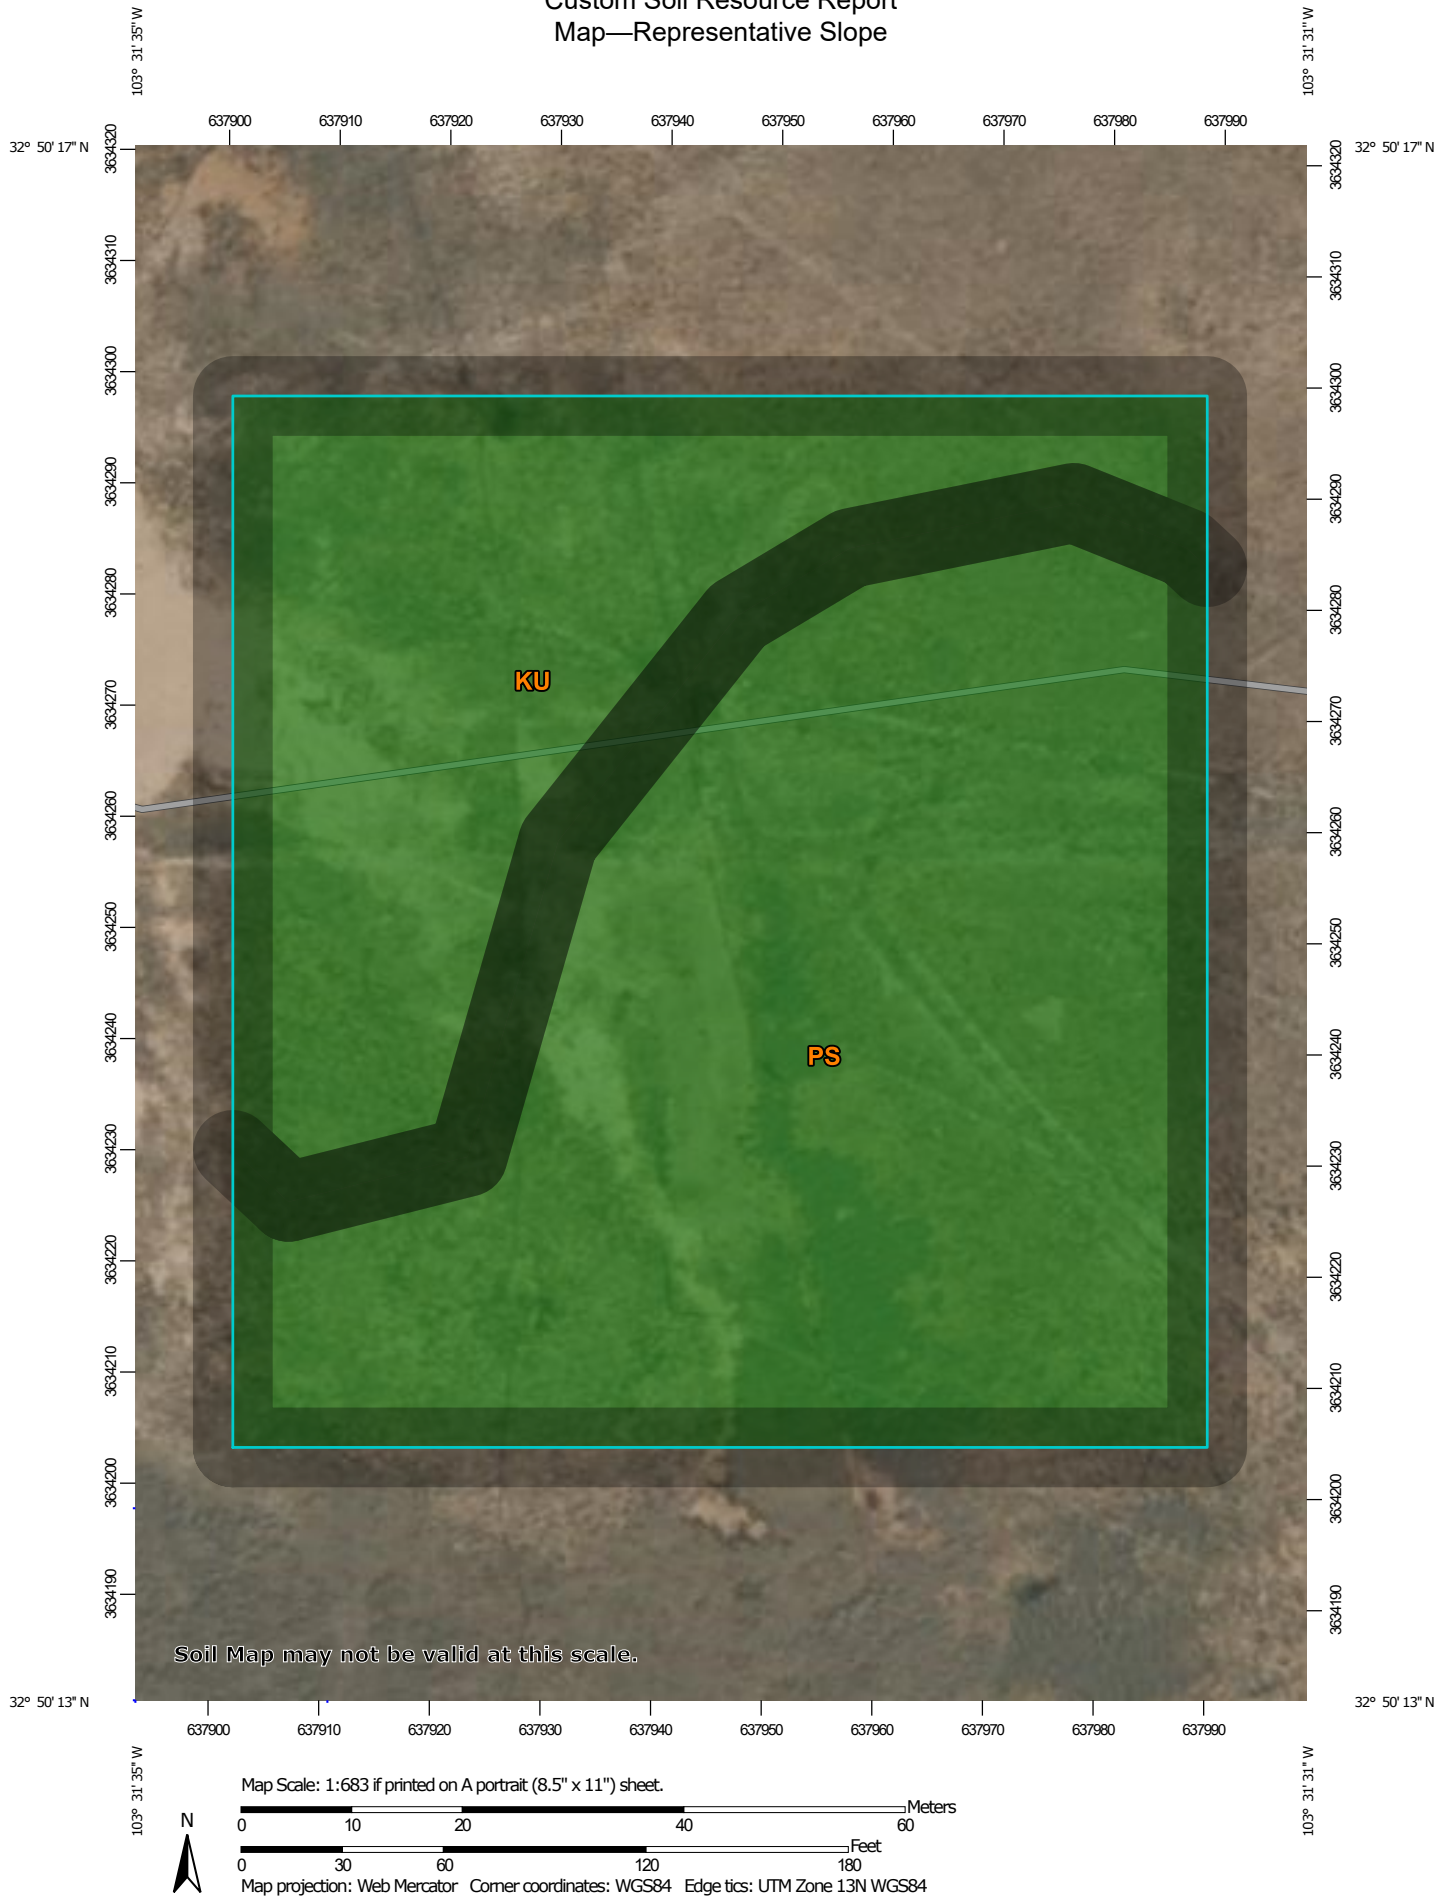
Custom Soil Resource Report
Map—Representative Slope

The slope gradient is actually recorded as three separate values in the database. A low value and a high value indicate the range of this attribute for the soil component. A "representative" value indicates the expected value of this attribute for the component. For this soil property, only the representative value is used.
