Re: Site Assessment, Remediation, and Closure Request
Riser 70 Main Line
API No. N/A
GPS: Latitude 32.825421 Longitude -103.883867
UL "A", Sec. 20, T17S, R31E
Eddy County, NM
NMOCD Ref. No. NAPP2315139771

Paragon Environmental, LLC (Paragon) has been contracted by Spur Energy Partners (Spur) to perform a spill assessment, conduct remediation activities for the release site known as the Riser 70 Main Line (Riser). Details of the release are summarized below:

Release Details			
Type of Release:	Produced Water	Volume of Release:	75 bbls
		Volume Recovered:	35 bbls
Source of Release:	Pipeline	Date of Release:	5/30/23
Was Immediate Notice Given?	Yes	If, Yes, to Whom?	Mike Bratcher, NMOCD
Was a Watercourse Reached?	No	If Yes, Volume Impacting Watercourse:	N/A
Surface Owner:	Federal	Mineral Owner:	Federal
Corrosion in the injection line.

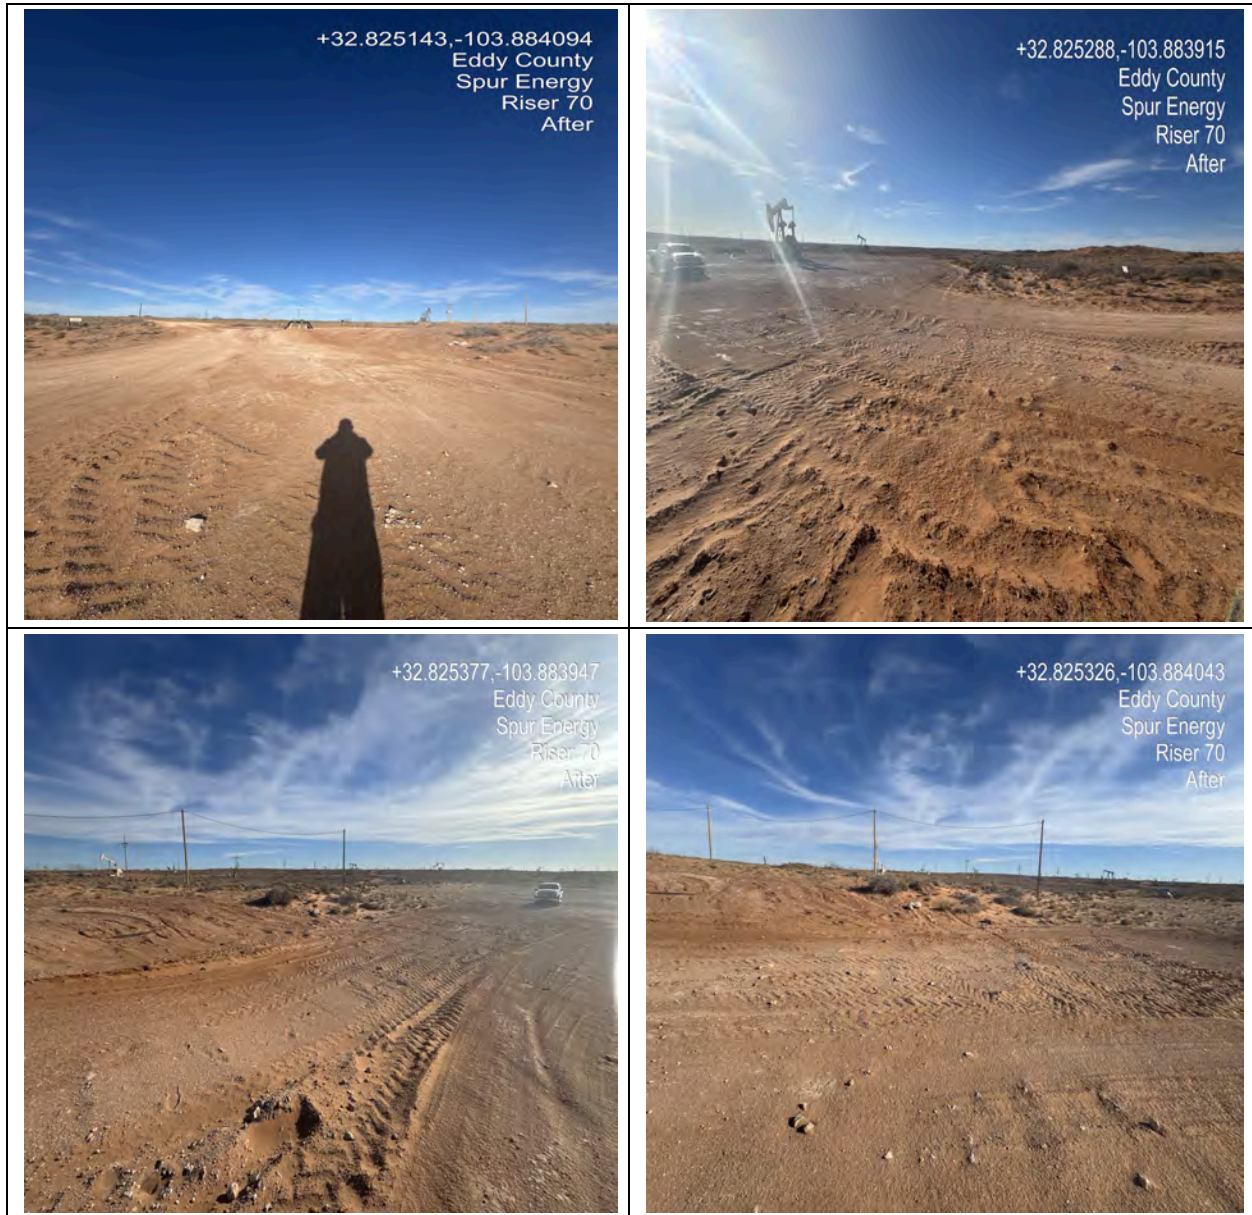
Photographic Documentation
Post

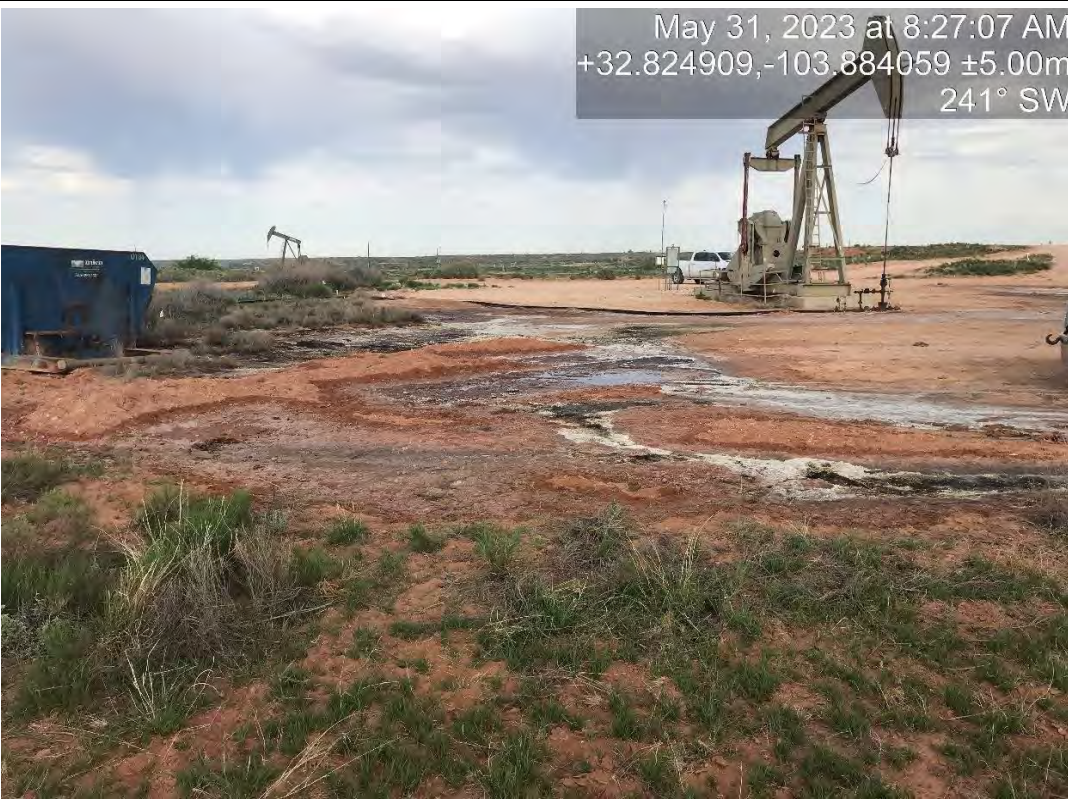
Photo Number: 3

<p>May 31, 2023 at 8:27:07 AM +32.824909,-103.884059 ±5.00m 241° SW</p>
Photo Direction: Southwest	
Photo Description: View of release area.

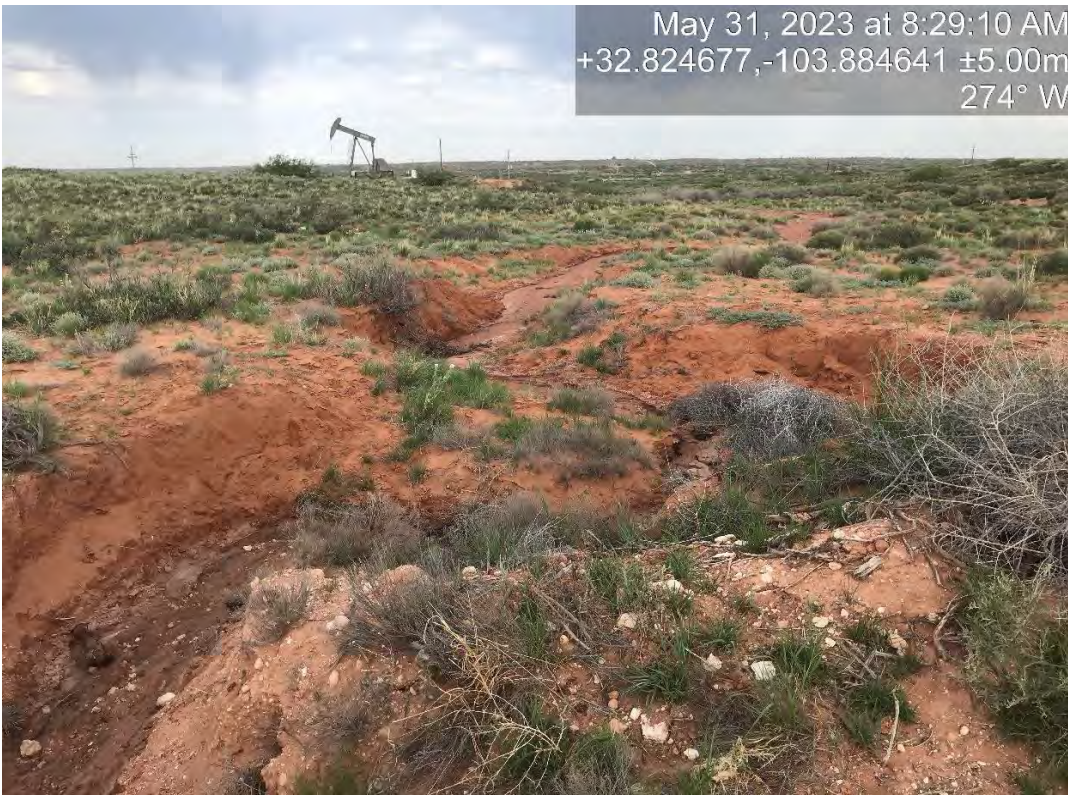
Photo Number: 4

<p>May 31, 2023 at 8:29:10 AM +32.824677,-103.884641 ±5.00m 274° W</p>
Photo Direction: West	
Photo Description: View of release area.

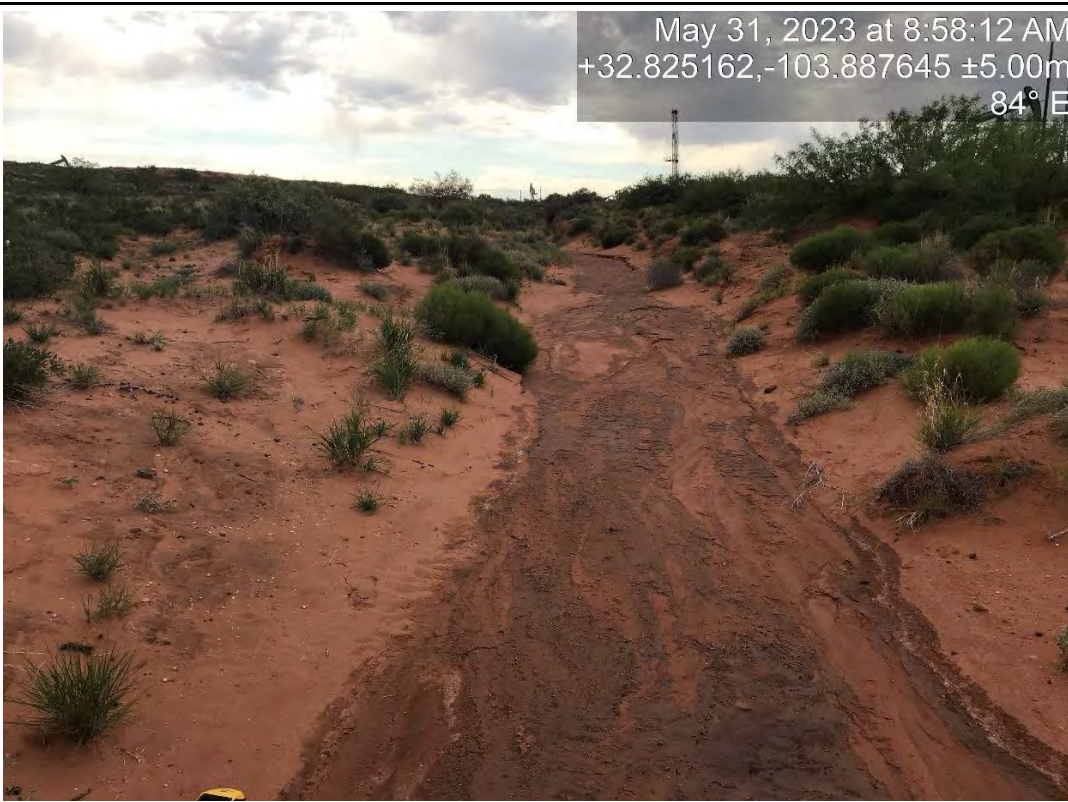
Photo Number: 5	<div>May 31, 2023 at 8:58:12 AM +32.825162,-103.887645 ±5.00m 84° E</div>

Photo Direction: East	
Photo Description: View of release area.

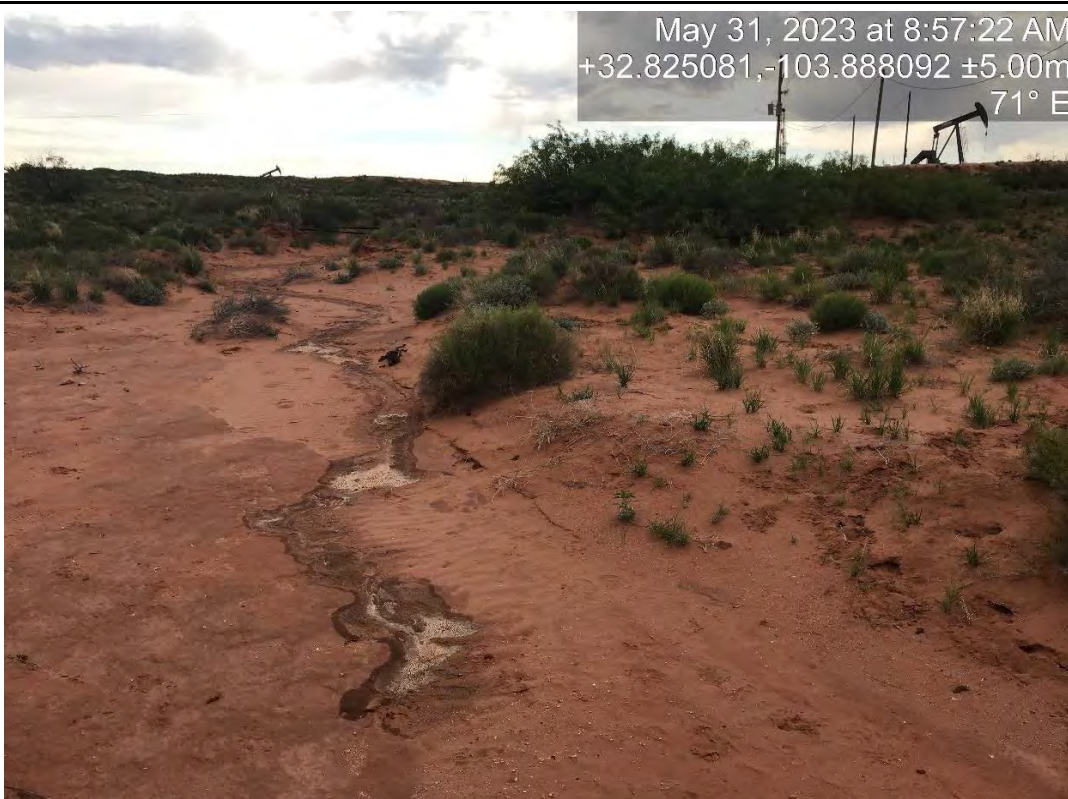
Photo Number: 6	<div>May 31, 2023 at 8:57:22 AM +32.825081,-103.888092 ±5.00m 71° E</div>

Photo Direction: East	
Photo Description: View of release area.

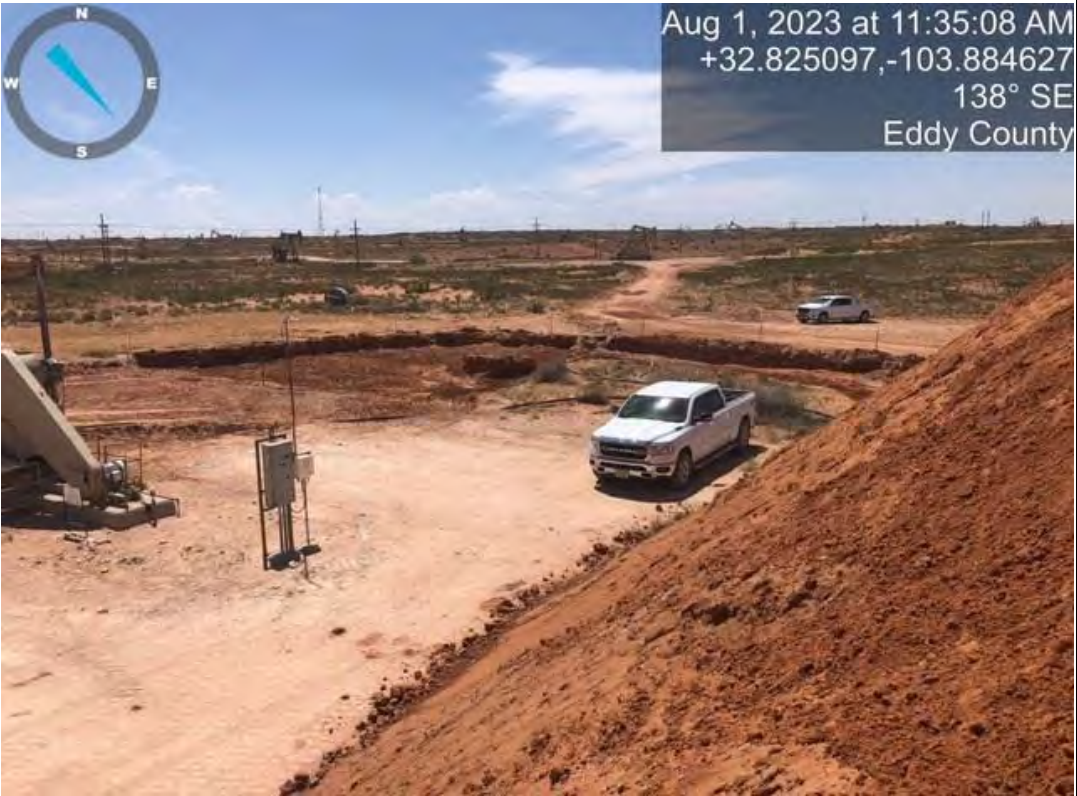
Photo Number: 8

<p>Aug 1, 2023 at 11:35:08 AM +32.825097,-103.884627 138° SE Eddy County</p>
Photo Direction: Southeast	
Photo Description: View of excavated area.

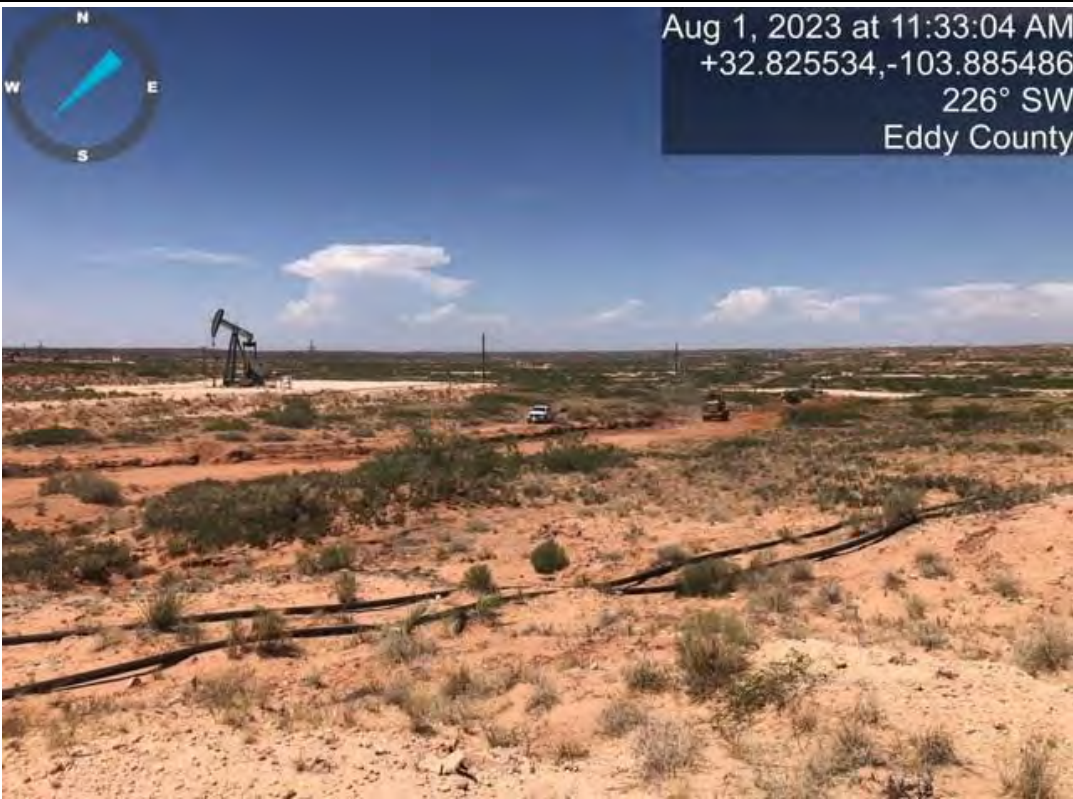
Photo Number: 10

Photo Direction: Southwest	
Photo Description: View of excavated area.

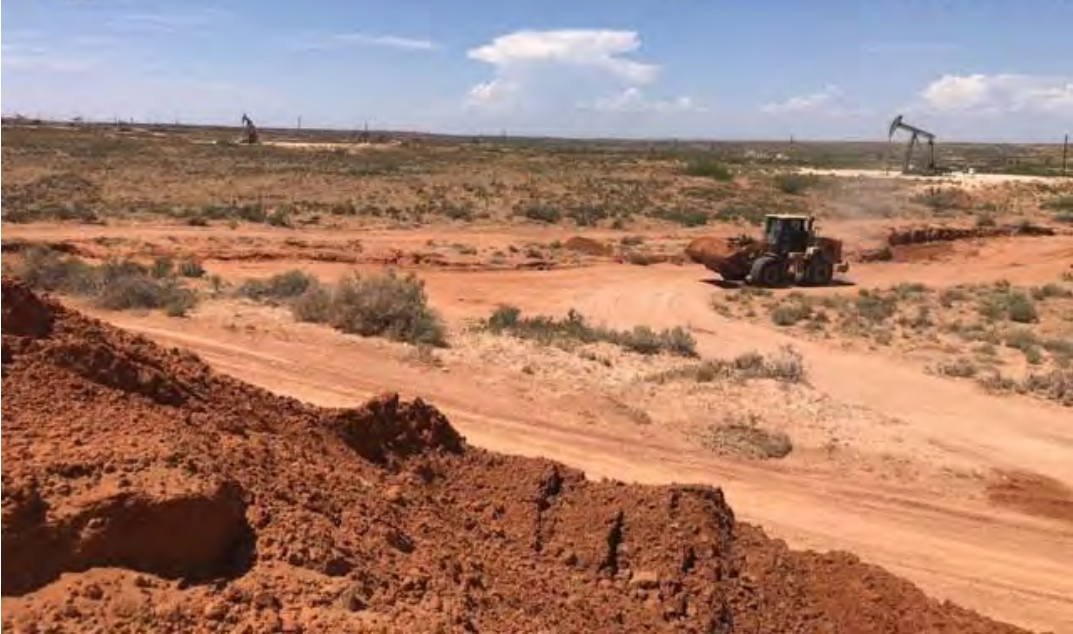
<div>Aug 1, 2023 at 11:35:16 AM +32.825097,-103.884627 221° SW Eddy County</div>

Photo Direction: Southwest	
Photo Description: View of excavated area.

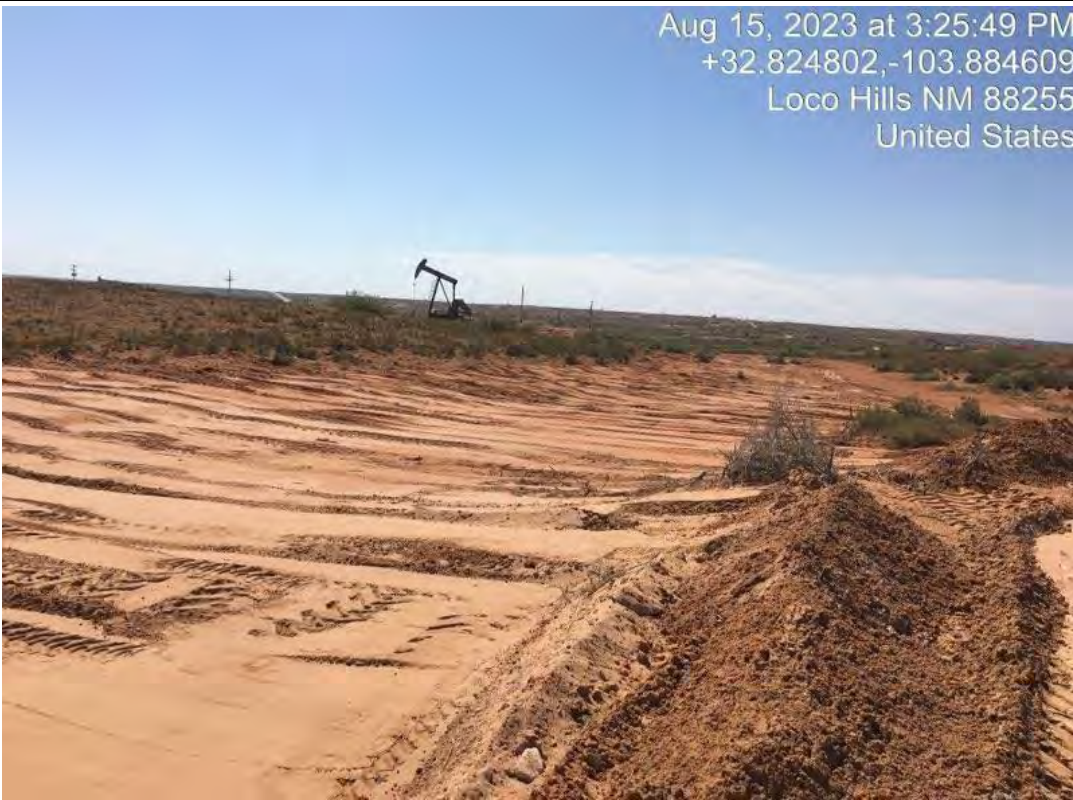
Photo Number: 13	<div>Aug 15, 2023 at 3:25:49 PM +32.824802,-103.884609 Loco Hills NM 88255 United States</div>

Photo Direction: West	
Photo Description: View of area after backfill and grading.

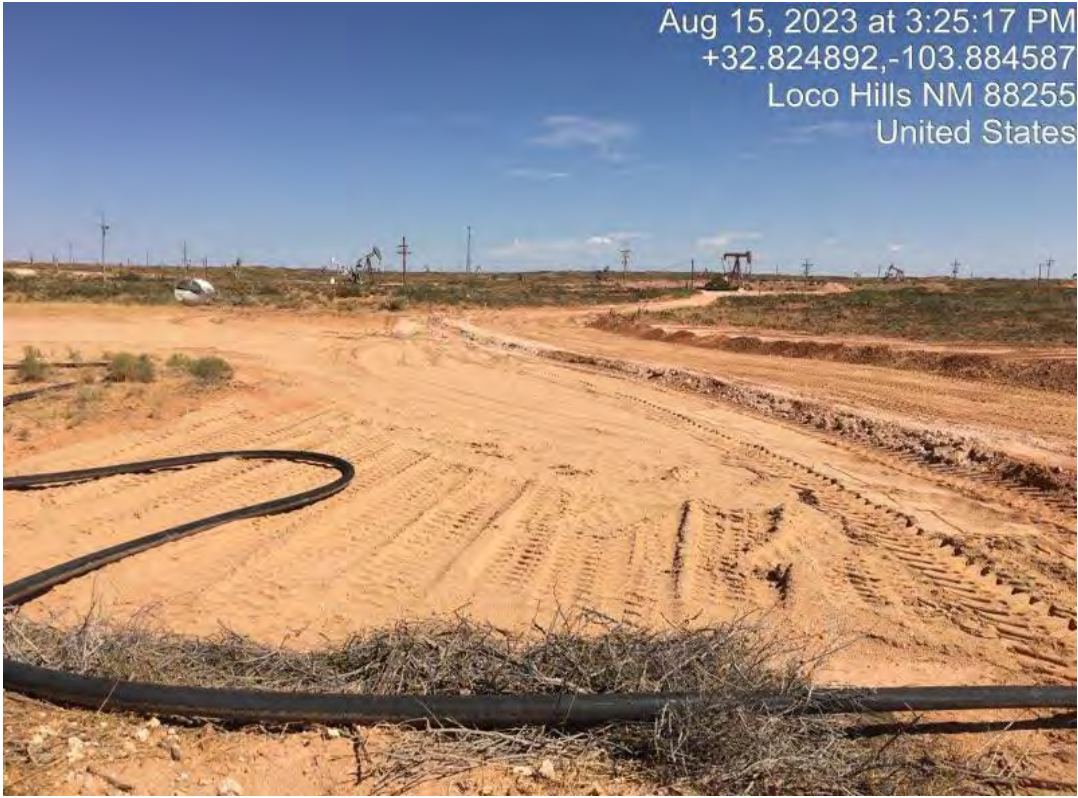
Photo Number: 14	<div>Aug 15, 2023 at 3:25:17 PM +32.824892,-103.884587 Loco Hills NM 88255 United States</div>

Photo Direction: South	
Photo Description: View of area after backfill and grading.

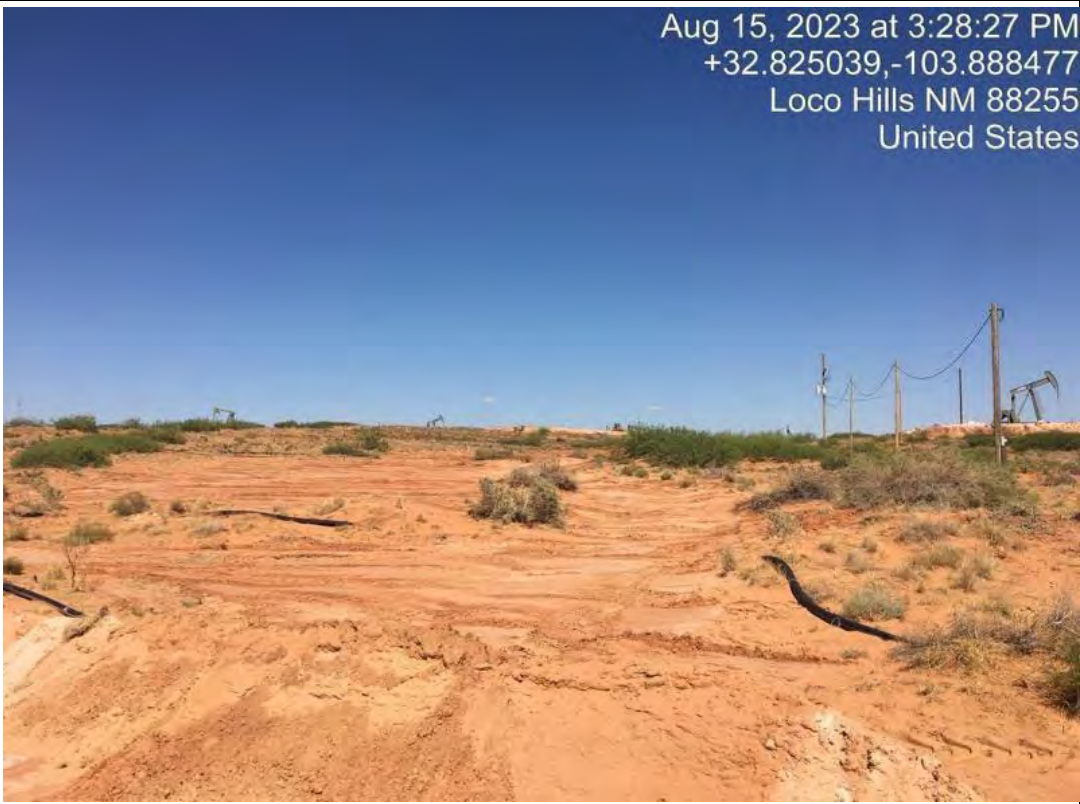
Photo Number: 15	<div>Aug 15, 2023 at 3:28:27 PM +32.825039,-103.888477 Loco Hills NM 88255 United States</div>

Photo Direction: East	
Photo Description: View of area after backfill and grading.

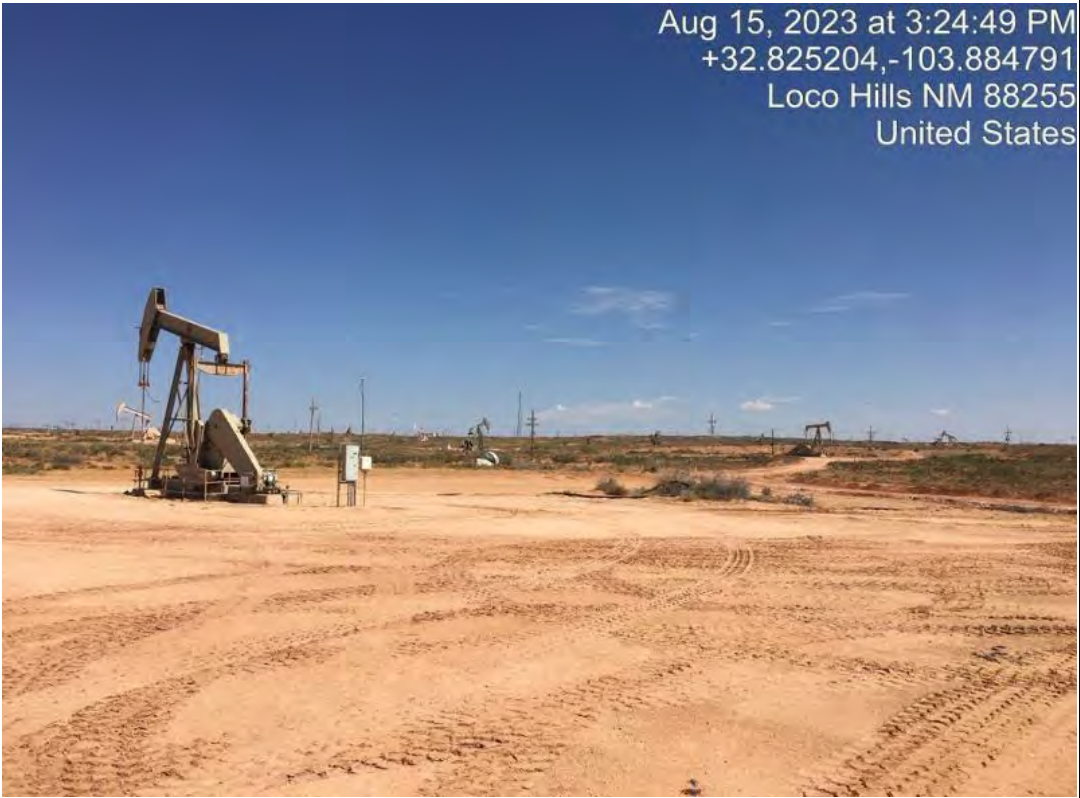
Photo Number: 16	<div>Aug 15, 2023 at 3:24:49 PM +32.825204,-103.884791 Loco Hills NM 88255 United States</div>

Photo Direction: South	
Photo Description: View of area after backfill and grading.
